Experimental investigation of masonry building damage caused by surface tension cracks on slow-moving landslides

Qin Chen^{1,2} · Lixia Chen³ · Renato Macciotta² · Kunlong Yin¹ · Lei Gui¹ · Yu Zhao³ · Yingxue Liao³

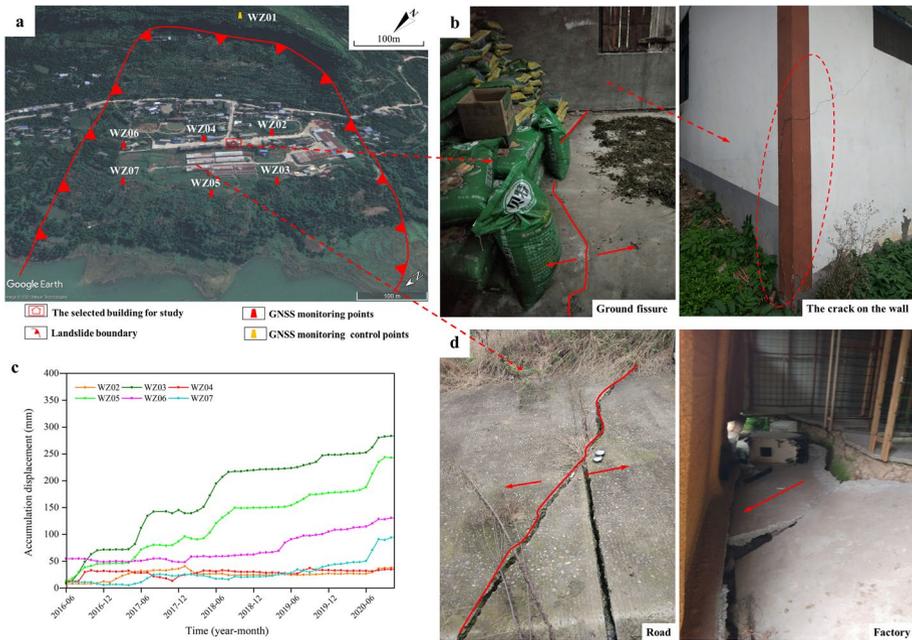
Fig. 1 Damage on masonry structure and road on the Xiangjiaping Landslide. **a** Google Earth image showing the landslide boundary and the location of the damaged building; **b** the ground crack of the damage building and the crack located in the corner of the wall. (taken in January 2019); **c** accumulated ground displacement of Xiangjiaping landslide obtained by GNSS monitoring (the monitoring data was provided by the Geological Environment Monitoring Master Station of Chongqing); **d** the deformation in the lower part of the Xiangjiaping landslide

The selected building for study is located mid-way within the area of the landslide showing the larger deformations. It is a one-story masonry structure. A surface crack developed through the building, paralleling to its longitudinal direction (Fig. 1b). The length and the maximum width of the surface crack were 14 m and 10 mm, respectively. It led to significant damage of the building walls. The crack on the wall extended from the transverse wall to the longitudinal wall along the corner which had a maximum length and width of about 4 m and 10 mm, respectively. Figure 1d also depicts ground fissures, road cracks, and significant differential settlements within the developed area on the landslide.

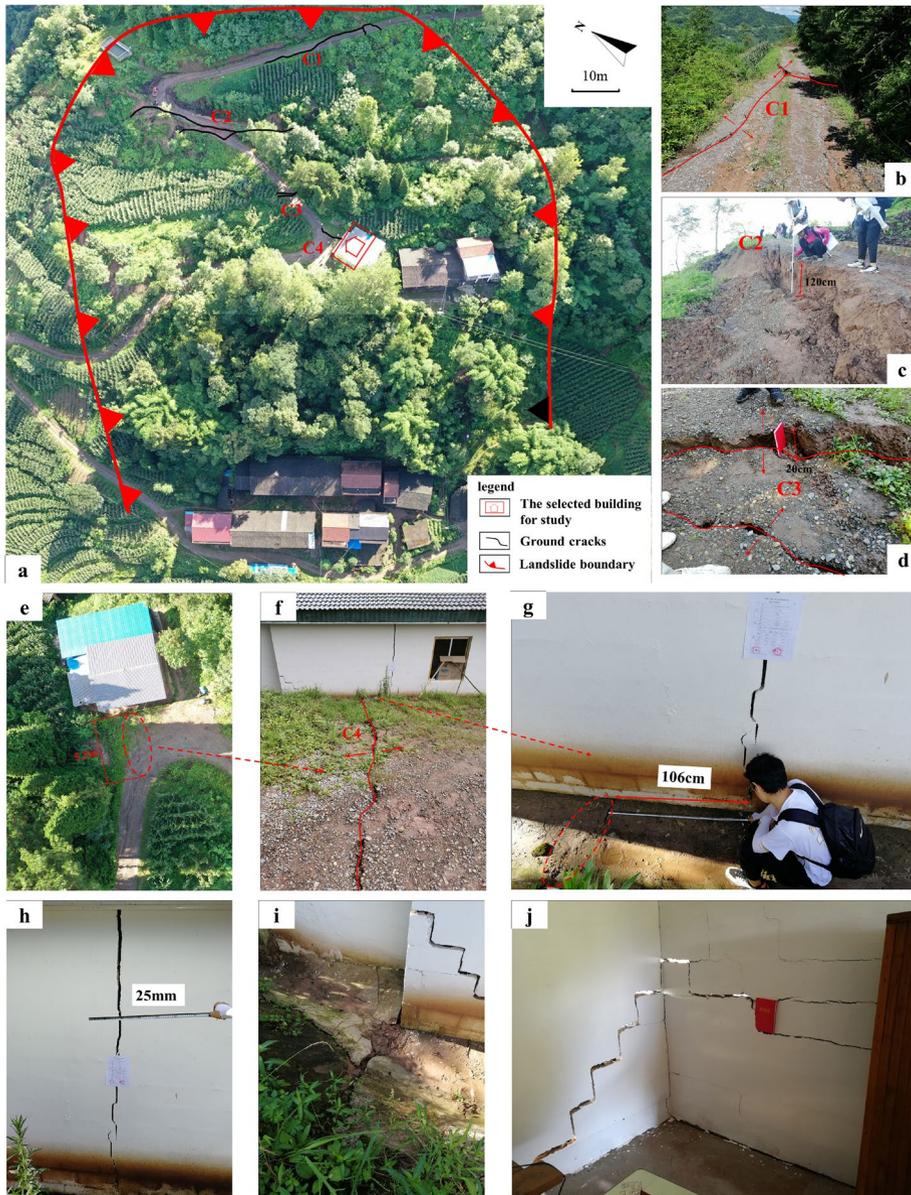
Fig. 2 Deformation on the Lipingcun Landslide and the damage of the building affected by surface crack C4. **a** unmanned aerial vehicle (UAV) image showing the landslide boundary (July, 2020); **b** surface tension crack C1; **c** surface tension crack C2. **d** Surface tension crack C3; **e** surface crack C4 traversing the building; **f** surface crack C4; **g** relative position of surface and wall cracks; **h** vertical wall crack; **i** crack on the corner of the wall; **j** cracks on internal walls

Surface tension crack C4, with a length 5.5 m, width of 10 cm, and maximum depth of 9 cm, severely damaged the walls, both in the transverse and longitudinal direction (Fig. 2f). A vertical crack on the wall was 106 cm distant from the ground crack (Fig. 2g). This vertical crack also occurred on the wall through its total height (floor to ceiling) with a length of approximately 3 m and maximum width of 2.5 cm (Fig. 2h). A diagonal crack (at 45° angle, following the mortar joining the bricks) was formed in a corner of the structure (Fig. 2i, j), rendering the corner of wall very fragile. It was observed in this and other structures that if a wall crosses a surface landslide tension crack, vertical cracks will develop on the wall near the surface landslide tension crack. The diagonal crack along the mortar joints appears to suggest weaker mortar on the corner of the structure and stress concentrations at the observed location. It is likely that the limited further deformation would have led to the collapse of the structure.

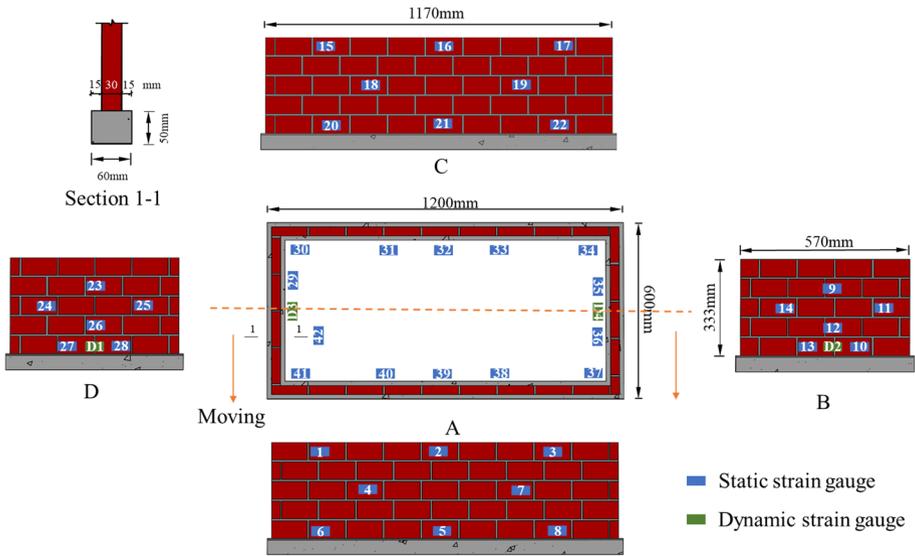
Fig. 4 Model plan (Walls A and C are longitudinal wall; Walls B and D are transverse walls)

Strain gauges were placed on the wall and foundation to monitor their deformation in detail and back calculate the internal forces developed. A total of 42 static strain gauges (collecting data twice per second) and 4 dynamic strain gauges (collecting data 5000 times per second) were installed. The strain gauges were arranged with a higher density at the areas assessed as having the higher potential for developing cracks (Fig. 4).

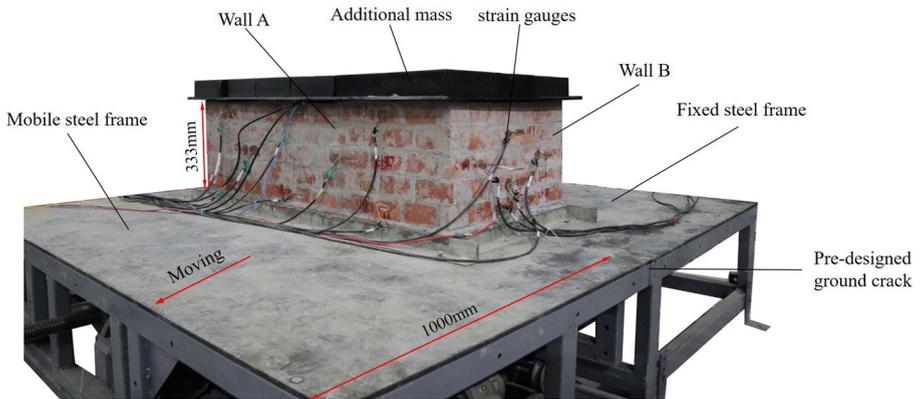
Fig. 5 View of the completed model

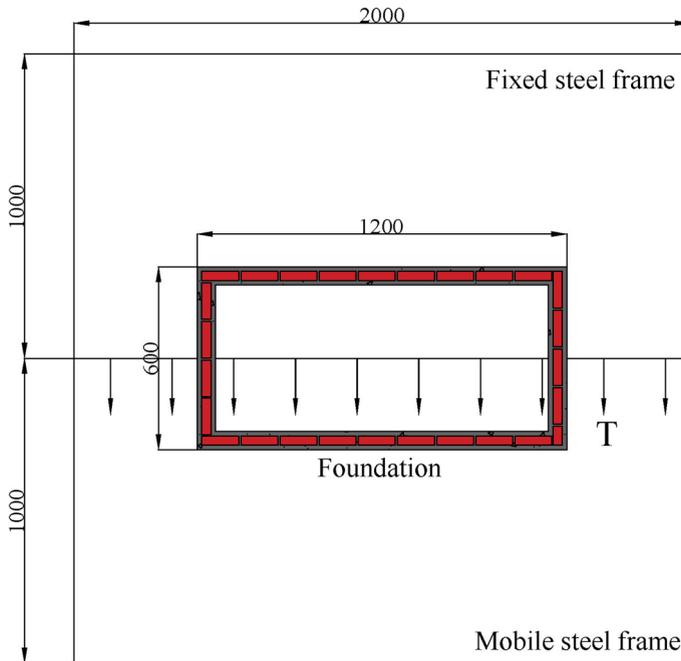
Fig. 6 Tension pattern of the model building's foundation (unit: mm; the "T" denotes the tractive force from the loading device)

cracking. To investigate the model building’s response to the development of a landslide tension crack, the foundation of the model building was subjected to frequency-scaled landslide ground motion in the direction of tension (Fig. 6).

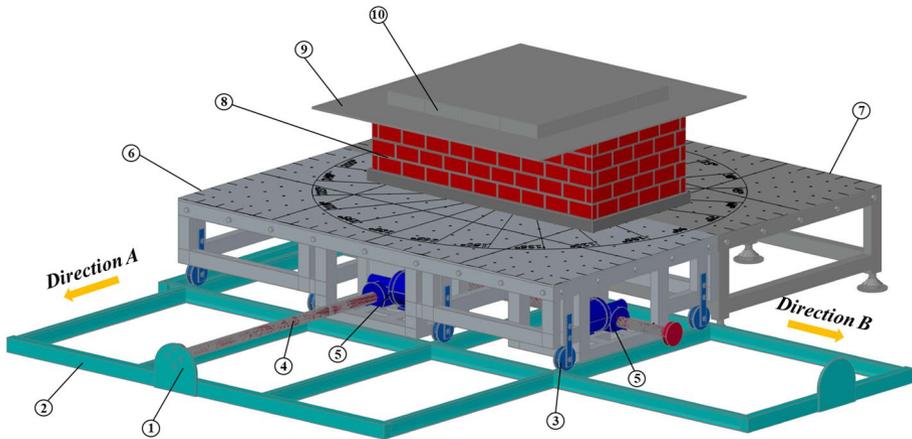
① Reaction frame ② Rail ③ Roller ④ Lead screw ⑤ Electric machinery ⑥ Fixed steel frame
 ⑦ Mobile steel frame ⑧ The model building ⑨ Load-bearing steel plate ⑩ Additional mass

Fig. 7 Diagram of the loading device

The experimental loading device we designed consists of two steel frames (one fixed and one mobile), a drive system that consists of the electronic machinery and a reducer device, a roller, and a rail (Fig. 7). Table 5 shows the characteristics of the loading device. The mobile frame can move along direction A or B. In direction A, the model will be under tension or compression at its base. In direction B, the model will be under shear. The drive system is made up of the electric machinery, lead screw, and reaction frame. In order to control the moving speed of the mobile frame accurately, the frequency of the reducer to change the rotation speed of the screw can be adjusted. The tractive force corresponding to each frequency was calculated according to the parameters of the loading device in Table 5. Figure 8 shows the corresponding relationship between the moving speed and the tractive force of the mobile frame and the frequency of the reducer. The speed, the tractive force, and frequency have a linear correlation. A patent application has been filed for this device (the patent No. ZL 201910793347.9).

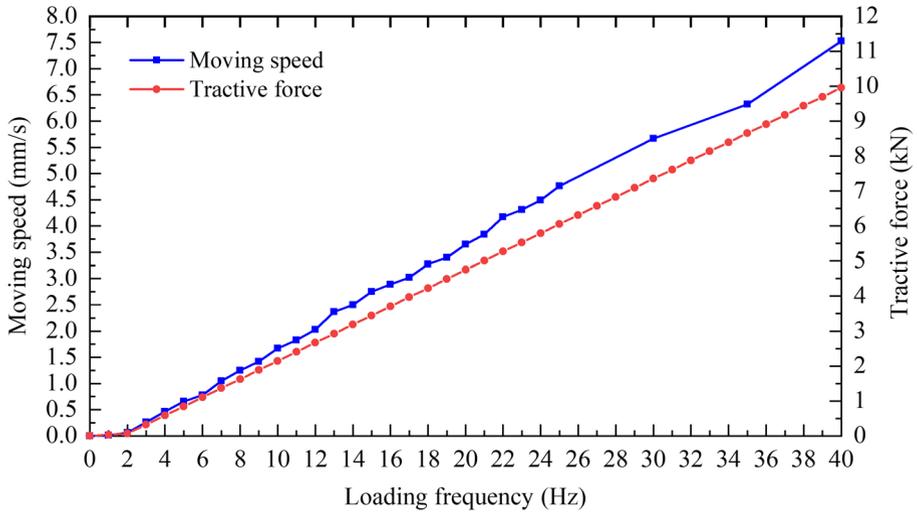
Fig. 8 Relationship between the moving speed and the tractive force of the mobile frame in Direction A

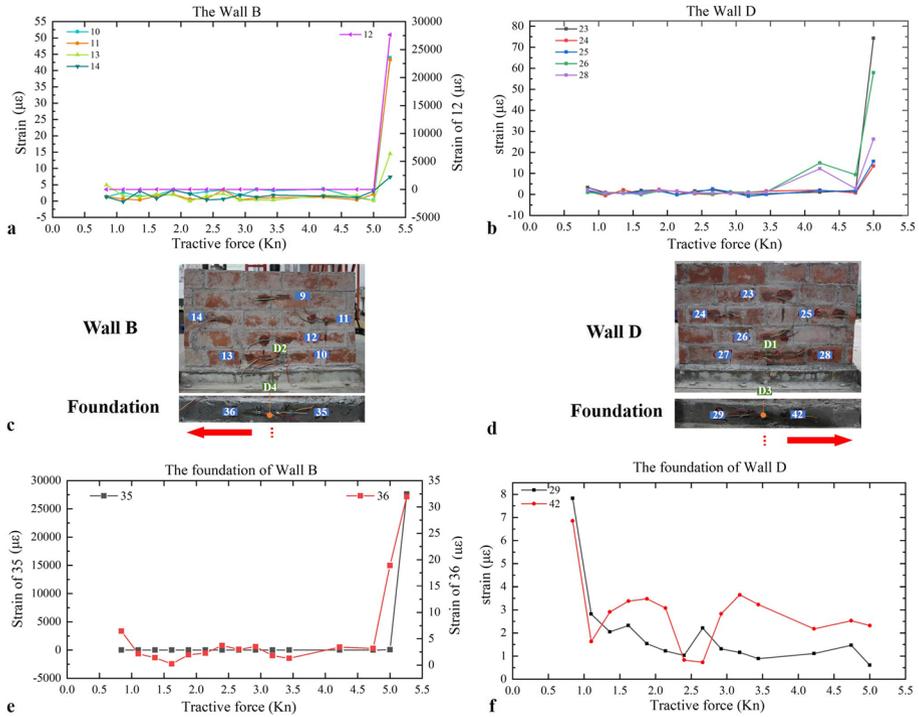
Fig. 9 Measured static strains and locations of static strain gauges on the transverse walls and their foundation. **a** strain response of Wall B; **b** strain response of Wall D; **c** location of strain gauges on Wall B and its foundation; **d** location of strain gauges on Wall D and its foundation; **e** strain response of the foundation of Wall B; **f** strain response of the foundation of Wall D

As shown in Fig. 9a, the strain values associated with each loading increment measured by the static strain gauges in Wall B appear stable and between 0 and $5 \mu\epsilon$. Strain then increased sharply as the loading force approaches 5.26 kN (the strain measured by Strain Gauge 12 increased to $27,628.74 \mu\epsilon$ in the last step). The sudden strain increase corresponds to the nature of the stress-controlled test as opposed to strain-controlled and identifies the moment of wall cracking at the location of the strain gauge. The strain measured by Strain Gauge 10 increased from 0.19 to $43.94 \mu\epsilon$, and the value of the Strain Gauge 11 from 2.12 to $43.3 \mu\epsilon$. The increase in strain measured by other strain gauges is relatively small in comparison. These suggest the internal force in wall B

Figure 9b presents the change in measured strain in Wall D during the test and against the applied force at each step. Up to 4.22 kN, the monitoring strain values in Wall D were also stable. It is observed that the values measured by Strain Gauge 26 and 28 rose about 10 µε for an applied load of 4.22 kN. This indicates that Wall D was subjected to tension at this moment of the test that led to internal forces that are enough to initiate small cracking and fissures (noticed during detail inspection of the video recordings); however, the remaining strength is sufficient to resist the external force and the wall had no large cracking development. When the loading force was 5.00 kN, all strain values increased suddenly, especially Strain Gauge 23 and 26, which are located in the middle of the wall. The measured strain value at Strain Gauge 23 increased from 1.92 to 74.26 µε and the value at Strain Gauge 11 increased from 9.32 to 57.87 µε.

Figure 9e shows that the strains measured at the foundations of Wall B had a similar behavior as those strains measured for the wall. The strain measured by Strain Gauge 35 increased to 27,614.72 µε suddenly, indicating the time of cracking. It is noted from Fig. 9f, that the measured strain values at Strain Gauge 29 and 42 in the foundation of Wall D were between 0 and 8 µε. These changes are very small compared to the other

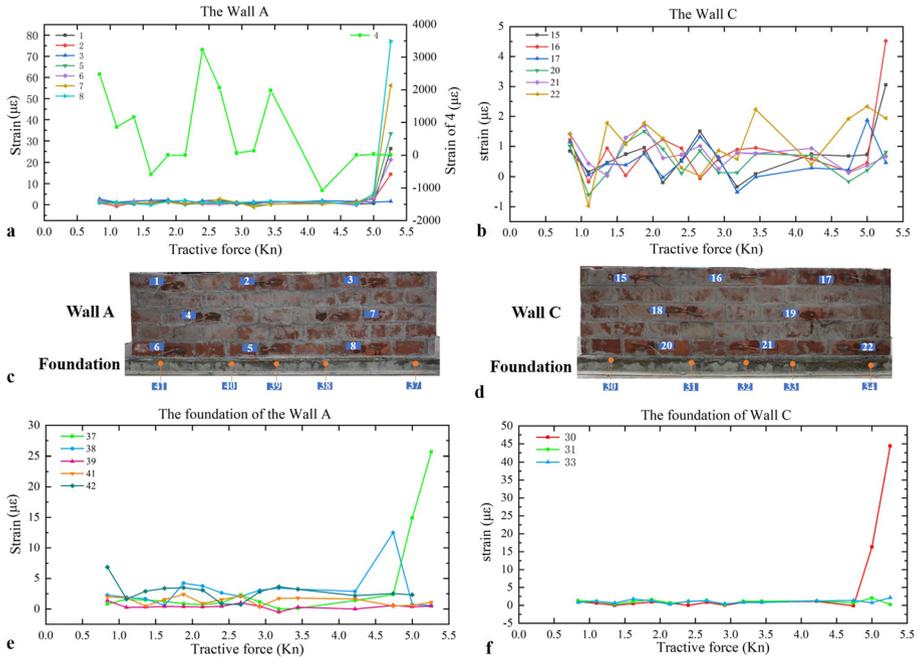
Fig. 10 Measured static strains and locations of static strain gauges on the longitudinal walls and their foundation. **a** Strain response of Wall A; **b** strain response of Wall C; **c** location of static strain gauges on Wall A and its foundation; **d** location of static strain gauges on Wall C and its foundation; **e** strain response of the foundation of Wall A; **f** strain response of the foundation of Wall C

Figure 10a shows that the measured strains in Wall A prior to the load step of 5.26 kN were stable except for Strain Gauge 4. The measured strains in all other strain gauges had a similar response to those in Wall B and Wall D, greatly increasing at the 5.26 kN step. This indicates that the macro-cracks initiated on Wall A at this final step. Strains measured at the strain gauges on Wall C ranged between -1 and $5 \mu\epsilon$ during the whole loading process (Fig. 10b). No macro-cracks were observed on this wall at that stage.

Figure 10e and f presents the measured strain response of strain changes at the foundations of Wall A and Wall C. The strain values were stable during the test except for the strain measurements at Strain Gauge 37 and 30. The strains at Strain Gauge 37 and 30 increased significantly during the last two stages of the test to maximum values of $25.66 \mu\epsilon$ and $44.4 \mu\epsilon$, respectively. These two strain gauges were placed near each corner of the foundation.

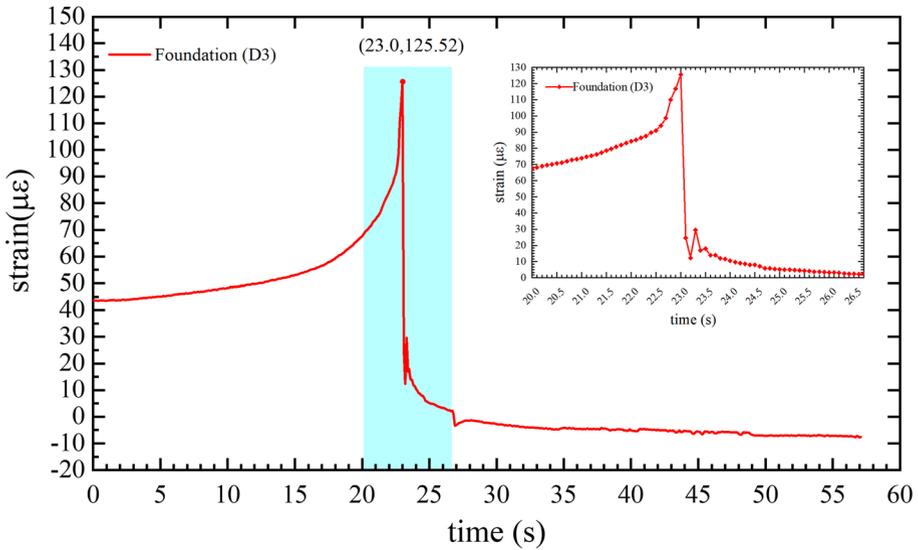
Fig. 11 Dynamic strain measured at the foundation of Wall D during cracking at the stage associated with a loading force of 5.00 kN

When the loading force transmitted through the mobile frame reached 5.00 kN, the measured strain at the strain gauge in the foundation of Wall D increased to $125.52 \mu\epsilon$ after 23 s of the loading being set (Fig. 11). This suggested the progressive cracking of the foundation at the position of the dynamic strain gauge D3 (See Fig. 9c). Once the

foundation collapses through cracking at a different location, the strain measured at D3 decreased rapidly due to a relief in the internal stress. It is noted that the strain recovery is total.

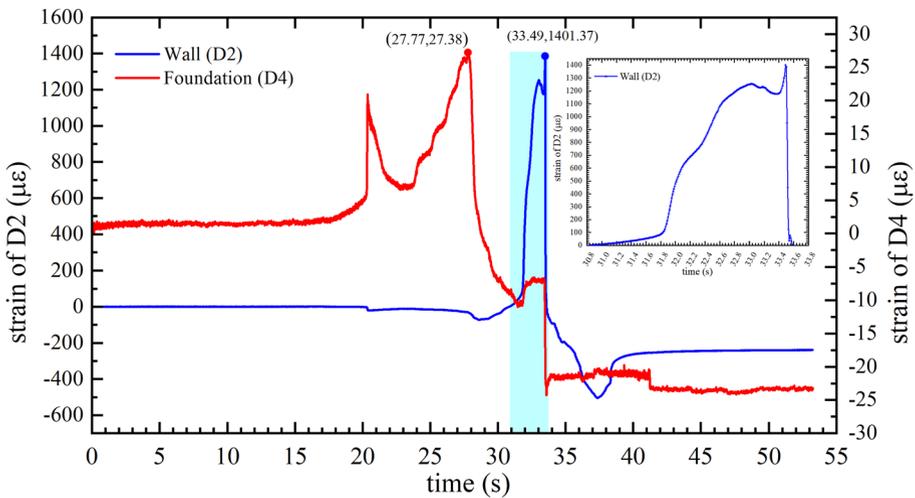
Fig. 12 Dynamic strain measured at Wall B and its foundation during cracking at the stage associated with a loading force of 5.26 kN

Wall B and its foundation began cracking at the stage associated with a force of 5.26 kN. Observations during the test identified that the foundation was damaged first, and then cracks appeared on the wall. Figure 12 shows the time elapsed between

foundation and wall cracking was 5.72 s. The maximum measured strain of the wall was $1401.37 \mu\epsilon$. Strains decreased rapidly after the foundation and wall crack significantly.

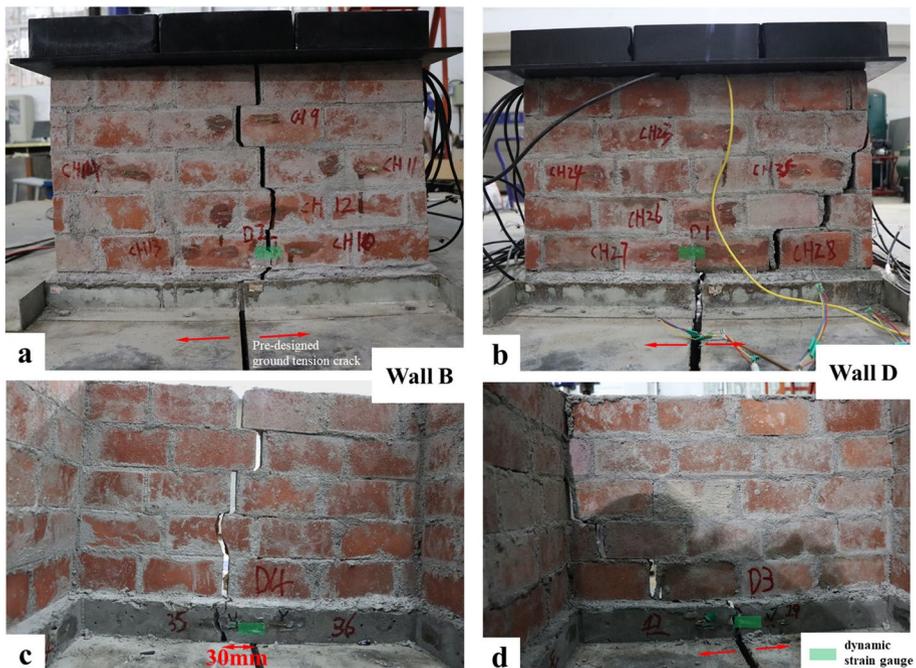
Fig. 13 Distribution of cracks on Wall B and Wall D. **a** outer surface of Wall B; **b** outer surface of Wall D; **c** internal surface of wall B; **d** internal surface of wall D

Wall B cracked at 34 s after application of the stage associated with a loading force of 5.26 kN (Fig. 13a and c). The crack was observed to increase with the sustained load. At first, the crack appeared on the foundation of Wall B, and then extended to the wall itself.

Foundation D cracked 23 s after application of the stage associated with a loading force of 5.00 kN. However, there was no obvious crack evolution with sustained loading. This suggests the overall reminding strength is greater than the tension applied through the mobile steel frame. At the stage associated with a loading force of 5.26 kN, the crack width was increased and it extended to the corner of the wall, at the connection with Wall A (Fig. 13 b and d). A diagonal crack of 45° was formed in wall D along the mortar joints (Fig. 14a). Another diagonal crack extended from the corner where the wall meets Wall D and to the top of the Wall A at an angle of 45° and along the mortar joints (Fig. 14b). As shown in Fig. 15, the crack in the foundation was 30 mm distant from the simulated ground crack. A vertical crack formed on the wall from bottom to top, and along the brick and mortar joint.

Common characteristics include that wall cracking mostly occurs in proximity of the location where the surface tension crack develops in the ground, and that wall corners show to be very fragile. The diagonal crack along the mortar joints usually appears on the corner of the wall, which seriously compromises the structure integrity and further movement is likely to lead to a total collapse. This damage characteristic is verified by the filed observation and some literatures (Antronico et al. 2015; Somma et al. 2020) as shown Fig. 16. Due to the weak tensile resistance of the masonry structure, when the masonry structure is damaged under the ground tension cracks, the wall cracks are easy to appear on the bottom of the wall and then extend to the wall corner, along the mortar joint with an angle of 30° or 45° . Meanwhile, when the wall across the ground cracks, the vertical cracks generally appear in the wall and extend from the bottom to top of the wall. Figure 17 shows the wall crack patterns and the ground surface cracks on the slow-moving landslides which is similar to the experimental results (Fig. 13a and c).

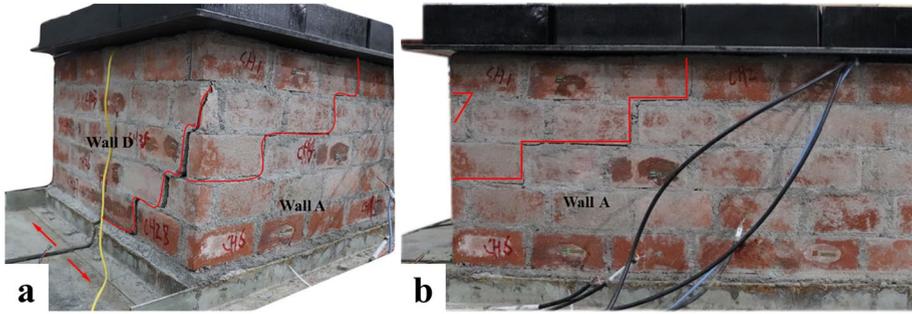
Fig. 14 Distribution of cracks on Wall A and Wall D. **a** Crack at the corner between the Wall A and Wall D; **b** cracks on Wall A

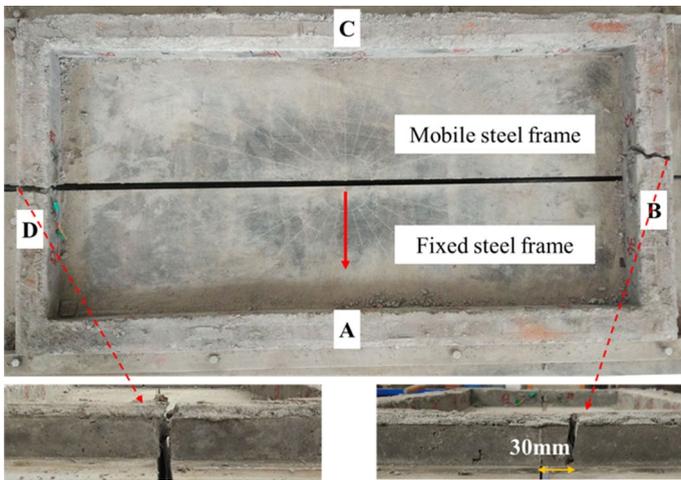
Fig. 15 Cracks at the foundation

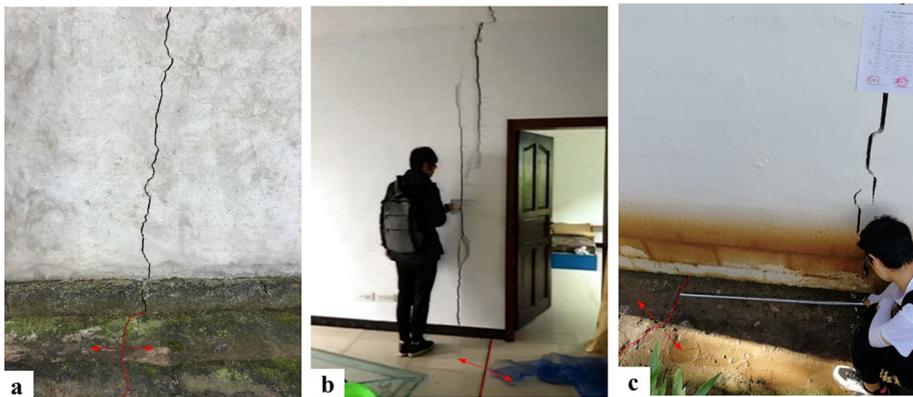
Fig. 17 The wall crack patterns and the ground surface cracks on the slow-moving landslides. **a** and **b** The photographs were taken by January 2019, in the Tangjiao landslide. **c** The photograph was taken by July 2020, in the Lipingcun landslide

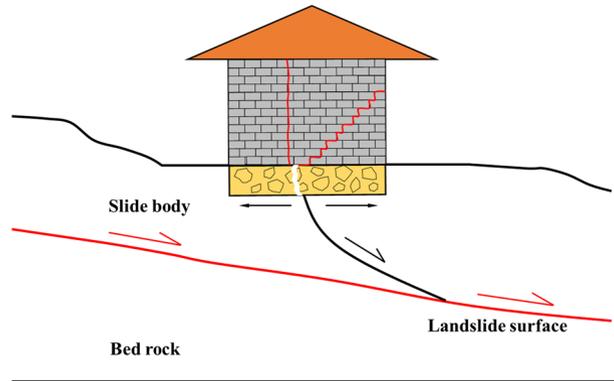
Fig. 18 The damage pattern of the masonry building affected by the tension crack on the slow-moving landslide

- (1) Buildings affected by tensile deformation are usually located at the crown or the toe of the landslide. These places are prone to transverse ground cracks in the rock and soil mass under gravity due to external factors. When the ground crack passes through the wall of the masonry buildings, it causes damage to the structure.
- (2) Because masonry structures have weak tensile resistance, when they are subjected to surface tensile deformation, the buildings are prone to oblique cracks extending from bottom to top along the mortar joints at 30° – 60° toward the wall corners.
- (3) When the ground crack goes through the wall, the wall usually develops vertical cracks extending from bottom to top through the wall. The floor, walls, and junctions between walls of the building appear cracks with basically the same width up and down, as shown in Fig. 18.

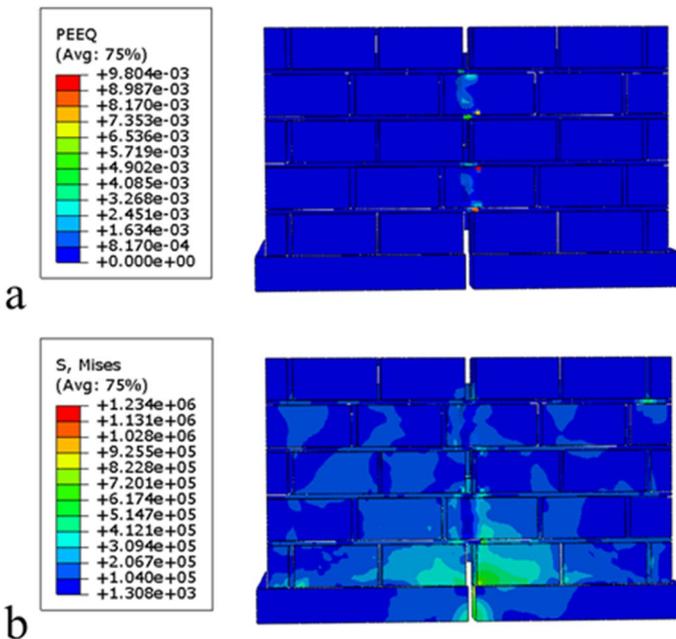
Fig. 19 The numerical simulation results. **a** The equivalent plastic strain distribution of the test model wall. **b** Mises equivalent stress distribution of the test model

the test, the simulation obtained the equivalent plastic strain and crack distribution of the model, as shown in Fig. 19a. A vertical crack appeared in the middle of the wall and extended upward from the bottom of the foundation to the top of the wall. The model damaged patterns of the numerical simulation are basically consistent with the experimental results. As shown in Fig. 19b, it shows the stress distribution of the wall with spanning the ground tension crack. The Mises equivalent stress is represented by stress contour to show the stress distribution of the model, which can quickly determine the most dangerous area in the model. The foundation and bottom of the model wall are under tension, which is basically consistent with the experimental results.

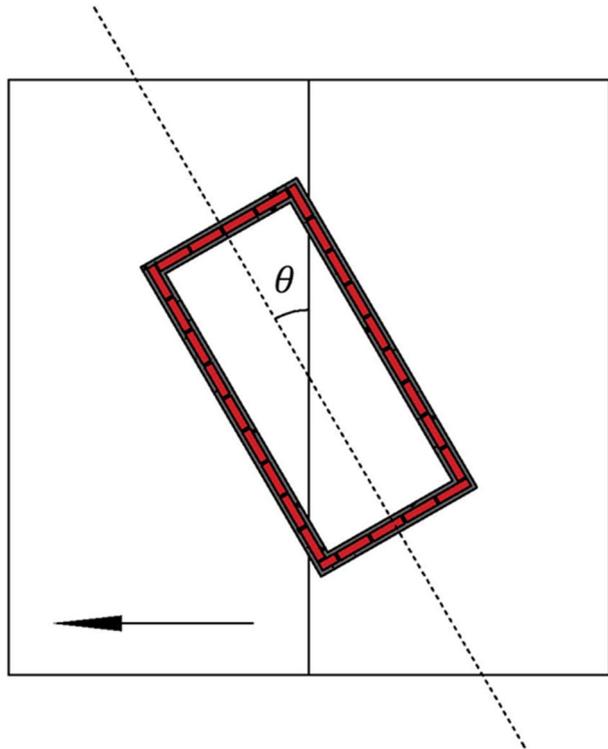
Fig. 20 The different loading angle of the masonry model

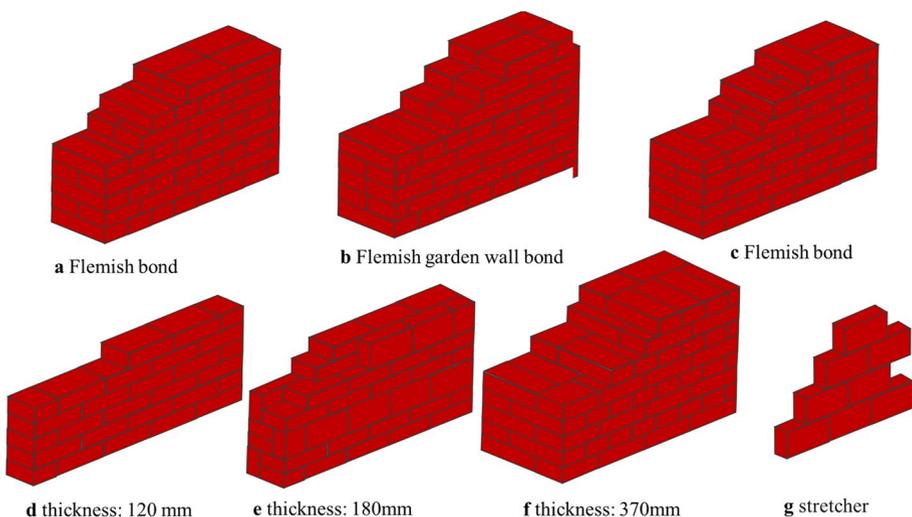
Fig. 21 Masonry construction methods

Meanwhile, the results of the experiment suggest that brittle failure of these structures under landslide-induced ground tension cracks. Increasing the ductility of the structures through implementation of reinforced masonry construction methods and reinforcement of the wall corners could be implemented to provide more structural stability and warning of impending collapse to residents.
