OPEN-HEARTH FURNACE STEEL MELTING BATH REFRACTORY SERVICING

Translated from *Novye Ogneupory*, No. 6, pp. 7–10, June 2010.

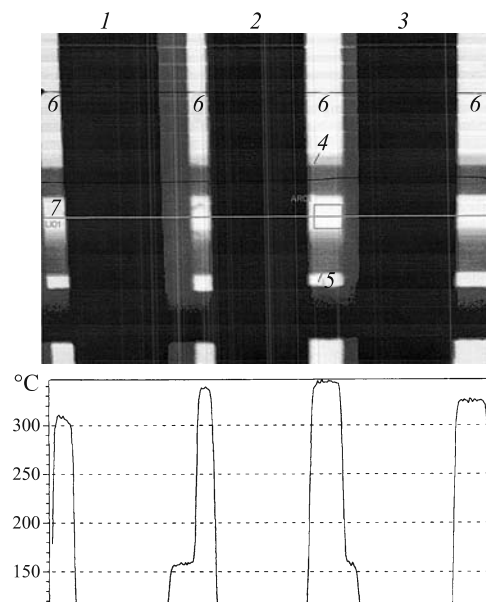
Fig. 2. Central part of hearth: 1 – 3) longitudinal beams; 4, 5) transverse beams; 6) hearth metal sheet; 7) surface with maximum temperature 348.8°C.

Towards the end of a furnace campaign the state of the hearth lining differs considerably in a worse direction (Figs. 1 – 3). The results obtained from recording the temperature field of the hearth metal sheet directly point to the intense wear of the sintered layer and the unsatisfactory state of the bath surface. A local increase or reduction in sheet temperature signifies a local change in refractory lining thickness. In contact areas of the surface of the sintered layer presence of lining wear was noted in the form of depressions (pits) or swelling in the form of bumps (build-ups).

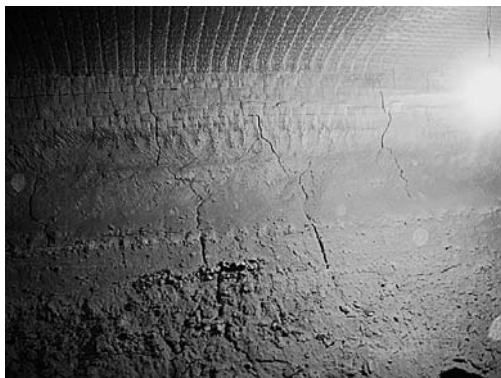
Fig. 4. Bank over rear wall.

nace shutdown, for intermediate and cold repair leads almost to breakdown of the sintered layer integrity. At its surface transverse and longitudinal cracks of different width appear (Figs. 4, 5). The monolithic nature of the surface of the sintered layer is disturbed due to metal or iron oxide reduced with carbon [2, 4], most intensively at the end of the period of charge melting and at the time of deoxidation. It has been established [4, 5] that during melting of a charge and bath boiling there is a progressive reduction in the content of magnesia-ferrite, magnesia-wüstite and monticellite within the sintered layer composition. Over the working surface of the hearth metal droplets are distinguished with a size of 1–2 and 0.3–0.4 mm at a depth of 10 mm or more. The structure of the sintered layer at the end of these periods is presented in Fig. 6. Mainly it is the final residual structure that points to periclase grain refinement.

periclase powder, laid to the level of the threshold of the charging doors, a layer of scale is added calculated at 5 – 50% of the total powder weight. Scale from rolling production previously ground and dried is used for this purpose. Scale $\text{FeO}\cdot\text{Fe}_2\text{O}_3$ contains a wüstite component, i.e. the FeO is always greater than Fe_2O_3 , and its melting temperature is 1370 – 1410°C. During warming scale and its reaction with periclase powder forms a melt that fill hearth cracks and promotes adhesion of the newly poured powder layer with the main part of the sintered layer. The restoration method in question for the sintered layer has undergone successful testing and shown reliable results.

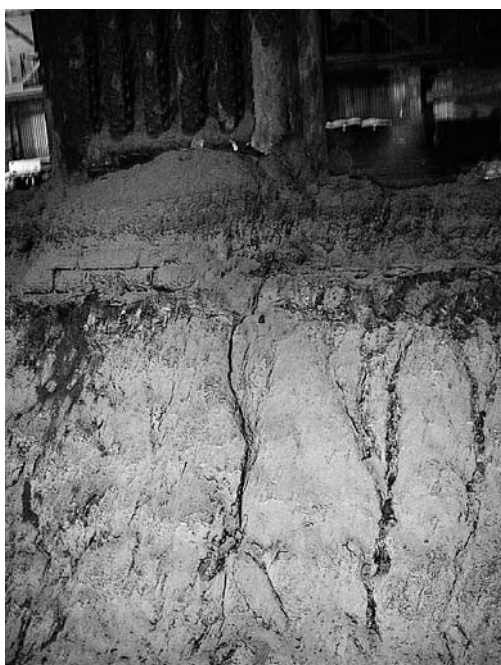
Fig. 5. Bank over front wall.
