OPERATIONAL PROBLEMS OF A GRAPHITIZED CATHODIC BLOCK LINING IN CONTEMPORARY ALUMINUM ELECTROLYZERS

A carbon lining in the form of cathode blocks with a different graphite content under electrolyzer conditions is subjected to mechanical wear as a result of rapid melt movement, and this is more significant than for amorphous carbon blocks. The problem of operating a graphitized cathode block lining is discussed. After performing an autopsy for cathode units the condition of some aluminum electrolyzer lining sections with blocks having a different degree of graphitization is studied. Reasons are examined and determined for premature electrolyzer breakdown with graphite-containing hearth blocks. Results are provided for temperature measurement of high-power electrolyzer cathode units.

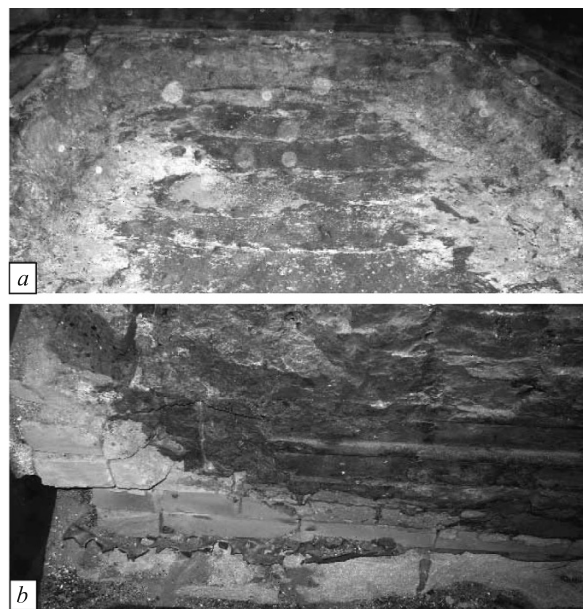
In order to evaluate hearth quality of contemporary electrolyzer with baked anodes after service on average of more than 900 days dry knock-out of the electrolyzer shaft was performed (autopsy for hearth sections). Visual examination of graphitized hearth of an electrolyzer showed (Fig. 1a) that wear of the cathode surface is identical without swelling of areas and sites of electrolyte penetration. It is seen that failure in a lining was minimized, and stability of the position of blocks was achieved due to thermophysical properties of carbon-graphite layer of a lining that provided stable heat balance with refractory layers, especially in the lower part of the socle (Fig. 1b). No large cracks were observed during examination of transverse sections of carbon-graphite blocks.

A carbon-graphite hearth has typical disadvantages in the form of manufactured cavities of cathode blocks with depth up to 10–20 cm. It should be noted that joints between blocks remain almost unchanged, but the hearth has a contoured nature of surface with wear among it. In some dismantled cathode units metal penetration is observed into the refractory socle in the form of plates with a size of 10–15 mm in joints between bricks. Accumulation of metal in the lower part of the socle beneath CCM blocks (in the region of blooms) points to formation of free surfaces and cracks during operation. Current temperature measurements

Fig. 1. Hearth surface condition constructed from graphitized blocks with 70–80% graphite (a); b) block cross section.

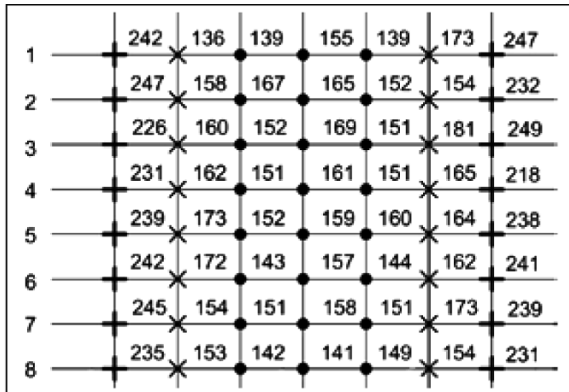
Marked local changes in outer temperature with standard measurements by means of contact thermocouples at the bottom of the cathode casing reveal where and when metal penetrates quite deeply through joints between blocks or cracks in a lining followed by movement over the top of the dry barrier layer (DBL). It is possible to determine the position of aluminum introduced into a lining after performing instructions for the procedure, i.e., measurement of bloom tempera-

Fig. 2. Temperature field of the bottom (●), blooms (+), and wall section (×) of an electrolyzer cathode casing with baked anodes.

ture, outer side walls, and bottom of the cathode casing. The nature of the temperature field of the cathode casing surface, bloom temperature and current distribution through blooms, may serve as evaluation criteria for current cathode condition. The more metal penetrates into a lining, the more significant is the change in hearth background temperature, and consequently the casing bottom temperature. Temperature is measured over the surface of the bottom of a cathode unit over projection of the axis for each bloom at three points, i.e., in the center at the intersection of bloom projection with a longitudinal axis of the electrolyzer and at two points in areas of intersection of projections of bloom axis with the projections of the anode contour on the bottom. A temperature field is shown in Fig. 2 for bloom, bottom and side walls of a cathode casing of a test electrolyzer with cathode blocks containing 70–80% graphite. Temperature values are confirmed and related with higher measurements of values of stress drop in blooms Nos. 3–7.

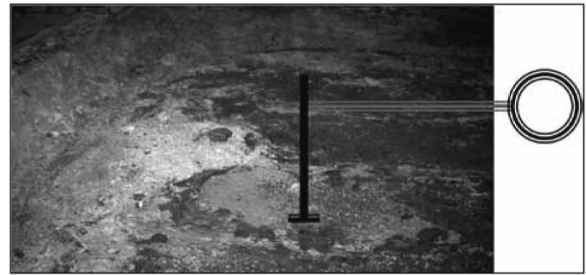
Fig. 3. Measurement of cathode surface mechanical wear.

Measurement of the depth of cathode block hearth depletion with a different degree of graphitization confirms the dependence of the degree of mechanical wear on graphite content. At a point of maximum erosion the residual graphite layer thickness is 7–8 cm. The nonuniform level of carbon block depletion may be explained by presence of localized regions with high current density due to its nonuniform distribution over a hearth [8]. In order to predict electrolyzer service life it is necessary to carry out autopsy of a considerable number of electrolyzers. From the data obtained it is possible to determine the depletion rate for hearth surface layers in relation to electrolyzer service life. Taking account of the degree of cathode section graphitization the rate of hearth erosion in relation to service life with conformity of temperature values for the bottom of the casing with a drop in stresses in blooms (by means of measurement with a special Γ -shaped probe in the center of the hearth) it is possible to predict electrolyzer operation as a whole. Measurements were performed both for switched-off and active electrolyzers from the center of the hearth and its sides (Fig. 3).

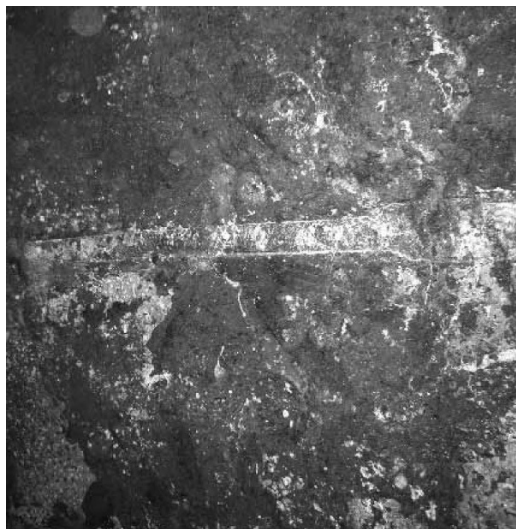
Fig. 4. Longitudinal cracks along hearth block.

quality and knock-outs corresponded to the standard. However, during autopsy block spalling was observed, formed during knock-out of joints into which melt penetration was more intense. It should also be noted that infiltration of fluorine salts into a refractory socle and DBL not only occurs along the joint-block boundary, but also through small vertical cracks in graphite hearth blocks (Fig. 4). A significant number of these cracks was detected in blocks in sections of maximum hearth deformation, which form during hearth swelling.
