# Motor Vehicles: Are They Emerging Threats to Lake Victoria and its Environment?

**Abstract** Lake Victoria and its basin supports more than 30 million people, while its fishes are exported the world over. This second largest fresh water body is however experiencing stress due to *eutrophication*, *sedimentation*, *declining levels* and more recently the *motor vehicle sector*. This contribution examines the general pollution from motor vehicle and gives an in-depth analysis of motor vehicle washing along the lakeshore. The results indicate the water samples from the motor vehicle washing and urban runoff points to be slightly acidic (i.e., average pH of 6.7) and average Total Phosphorus levels of 0.4 and 2.4 ppm respectively. This implies that there was high soap input at these points. The conductivity for the motor vehicle washing points averaged at 150  $\mu\text{S}/\text{cm}$ , while the urban runoffs point was more varied ranging from below 150  $\mu\text{S}/\text{cm}$  to over 400  $\mu\text{S}/\text{cm}$  (average 301  $\mu\text{S}/\text{cm}$ ). A positive correlation coefficient of more than 0.7 is obtained between the total daily count of vehicles and each of the water q

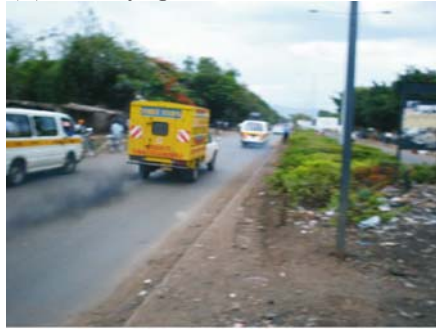
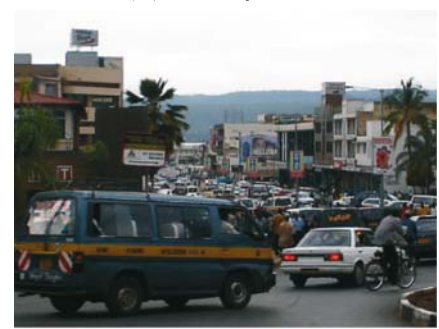
**Fig. 1** Vehicle congestion and exhaust pollution**(a)** Heavy gas emitters

**(b)** Heavy traffic

during 2004 is summarized in Table 1 (KCEP, 2005), while the congestion is depicted by Fig. 1b. Most of the vehicles within the town, and indeed the whole country, are of the old generation which cannot run sustainably on unleaded fuel. The high lead content combined with the low combustion efficiency of the old type of engines lead to emission of high volumes of exhaust gasses, which contain semi-combusted fuels combined with worn out engine parts and waste oils, hence high concentration of particulate matter in the air (Fig. 1a). These contributes towards atmospheric pollution of the Lake Victoria, leading to further eutrophication. Atmospheric pollution has been shown by (LVEMP, 2003) to be the leading pollutant of the lake contributing more than 30%. Tamatamah, Hecky, and Duthie (2005) puts the total atmospheric pollution of Lake Victoria to 55%. Major motor vehicle related activities which end up polluting the Lake as runoff included; *sand transportation from the beaches, bus park, garages* (locally known as ‘jua kali,’ translated as hot sun since people work in open areas) and the *oil depots* or Petrol stations (Fig. 2).

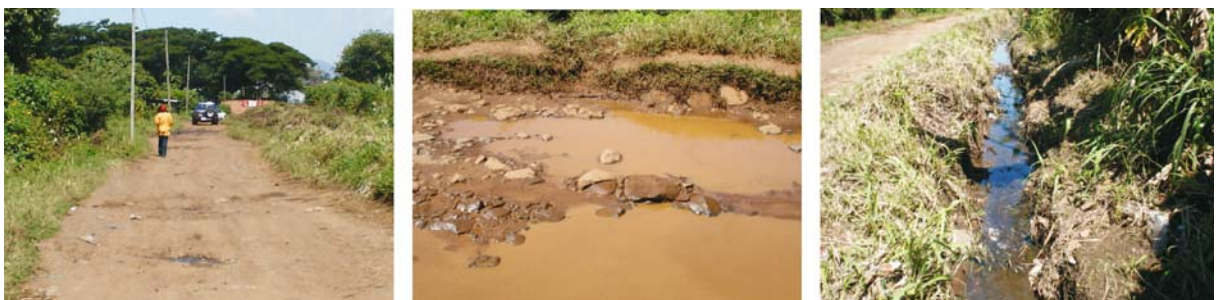
**Fig. 2** Eroded earthen roads and trenches at some of the beaches

Sand harvested within the beach are normally transported using Trucks. These were noted to enhance soil erosion of the roads causing the formation of ruts on the roads. In a study conducted for a duration of three months commencing from 6th November 2005 to 7th February 2006, an average of 14 lorries/day transported sand from Usoma beach (the leading sand mining beach in Kisumu). They carried averagely 119 tones per day. Such rate estimated in a year of 365 days forms 43,435 tones collected from the beach. With these weight, the roads are eroded and fill up with muddy water and eventually end up in the lake during rainy seasons contributing to sedimentation of the lake.

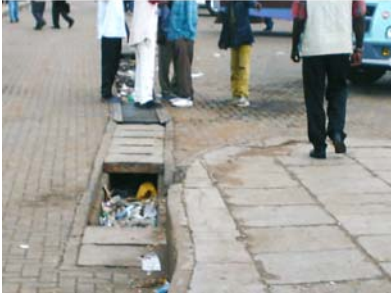
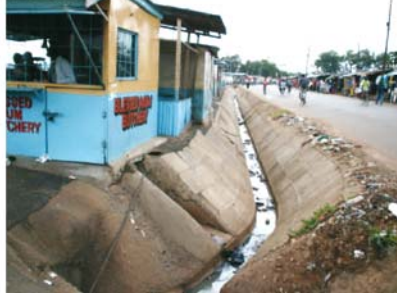
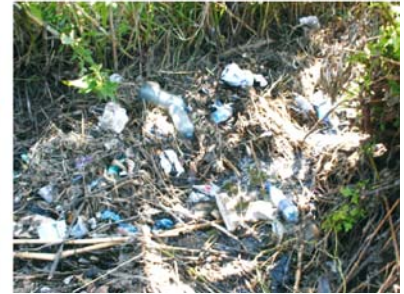
**Fig. 3** Waste accumulation at bus termini

Waste disposal in drains

Waste gets into main drain

package waste at Lake Shore

park. The provision for vehicle parking and transport however comes with the need for provision of services for the passenger-generated waste which is not the case for Kisumu. Passenger waste thus result in severe waste problems at the Kisumu bus park, the highways and taxi parking. This has seen the accumulation of both liquid and solid wastes at the termini. With the low waste services in the town, most of the wastes end up in the drains hence blocking them during rainstorms or swept into the lake via these drainage channels as illustrated in Fig. 3.

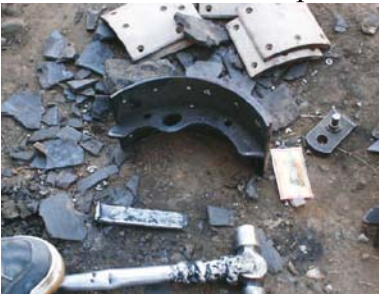
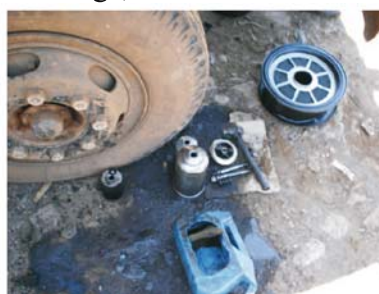
**Fig. 4** Wastes from vehicle repair known as Jua Kali

Old and broken brake pads

Bearings, air and oil filters

scrapped paint and scrap metals

dumped at site which eventually find their way into the Lake during runoffs (see, e.g., Fig. 4). From these garages, Spray painting of vehicles also contribute to the metal content of the runoff. This is in the form of the fillings from the old paint work (Enamel) before spraying, the actual spraying, and washing of the sprayed vehicles (see, e.g., Fig. 5). Welding is the other form of pollution at the Jua Kali garage. Vehicle repairs involve some welding in the body work, as well as the making of other metal products like grills for doors and windows. Welding is done using electric arc welder, oxy acetylene gas, as well as using kerosene burners. The fumes emitted from the welding processes are not only harmful to the welders but to the general public as well as the environment.

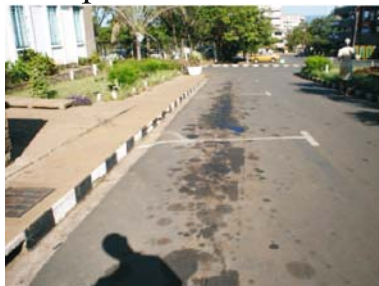
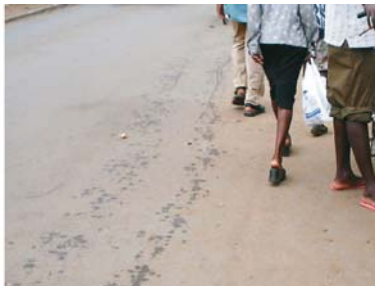
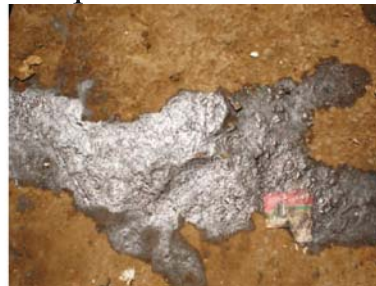
**Fig. 6** Oil spills

**Oil spills on tarmac roads**

**Oil spills on earthen roads**

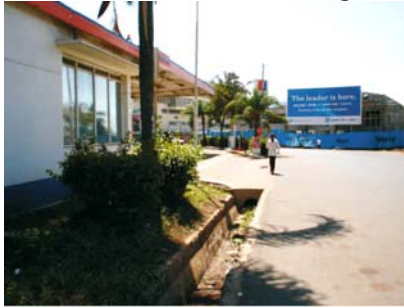
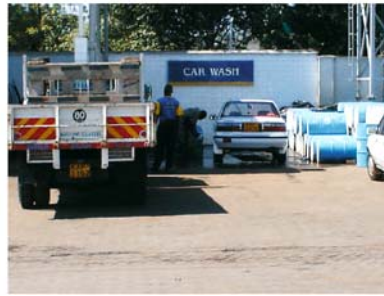
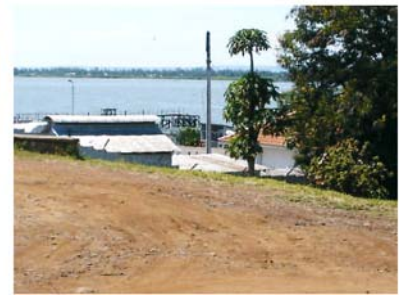
**Fig. 7** Petrol station operations and the Caltex petrol depot at the lake side

## The waste water drainage

## Car washing

## The Lake side Caltex depot

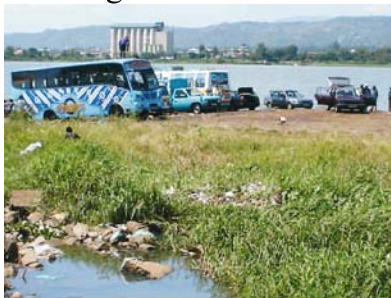
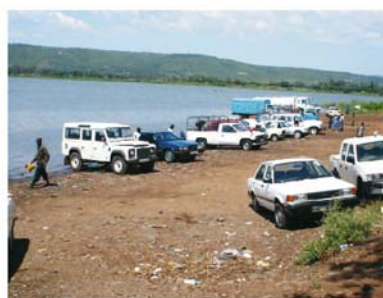
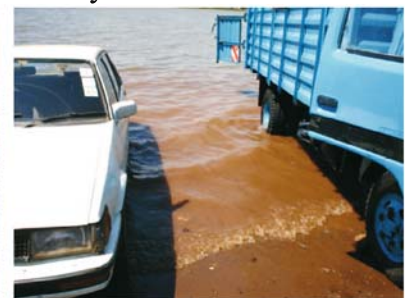
**Fig. 8** Direct motor vehicle washing at Kichinjio beach

## Washing of Busses

## Small cars and Tankers

## Dirty water

accumulated in transit are all washed into the lake. Some of the vehicles have leaking systems hence the oils or the fuels drip into the lake, causing further problems. As can be seen in Fig. 8, the shores are no longer supporting the original vegetation or other small life forms, due to the conscious removal by the motor vehicle washers or possibly due to the decrease in the oxygen levels in the water occasioned by oil covering water surface. Oils washed off the vehicles (particularly petroleum vehicles, e.g., Fig. 15) floats on water surface forming a seal, hence reducing the amount of oxygen available in water for the survival of the flora and fauna. This would interfere with the amount of food available (see, e.g., Leong, 2003) hence the trophic relationships at the particular site. This could explain the reason why there are no snail shells and predatory birds (like the Harmakop, in Fig. 9) at the motor vehicle wash place.

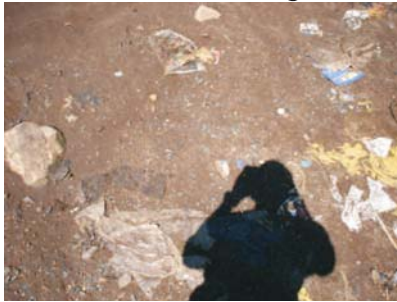
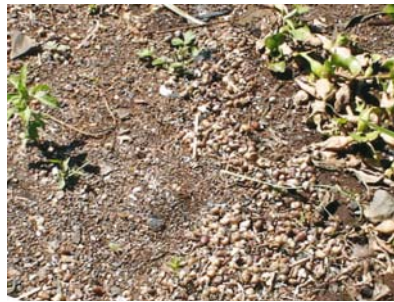
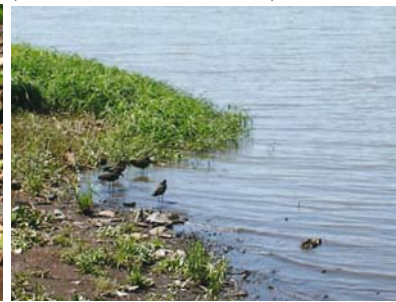
**Fig. 9** Difference between disturbed and undisturbed sites at Kichinjio beach

## Ground at car washing site

## Snail shells and Birds (at undisturbed sites)

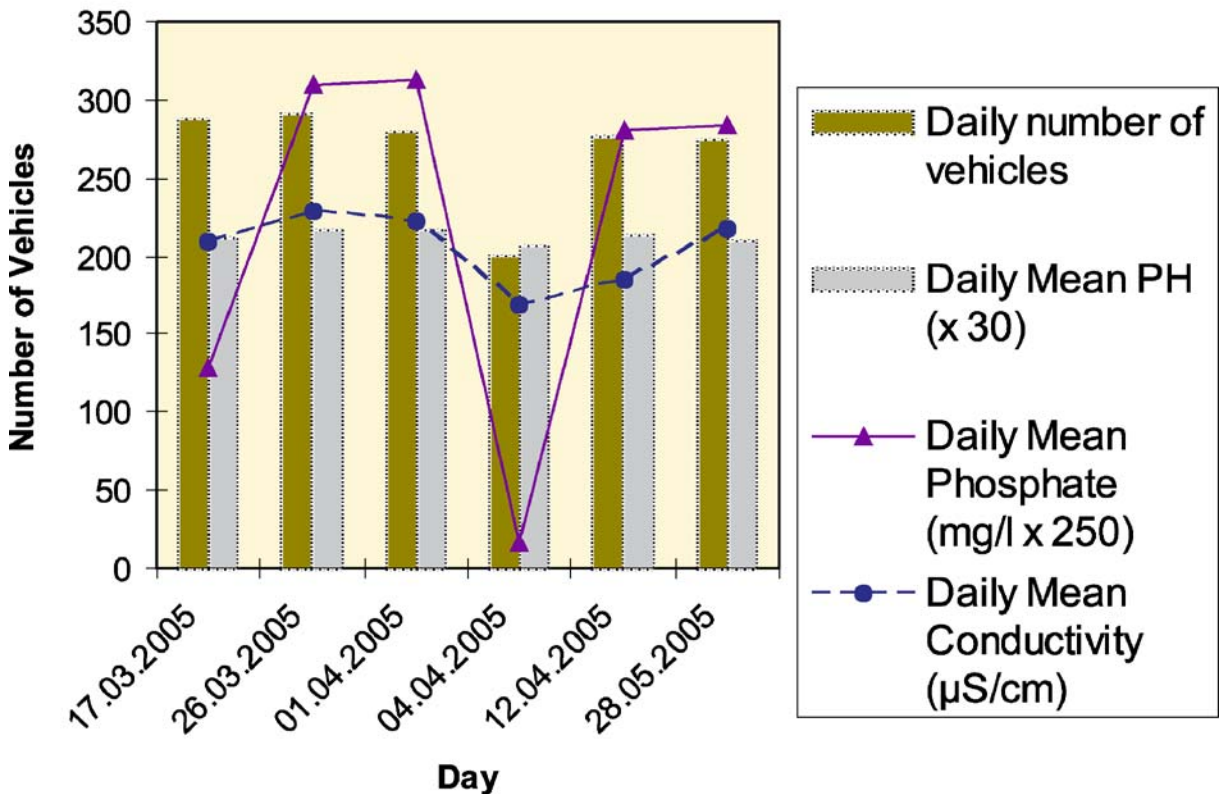
**Fig. 14** Relationship between water quality parameters and total number of daily vehicle count

### A Plot of Water Parameters against Number of Vehicle Washed

In Fig. 13, water quality parameters at various stations are presented. Figure 14 presents relationship between the three water parameters and the total daily motor vehicle counted during the sampling period. The correlation coefficients are computed and presented in Table (3).

expected as the garages are engaged with so much metal works and often deal with solutions and chemicals, most of which find their way into the lake. Figure 14 indicate the phosphate and conductivity values to be particularly low on the fourth of April, thus coinciding with the day when the number of cars washed was low. A strong correlation coefficient of 0.81 indicate a strong correlation between the total number of vehicles washed and the measured conductivity. For the same area, Njuru and Hecky (2005) indicate an average conductivity of 171  $\mu\text{S}/\text{cm}$ . The average of the car washing points (2, 4 and 5) in these study from Table 4 is 180.3  $\mu\text{S}/\text{cm}$ , i.e., an increase of about 9.3  $\mu\text{S}/\text{cm}$  or a contribution of about 5.5% from direct car washing. For the runoff point 1, this will be 76% increase in metallic substances from open shed garages. Undisturbed point 6 recorded a higher value of 19.8%. This could be due to other Municipality waste, i.e., from a burst sewer.
