# Influence of Air Pollution and Humidity on Limestone Materials Degradation in Historical Buildings Located in Cities Under Tropical Coastal Climates

F. Corvo · J. Reyes · C. Valdes · F. Villaseñor ·  
O. Cuesta · D. Aguilar · P. Quintana

Received: 12 November 2008 / Accepted: 13 April 2009 / Published online: 8 May 2009  
© Springer Science + Business Media B.V. 2009

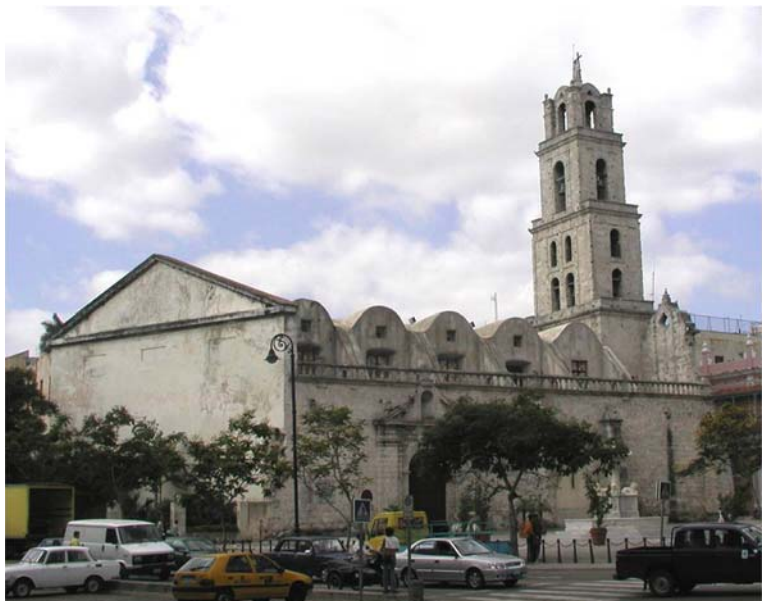
**Fig. 2** Basilica Minor and Convent San Francisco de Asis, old Havana City

The San Francisco de Asís Minor Basilica and the convent were built at the end of the sixteenth century and rebuild in baroque style in the middle of the eighteenth century. In the present time, the building

houses a museum of religious art, concert, and art expositions hall. The spacious building itself is a wonderful example of eighteenth century architecture and is located approximately 200 m away from the coastline (Fig. 5). The wall of this building bordering Oficios Street is placed in a site where direct influence of sun radiation in the lower part of the building is limited by other buildings located in front of it. The marine breeze coming predominantly from the inner side of the bay, which is probably the most contaminated, goes through the narrow corridor

formed by the buildings. Other walls near San Francisco Square are placed in an open ample space, where they receive the influence of marine breeze from the outer side of Havana Bay and direct sun radiation.

In this paper, we will refer particularly to the San Francisco de Asís Minor Basilica and the convent in the old Havana (Fig. 2) and Forts San Pedro and San Carlos in San Francisco de Campeche City (Figs. 3 and 4).

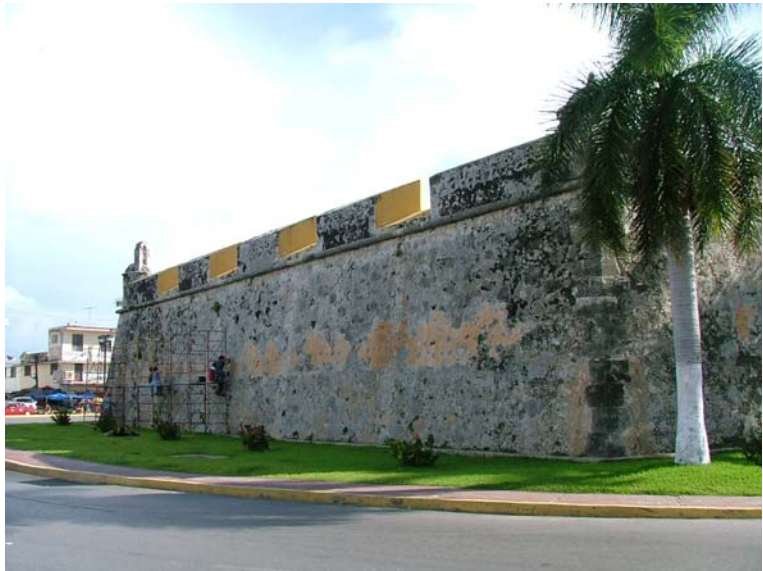
**Fig. 3** San Pedro Bastion at Campeche

On the other hand, Forts San Pedro and San Carlos crowned the northwest and southeast corners of the irregular hexagonally shaped bastion and rampart fortified system surrounded San Francisco de Campeche urban core. Continuous vehicle traffic flows through a street next to the San Carlos building which is located about 100 m away from the shoreline. San Pedro Fort

does not receive direct marine aerosol as is the case of San Carlos Fort (see Fig. 6) because it is relatively far from the shoreline (about 1 km). Nowadays, these colonial constructions are surrounded by traffic jammed streets in which intense commercial, cultural, and tourism activities are carried out.

Local calcareous materials including quarried limestone blocks, sand, slake lime, and carbonate clay marls (known as *sahacab* in Yucatán Mayan language) were combined to erect both forts. Periodic restoration projects carried out in the recent past introduced white and gray cement mortars mixed with

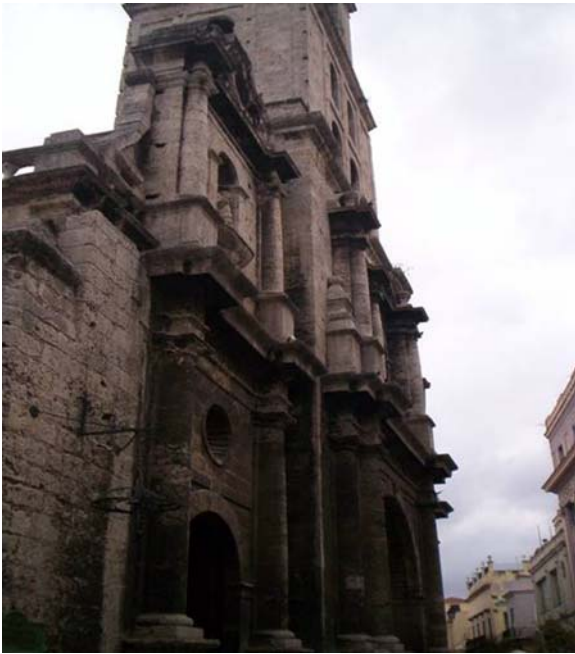
- Appreciable deterioration of paint coating because of extremely high humidity in the indoor wall corresponding to Oficios Street.
- Black crust in the outdoor facade of the Basilica at Oficios Street. Only in the lower part, where sun radiation does not impact directly and the presence of biological organisms is not observed as shown in Fig. 7. In the last restoration procedure (1999–2000), this black crust was not cleaned. The upper surface of the tower does not present black crusts.

**Fig. 7** Facade of Basilica Minor at Oficios Street. Black crust in the *lower part*. No crust observed in the tower

the lower part of the Basilica surface. No black crust is observed in the upper side where sun and wind reach directly the surface. This situation suggests that perhaps black crust has been formed due to the presence of almost permanent high humidity in the lower surface of the Basilica. This humidity has allowed the occurrence of sulfur compound reactions. Deposition of higher sulfur compounds should occur during the day, when the upper surface of the Basilica is dry, so the formation of the black crust is more difficult.

3. A higher pollution in Havana is the cause of black crust formation (composed mainly of gypsum) at the facade of San Francisco de Asís Basilica Minor. It is formed in the part of the facade where direct influence of sun radiation is lower, that is, in conditions where wet/dry cycles are near to indoor conditions, but under the influence of outdoor pollutants, humidity, and rain. Under the direct influence of sun radiation and wind (bell tower), no black crust formation was observed.

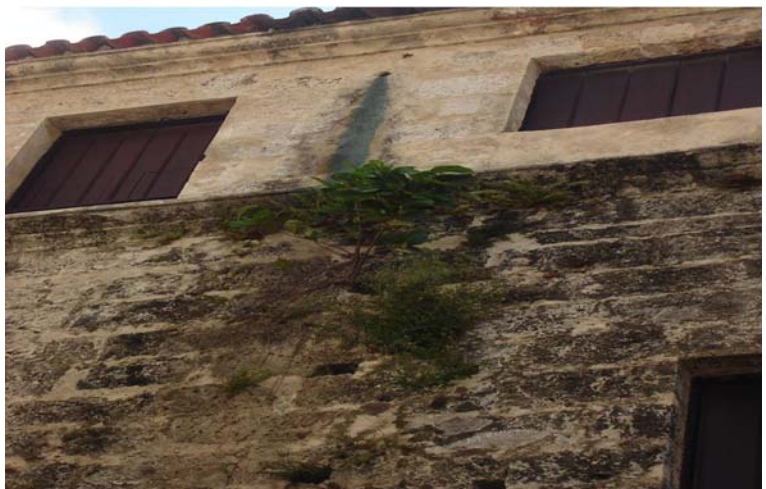
- Growing of plants and other organisms in the wall of the convent corresponding to Oficios Street (Fig. 8). In the last restoration procedure of the building, this wall was cleaned.

**Fig. 8** Oficios Street wall, Convent San Francisco de Asis. Presence of plant and development of biological patina

As can be observed, biodegradation is the main factor affecting the convent wall at Oficios Street. Taking into consideration that the influence of sun radiation at this narrow street is lower, these two conditions—increase of humidity due to defects not yet repaired and decrease in the influence of direct sun radiation—provoke conditions that enhance biodegradation. No inorganic crusts are observed. In other walls of the convent or Basilica, a lower biodegradation is observed because they are submitted more directly to the influence of sun radiation and present a lower humidity.

4. The presence of oxalates at Campeche crusts shows that biodegradation is an important mechanism in these conditions.
5. The higher humidity of the wall of the convent at Oficios Street causes a significant biodegradation. The influence of air pollution is not very significant despite relatively significant pollution levels.

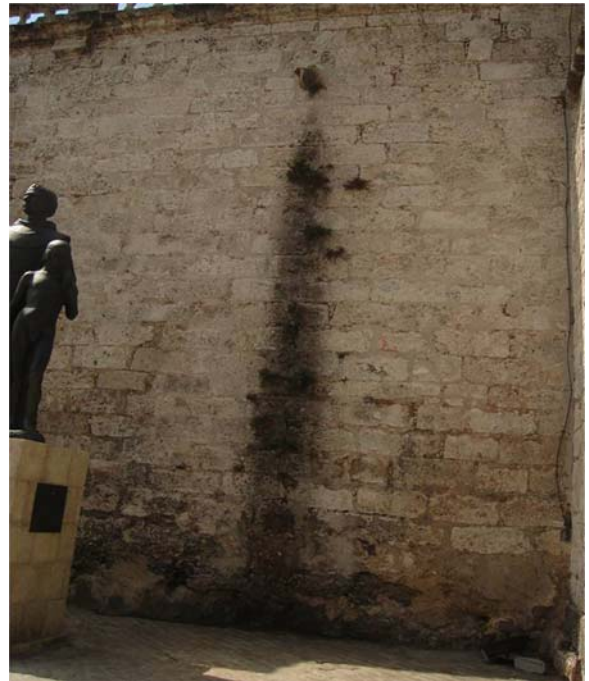
- Black crusts and patinas formed on the wall in front of San Francisco Square are probably a mixture of biological and inorganic products (Fig. 9). Patinas are observed as a consequence of water drainage.

**Fig. 9** Basilica Minor San Francisco de Asis, San Francisco Square wall. Patina formed due to water drainage

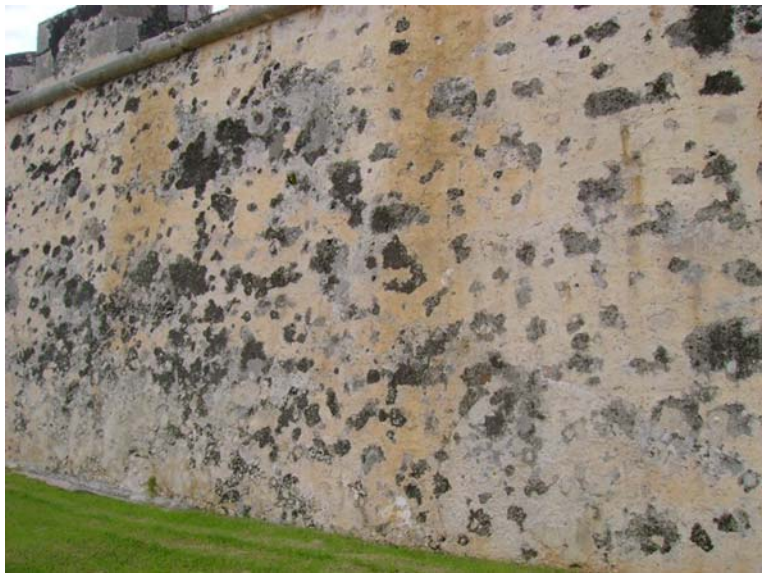
- Deposits of white, brown, gray, and black crusts can be observed in areas where mortar has lost continuity as a consequence of inhomogeneous permeabil-

ity, mechanical effects caused by human activity, erosion by natural agents, or in zones where there are residual pigments, acting like nucleation center for the growth of crusts (Fig. 10).

**Fig. 10** Presence of crusts having different colors at San Carlos Bastion

Crust formed at Fort San Carlos is mainly formed by calcite, the original main content of the stone. Different minor phases are: aragonite, dolomite, and quartz (Table 4). The presence of whewellite and weddellite in the samples is an index of the influence of biological activity in stone deterioration, although the presence of bassanite shows the influence of environmental  $\text{SO}_2$ .

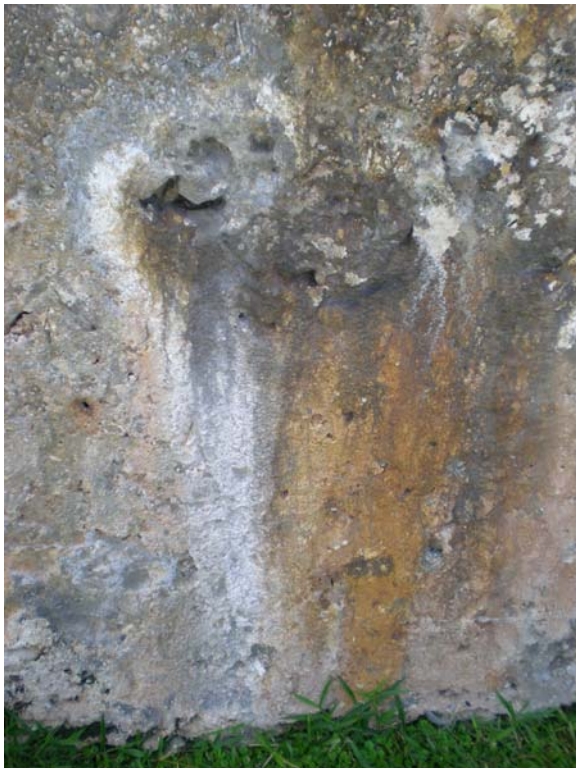
- Formation of caverns and cracks because of karst effects and erosion in walls W, S, and E of Fort San Carlos and SE in For San Pedro (Fig. 11).
- The use of Portland cement mortars in recent restoration works induces changes in permeability properties of rocks and mechanical stresses. It is

**Fig. 11** Example of Carsick structures provoked by water infiltration observed at San Pedro and San Carlos fortress

6. Water infiltration causes the formation of caverns and small cracks at San Pedro and San Carlos walls.
7. The influence of water and humidity enhances the development of biodegradation. Reparation and maintenance defects significantly increase the possibilities of degradation.

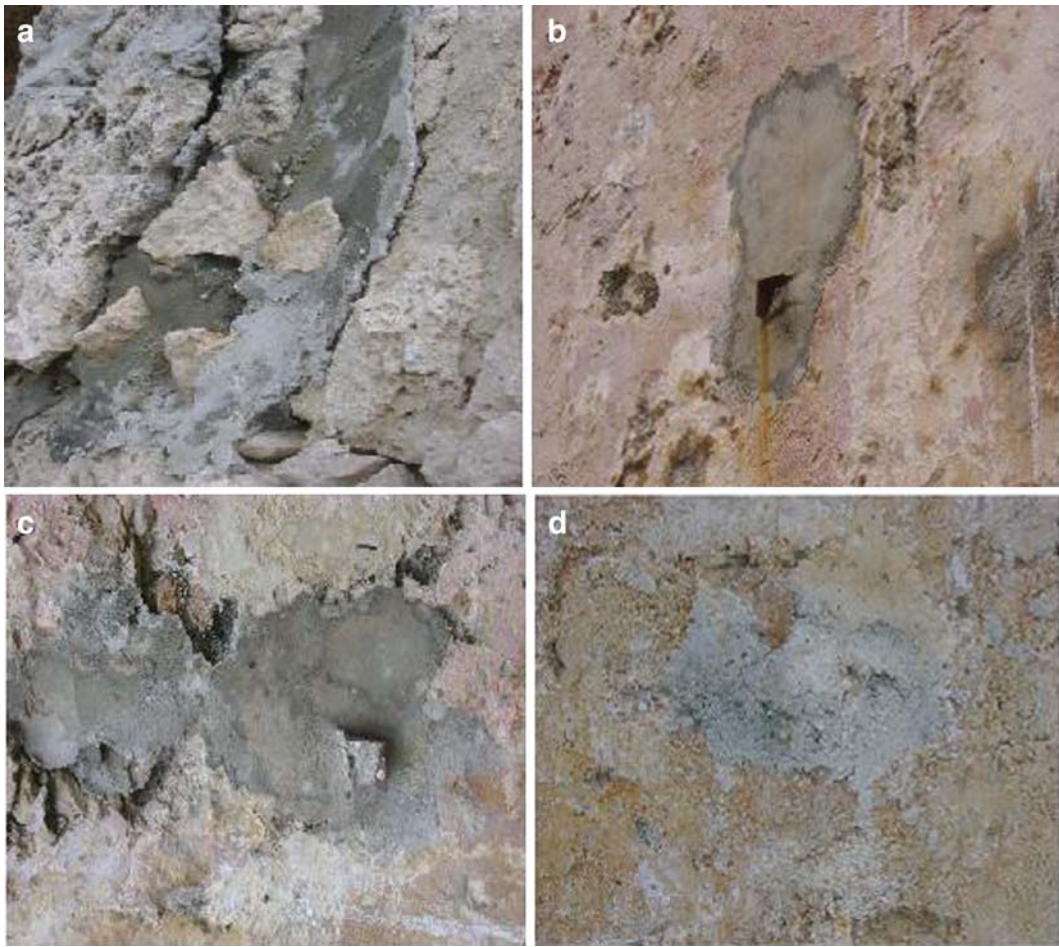
not compatible with rock and traditional mortars. It can induce cracks formation and losses of components (Fig. 12a–d).

**Fig. 12 a–d** Use of Portland cement mortar at San Carlos fortress

With regard to the San Carlos fortress, the use of cement mortars could have caused differences in water permeability across the wall. This situation could cause cracks and falling of mortar parts in the wall. Growing of plants is observed at San Carlos and San Pedro walls. Other important phenomena observed in the walls of both buildings are karst structures provoked by water infiltration across masonry during rainy season. The massive structure in both buildings is an artificial rocky outcrop, across which rain water fluid causing dissolution and erosion of stone and mortar components takes place. During this process, cracks and small cavities are formed inside the masonry. Water fluids forming drainage structure can be observed in walls of the buildings (Fig. 11). White to dark brown deposits are formed over mortar and stone in the near of water drainage discharge. According to XRD analysis, these deposits are rich in calcium carbonate, as a probable consequence of calcium carbonate recrystallization.

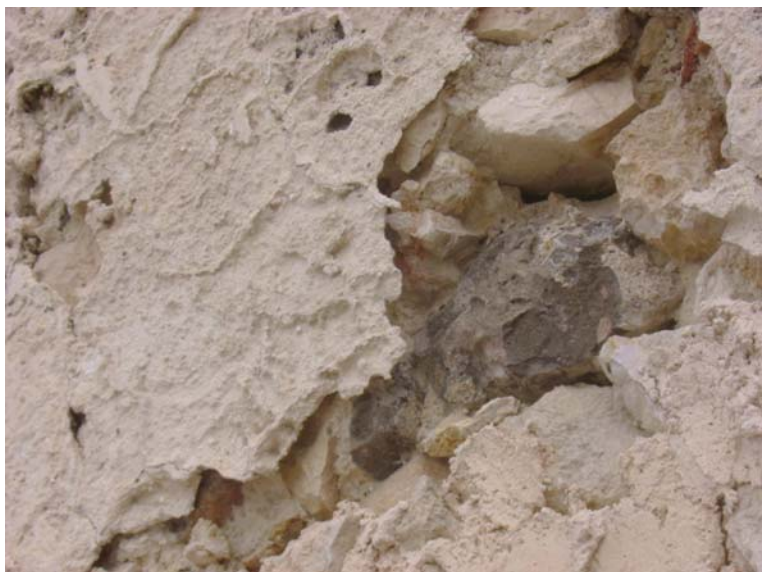
- Traditional mortars without enough consolidating properties fall down (Fig. 13).
- General microbial colonization inducing the formation of patinas in walls and stone blocks of vortices, doors, watchtower, and access ramps in both buildings.
- Presence of plants is observed in some places of these two fortresses, where mortars have fallen off.

**Fig. 13** No consolidation between stone substrate and mortar at San Carlos fortress
