Experimental and Theoretical Investigation on Masonry after High Temperature Exposure

S. Russo · F. Sciarretta

Keywords Brick masonry · High temperatures exposition · Residual properties

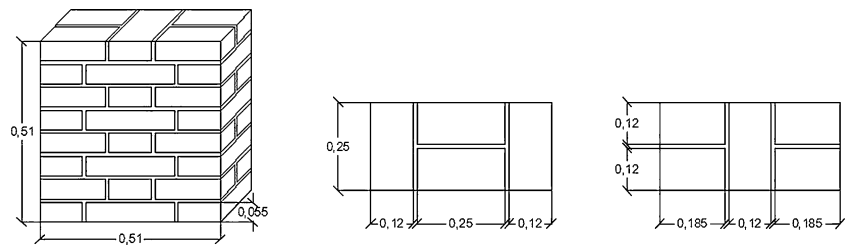
Fig. 1 25 cm thick masonry specimens

The physical model refers to masonry 25 cm thick, made of hand-made type clay bricks (sized 250×120×55 mm) and cement mortar, with joints 1 cm thick, assembled in the so-called ‘gothic bond’ pattern (in each row, alternate ‘heads’ and the ‘sides’ of the bricks are visible); square specimens of 51×51×25 cm were built (Fig. 1). Attention was paid to the selection of materials, masonry thickness and pattern, in order to represent a type of load-bearing masonry wall which could be common both to traditional and new buildings. These bricks are suitable for load-bearing walls, as they are similar to ancient ones in composition, dimensions and crafting process. A cement mortar classified as M10 following the standard UNI EN 998–2 was chosen because of its wide diffusion in existing load-bearing masonry structures in Italy; it is made of cement, hydraulic lime and sand in the proportions of 1 : 0.5 : 4.

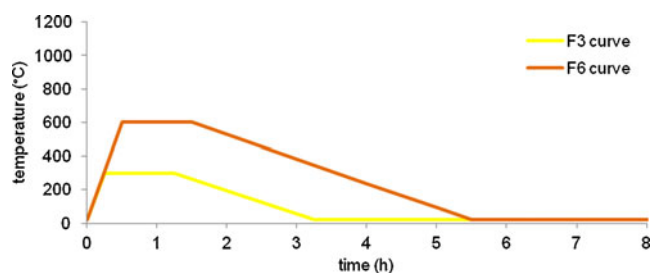
Fig. 2 Time-temperature curves of the two exposure conditions

temperature (1 h). Following also other authors’ procedures [10, 12] the heating rate was decided to be as high as possible, in order to simulate a fast rise of temperature; as well, in order to reflect an accident condition such as fire, a very short exposure was established. The time-temperature curves representing the two conditions are shown in Fig. 2.

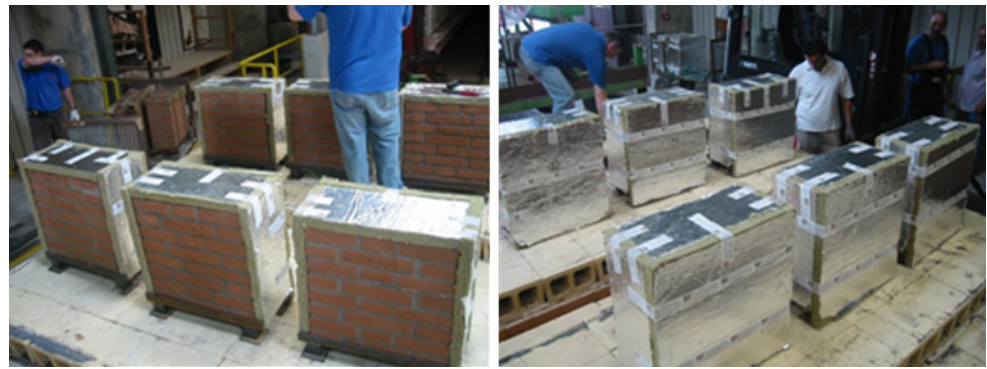
Fig. 3 Masonry specimens being put inside the oven

The high-temperature exposure cycle was performed by means of a brick furnace, normally used for baking hand-made clay products. This oven ensured a quick heating process, a duration at a well approximately constant maximum temperature, and a uniform internal temperature; it allowed for all ten samples in each thermal cycle to be exposed. The temperature of the specimens during the exposure was recorded by means of nine thermocouples applied to three masonry specimens—one on a brick, one on the central bed joint and the last on the unexposed side, each inserted in a 7 mm deep hole (Fig. 4); another thermocouple was used to record the air temperature inside

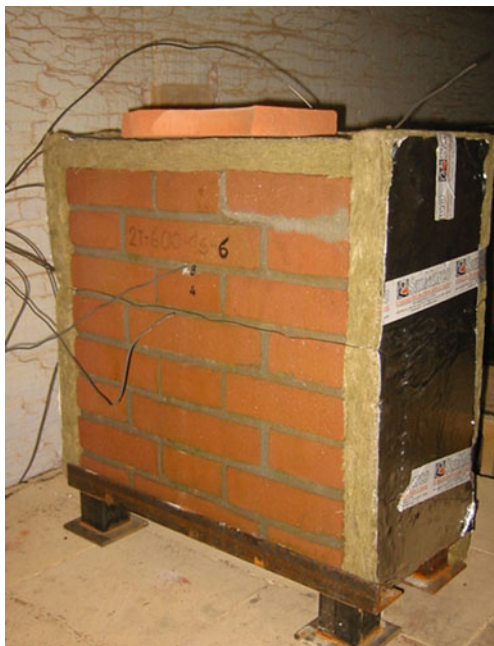
Fig. 4 Masonry specimen with applied thermocouples

the oven. It can be noticed that the real time-temperature curve fits with good approximation the prescribed one, until cooling begins; the temperature on the insulated side remains about 400°C lower than the air temperature, so that an appropriate simulation of the load-bearing separating wall is attained (Fig. 5).

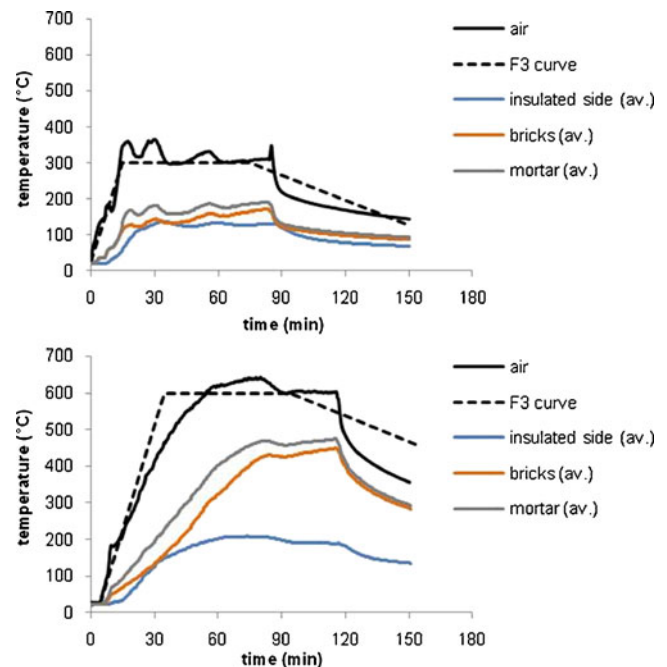
Fig. 5 Time-temperature graphs of the cycles compared to the prescribed curves

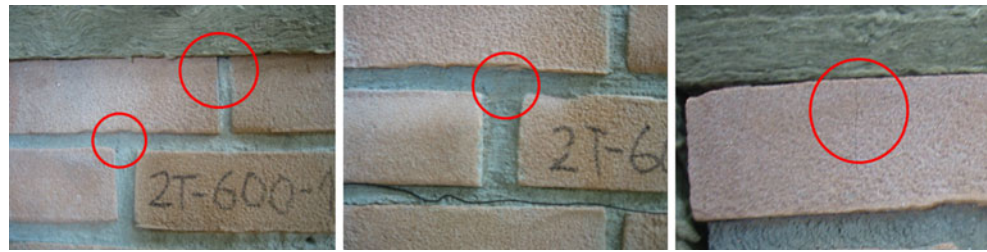
Fig. 6 Cracking and interface detachment on 600°C (F6) exposed masonry specimens

Just after the 300°C cycle, the exposed faces of the masonry specimens showed very little damage, i.e. some detachments at brick-mortar interfaces; after the 600°C exposure, interface cracking and micro-cracking in all materials (including bricks and mortar specimens) were clearly visible (Fig. 6). After removal of rock wool claddings, in both cases of exposition, the insulated faces of the masonry samples looked undamaged.

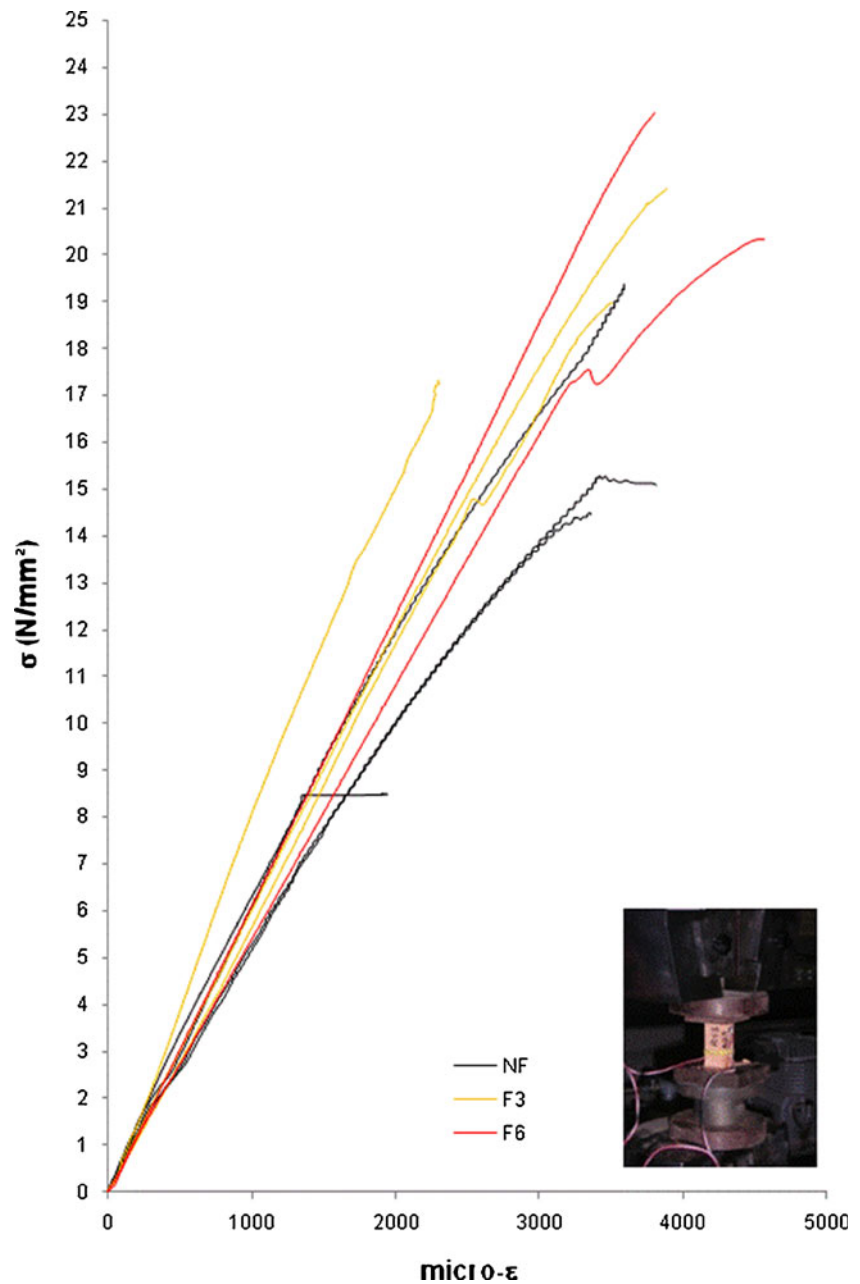
Fig. 7 Stress-strain diagram of elastic modulus tests on bricks

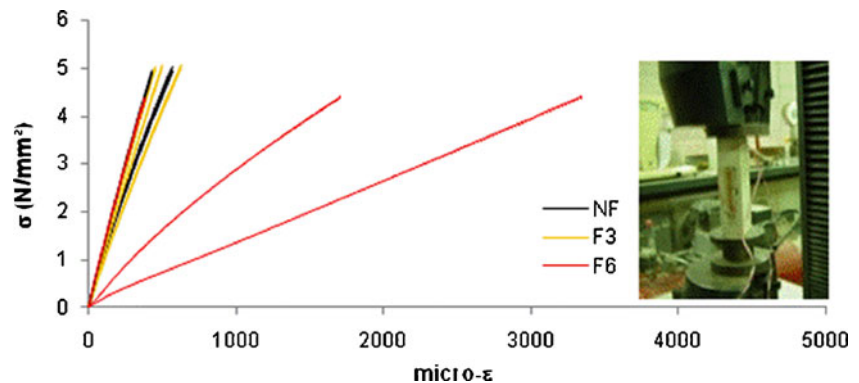
Fig. 8 Stress-strain diagram of elastic modulus tests on mortar samples

specimens before flexural and compressive tests. The stress-strain diagram of these tests is depicted in Fig. 8 and the corresponding data are listed in Table 4. The tests point out a clear increase in compressive strength (+29%) of F3 samples and an equal decrease of F6 samples; while the flexural strength decreases in F3 (−23%) and especially in F6 samples (−61%) which is greater in bending than in compression; the elastic modulus undergoes a considerable decrease as well (−10% in F3 and −51% in F6 samples).

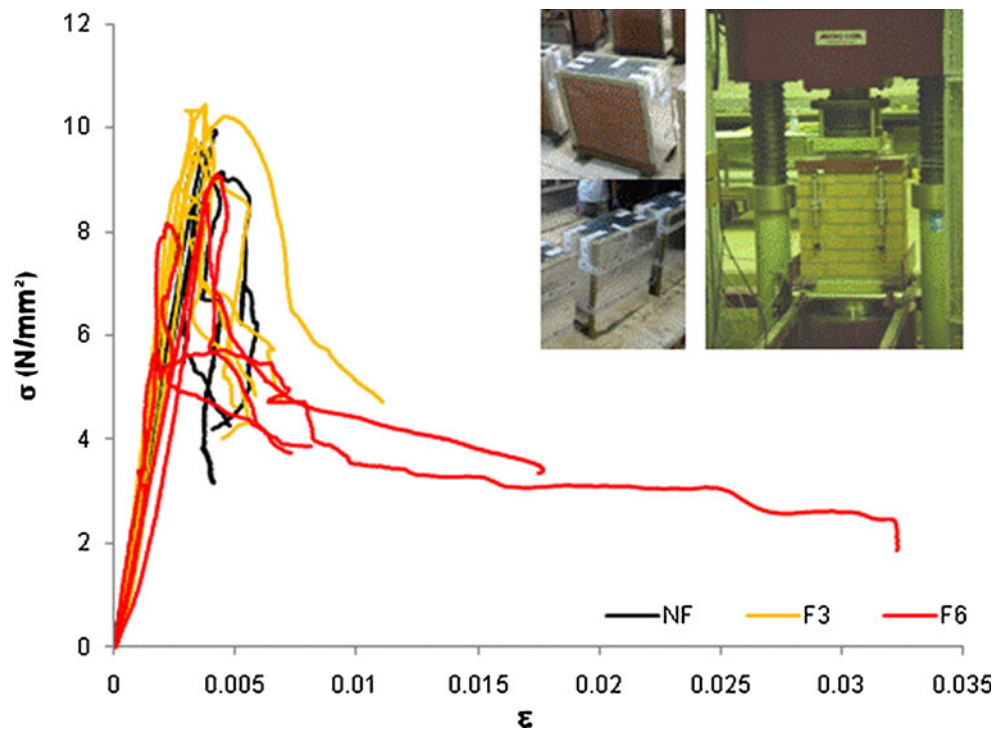
Fig. 9 Stress-strain diagram of compressive tests on masonry samples

Concerning unexposed specimens, the increase in strain in the softening phase is generally small. Immediately

before the peak load, vertical cracks occurred in the bricks and at brick-mortar interfaces following the vertical

alignment of joints. During the performing of tests on F6 samples, cracks occurred first on the exposed side, immediately followed by superficial detachment of bricks; at the end of the tests, the damage of the exposed face was fairly greater. In a less evident way, this was also the behaviour of F3 samples. Moreover, at the peak stress, a vertical crack appeared along the middle of both lateral faces; after this was noticed, two additional extensometers were applied horizontally on the lateral faces of the remaining samples. The strength and stiffness of F3 masonry samples are slightly higher than NF (respectively +4% and +10%), while F6 samples show a decrease of -13% in strength and -7% in stiffness with respect to unexposed ones. The peak strain decreases (-12% in F3 and -10% in F6 cases), while the ultimate strain considerably increases with increasing temperature (+51 in F3 and +158% in F6 tests). Taking into consideration all the investigated properties except ultimate strain, their variations between NF and F3 specimens can be considered small; on the opposite side, the great increase in ultimate strain of both F3 and F6 samples points out that the softening phase is markedly influenced by exposure effects. The properties of F6 samples seem to indicate that at 600°C a not

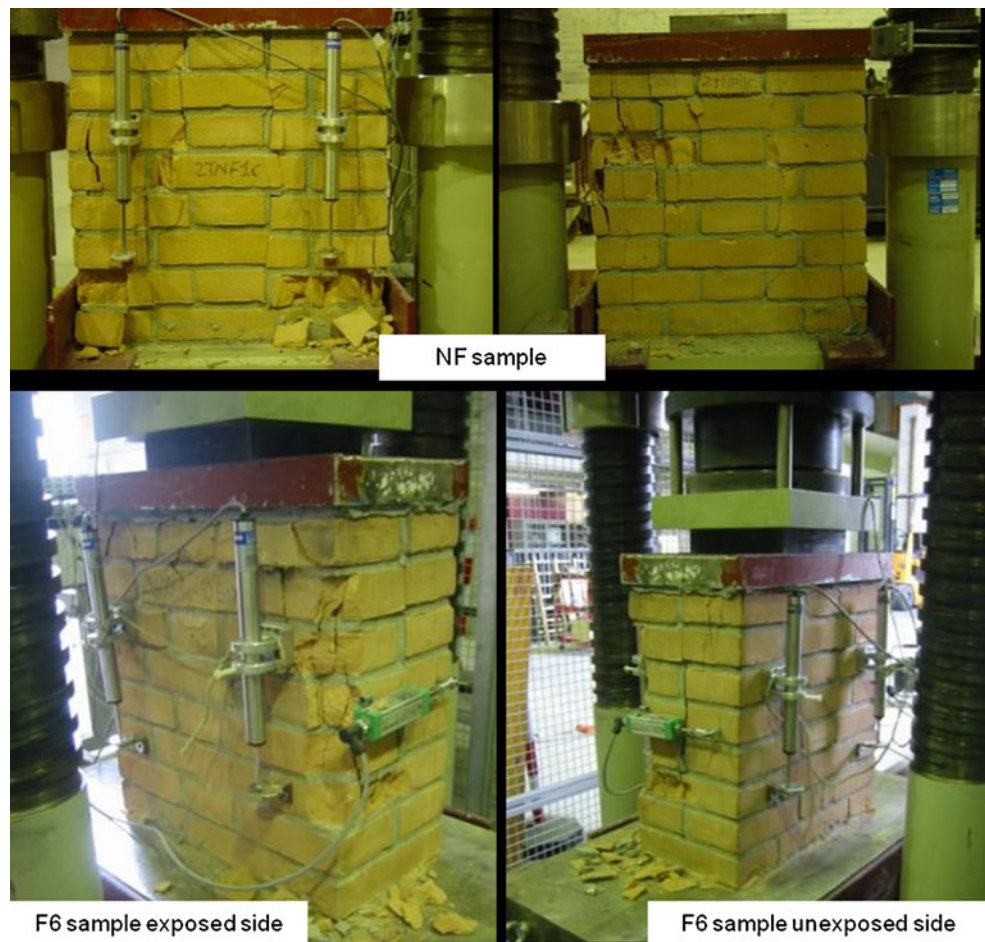
Fig. 10 Both sides of unexposed (NF) and exposed (F6) specimens after the compressive test

negligible influence of thermal damage on the mechanical strength begins to appear. Figure 10 shows an exposed and an unexposed specimen after testing.

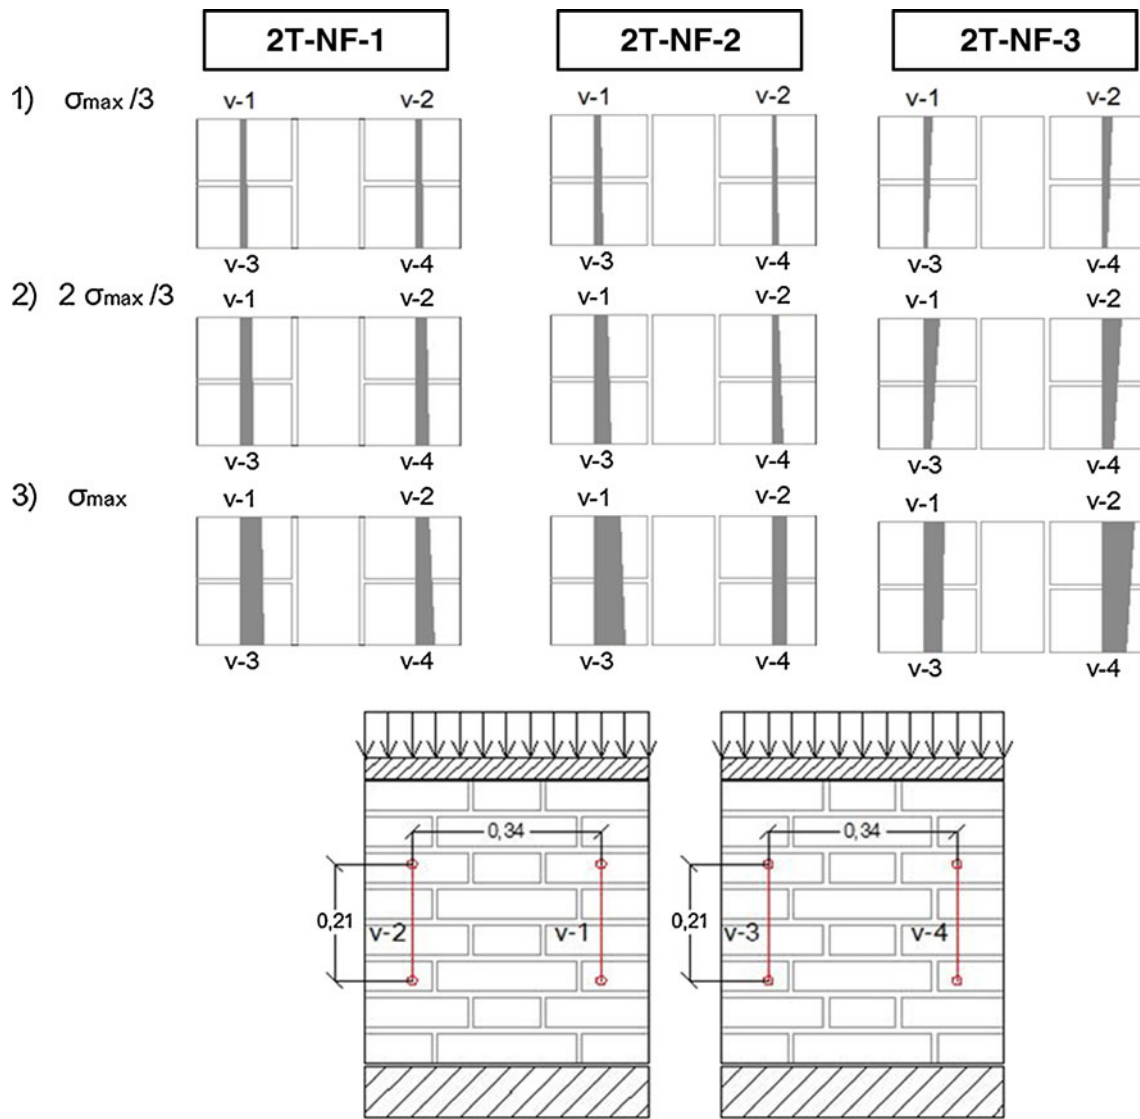
Fig. 11 Distribution of strain—NF specimens

Provided that the uniformity in the distribution of compressive load at the top of the sample had been assured, the uniformity of strain distribution, which is good in the unexposed samples (Fig. 11), is related to the temperature

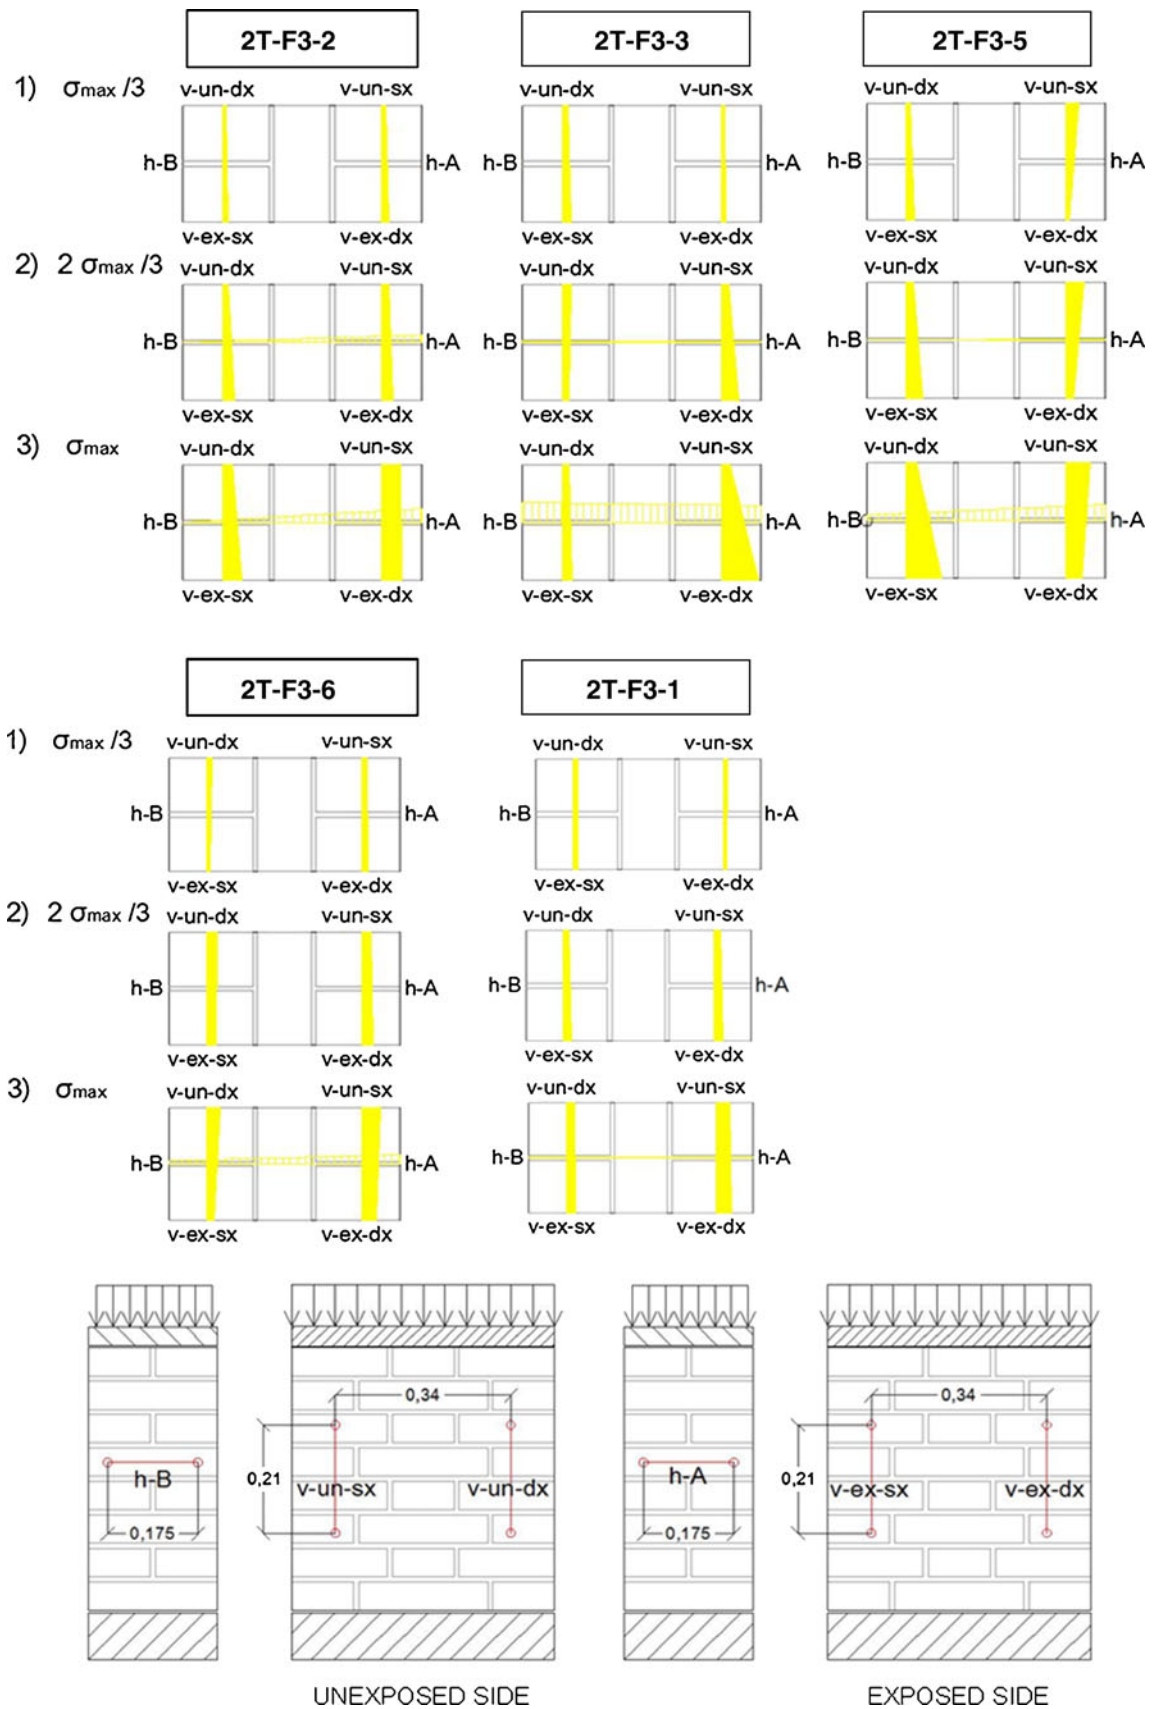
Fig. 12 Distribution of strain—F3 specimens

of exposure. The results confirm that exposed specimens have generally larger vertical deformations at the exposed side. This asymmetrical distribution (Figs. 12–13) can be seen as a consequence of thermal damage that affected the exposed side. The samples with the most uneven strain distribution (e.g. 2T-F3-3, 2T-F6-8) have most notably shown the concentration of mechanical damage on the exposed side at failure; at the end of the test, the detachment of the thermally damaged thickness of the specimen was visible on the exposed side (see also Fig. 10 above). Looking at the last two columns of Table 6, reporting the mean values of strain on each of the two faces of the samples, the occurrence of greatest compressive deformation at the exposed side is frequent; in such cases, a decrease in elastic modulus in the thermally damaged thickness can be inferred, likely due to thermally induced cracking which mostly occurred at brick-joint interfaces

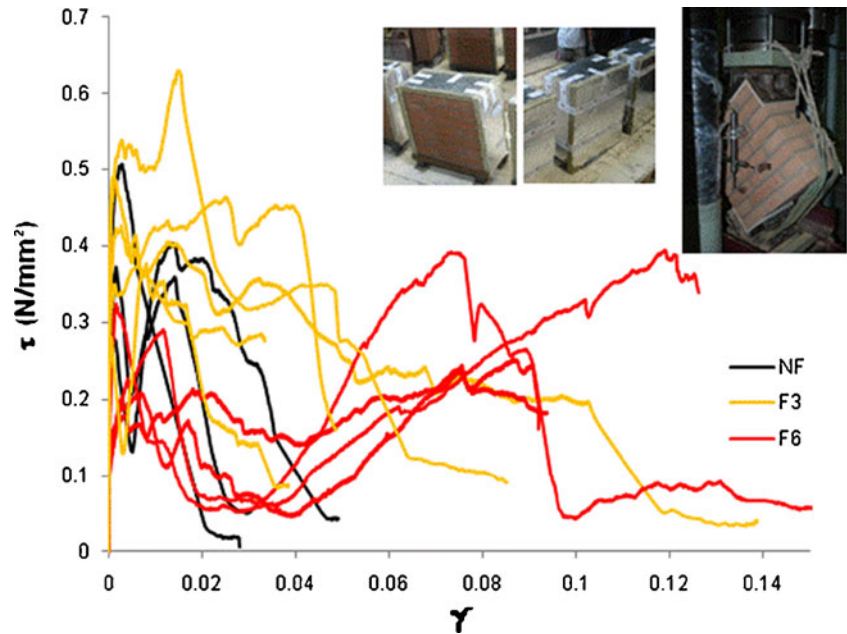
Fig. 14 Shear stress-strain diagram of diagonal compressive tests on masonry samples

peak stress $\tau_{1,\theta}$, shear strength $f_{v0,\theta}$ (corresponding to the maximum stress value), shear modulus G_θ and peak strain $\gamma_{1,\theta}$ are listed in Table 7, while Fig. 14 shows the

corresponding stress-strain diagrams. The shear modulus was calculated as the average of the stress-strain ratio at one and two third of the first maximum stress value.

In this case again, the fairest difference resorting from the diagrams lies in the longer post peak branches of exposed masonry samples. Moreover, F3 and F6 samples reached the maximum stress at much larger strain values than unexposed ones. The repeated increase-decrease in stress, which originate a saw-shaped diagram, is a well-known phenomenon in diagonal compressive tests. It can be ascribed to the combined strength contributions of brick-mortar cohesion (decreasing with the growth of interface cracks) and friction along the bed joints. This could be seen in all the tested samples NF, F3 and F6, but the phenomenon appears quite magnified with increasing temperature of exposure; in fact, in F6 samples (red lines in Fig. 14) noticeable increases in stress begin at

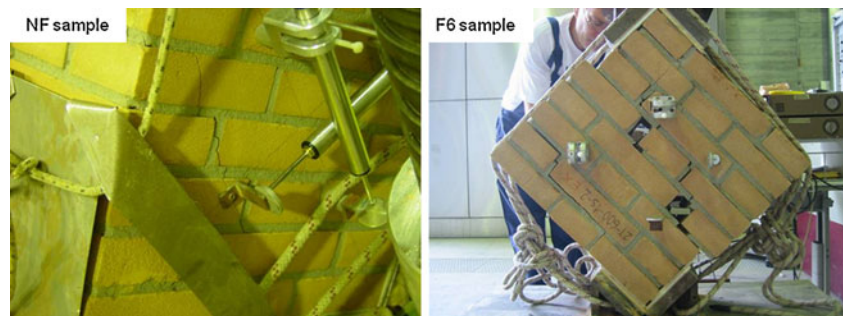
Fig. 15 Exposed and unexposed specimens after diagonal compressive tests

end criterion could not be observed for instruments' safety reasons. Figure 15 shows a comparison between an exposed and an unexposed sample after testing.

The concentration of cracking at interfaces, together with lower first peak stress values, indicates a loss of brick-mortar cohesion in the exposed samples; this phenomenon can be linked to the interface cracking, as an effect of fire exposure, observed in the samples' exposed surfaces just after the thermal cycle.

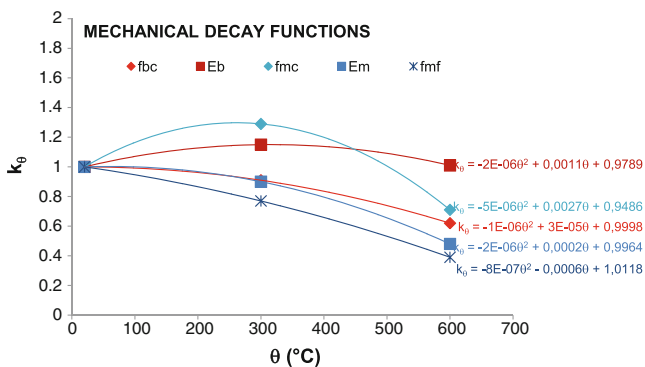
Fig. 16 $k_\theta - \theta$ diagrams for the mechanical properties of brick and mortar

As it can be seen from the graphs, $f_{c,\theta}$ and $f_{v0,\theta}$ increase at 300°C and decrease at 600°C similarly to the strength of the mortar $f_{mc,\theta}$, while the elastic modulus $E_{c,\theta}$ follows the same trend as $E_{b,\theta}$. In both cases, the variations in the properties of masonry are smaller than those of components. As well, the tensile and shear strength of masonry show a trend similar to the compressive strength of mortar; the shear modulus progressively decays similarly to the elastic modulus of mortar. The great increase in peak strain both in compression and in shear ($\varepsilon_{c1,\theta}$, $\varepsilon_{c2,\theta}$, $\gamma_{1,\theta}$) is of such entity that can't totally be ascribed to the variations in stiffness and strength of the two components; more likely, a different mechanical stress redistribution in the exposed masonry assemblies could have been induced by thermal micro-cracking. As above said, local losses of brick-mortar cohesion were actually detected in the masonry samples just after thermal cycles as the prevailing phenomenon of thermal damage. Moreover, this may also be the reason of the great decrease in shear modulus with increasing temperature; diagonal compressive tests showed that, since the early stage of collapse, interface detachment becomes more frequent than brick cracking as the temperature of exposition increases.
