An Investigation of the Seismic Behaviour of an Ancient Masonry Bastion Using Non-Destructive and Numerical Methods

Keywords Historical masonry structures · Bastion · Seismic earthquake response · Operational modal analysis · Turkish earthquake code

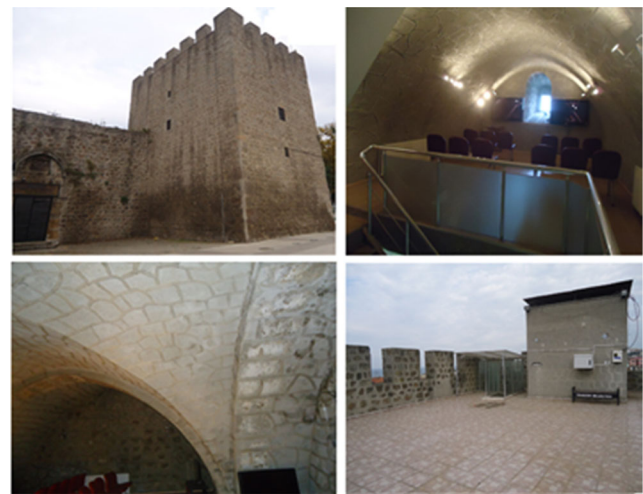
Fig. 1 Pictures of Zağanos Bastion

The Zağanos bastion was located in the middle part of the castle. It was constructed from brown conglomerate stone. The masonry technique used in the bastion was different from other parts of the castle. The stones were arranged in a linear line, and there was no mortar in the wall. The stones were used as bond and stretcher stones. In the last century, some additional features such as an elevator, RC floor and cement based mortar were added which undermined the authenticity of the original structure. The structural system of the bastion is based on load-bearing walls, vaults and arches. It is approximately 17 m in height, 15 m wide and 10 m deep. The thickness of the bastion walls is approximately 2.55 m from ground to the middle of the bastion, and 1.25 m from the middle to the top. The bastion has two main storeys which have vault roofs and they were divided into two parts with RC floors, thus four storeys were obtained. Some pictures of the bastion are given in Fig. 1.

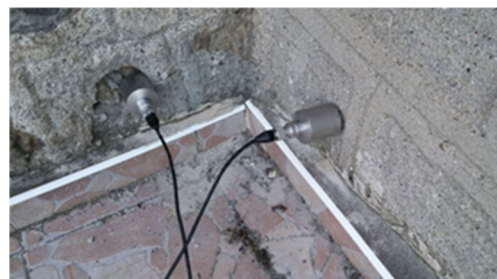
Fig. 2 The accelerometer connections

g sensitivity, uni-axial signal cables, PULSE and OMA software were used as the test equipment. The frequency range was selected as 0–15 Hz and eight accelerometers were located at the top of the bastion in transverse and longitudinal directions (Fig. 2).

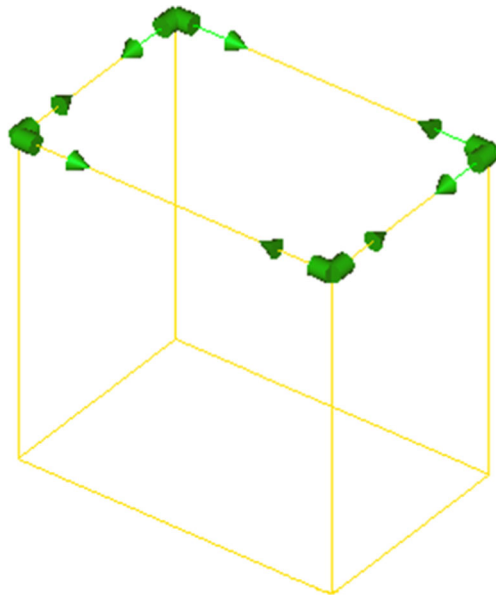
Fig. 3 Bastion model and accelerometer layout used in the ambient vibration test

OMA software [29] for signal processing. Then, modal parameters were extracted using EFDD and SSI techniques. A representative model generated in PULSE software for the bastion and accelerometers layout, along with their directions, are presented in Fig. 3.

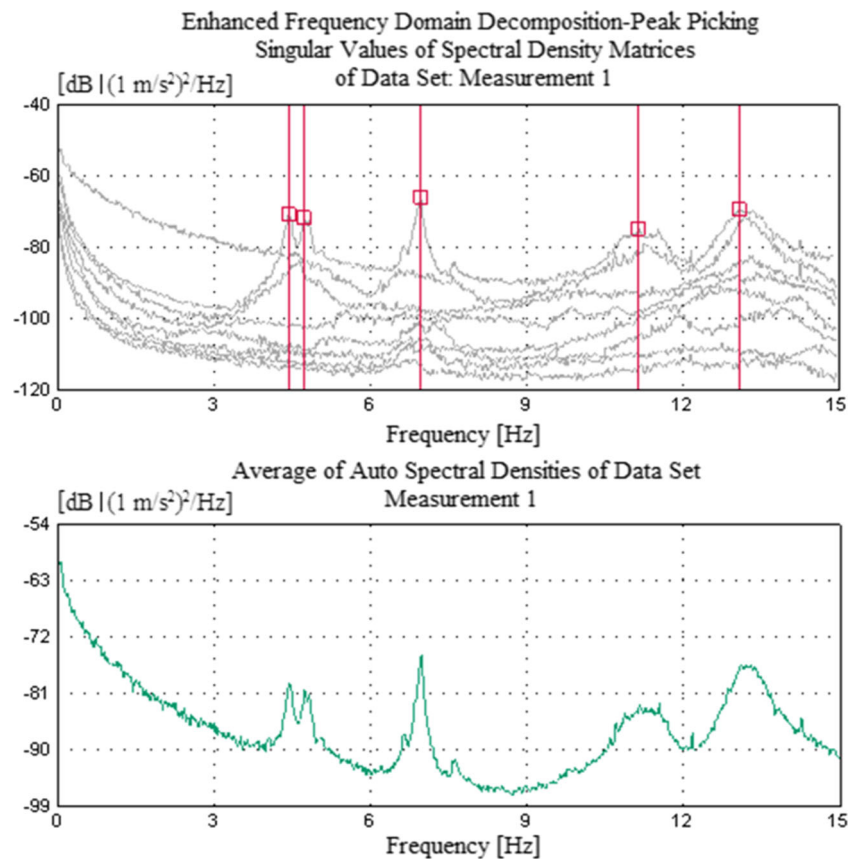
Fig. 4 SVSDM (a) and AASD (b) of the data set

Singular values of the spectral density matrices (SVSDM) of the data set and the average of the auto spectral densities (AASD)

of the data set obtained by EFDD technique for the bastion are given in Fig. 4. As shown, the first three natural frequencies are obtained between the 0 and 15 Hz frequency range.

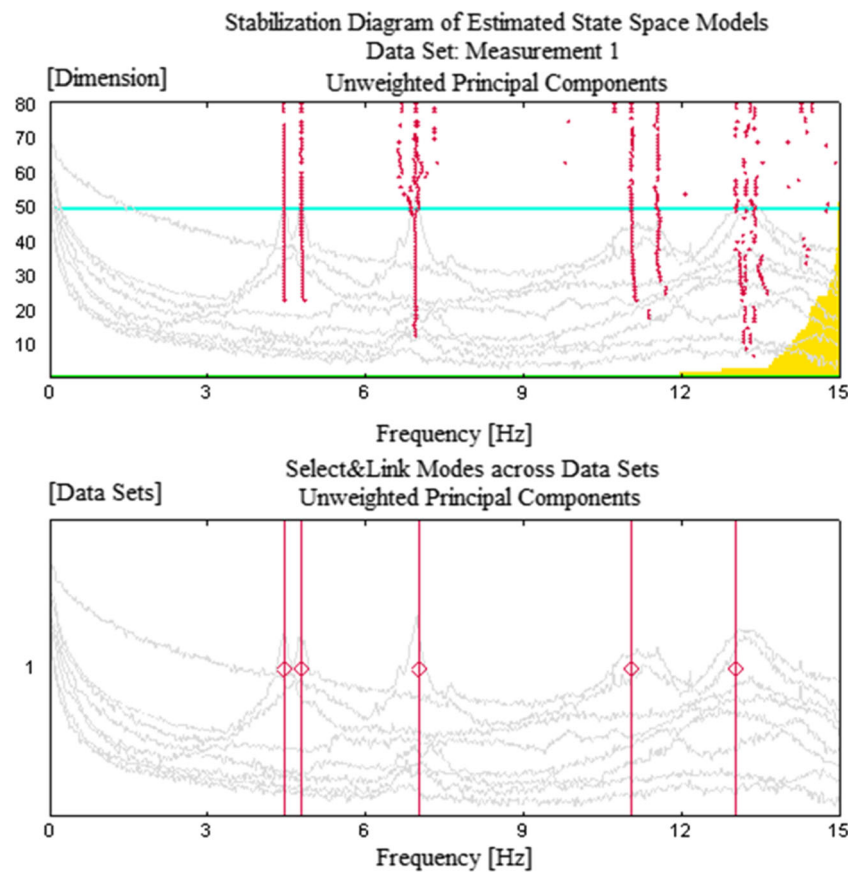
Fig. 5 The stabilization diagram (a) and singular values (b) for the first three modes

The dynamic characteristics of the bastion were also identified using the SSI technique. The stabilization diagram and singular values for the first three modes are given in Fig. 5. For signal processing control, maximum state space dimension to estimate is selected as 80. The automatic model estimation option was chosen using Unweighted Principal Component (UPC) estimators with values of 1, 80, and 1 for start, stop and increment, respectively. The natural frequencies, mode shapes and modal damping ratios were calculated using the stable values. The stability of the poles is often evaluated in terms of the variability of three parameters - frequency, modal shape and damping ratio - throughout model order variations. As can be seen in Fig. 5, three natural frequencies are also identified between 0 and 15 Hz. Figure 6 illustrates the first three mode shapes. The first one is transverse mode, the second is longitudinal mode, and the third is torsional mode.

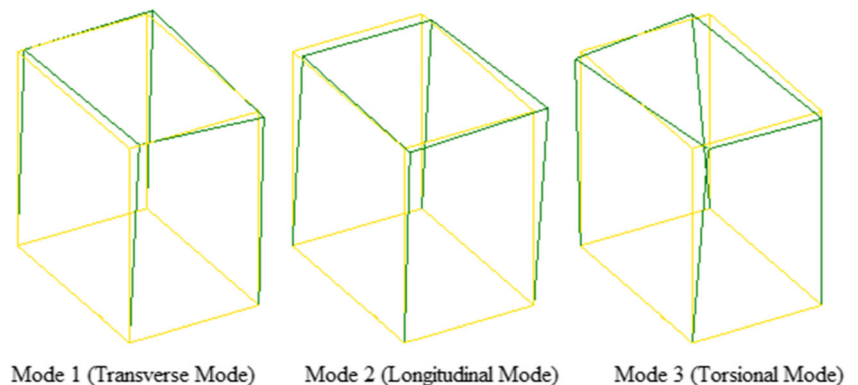
Fig. 6 The mode shapes of the bastion

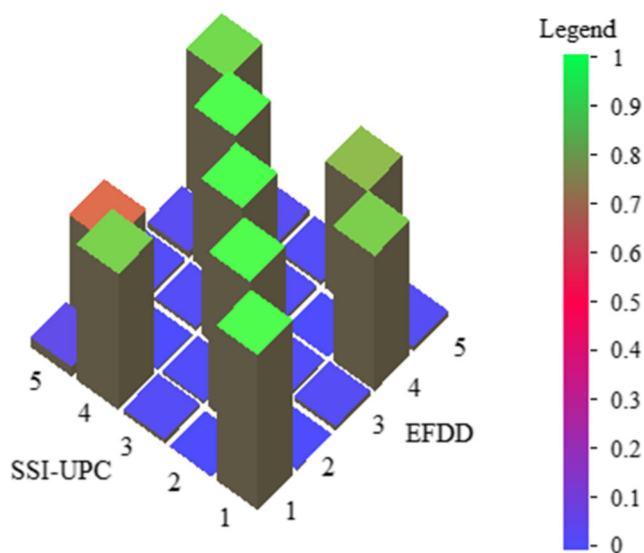
Fig. 7 Modal assurance criterion correlation obtained from experimental measurement

The graphics were automatically constituted by OMA software using Eq. 1. Figure 7 shows the MAC graphics estimated by using EFDD and SSI techniques for the three mode shapes. Figure 7 shows that the correlation between the mode shapes reflected by MAC values seems very good. The MAC values located on the diagonals were obtained as nearly one. This means that there is a close agreement between results and the EFDD and SSI results are almost overlapping. The other values (except diagonal) were attained as nearly zero.

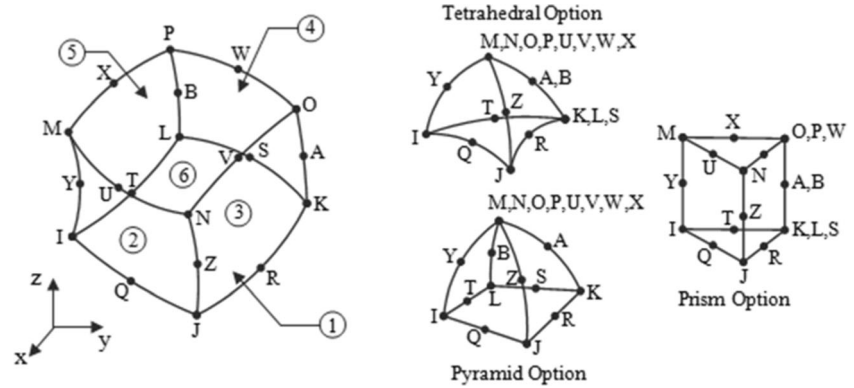
Fig. 8 SOLID186 element

A finite element model of the Zağanos bastion was constituted with ANSYS software [31]. In the finite element model of the bastion, SOLID186 solid element was used. This element has 20 nodes and three degrees of freedom per node namely translations in nodal x , y and z directions. The element has the capability of plasticity, elasticity, creep, stress stiffening, large deflection, and large strains. In addition, the element has tetrahedral, pyramid or prism options for meshing, and these options provide easy meshing for models [31]. A schematic picture of SOLID186 is given in Fig. 8. Building survey drawings of the bastion used in the FE modeling are given in Fig. 9.

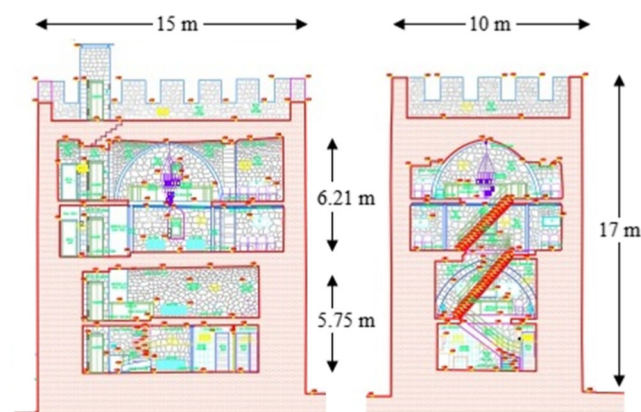
Fig. 9 Rilievo drawings of the bastion

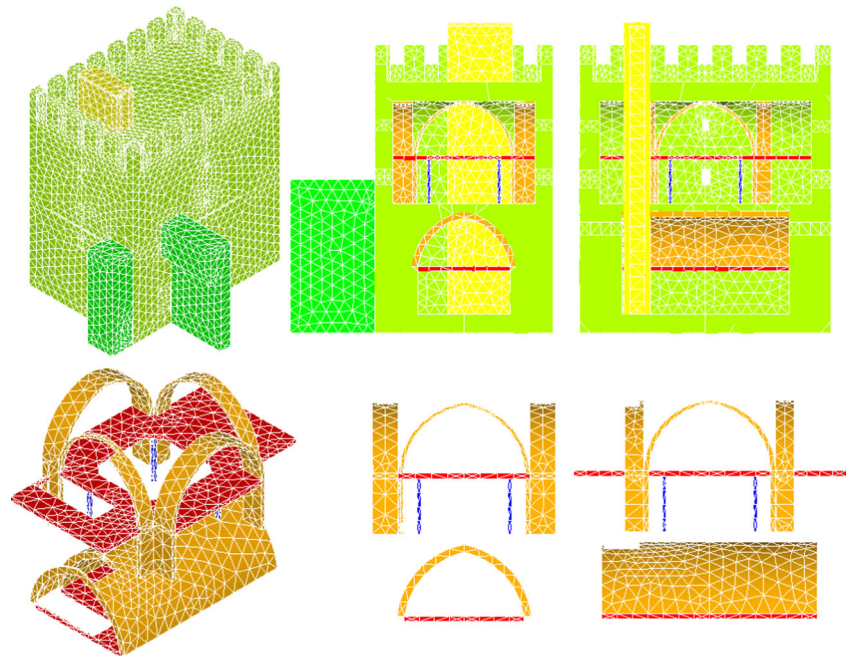
Fig. 10 Views and sections of the finite element model of the bastion

The finite element model of the bastion includes 105,848 nodes and 67,289 solid elements. The supports of the bastion are assumed to be fixed in the model. The finite element model of the bastion is shown in Fig. 10.

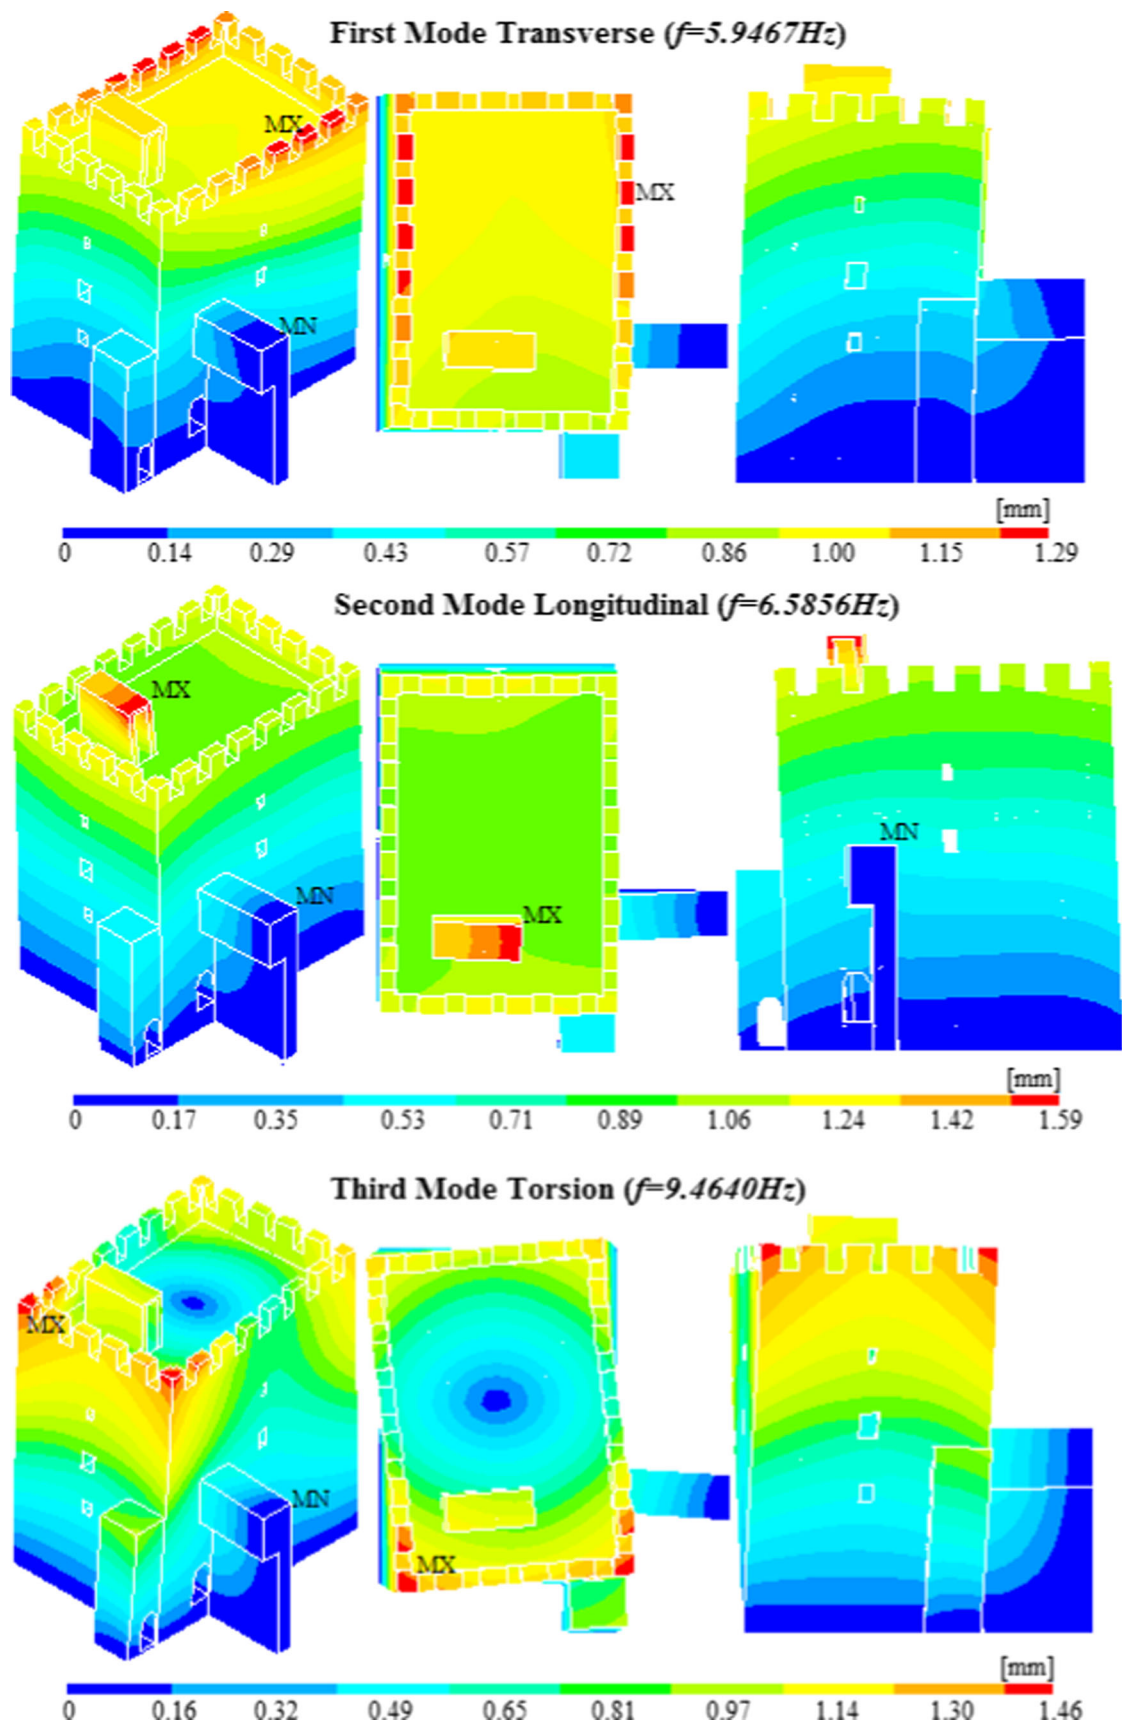
Fig. 11 First three mode shapes and frequencies

The dynamic characteristics of the bastion were extracted from the FE modal analysis. The first three frequencies were obtained as 5.9467 Hz , 6.5856 Hz and 9.4640 Hz , respectively. Mode shapes of the bastion appear as transverse, longitudinal and torsional modes, respectively. The frequency values and corresponding mode shapes are shown in Fig. 11. A contour plots refer to modal displacements. Experimental and analytical modal displacements were used to obtain the MAC values. Experimental and numerical natural frequencies are given in Table 4. The maximum difference between the frequencies was obtained as 26 %.

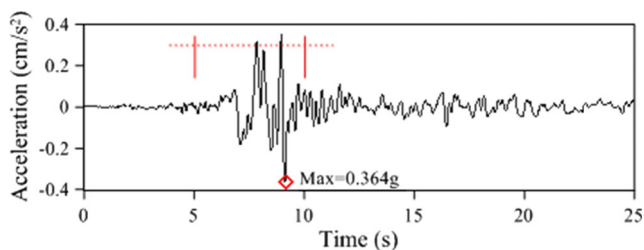
**Fig. 12** The acceleration record of the Kocaeli (1999) earthquake horizontal component

[38]. The time-histories of the record with 0.364 g peak ground acceleration is given in Fig. 12. Only the time between 5 and-10 s of the earthquake motion, which is the most effective duration, was taken into account. This was because of the computational demand of this method and because it was less time consuming.

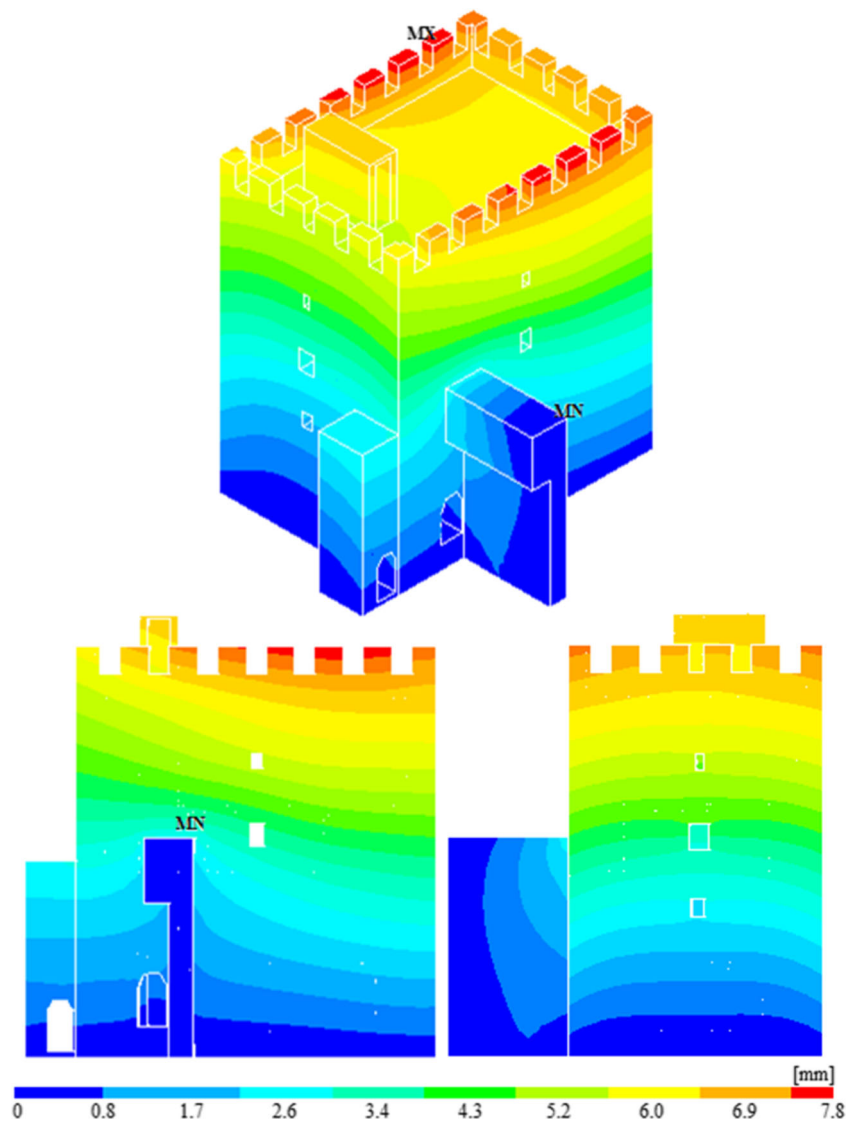
Fig. 13 Contour diagrams of the maximum displacements of the bastion from seismic analysis

The maximum displacement contour diagram for the bastion is given in Fig. 13. The maximum displacement occurs at

the upper part of the bastion with a value of 7.8 mm. Also, the displacements decrease towards the lower part of the bastion.

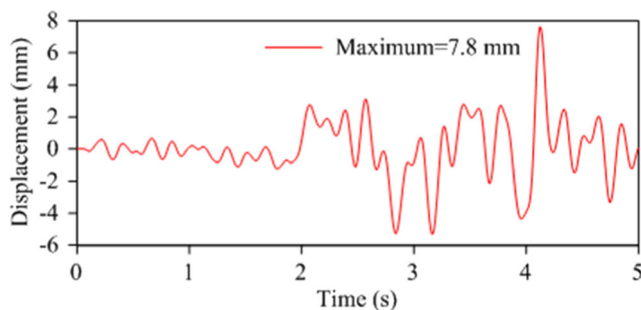
Fig. 15 Time-history lateral displacement graphic of the bastion

Results show that, structural components such as the elevator wall, RC floor and steel columns, which were added to the original structure at a later date, affect the structural behavior of the bastion. The maximum results were obtained for these elements. However, these results do not reflect the behavior of the entire structure. The main components of the bastion are the masonry walls, arches and vaults. These showed lower stress and strain values than the elements added later. Therefore, the maximum results obtained from the main component of the bastion are considered in the overall evaluation of structural behavior. The time history of displacement graphic is shown in Fig. 15.

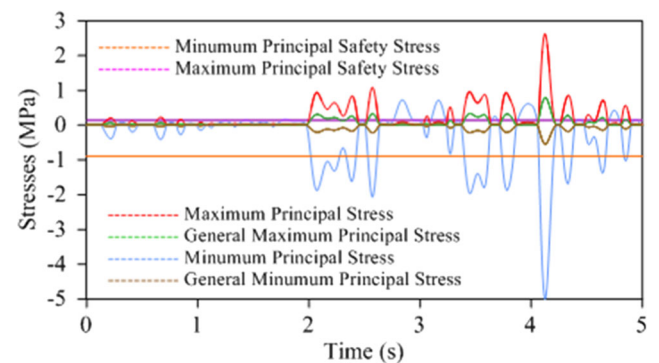
Fig. 16 Time-history stresses compared to the code restrictions

Figure 16 gives a comparison of the maximum and minimum principal stress results which occurred at certain localized points of the bastion, the general stress results obtained for the masonry components of the bastion, and the code requirement. The maximum and minimum principal stresses which occurred between the element joints are higher than those for the code requirements. These are 0.9 MPa and 0.135 MPa for the minimum and maximum principal safety stresses, respectively. The minimum principal stresses obtained for the masonry components were generally lower than the code

requirements. However, maximum principal stresses exceeded the code requirements at several points.

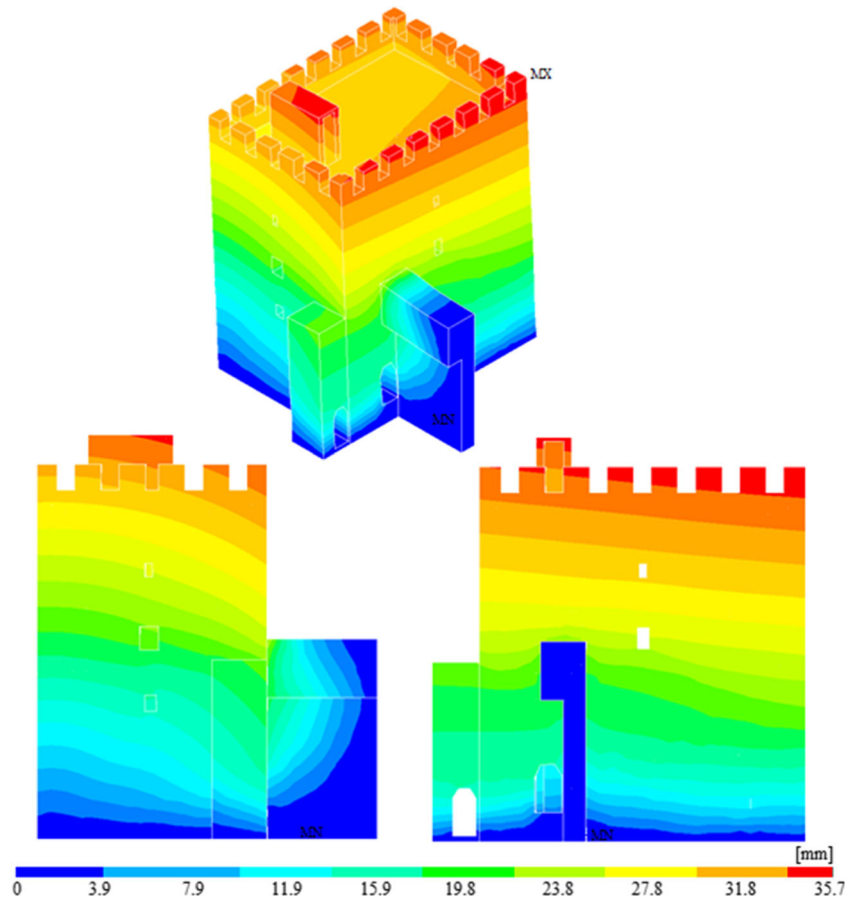
Fig. 17 Contour diagrams of the maximum displacements from nonlinear seismic analysis

The maximum displacements contour diagram obtained from the nonlinear seismic analysis is given in Fig. 17. The maximum displacement occurred at the upper part of the bastion, with a value of 35.7 mm. The displacements decreased towards the supports of the bastion.

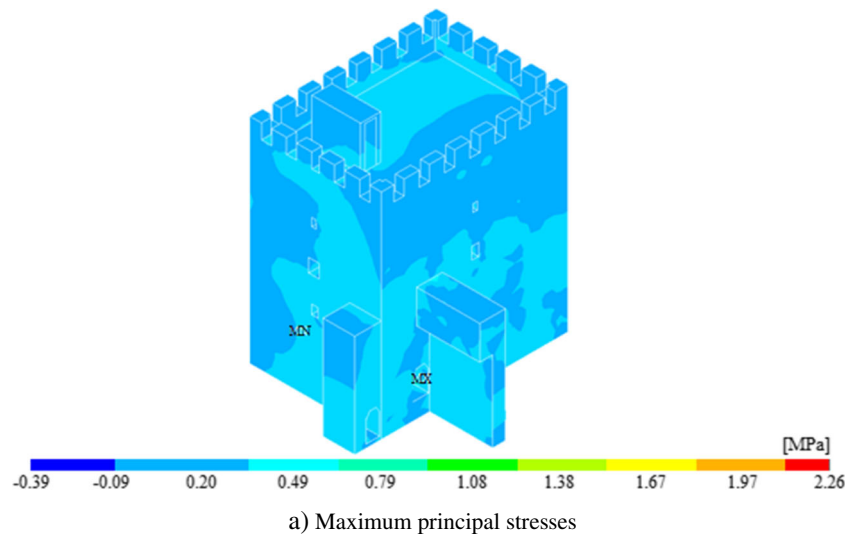
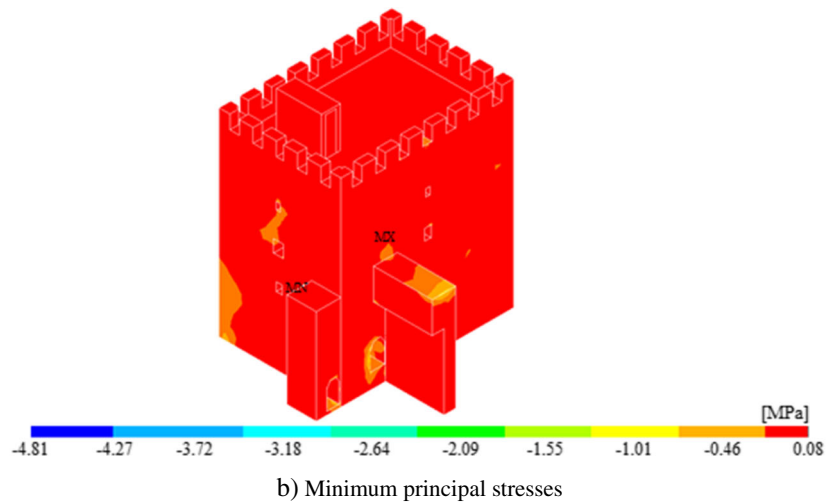
Fig. 18 Contour diagrams of the maximum and minimum principal stresses from nonlinear seismic analysis

The stress results of the bastion are given as principal stresses. According to the stress results, it is possible for some failure and cracks to occur at the maximum stress points if the stresses reach the material strength. The cracks can also be seen in the nonlinear analysis. In Fig. 18, the maximum and minimum principal stresses are presented. The maximum principal stress was obtained on the RC floor, with a value of 2.26 MPa. The stresses which occurred on the arches did not exceed the value of 0.49 MPa. Other than these points,

maximum principal stress did not exceed the value of 0.49 MPa at the bastion. The minimum principal stresses occurred on the RC floor with a value of 4.81 MPa. Stress points were found between the arch and elevator with a value of 1.55 MPa. Apart from this, minimum principal stresses did not exceed the value of 1.01 MPa at the other arches. The minimum principal stresses were not found to exceed the value of 1.01 MPa anywhere else in the bastion.

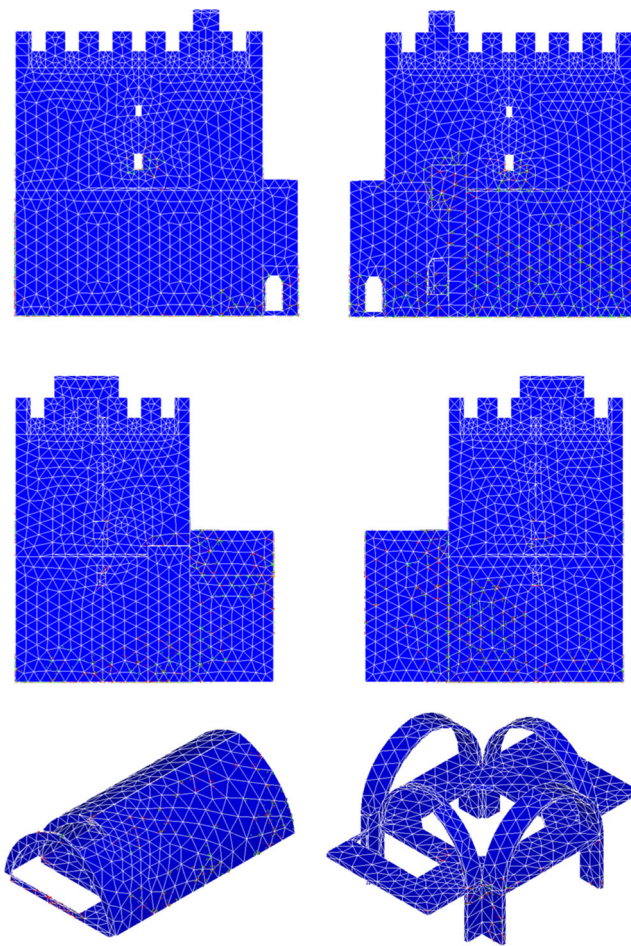
Fig. 19 Crack distributions obtained from the nonlinear seismic analysis

The cracking distributions of the bastion are given in Fig. 19. Only cracking signs were observed. As shown in Fig. 19, the cracks occurred generally in the lower part of the bastion. Some damaged and cracked sections were also detected near the windows and gate, side rampart, RC floors, arches and vaults.

- Cracks occurred generally at the lower part of the bastion. These were found mostly near window spaces and gates, side ramparts, RC floors, arches and vaults. The locations of these cracks are related to the direction of seismic loading. If the loading was applied in a longitudinal direction, the cracks would appear at different points.
