Measurement and removal of asbestos in residential dwellings to be demolished—urban transformation experience in Izmir, Turkey

Abstract

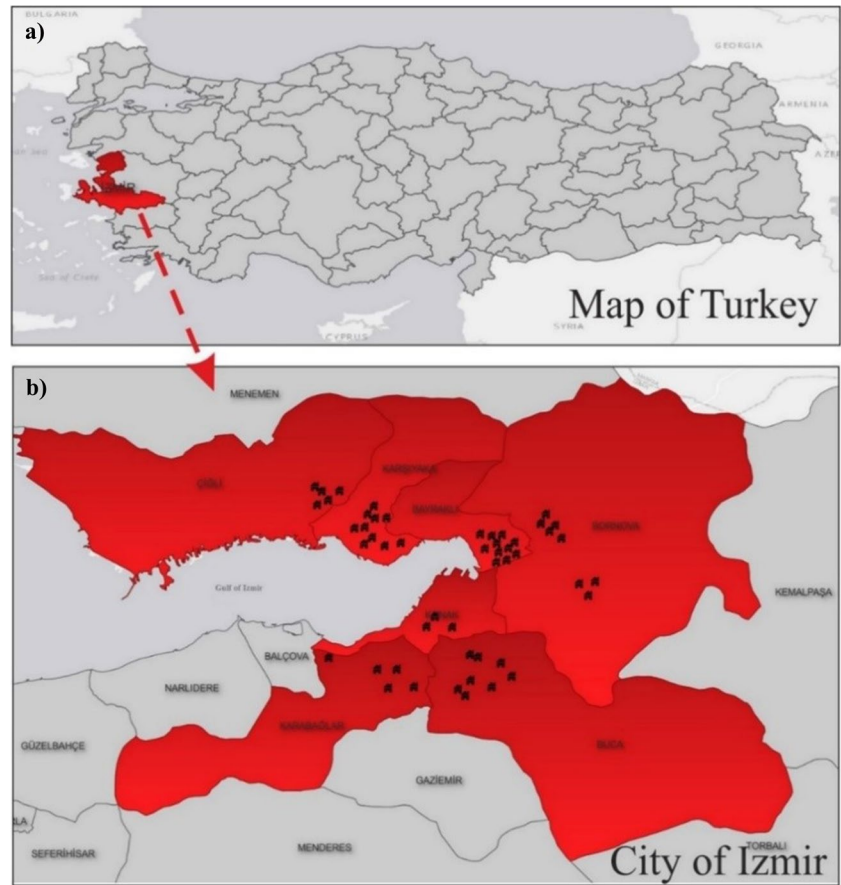
Fig. 3 Location of Izmir (a) and distribution of targeted dwellings for sampling (b)

Izmir, located in the Aegean Region, is one of the most crowded cities with a population of 4,462,056 in Turkey (Fig. 3a). To determine the situation of asbestos-containing dwellings (ACDs) in Izmir, 50 buildings (total area—TA: 10,325 m²) were chosen. The construction dates of the dwellings vary between 1955 and 1998. The distribution of dwellings selected for sampling by seven districts which are 5 dwellings (TA: 740 m²) in Karabağlar, 8 dwellings (TA: 1050 m²) in Bornova, 5 dwellings (TA: 1155 m²) in Çiğli, 10 dwellings (TA: 1640 m²) in Karşıyaka, 8 dwellings (TA: 820 m²) in Buca, 3 dwellings (TA: 625 m²) in Konak, and 11 dwellings (TA: 4295 m²) in Bayraklı is given (Fig. 3b). These districts were intentionally chosen due to the urban renewal process rapidly ongoing and dwellings that are going to be demolished. The mean of the population of these seven districts is about 370.000 (TURKSTAT 2022).

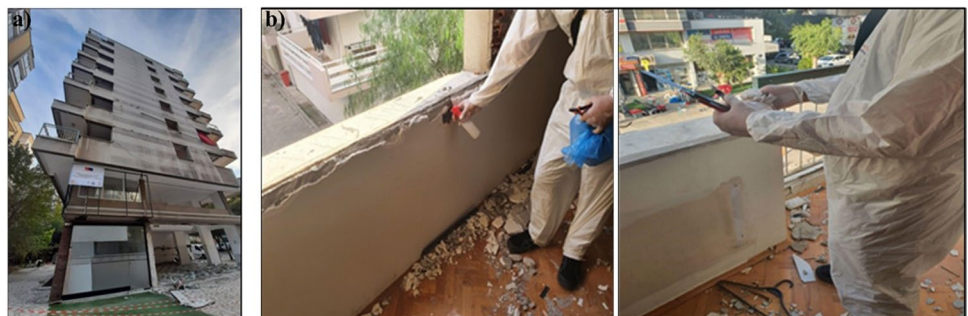
Fig. 4 One of the target buildings (a) and sampling from wall covering (b)

collected from floor tiles, wall coverings, roofing materials, insulation boards, decoration materials, etc. In total, 505 bulk samples were taken (Fig. 4a and b) and prepared for PLM analysis in an accredited laboratory (Fig. 5).

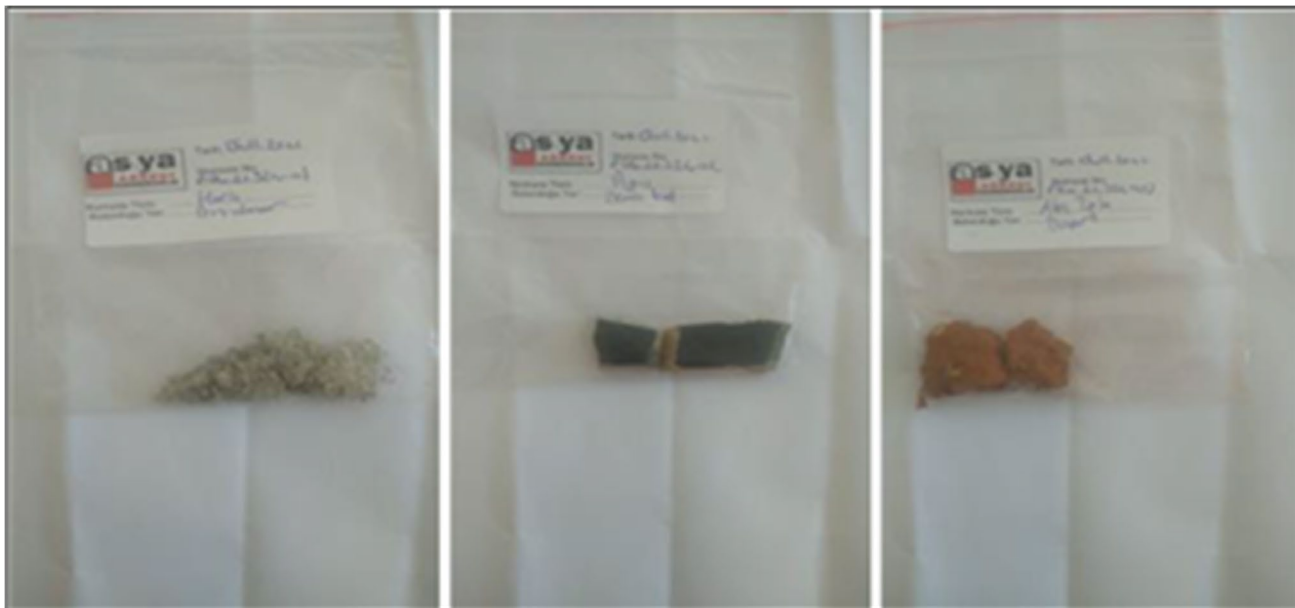
Fig. 5 Packed and labeled bulk samples

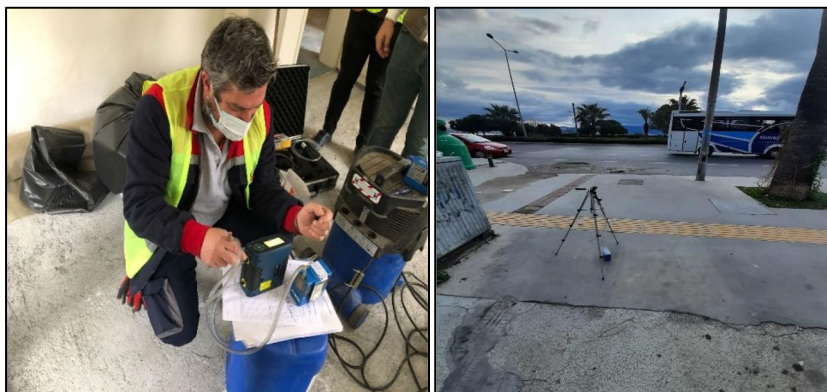
Fig. 6 a Personal exposure gauges for air sampling. b Outdoor air measurement

Four air samples were taken from each building to determine the respirable asbestos fibers in the outdoor air. One sample was taken from outdoors during the removal process and one sample for personal exposure was taken instantaneously during removal and transportation for disposal. The outdoor air sampling is executed at a height of 1500 mm above ground level. The other two samples were collected as blind samples from the outdoor environment.

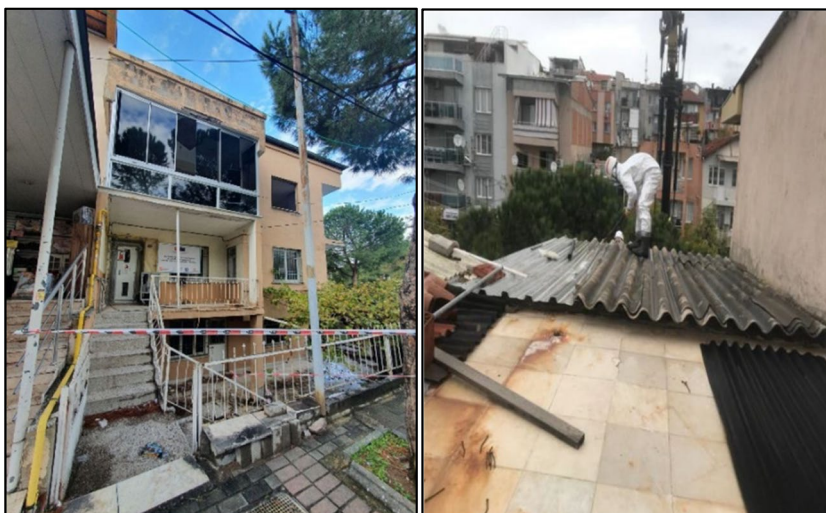
Fig. 7 Asbestos removal process

As part fieldwork of this study, the removal, transportation, and abatement process of a detected asbestos is depicted in Figs. 7 and 8. It is seen that roofing material is removed and packed by trained field personal. The forklift carried the package to the vehicle for transportation to the asbestos disposal facility.

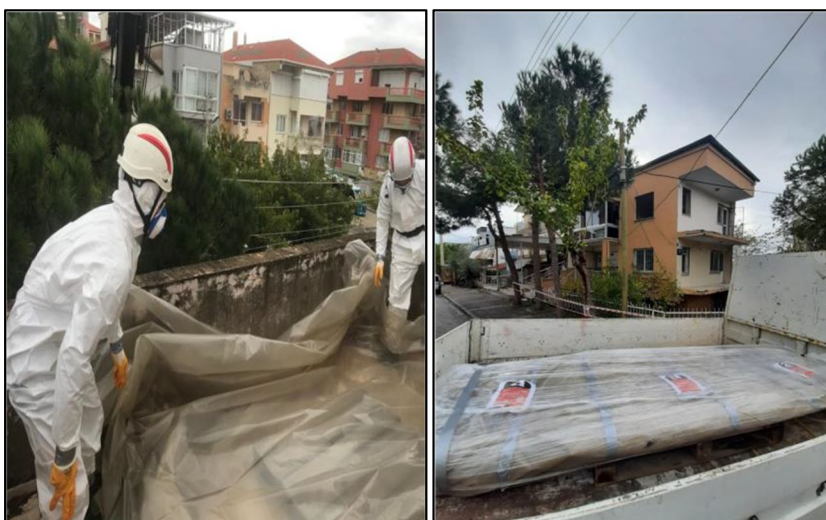
Fig. 8 Packing the removed material and sending to the disposal facility

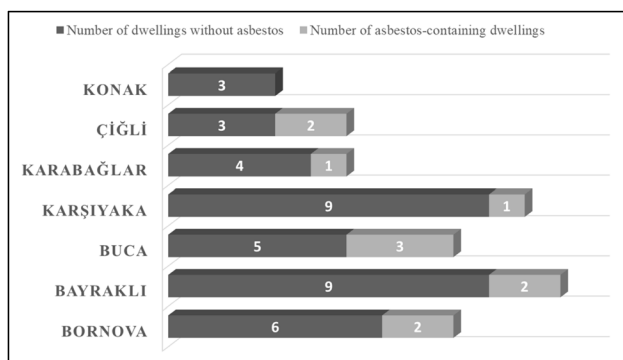
Fig. 9 The distribution of ACDs in different districts of Izmir

ACDs were located in Buca (3), Bayraklı (2), Bornova (2), Çiğli (2), Karşıyaka (1), and Karabağlar (1). The distribution of the ACDs is shown in Fig. 9. The ratio of ACDs to the total number of buildings was obtained as 22% (11 ACDs in 50 buildings). The total area of ACDs was 2.112 m² (20%). The ratio of ACM (%) of each building is given in Table 1. The minimum rate is calculated as 4% and the maximum rate of ACM in dwellings is 25%.
