## Archaeological Survey of the Ex-USS *Independence* (CVL22)

In August 2016, a multidisciplinary team conducted the first archaeological survey of the deep-water (829 m) wreck of the ex-USS *Independence* (CVL22) using the remotely operated vehicles *Argus* and *Hercules*. The survey provided 34 h of direct observation with video and still camera documentation of the wreck, which the previous year had been initially identified with a limited three-dimensional sonar survey of the site. The 2016 assessment added considerably to an understanding of changes to *Independence* after its use as a target vessel for the 1946 atomic bomb tests at Bikini Atoll, as a radiological laboratory, training facility, and finally as a receptacle for “nuclear waste” prior to its scuttling off California in January 1951. The location and detailed examination of the wreck, along with additional archival research, offers a more nuanced definition of the carrier’s role within the context of the Cold War between the USSR, its adversaries and the race to establish nuclear supremacy, as well as site formation processes and ongoing biological colonization of the wreck site. As well, no evidence of residual r

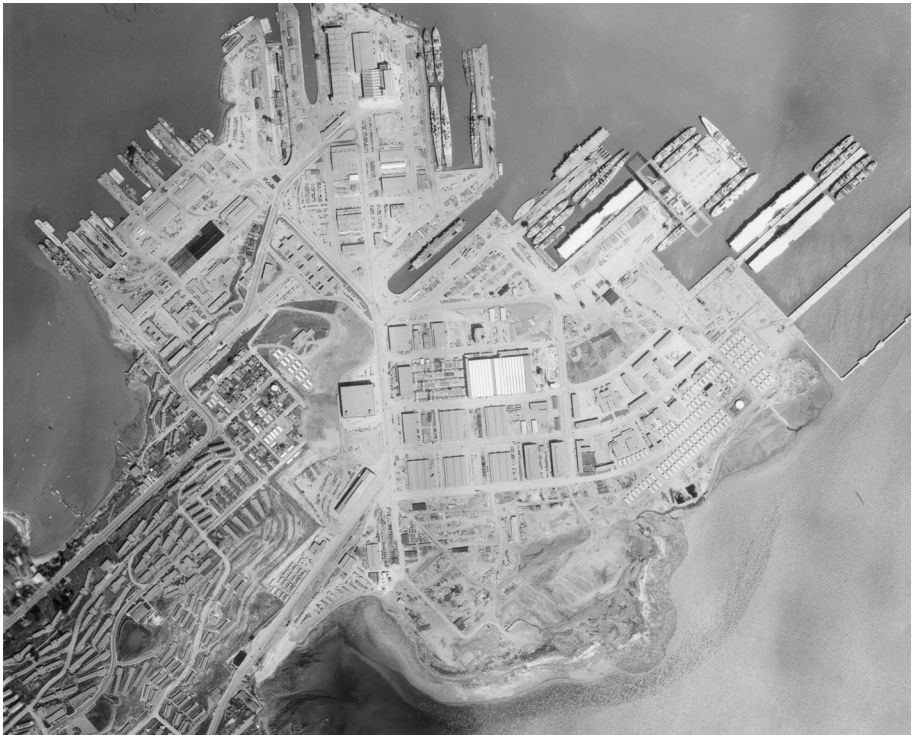
**Fig. 1** Aerial photograph of Hunter’s Point Naval Shipyard in San Francisco from 1948 showing USS *Independence* (CVL22) at the pier. National Archives

*Independence* arrived at Hunter’s Point Naval Shipyard in San Francisco, on June 16, 1947 (Fig. 1). There it became the platform for the U.S. Navy’s radiological decontamination school, later called the Naval Radiological Defense Laboratory, until December 1950.

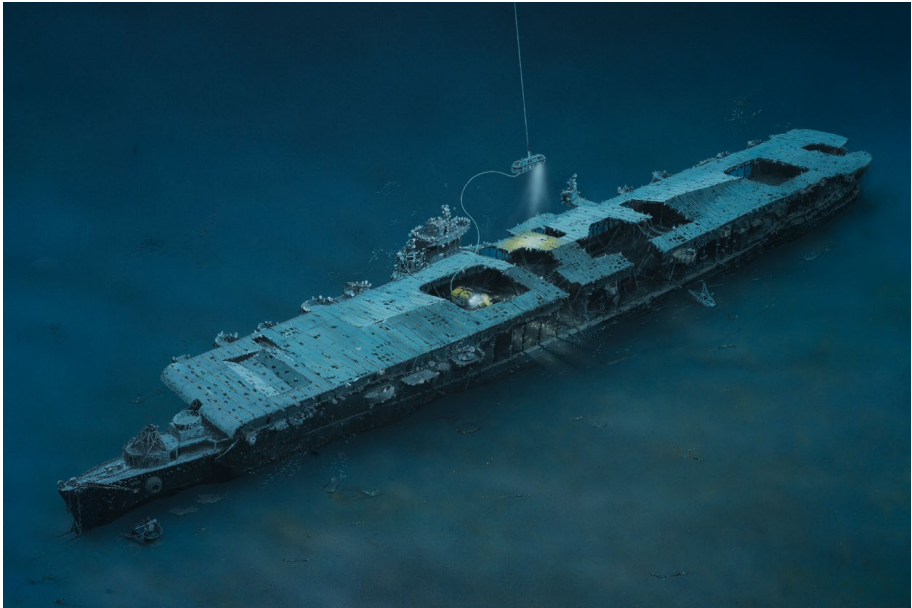
**Fig. 2** Oil painting of the USS *Independence* shipwreck site by Danijel Frka, Russell Matthews Collection

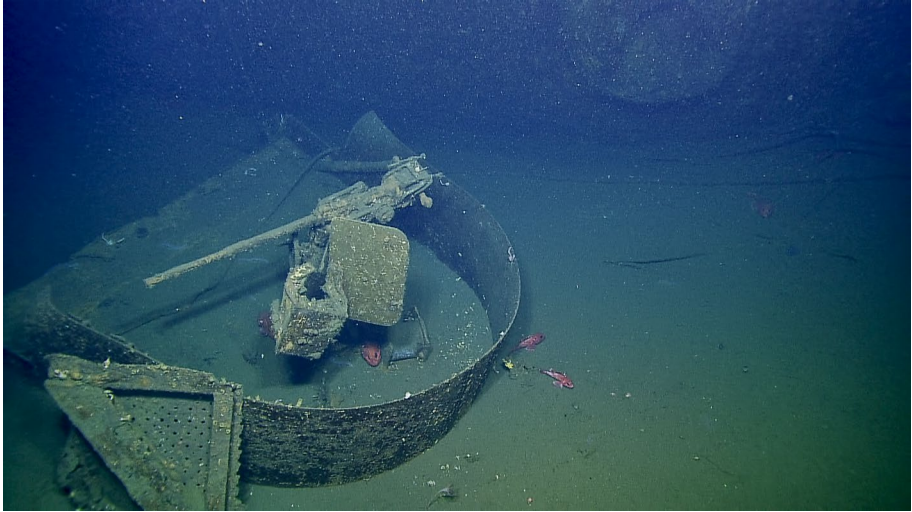
**Fig. 3** ROV image of the 20 mm gun and mount from frame 20 that fell forward to rest on the seabed near the bow. Image courtesy of Ocean Exploration Trust

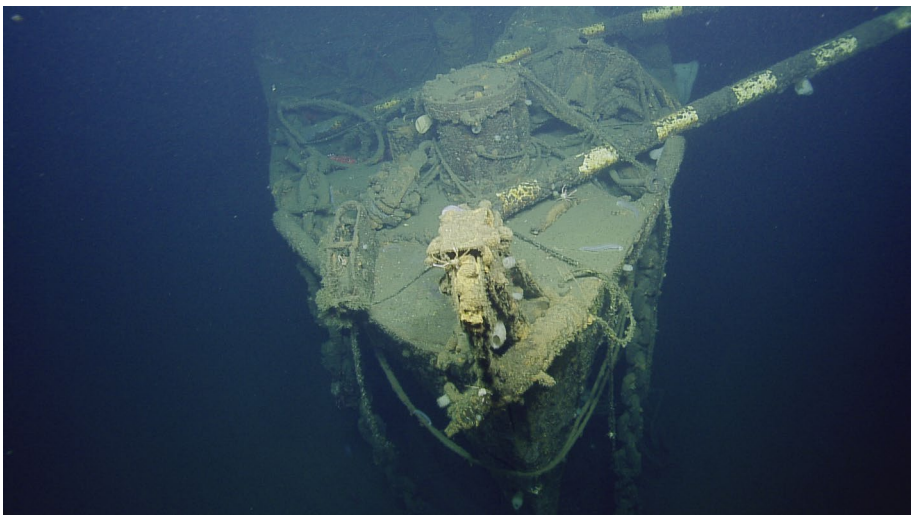
A prominent feature at the bow is a towing bridle attached to a stud-link anchor chain; the chain runs across the forecastle deck into the deck house below the 40 mm mount at

**Fig. 4** ROV image of the bow of *Independence* showing the towing bridle and two fallen range poles. Image courtesy of Ocean Exploration Trust

the bow (Fig. 4). The chain is stowed in the same position that it was for *Crossroads*, but at Bikini this was a single strand rigged at the starboard chock that ran out and down to the bow mooring block. This strand, with another added to the port and running through that chock, was shortened and rigged to form the bridle for towing *Independence* from Bikini, and ultimately from Hunter's Point Naval Shipyard to the site of the sinking. The chain formed the bridle legs and prior to their terminal ends, they are connected by what appears to be served and parceled (which provided multi-layer protection) wire-rope

span that took the place of a more standard “fish plate” for the attachment of the fore pennant (the actual tow line). A series of loose rope lines attached to and looped near the bridle are likely the pennant and bridle retrieval lines used by the towing crew.

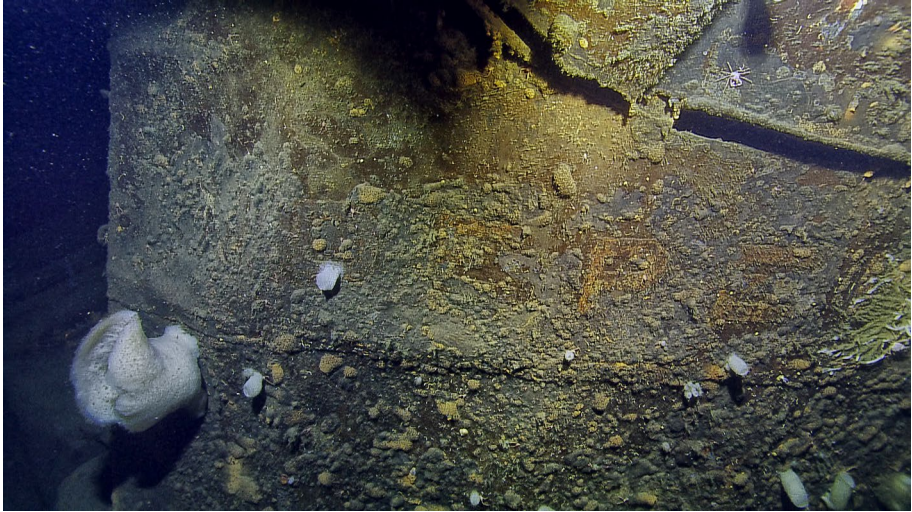
**Fig. 5** ROV image of the block letters of USS *Independence* on the stern. Image courtesy of Ocean Exploration Trust

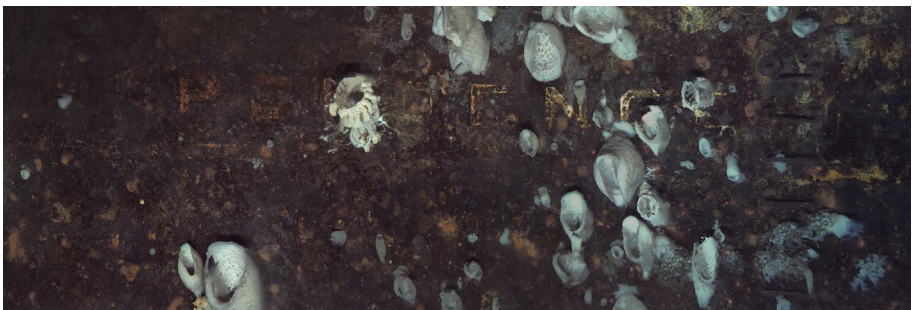
**Fig. 6** Photomosaic of the full name on the stern. Image by Ian Vaughn, courtesy of Ocean Exploration Trust

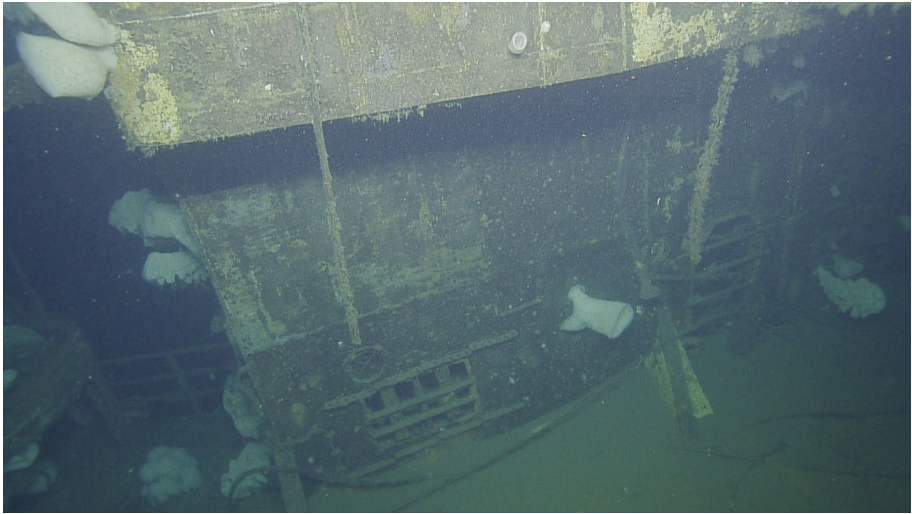
**Fig. 7** ROV image of the side of the island superstructure and remnants of the painted “kill board.” Image courtesy of Ocean Exploration Trust

groups and deck force with anti-aircraft guns (Fig. 7). Kill boards were painted on both ships and on the sides of aircraft as a means of keeping score. The *Independence* kill board is documented in wartime photographs (Fig. 8). Its surviving traces consist primarily of the lighter-colored background for the small Japanese flags that depict a kill, as well as the background for lettering denoting air groups. The differential survival of the paint is an archaeological signature of the Test Able atomic blast: “Red paint from the Japanese flags on the “Island” has turned white from the effects of radiant heat” (Bureau of Ships 1946A: 114). The lighter paint reflected the thermal energy of the bomb, while the darker colors that absorbed it either burned away or faded.

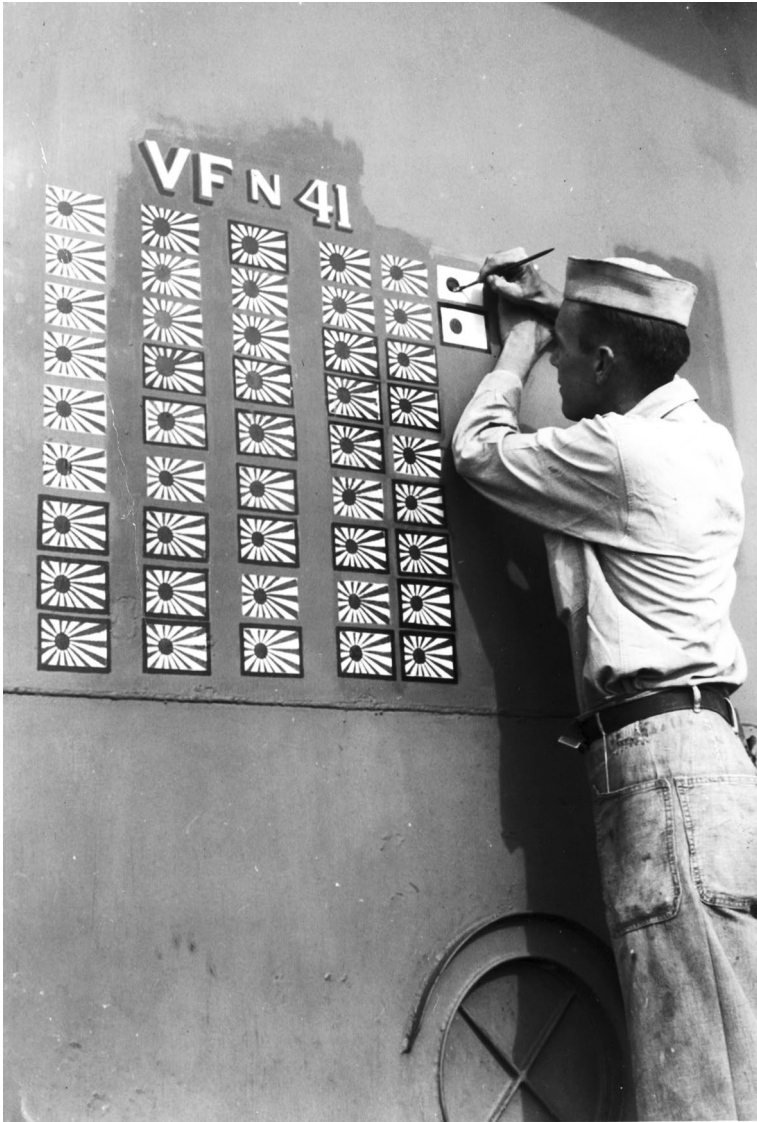
**Fig. 8** Historic photo of sailor painting new entries on the kill board on *Independence's* island superstructure. National Archives

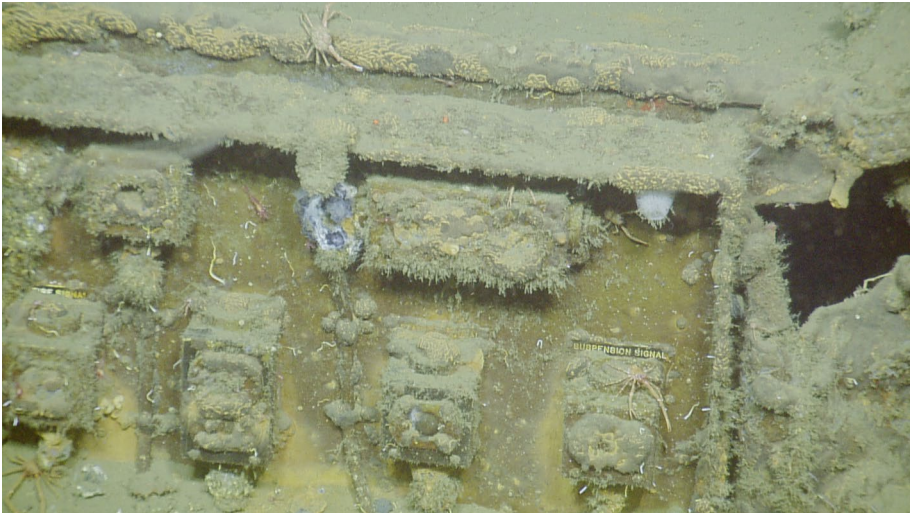
Fig. 10 ROV image of switch panel on the navigation level with plastic labels still readable. Image courtesy of Ocean Exploration Trust

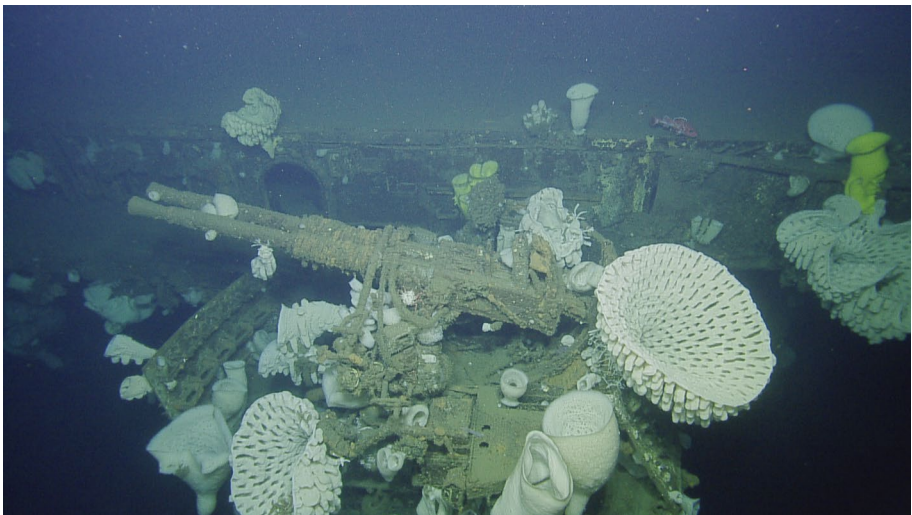
**Fig. 12** ROV image of gun tub and 40 mm gun covered in large sponges. Image courtesy of Ocean Exploration Trust

On an otherwise featureless sediment bottom with few rocks, *Independence* forms an ideal habitat for sponges. Well-fed by ocean nutrients anchored to hard structure, a variety of sponges were observed (e.g. Fig. 12).

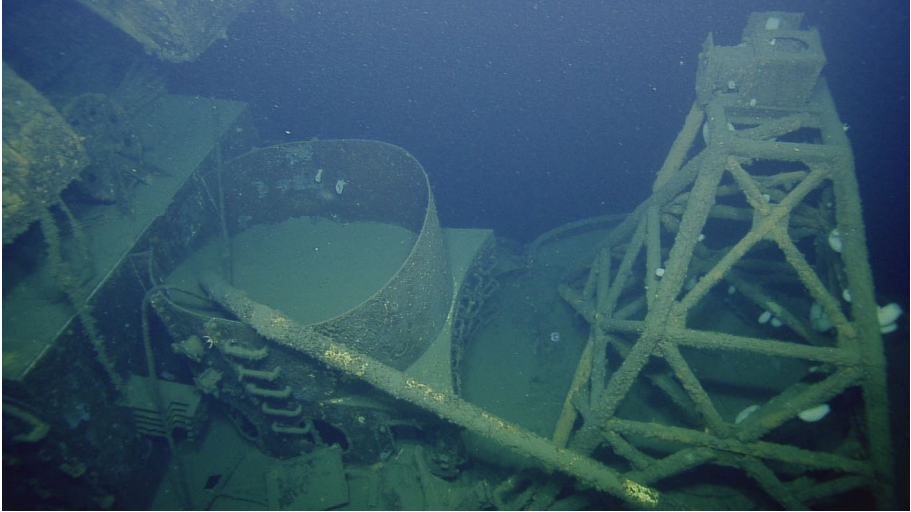
Pre-sinking photographs showed that two welded tubular steel towers for mounting peak-over pressure gauges, known colloquially to Crossroads crews as “Christmas Trees,” remained on *Independence* when it was scuttled. The dives initially noted that one tower, formerly on the flight deck near frame 90, was missing while the other remained in position in the forward 40 mm gun tub at the bow (Fig. 13). Later, the second, which had been placed on the port side of the flight deck aft of the forward elevator, was found lying off the side of the ship on the ocean floor. It may have detached and fallen to the seabed when *Independence* hit bottom, or fallen due to subsequent deterioration of the flight deck. Other effects from the sinking of the carrier include the buckling and collapse of the tubular steel range poles set along the carrier’s centerline for measuring the rate of sinking (Fig. 14), and fire hose that unspooled from reels as *Independence* sank. Post sinking changes to the wreck include fishing trawl nets tangled and caught in the wreck, particularly at the starboard aft quarter and close to the island, on the starboard side (Fig. 15).

**Fig. 13** ROV image of “Christmas tree” blast gauge tower still in position in the forward 40 mm gun tub at the bow. Image courtesy of Ocean Exploration Trust

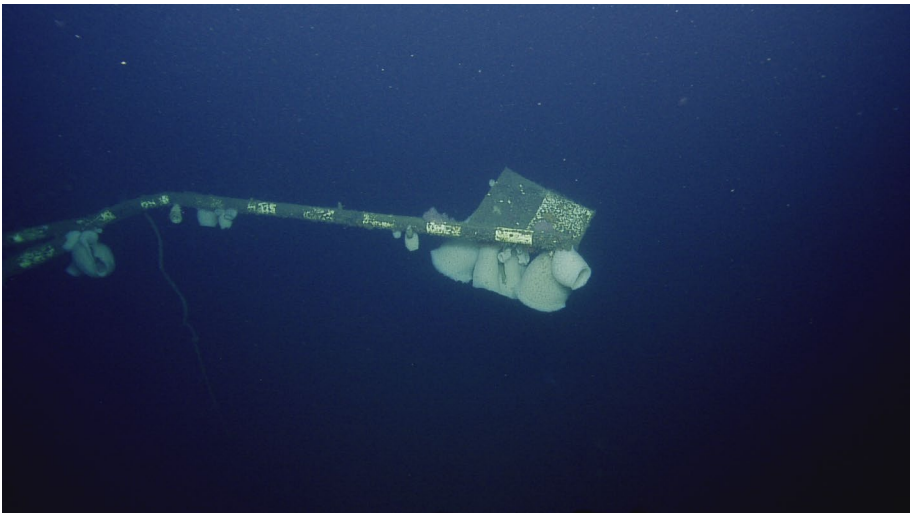
**Fig. 14** ROV image of fallen range pole, now a surface for sponge colonization. Image courtesy of Ocean Exploration Trust

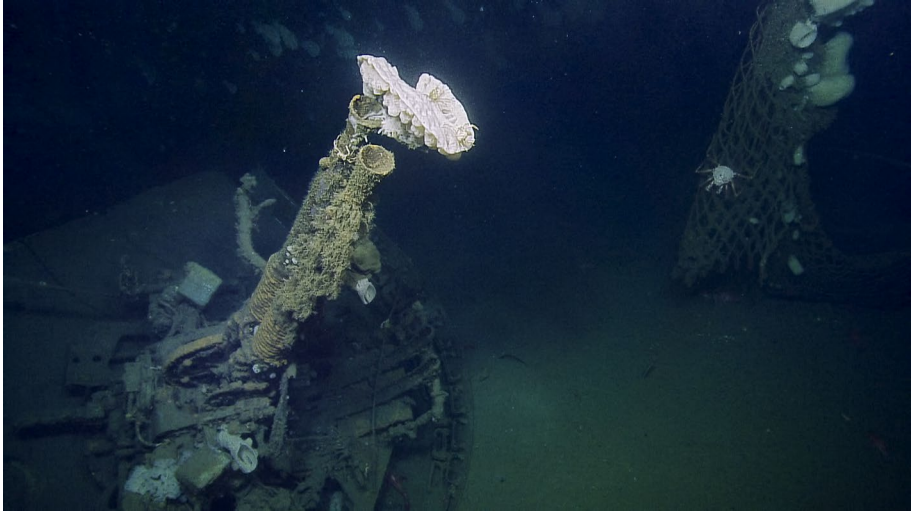
**Fig. 15** ROV image of 40 mm gun with snagged trawl net in the background. Image courtesy of Ocean Exploration Trust

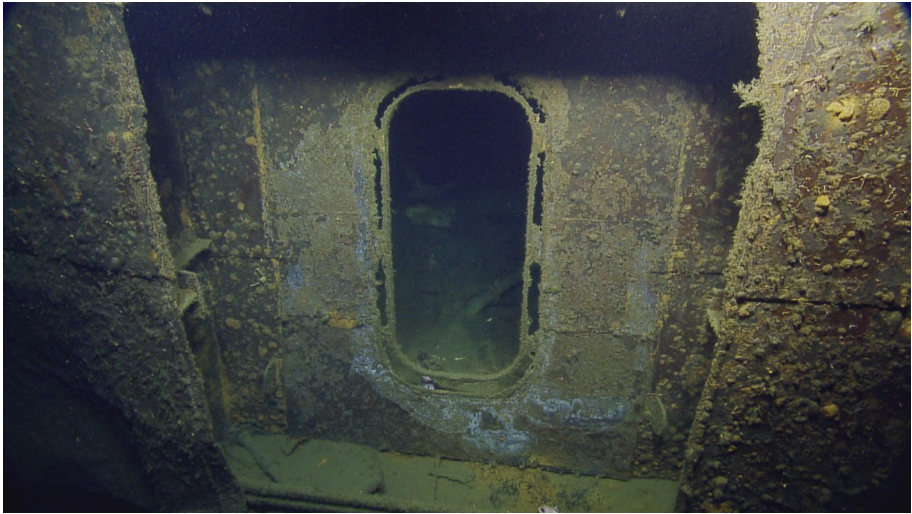
aft starboard engine room. It may have been installed in 1950 to provide access for waste storage in the engine room (Fidler 1950; Bird 1950a, b). Instructions for access called for a “watertight door” on the starboard side at the third deck level between frames 26–29, with instructions to cut out an existing hatch to do so, according to a July 6, 1949 memorandum from the Director of the Naval Radiological Defense Laboratory to the Planning Officer of the San Francisco Naval Shipyard (reproduced in Delgado 2016b: 74). As the door we

**Fig. 17** ROV image of an access door cut through a hatch on the starboard side of *Independence*, above the torpedo blister near frame 130. Image courtesy of Ocean Exploration Trust

noted in 2016 was the only such feature we observed, the location outlined in the plan was shifted to the location we documented (Fig. 17).

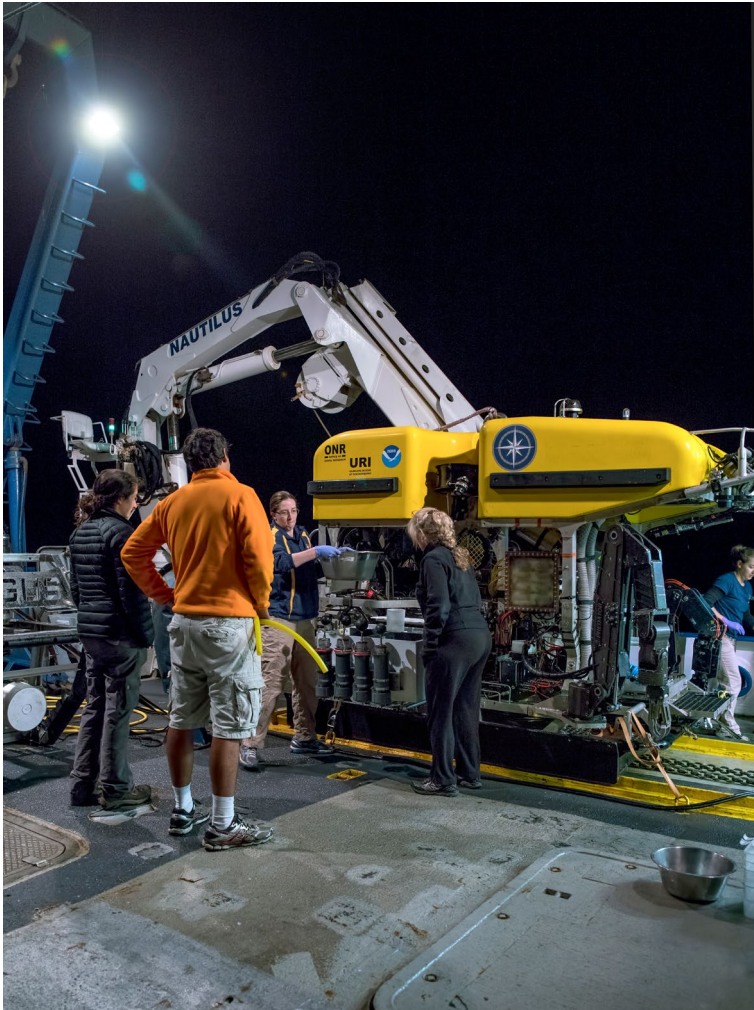
**Fig. 18** Photo of *Nautilus* science team recovering sponges from the bio-boxes aboard the *Hercules* ROV. Image courtesy of Ocean Exploration Trust

The science team’s biology group used *Hercules* to collect a variety of sponges for analysis and as an ideal means to determine the presence of radionuclides (Fig. 18). A key aspect of the survey was determining if, after 70 years since its exposure to two atomic blasts, *Independence* remained radioactive. We did not suspect so, given the normal rate of radioactive decline of isotopes, and the low levels recorded on *Independence* just prior to sinking. Under the guidance of Professor Kai Vetter, students of the University
