## USS *Independence's* Aircraft

### Abstract

Submerged aircraft are a newly emerging area of study in underwater archaeology. In August 2016, a multidisciplinary team conducted the first archaeological survey of the deep water (829 m) wreck of the ex-USS *Independence* (CVL22), a WWII era light carrier scuttled off San Francisco after its use as an atomic bomb test target and subsequently as a floating radiological laboratory and training facility. Using the remotely operated vehicles *Argus* and *Hercules*, the expedition documented and studied *Independence* including assessment of a sonar target thought to be an aircraft resting inside the sunken carrier's forward elevator pit. The survey confirmed the presence of a plane, but previous assumptions as to the type and identity of this aircraft, based on archival records, proved erroneous. As well, the remains of a second, and possibly a third, aircraft were also encountered during the 2016 survey. These artifacts, through their context, both as naval warplanes on an aircraft carrier, and as test articles for seaborne nuclear weapons development, more precisely fit within the parameters of maritime archaeology. They join other a

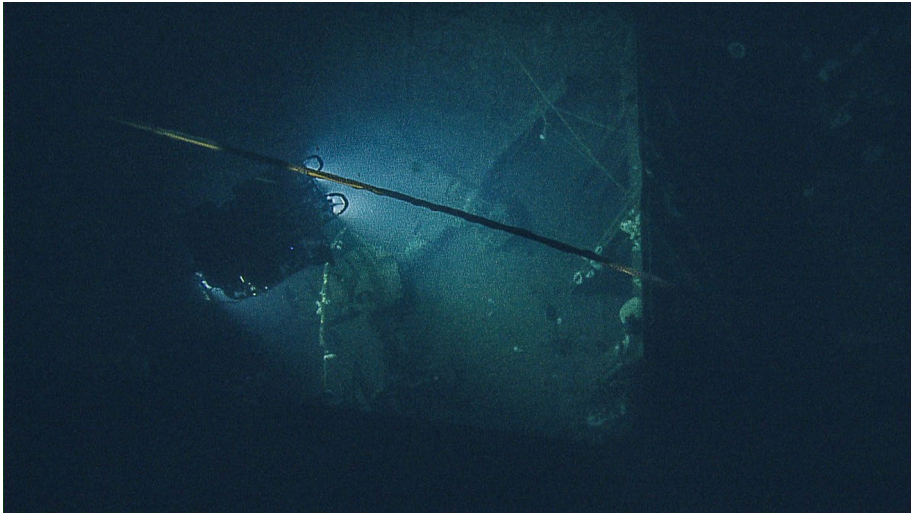
**Fig. 2** ROV image from *Argus* of ROV *Hercules* exploring the Grumman F6F-5N Hellcat wreckage inside the elevator pit. Image courtesy of Ocean Exploration Trust

The discovery of this aircraft inside the shipwreck with ROVs *Hercules* and *Argus* (Fig. 2) not only documents an additional element of the *Independence* site, it also brings up questions about the completeness and accuracy of the historical record. More importantly, however, it also raises the issue of the nature and scope of the material culture that comprises the maritime archaeological assemblages of Operation Crossroads. The aircraft onboard *Independence*, we maintain, are maritime elements not only because of their underwater deposition on a shipwreck, but because they were distinctly naval in terms of their original development and deployment in World War II, and were then used in naval tests of the atomic bomb. These aviation artifacts are a reminder of other Crossroads aircraft that are part of the archaeological record. They point to a significant element of the submerged maritime archaeological site that is the simulated atomic battlefield at Bikini Atoll.

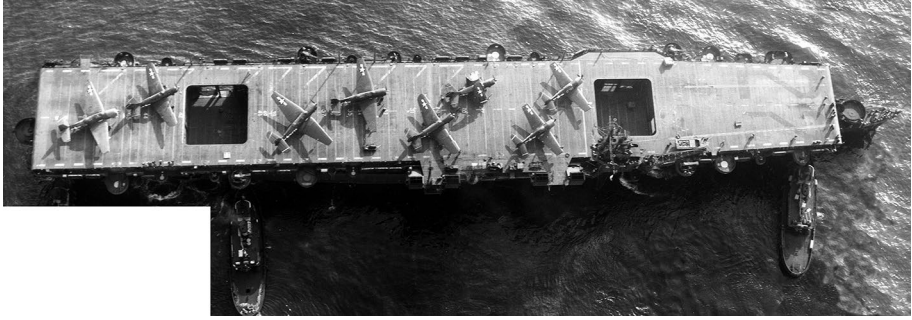
**Fig. 3** Historic aerial photo USS *Independence* equipped for Operation Crossroads with aircraft positioned on deck. National Archives

Of the fourteen target aircraft “missing” after the Able Test, half had come from USS *Independence* (Figs. 3, 4) (see Table 1). The other seven included an OS2U-3 Kingfisher spotter plane from USS *Arkansas*, an OS2U-3 each from the cruisers USS *Salt Lake City* and USS *Pensacola*, plus two F6F-5 Hellcats and two FM-2 Wildcat aircraft lost when the attack transports USS *Gilliam* and USS *Carlisle* sank with them aboard (Bureau of Aeronautics 1946:155, 162, 163, 165, 189). A further eleven badly-damaged planes had to be jettisoned from the battleships USS *Nevada* and USS *Pennsylvania*, as well as the

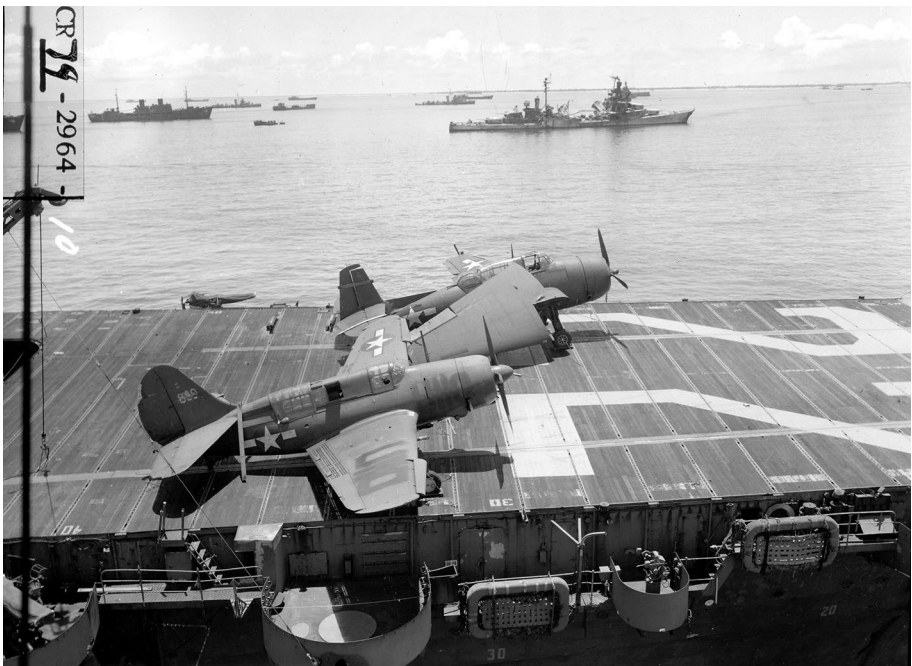
**Fig. 4** Historic photo of aircraft on the deck of USS *Independence* before the Baker test. National Archives

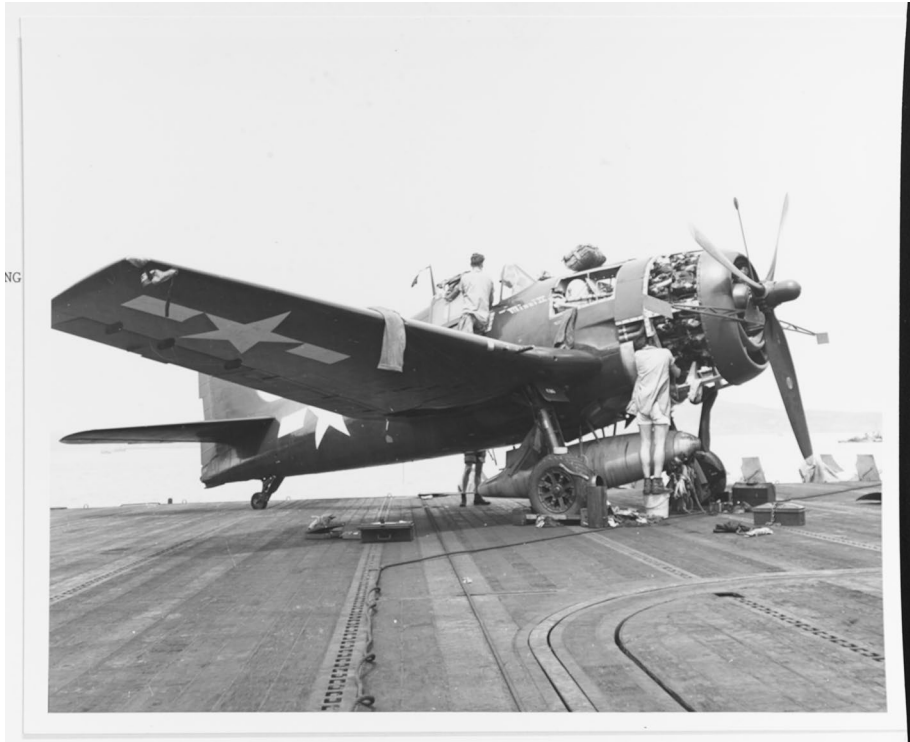
**Fig. 6** Historic photo of a Grumman F6F-5N Hellcat on deck. National Archives

The final report from the Bureau of Aeronautics Group at Crossroads noted that out of the 73 aircraft deployed on target vessels, 14 had been placed on *Independence* for Able, and two more for Baker (Fig. 5). These were made up of five Grumman TBM-3E Avengers, five Grumman F6F-5N Hellcats (Figs. 6, 7), and four Fairchild-Canada SBF-4E Helldivers (Figs. 8, 9) for Able, as well as an SBF-4E and TBM-3E for Baker. The Able planes were either noted as “missing” ( $n=8$ ) because they had been blown off the flight deck or were found to be badly damaged and subsequently jettisoned ( $n=7$ ) (Table 1). The pair of aircraft staged just prior to Baker survived that blast and remained on *Independence* post-Crossroads (Fig. 10). Indications on the sonar survey of a possible plane inside the forward elevator pit led us to surmise that it may have been one of these two particular aircraft.

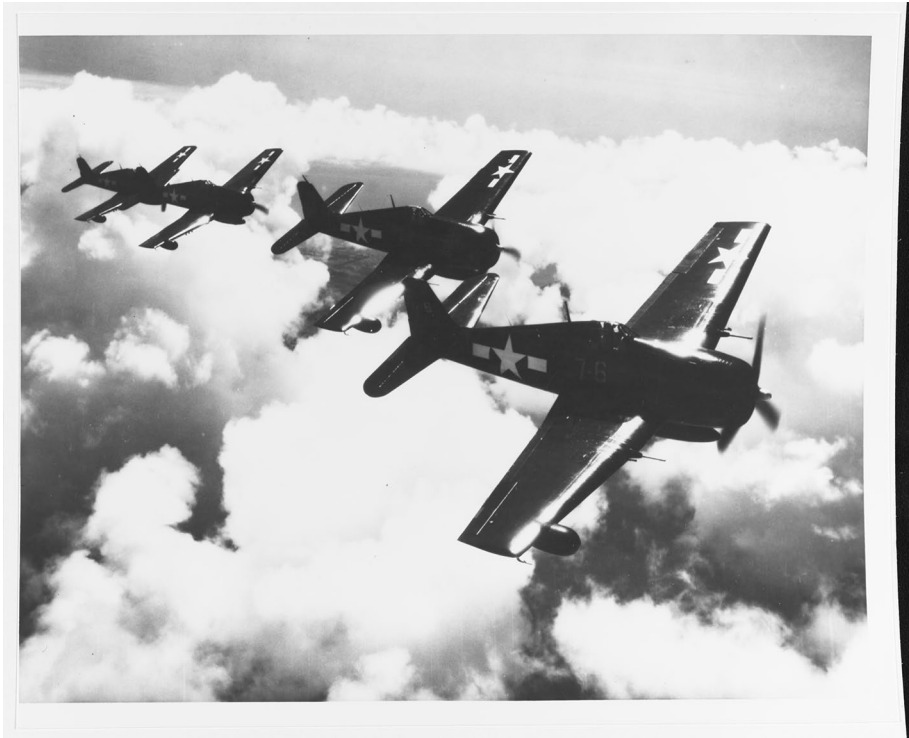
**Fig. 7** Historic photo of Grumman F6F-5N Hellcats flying in formation. National Archives

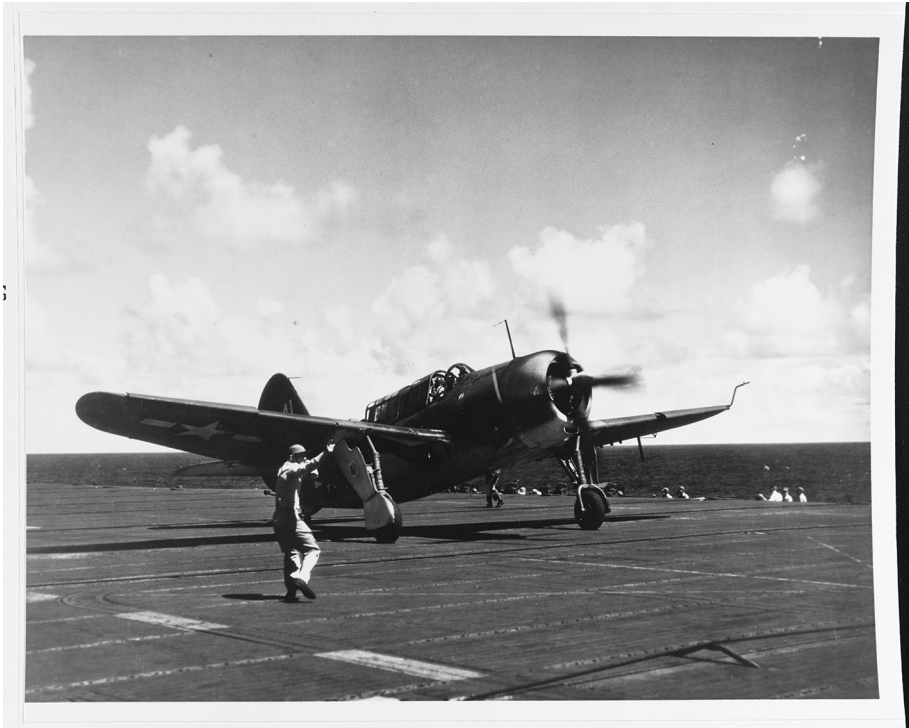
**Fig. 8** Historic photo of a Fairchild-Canada SBF-4E Helldiver on deck. National Archives

The SBF-4E Helldivers aboard *Independence* for Able were Canadian Fairchild-built versions of the Curtiss SB2C Helldiver (Fig. 8), which was developed in 1939–1940 but

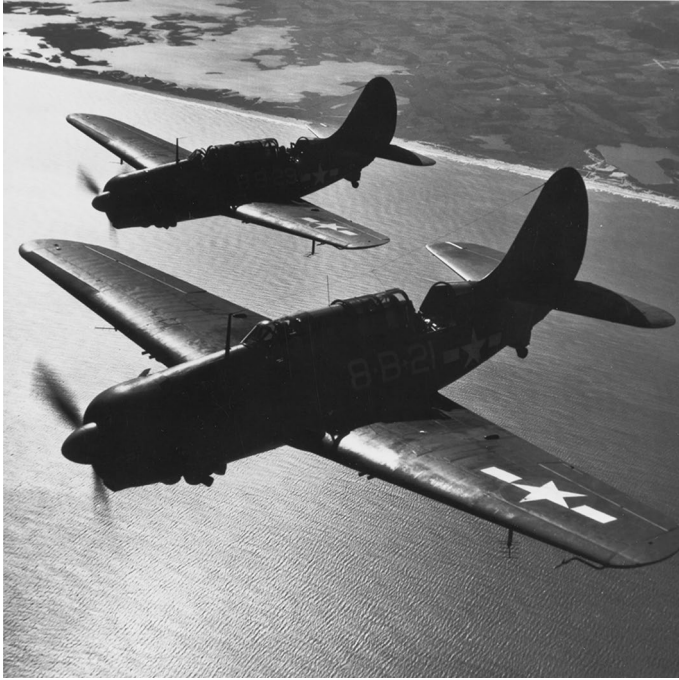
**Fig. 9** Historic photo of Fairchild-Canada SBF-4E Helldivers flying in formation. National Archives

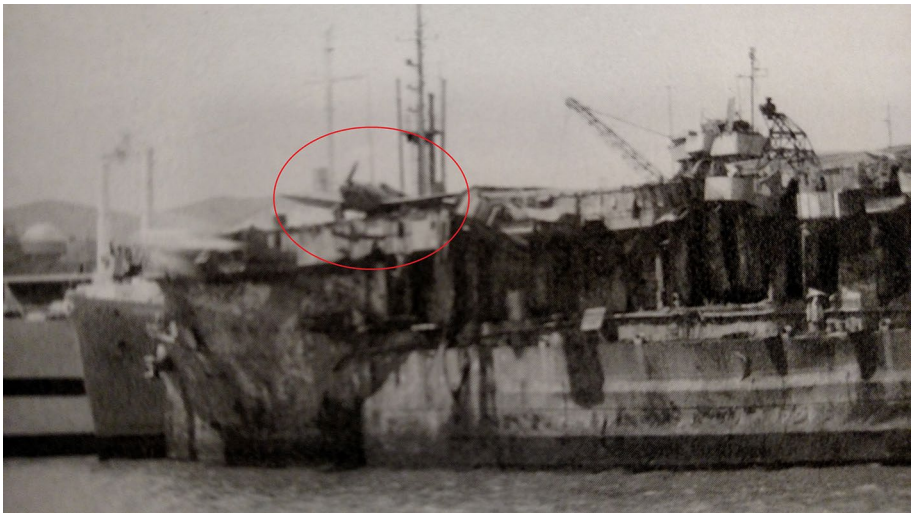
**Fig. 10** Historic photo of USS *Independence* after the Able test showing an aircraft remaining on deck. National Archives

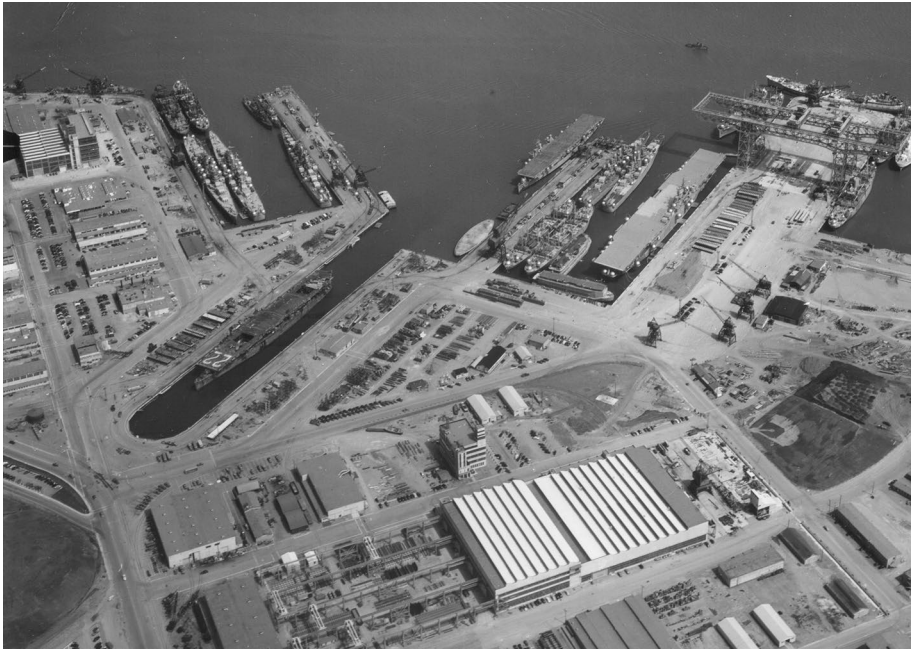
**Fig. 11** Aerial photograph of Hunter's Point Naval Shipyard in San Francisco from 1948 showing USS *Independence* (CVL22) at the pier. National Archives

Archival records noted that the two planes, a TBM-3E Avenger (BuNo. 69169), and an SBF-4E Helldiver (BuNo. 31899), came to San Francisco on board the carrier. The Avenger was removed from *Independence* in October 1947, shipped to Philadelphia, dismantled for detailed analysis of bomb damage, and then disposed of at sea (Heilman 1950:5–7). The historical record is silent on the fate of the SBF-4E. However, it is clearly visible on the flight deck near the forward elevator pit in a photograph taken of *Independence* at Hunter’s Point Naval Shipyard on April 19, 1948 (Fig. 11). Prior to the 2016

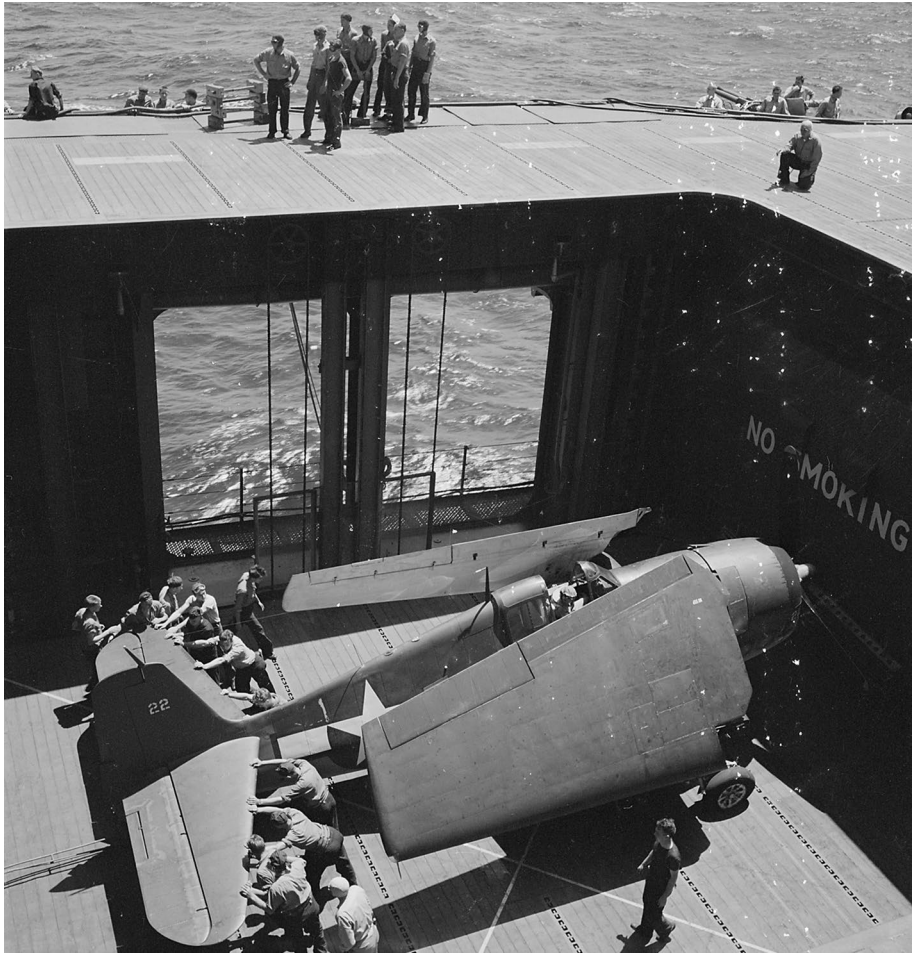
**Fig. 12** Historic photo showing an aircraft in the elevator pit on USS *Independence*. National Archives

mission, our hypothesis was that if an aircraft was indeed resting in the elevator, it might well be this dive bomber (Fig. 12) (Delgado et al. 2016a, b:21). However, our subsequent survey of the damaged but substantially intact plane inside *Independence* showed it to be a Hellcat rather than the anticipated Helldiver.

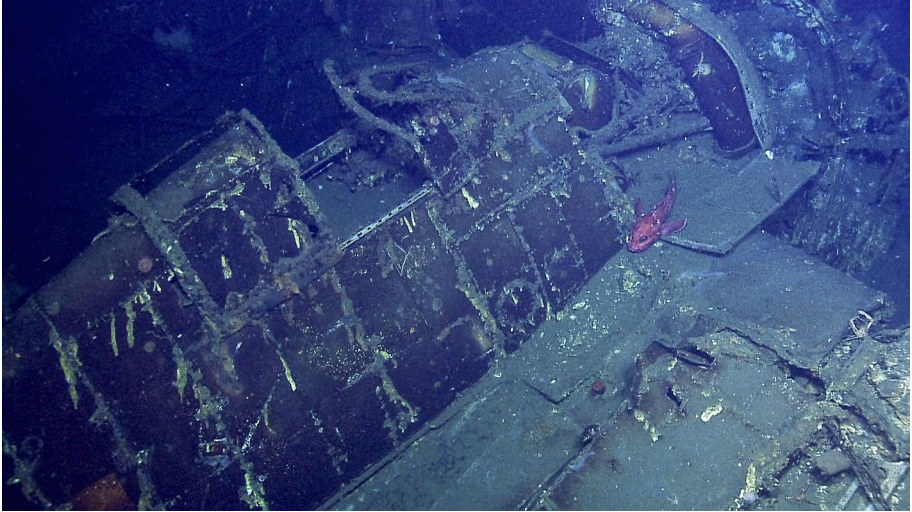
**Fig. 13** ROV image of Hellicat wreckage in the elevator pit on the USS *Independence* wreck. Image courtesy of Ocean Exploration Trust

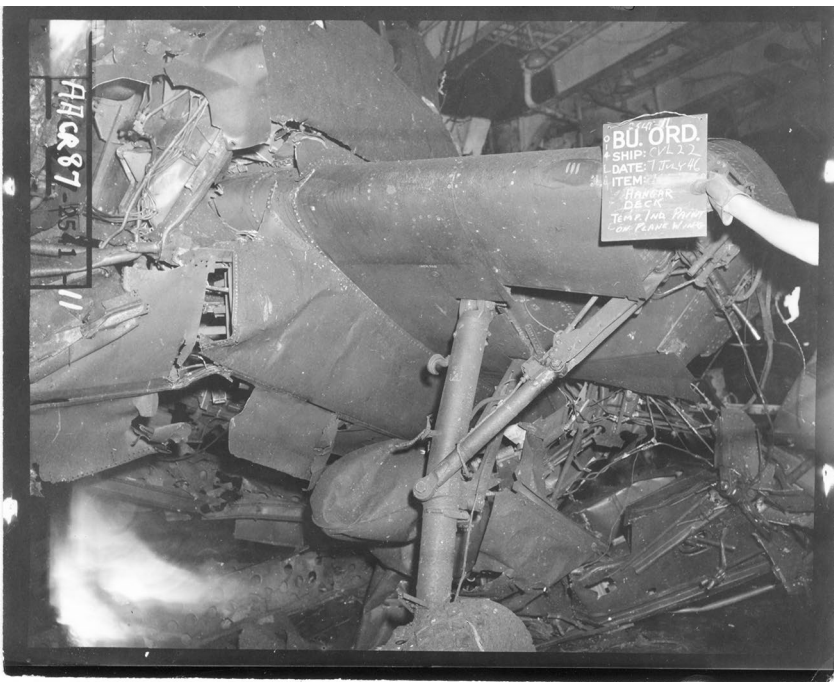
**Fig. 14** Historic photo of a damaged aircraft in the forward elevator pit following the Able test. National Archives

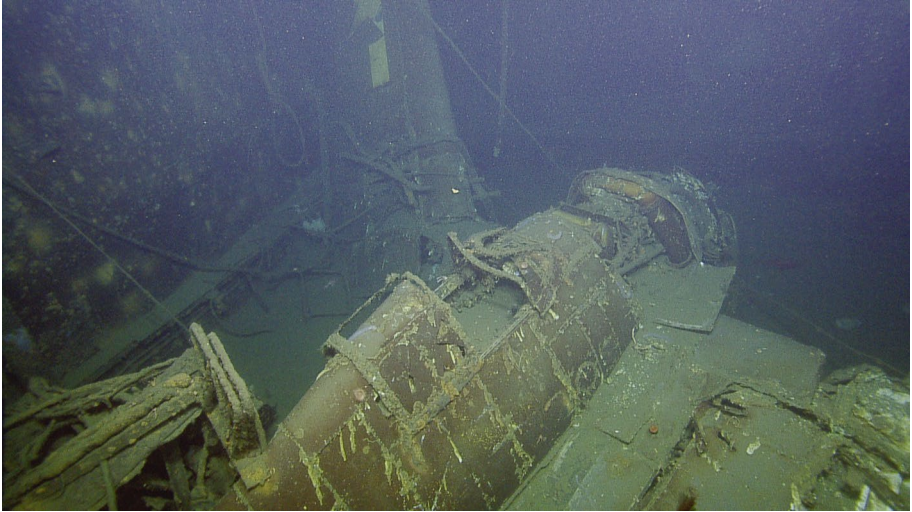
**Fig. 15** ROV image of Hellcat wreckage in elevator showing port wing resting against the forward bulkhead. Image courtesy of Ocean Exploration Trust

As we now know, this aircraft remained on board *Independence*. Its current arrangement is different from that shown in the post-Able photograph (Fig. 15), either due to repositioning for ocean transit or as a result of the carrier rolling during sinking. As previously described, the empennage was not observed by our team, nor the outer edge of the

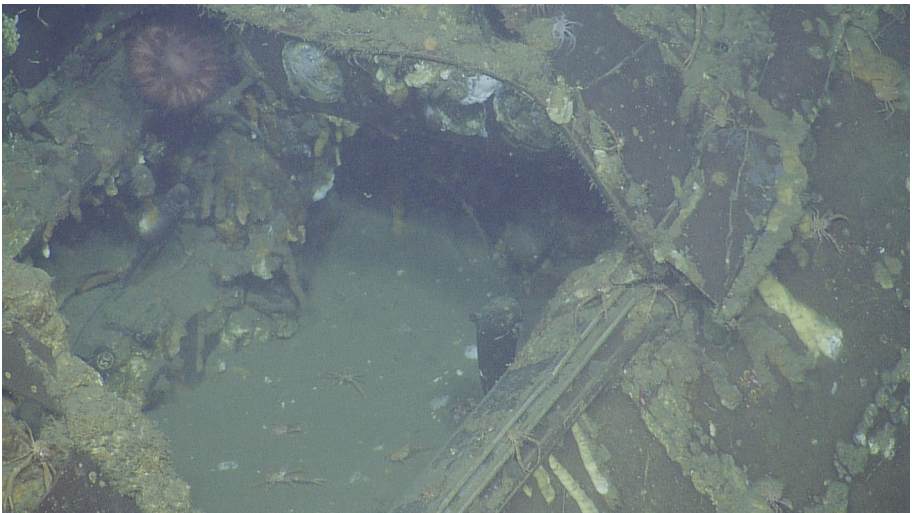
**Fig. 16** ROV image of the cockpit of the Hellcat in the elevator pit. Image courtesy of Ocean Exploration Trust

starboard wing. However, the rear fuselage, cockpit area (Fig. 16) and power plant were documented, along with the broken port wing resting upright against the forward bulkhead of the elevator pit. All six AN/M2 Browning .50 caliber air cooled machine guns, comprising the Hellcat's potent primary armament, were still present, arranged in offset rows of three in each wing. The canopy glass was missing along with the armored windscreen, the frame of which appeared crushed back and downwards, as might be expected to result from a fall into the open elevator shaft. Many of the nose panels were likewise gone, exposing the engine mounts, oil tank and other accessories, while the powerplant itself sagged forward. No sign of the 3-bladed Hamilton Standard propeller was readily apparent.

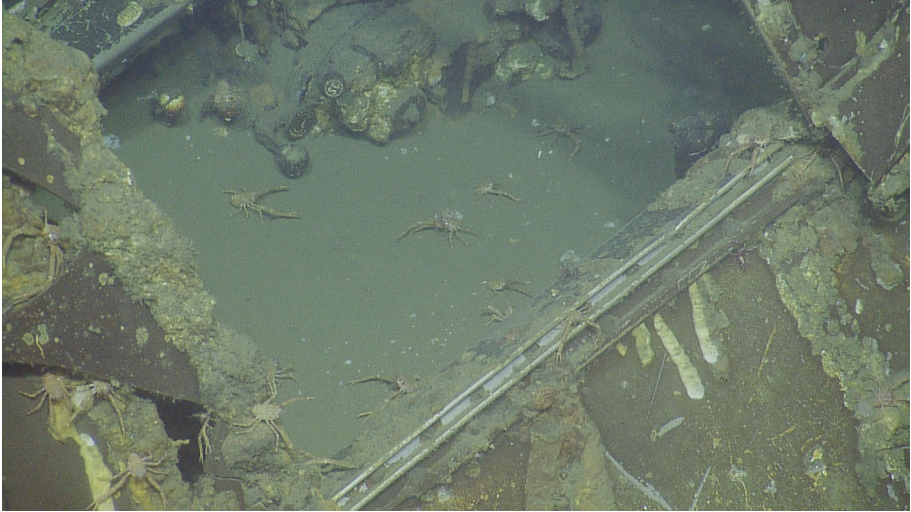
**Fig. 17** ROV image showing the sediment filling the interior of the Hellcat's cockpit. Image courtesy of Ocean Exploration Trust

The cockpit is partially filled with sediment (Fig. 17), but close visual inspection by the ROV revealed some instruments in the (unobscured left-hand portion of the) panel and the top edge of the throttle with its super charger control knob (indicated by the appropriate initials "SC") was plainly visible. We were unable to view the port side of the fuselage with our cameras, but there are remnants of Navy blue paint and stenciled lettering on the starboard side (Fig. 18). The white "star and bars" of the US national insignia still stand out proudly on the top skin of the port wing (Fig. 19).

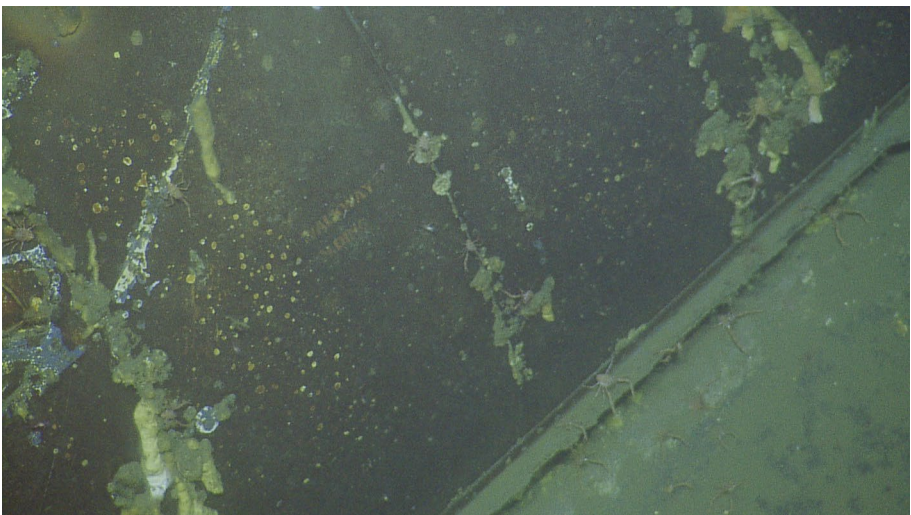
**Fig. 18** ROV image of the starboard side of the Hellcat showing the remnants of Navy blue paint and stenciled lettering. Image courtesy of Ocean Exploration Trust

Both aircraft retained traces of paint, including some stenciling. The intact wing of the Hellcat, as well as the partial wing of the Helldiver also retained the white-painted elements of the “star” national insignia they had been painted with when in service. No trace of the blue or red paint was observed. This find is in line with post-Able observations that darker paint had blistered or burnt away, as did dark fabric and rope on target ships, aircraft and test equipment (Shirley 1946: 4–6 and Bureau of Ships 1946a:114). The same phenomenon had been noted at Hiroshima with light-colored clothing remaining intact while darker clothing and patterns on light clothing burned away and left burns on skin in the same pattern (Glasstone 1950:203–204). This is because atomic blast induced thermal radiation, heat will be absorbed depending on the reflectivity of the surface (Glasstone and Dolan 1977:282). The white paint, being the most reflective, survives on the aircraft wings because it reflected the thermal energy of the Able blast while the red and blue paint absorbed it and was either burned or charred off, or in the case of reds, faded within a few days.

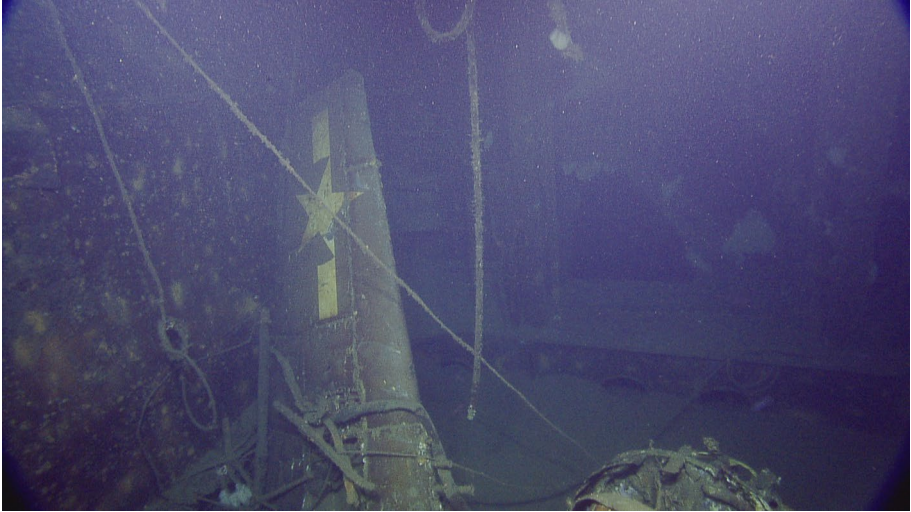
**Fig. 19** ROV image of the port Hellcat wing against the forward bulkhead showing the white “star and bars” of the US national insignia. Image courtesy of Ocean Exploration Trust

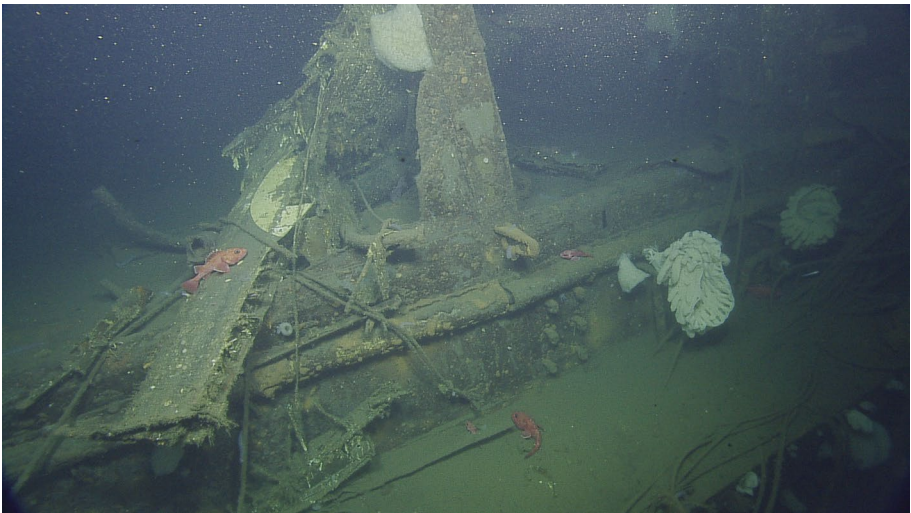
**Fig. 20** ROV image of the wreckage of the Helldiver, consisting of the remains of a wing section with an associated pile of unidentifiable aluminum debris. Image courtesy of Ocean Exploration Trust

Remains of the second plane consist of little more than a wing section with an associated pile of unidentifiable aluminum debris (Fig. 20). This wing was ultimately recognized to be from the port side of a Helldiver aircraft. The general determination was made possible by noting the presence of perforated flaps, known as "dive brakes." Characteristic only of dive bombing planes, these specially ventilated split flaps would be deployed in combat,

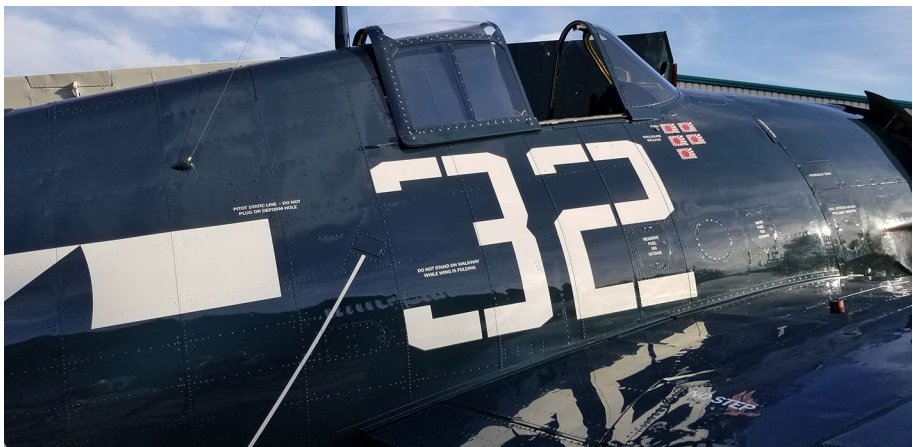
**Fig. 21** Restored F6F-3K Hellcat drone from Operations Crossroads, BuNo. 41834, on display at Dulles Airport in the Smithsonian National Air and Space Museum's Stephen F. Udvar Hazy Annex outside Washington, D.C. Photo by Hill Godspeed

Additionally, while the location of the crashed F6F-3K Hellcat drone from USS *Shangri La* is not currently known, it would also comprise an important part of the aviation assemblage at Bikini, especially as it would be the sole remaining drone available for study within an archaeological context and that retains its unaltered Crossroads configuration. Only one other F6F-3K Hellcat drone is known to exist; stripped of its Crossroads equipment and restored to stock condition, BuNo. 41834 is on display at Dulles Airport in the Smithsonian National Air and Space Museum's Stephen F. Udvar Hazy Annex outside Washington, D.C. (Fig. 21).
