Photogrammetric reconstruction of changes in vertical river position using archival aerial photos: case study of the Czarny Dunajec River, Polish Carpathians

Maciej Hajdukiewicz¹ · Bartłomiej Wyźga² · Hanna Hajdukiewicz² · Paweł Mikuś²

Received: 22 January 2019 / Accepted: 16 May 2019 / Published online: 24 May 2019
© The Author(s) 2019

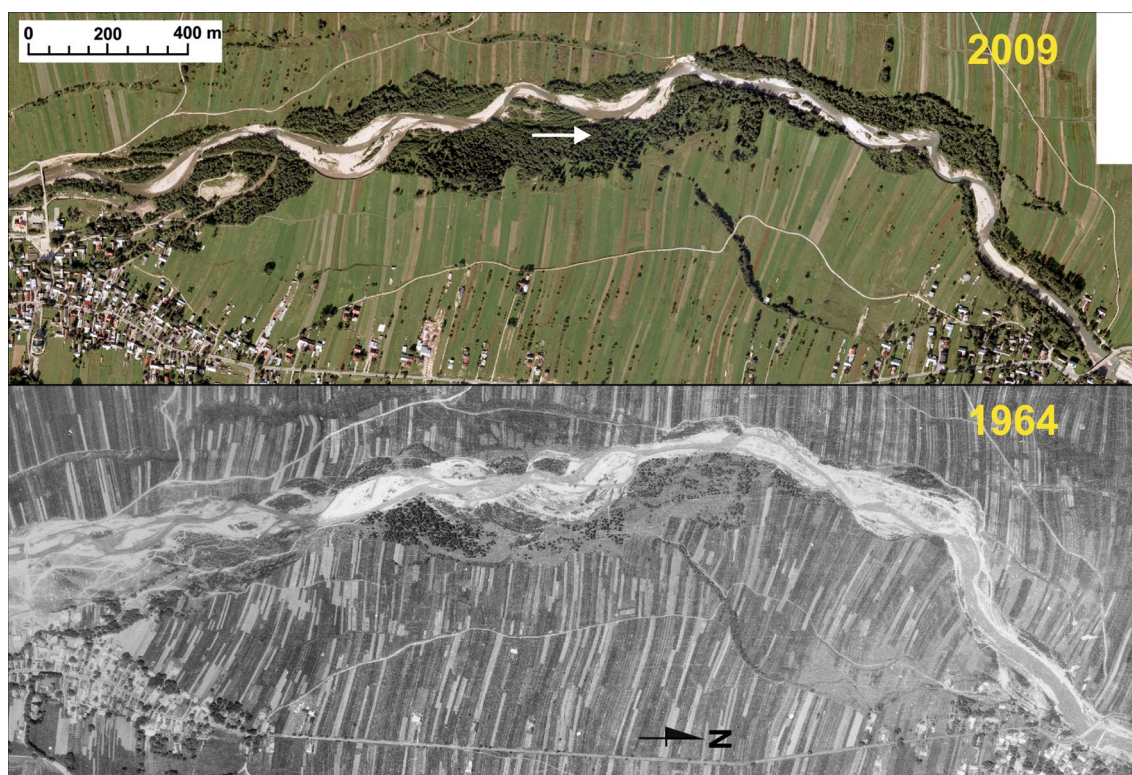
Fig. 2 Study reach of the Czarny Dunajec shown on orthophotos from 1964 and 2009

A 3-km-long river reach between the villages of Chochołów and Koniówka (Figs. 1a, 2) is typified by especially deep channel incision. This reflects intense gravel mining carried out close to the downstream end of the reach in the 1950s–1960s and lithological characteristics of the bedrock. Only in the uppermost part of the reach located within the Gubałówka Hills, the river is underlain by relatively resistant sandstone layers of Paleogene age. Along most of the reach, located within the intramontane Orawa–Nowy Targ Basin, the river is underlain by unconsolidated clays of Miocene–Pliocene age. After the dissection of gravelly alluvium, the river continued to incise into the clays, while maintaining a thin layer of gravels on the channel bed (Zawiejska and Wyźga 2010). As rapid channel incision became apparent shortly after the onset of large-scale gravel mining, in the early 1960s an 1.8-m-high weir was constructed at the downstream end of the reach to prevent undermining of the piers of the bridge at Koniówka. In the subsequent decades, vertical position of the river channel in a 7-km-long downstream reach was stabilized by a number of concrete weirs. In turn, immediately upstream of the Chochołów–Koniówka reach, the river incised by about 1 m, after which bed degradation ceased with the exposure of resistant sandstone layers on the channel bed.

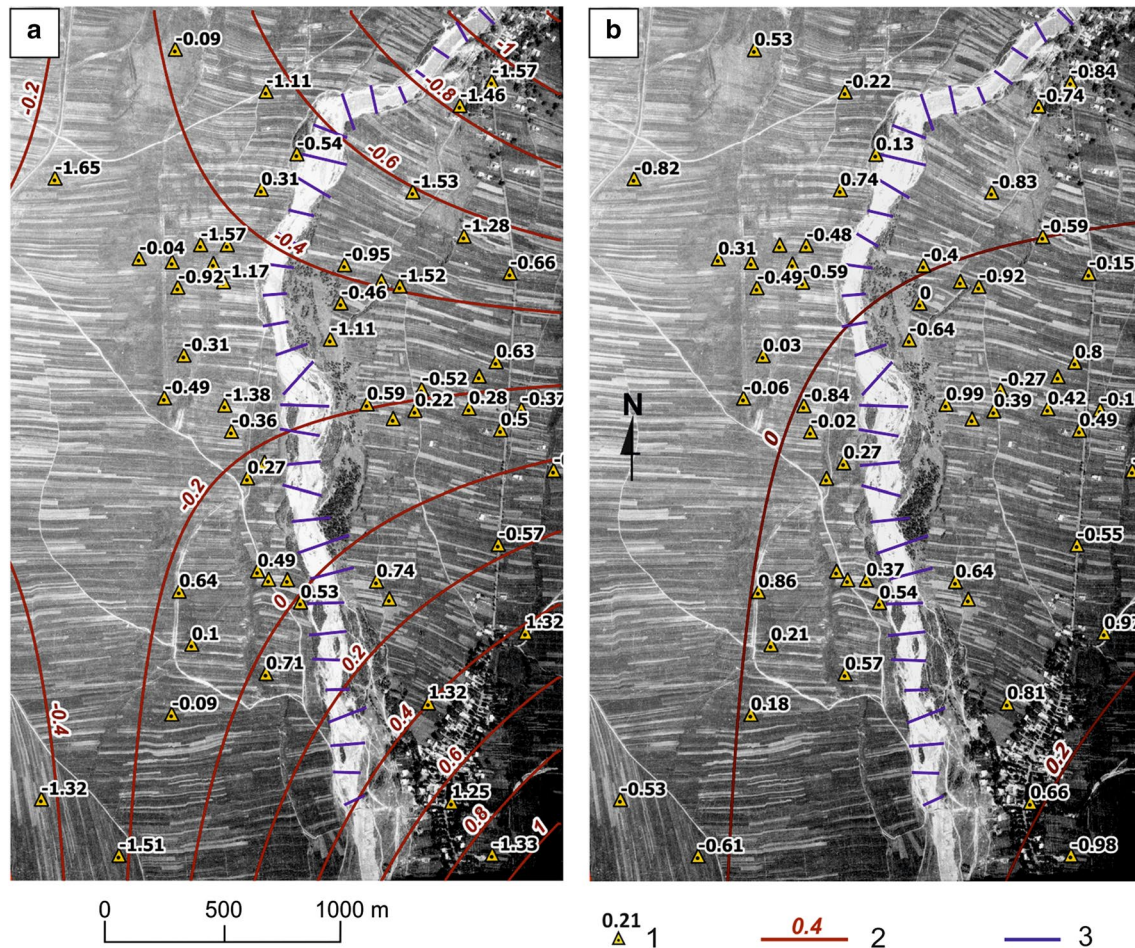
Fig. 3 Spatial distribution of errors on the DEM from 1964 extracted without known parameters of camera distortion (a) and after calculation of distortion parameters, with a modified set of GCP (b). The

errors are shown on the background of orthoimage of a single aerial photo. 1—values of vertical error of check points (m); 2—isolines of vertical error; 3—study cross sections

quality of the photos, exceeded 1 m. Spatial distribution of the errors was analysed using a set of 96 check points with bilinear interpolation of the plane of average error value. If a significant trend of the spatial distribution of errors was found (Fig. 3a), the next iteration of external orientation of the aerial photos was performed with a modified set of GCPs to obtain a new extracted DEM without a significant systematic error (Fig. 3b). After this procedure, local errors were considerably reduced, while remaining substantially larger than the overall trend. In this case, differences in the trend were comparable to the accuracy of the reference ALS survey.

Calculation of differences in vertical river position in the study reach between the dates of aerial photos required establishing limits of uncertainty related to elevation measurements in different parts of study cross sections. In the large sample of measurements taken in the cross sections (31 cross sections multiplied by a few tens to more than hundred measurements per cross section), random error component could be assumed to balance to a negligible cumulative value (cf. Schiefer and Gilbert 2007). Residual systematic errors observed for the network of check points after extraction and edition of a given DEM (Fig. 3b) resulted in an

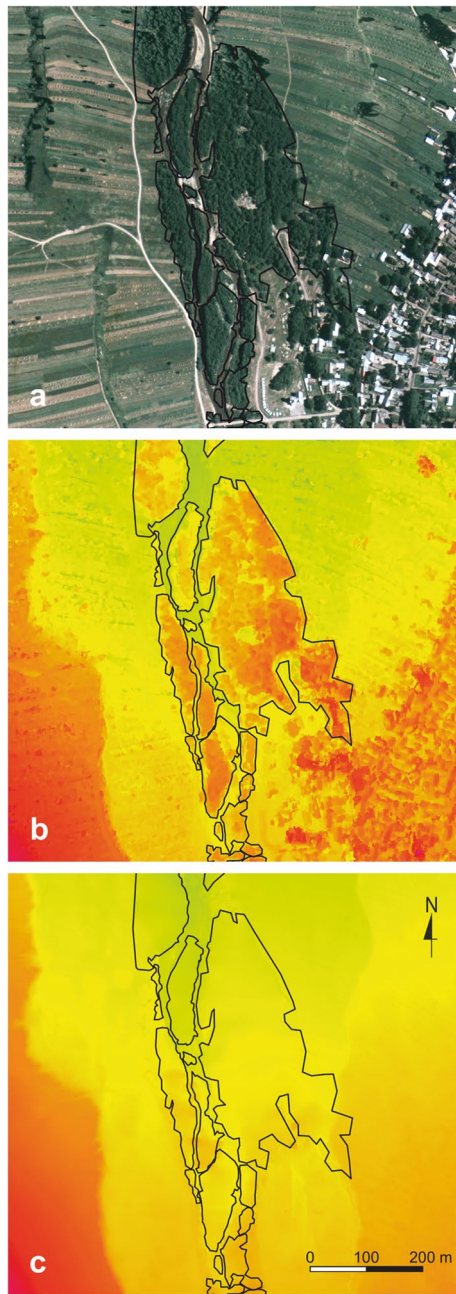
Fig. 4 Fragment of the orthophoto of the Czarny Dunajec valley floor from 1994 (a) and DEM for this area after extraction of a stereopair of archival aerial photos (b) and after edition (c). Black lines delineate areas where the elevation of terrain surface was distorted by vegetation

extraction process where the surface of trees or shrubs must have been confused with the terrain surface (Fig. 4a). Such errors were corrected using the PCI Focus tool. The erroneously classified areas were masked using on-the-screen vector polygon digitization (Fig. 4b), and then, one of the following methods of altitude correction was applied for each polygon: linear interpolation from the edges in the case of riparian forest with variable tree heights or subtraction of a constant value in the case of trees or shrubs of the same height. The latter method was applied only to small areas of planted trees in the neighbourhood of riparian forest (ca 5% of edited area). Figure 4c presents the DEM after editing. The proportion of edited area equalled less than 1% for the DEM extracted from the photos taken in 1964, 2% for the DEM from 1983 and 6% for that from 1994. The increase reflected progressive expansion of riparian forest along the river (Hajdukiewicz and Wyżga 2019) and growing density of trees in the forest over the study period—in the case of sparse forest, DEM was usually extracted properly.

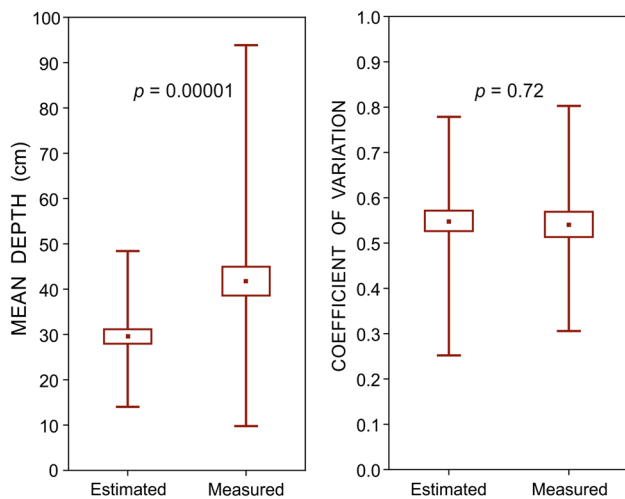
Fig. 5 Mean and coefficient of cross-sectional variation of low-flow water depth in 31 cross sections of the Czarny Dunajec estimated from the orthophoto from 2016 and measured in the field in 2017. Statistical significance of the difference of the parameters between estimated and measured water depth, determined by a Wilcoxon test, is indicated

Estimation of water depth in low-flow channels shown on the orthophoto from 2016 and subsequent field measurements of water depth in the study cross sections indicated nearly the same cross-sectional variation of water depth (Wilcoxon test, $p = 0.72$), with the average coefficient of variation amounting to 0.549 for the estimated depth and to 0.541 for the measured depth (Fig. 5). However, mean values of the water depth determined on the basis of the orthophoto appeared to be underestimated by 0.12 m in comparison with the values derived from field measurements (Fig. 5), with the difference being highly significant statistically ($p = 0.00001$). These results suggested that the estimates of water depth derived from older aerial photos should be increased, while maintaining the same degree of water depth variation across the low-flow channels. To verify this, cross-sectional flow area in each study cross section was calculated as a product of low-flow channel width and mean estimated water depth and averages of the cross-sectional flow area in all cross sections were computed for each date of the archival aerial photos. These calculations indicated that the average cross-sectional

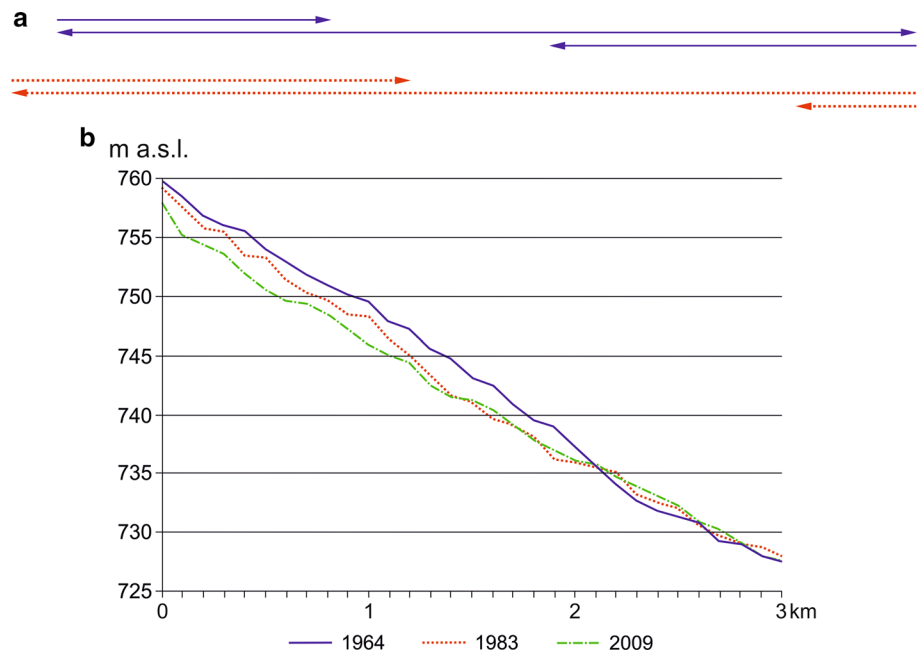
Fig. 7 **a** Extent of DEMs extracted from stereopairs of laterally overlapping aerial photos from 1964 and 1983 along the study reach of the Czarny Dunajec River. **b** Changes in the elevation of low-flow water surface along the study reach of the Czarny Dunajec between 1964 and 2009

The measurements taken on the orthorectified aerial photos enabled us also to determine changes in river width between the consecutive dates of the photos. Even though this information was a by-product of the study focused on vertical channel changes, it appeared useful in explaining the latter changes, and thus, it is provided below. Width of the active channel in the study reach significantly decreased over the study period (Friedman test, $p = 0.00001$) (Fig. 8a). In 1964, it varied between 45 and 147 m, with the mean equal to 81.5 m. In 1983, it still highly varied between 25 and 127 m, but the mean significantly decreased to 51 m (Fischer's LSD test, $p = 0.00001$). In 2009, the variation in active channel width decreased to the range 26–98 m, whereas the mean remained similar, amounting to 49 m (Fig. 8a). The width of active river zone in the study reach exceeded that of the active channel only slightly, by 1–8%, and the pattern of its temporal changes was similar.

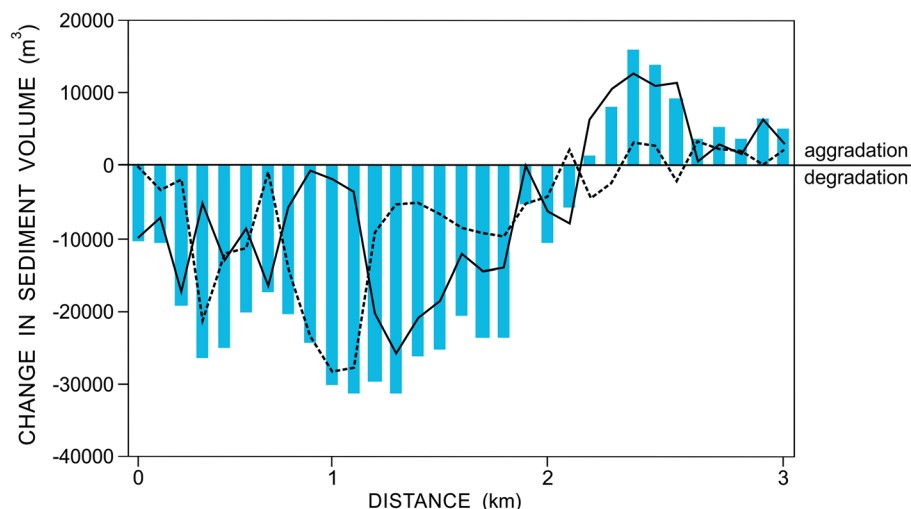
Fig. 9 Changes in sediment volume within the river migration belt in the study reach determined for successive 100-m-long river segments on the basis of DEMs extracted from archival aerial photos. Columns show a total change in sediment volume between 1964 and 2009, while solid and dashed lines indicate changes in the periods 1964–1983 and 1983–2009, respectively

Figure 9 presents results of the analysis for the whole period 1964–2009 and its earlier (1964–1983) and later (1983–2009) parts. During the years 1964–2009, an average of $11780 \pm 1710 \text{ m}^3$ of sediment was evacuated from a 100-m segment of the study reach, which corresponds to an annual loss of $256 \pm 37 \text{ m}^3$ of sediment per segment. Average values of the annual loss of sediment from a river segment during the periods 1964–1983 and 1983–2009 were similar and amounted to $267 \pm 39 \text{ m}^3$ and $248 \pm 36 \text{ m}^3$, respectively. However, while the upstream two-thirds of reach length experienced bed degradation

and sediment loss, sediment deposition and bed aggradation occurred in the downstream one-third of the reach length (Fig. 9). In the upstream part, the average rate of annual loss of sediment equalled $453 \pm 65.5 \text{ m}^3$ per segment, whereas the average rate of annual sediment deposition in the downstream part amounted to $158 \pm 23 \text{ m}^3$ per segment. Both the disparity in these average rates and the considerably longer degraded part of the study reach explain the marked prevalence of sediment removal from the reach (Fig. 9).

The analysis also provided more detailed information about the temporal and spatial variation of changes in sediment volume within the study reach. In the downstream one-third of reach length, sediment deposition occurred in the earlier part of the study period, whereas in the later part no net change in sediment volume was recorded (Fig. 9). In the middle part of the reach, the main phase of sediment loss took place in the earlier part of the study period, whereas further upstream more sediment was removed in the later part (Fig. 9).

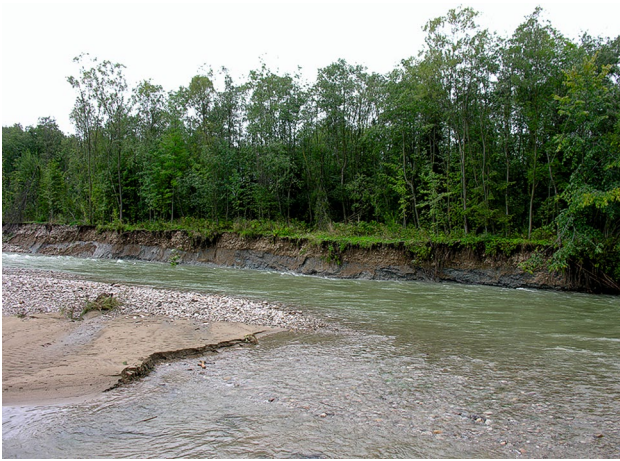
Fig. 10 Deep channel incision in the middle part of the study reach caused dissection of non-resistant bedrock. The gravelly alluvium visible in the upper part of the undercut bank was deposited in the channel active in 1964

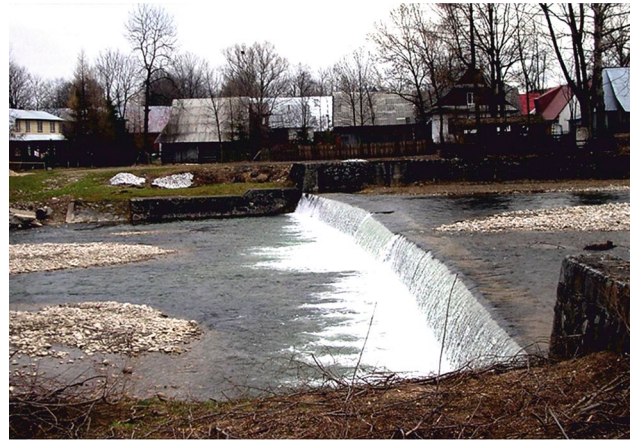
Fig. 11 High weir constructed at the downstream end of the study reach in the early 1960s that has induced bed aggradation in the lower part of the reach

The degree of uncertainty of the extracted DEMs is even less significant when compared with the amplitude of changes in the vertical position of low-flow water surface in the reach during the study period. The changes ranged from 3.61 m of channel incision in the middle and upper parts of the study reach to 1.34 m of channel aggradation in its lower part. In the middle part of the reach, channel incision exceeding 3 m since the mid-twentieth century was previously documented for selected river and floodplain cross sections, in which the elevation of paleochannels from different decades was compared with that of the contemporary river (Zawiejska and Wyżga 2010; Wyżga et al. 2016a, b, c). Here, the river not only dissected gravelly alluvium but also incised deeply into clayey bedrock and the strong lithological contrast between the gravels and the bedrock allows for easy comparison of the vertical position of paleochannels and the contemporary channel (Fig. 10). Channel aggradation in the lower part of the reach must have been facilitated by the delivery of bed material eroded in the incising upstream part of the reach, but its direct cause was the construction of a 1.8-m-high weir at the downstream end of the reach in the early 1960s (Fig. 11). Sediment deposition and channel aggradation in a short river stretch immediately upstream of the weir must have already occurred before the aerial

photo was taken in 1964, and only minor changes in vertical channel position were recorded there during the study period. However, during that period considerable channel aggradation took place between 2.2 and 2.6 km of reach length (Fig. 7) as the river tended to adjust its longitudinal profile to the new erosion base created by the weir.

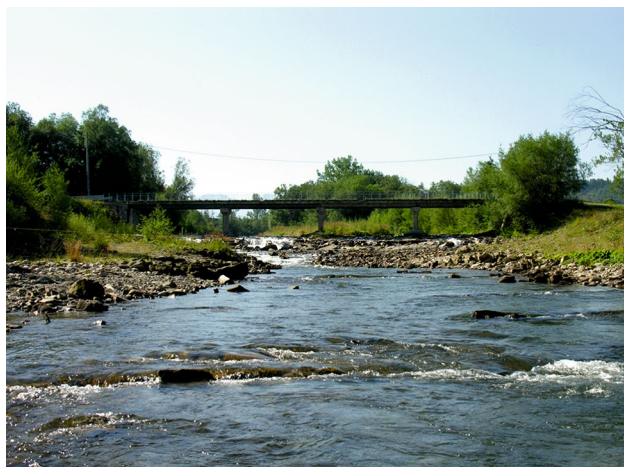
Fig. 12 View of the uppermost part of the study reach where recent, deep channel incision has induced backward erosion threatening the bridge

So far, only a few studies have reconstructed changes in vertical channel position on the basis of repeated surveys performed along a river course (e.g. Wyżga 1993; Piégay and Peiry 1997). The obvious reason for this is the scarcity of reliable longitudinal surveys of river channels from the past. The photogrammetric method offers a possibility of reconstructing vertical channel changes for different periods between the dates of archival aerial photos, which would provide information not only about the total amount of change, but also about its temporal and spatial dynamics. In the study reach of the Czarny Dunajec, the total amount of incision between 1964 and 2009 was similar along the upper two-thirds of the study reach, but the analysis of incision in the periods 1964–1983 and 1983–2009 clearly demonstrated the progressive upstream shift of incision. Backward erosion in the uppermost part of the study reach has long been retarded by the occurrence of resistant sandstone bedrock and the effective dissipation of flow energy in the multi-thread channel. However, artificial cutoff of one of the braids in 2005 concentrated river flow in the remaining single channel, and that induced its rapid incision (Wyżga et al. 2016a). This has accelerated backward erosion in the uppermost part of the reach, which now threatens the stability of a bridge located at the upper end of the reach (Fig. 12).
