Complications related to medical devices of the abdomen and pelvis: pictorial essay

Abstract A variety of medical devices are used to monitor or treat abdominal and pelvic diseases. They are routinely recognized on abdominal radiographs and computed tomography (CT), and complications associated with their use are not uncommon. The complications associated with the use of the medical devices are migration, malposition and fracture, which can be easily recognized on abdominal radiographs. Additional potential complications include bleeding, obstruction, infection and organ injury, which may be detected on CT. Therefore, awareness of these complications and familiarity with their imaging findings are important aspects of the management of patients with medical devices. The aim of this pictorial review is to demonstrate the abdominal radiography and CT features of potential complications associated with the use of medical devices.

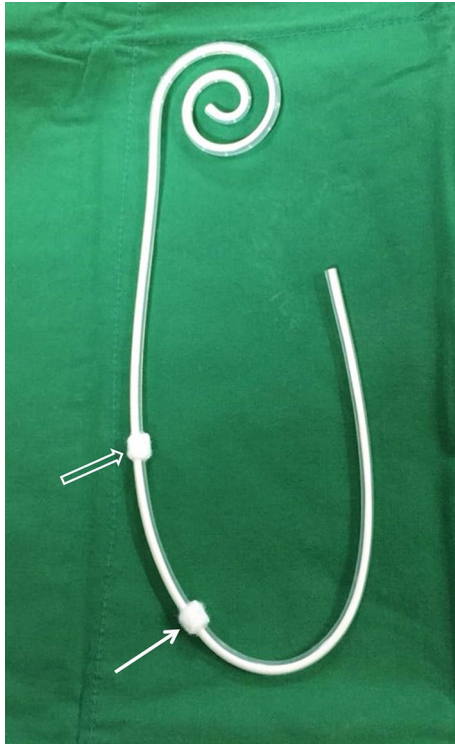
Fig. 8 Photograph of a CAPD catheter. The subcutaneous cuff (arrow) and deep cuff (open arrow) are designed to maintain the catheter anchoring

CAPD is mainly used for the treatment of patients with end-stage renal failure (Fig. 8) [8]. In catheter placement, the distal tip of the CAPD catheter should be inserted in a dependent position into the pelvic cavity to allow adequate outflow during dialysate exchange. Migration of the catheter tip out of the pelvic cavity causes impaired dialysate outflow and inadequate fluid drainage (Fig. 9). The incidence of this event is reported as 57 % of patients within 1 year of catheter placement [8].

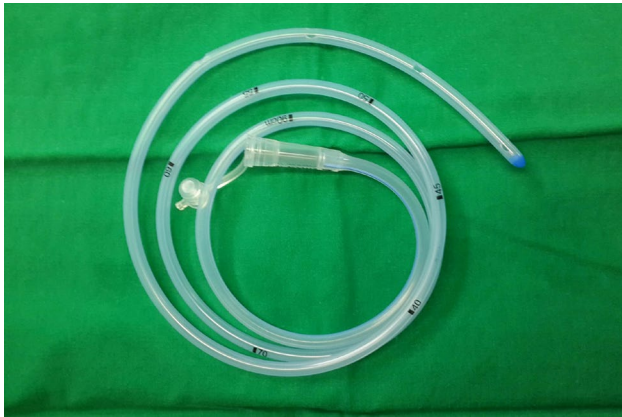
Fig. 11 Photograph of a nasogastric tube

Common medical devices of the abdomen and pelvis, such as nasogastric tubes (Fig. 11), gastrostomy tubes (Fig. 12) and Foley catheters (Fig. 13), may be inappropriately positioned [4].

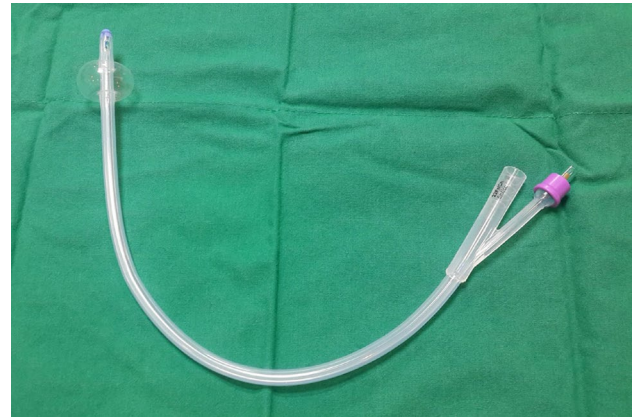
Fig. 13 Photograph of a Foley catheter

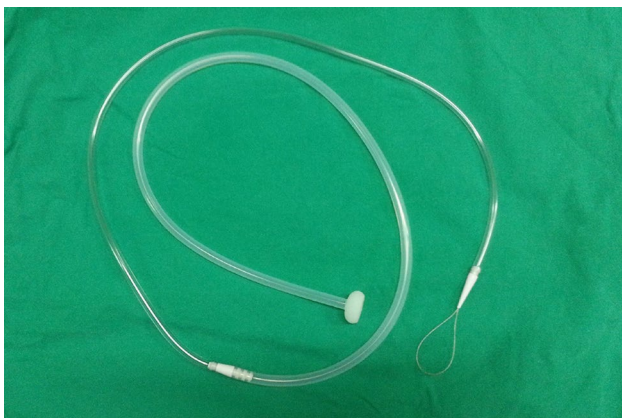
Fig. 12 Photograph of a percutaneous endoscopic gastrostomy tube

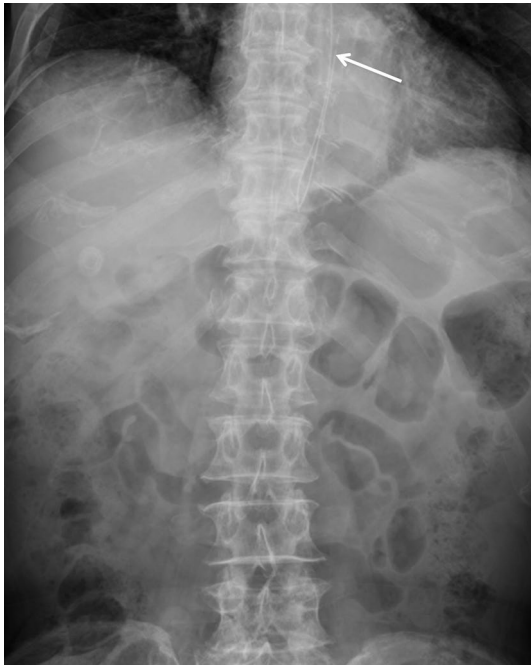
Fig. 14 Malposition of a nasogastric tube in an 89-year-old male with chronic renal disease. Abdominal radiograph shows a tube coiled in the esophagogastric junction with the tip (*arrow*) in the distal esophagus

Nasogastric tubes have been inserted at the bedside blindly, without fluoroscopic visualization [2]. The tube is often inserted not in the stomach, but in another site of the gastrointestinal tract such as the esophagus or duodenum, sometimes even the trachea (Fig. 14). Gastrostomy tubes are placed surgically, endoscopically or percutaneously for long-term assisted feeding. The inflated balloon component of the tube maintains the position of the tip, which should be placed in the stomach [2]. Malposition is one common complication after gastrostomy tube insertion (Fig. 15).

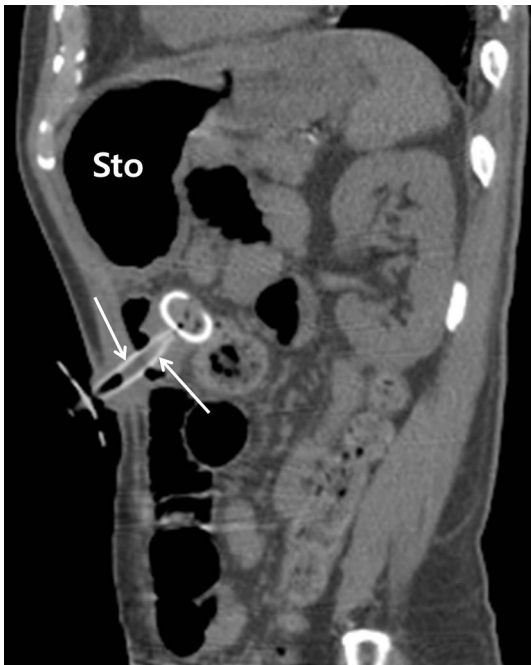
Fig. 15 Malposition of a percutaneous endoscopic gastrostomy tube in a 75-year-old male with a cerebrovascular accident. Sagittal reformatted CT scan shows a tube (*arrows*) within the small bowel loop, not in the stomach (Sto). The misplaced tube was subsequently removed, and another gastrostomy tube was properly placed in the stomach (not shown)

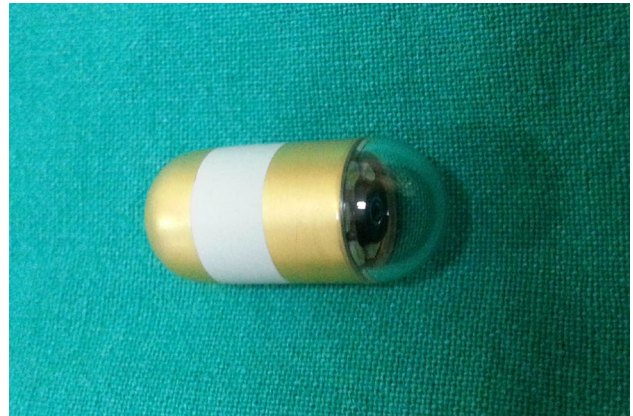
Fig. 19 Photograph of a capsule endoscope

Capsule endoscopy has been used to evaluate small bowel disease (Fig. 19). A diagnostic endoscopy capsule
