# Spatial Variability of Mass Movements in the Satluj Valley, Himachal Pradesh during 1990 ~ 2006

Vikram GUPTA\* and M.P. SAH

**Abstract:** Satluj Valley is known to have a history of landslides and related mass movement activities since the geological times. Geological and geomorphological settings combined with anthropogenic activities constitute a propensity towards slope failure. During the last two decades, the area witnessed substantial increase in anthropogenic pressure, mainly due to the exploitation of hydropower potential, changing land use pattern and population growth. In addition, a shift of the climatic patterns in the form of larger area falling under the influence of rains was observed. These natural as well as anthropogenic changes in the area have resulted in increased spatial coverage of landslides in the area. This paper documents these changes during 1990 ~ 2006.

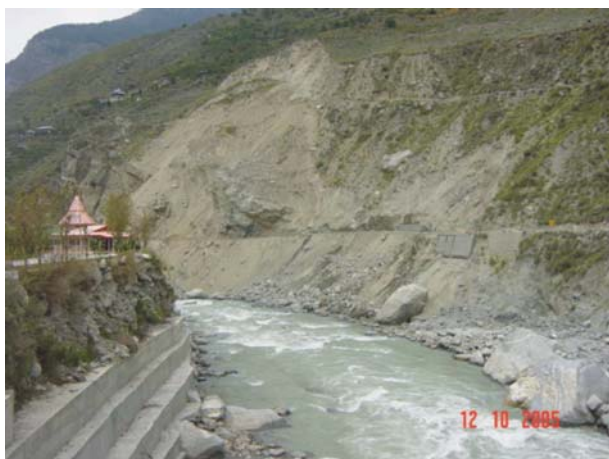
**Figure 6** Translational debris landslide located about 200 m upstream of the Tapri Village affecting the NH-22 and the link road to the Tapri Village.

The Tapri landslide ( $78^{\circ}05'47''\text{E}$ ;  $31^{\circ}31'09''\text{N}$ ) is located about 200 m upstream of the Tapri Village on the south facing hill slope along the Satluj River (Figure 6). The hill slope gradient in the lower section is about  $45^{\circ}$  and in the middle reaches it is about  $30^{\circ}$ . The hill slope essentially is made up of augen gneisses belonging to Wangtu Gneissic Complex (WGC) and is covered with thin veneer of Quaternary deposits in the form of sandy silt with pebbles and boulders of gneisses embedded in it. The lower slope is mostly covered with scattered trees and bushes, whereas, the middle and the upper slopes are covered with horticultural fields and open forests, respectively.

The Tapri landslide first triggered during 2000 LLOF because of the bank erosion of the Quaternary deposit and has been active since then. It is about 350 m long, 600 m wide and 7 m deep, covering a surface area of about  $0.25 \text{ km}^2$ . The scarp of the landslide is arcuate and is located at 1800 m above msl. It is a typical translational landslide with slip surface trending  $35^{\circ}$  due south. The rocks encountered in the main body of the landslide are hard and jointed gneisses that dip  $45^{\circ}$  due NE. The landslide continues to pose threat to the NH-22 and the link road to the Tapri Village. Toe cutting by the Satluj River further adds to slope instability.

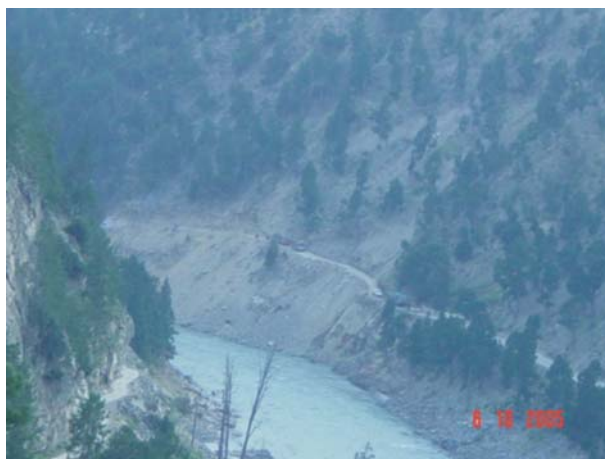
**Figure 7** Shongtong landslide located about one km upstream of the Shongtong Village and affecting the NH-22.

The Shongtong landslide ( $78^{\circ}16'42''\text{E}$ ;  $31^{\circ}31'29''\text{N}$ ) is located about one km upstream of the Shongtong Village on the southeast facing hill slope on the right bank of the Satluj River (Figure 7). The hill slope gradient in the lower section is about  $40^{\circ}$  and is essentially made up of pebbles and boulders of the mica gneisses embedded in the sandy silt. In-situ rocks are not visible and thickness of this Quaternary cover is about 15 ~ 20 m. The lower part of the slope is covered with scattered trees and bushes, whereas middle slope is gentler and is occupied by agricultural and horticultural fields.

The Shongtong landslide first became active during the drawdown of 2005 LLOF. It is about 300 m long, 500 m wide and 5 ~ 10 m deep, covering a surface area of about  $0.20 \text{ km}^2$ . The slip surface of this landslide is not clearly visible. However, based on the material involved, it can be

classified as a translational debris landslide. It affects about 500 m stretch of the NH-22. Toe cutting by the Satluj River particularly during peak discharge may further adds to the slope instability

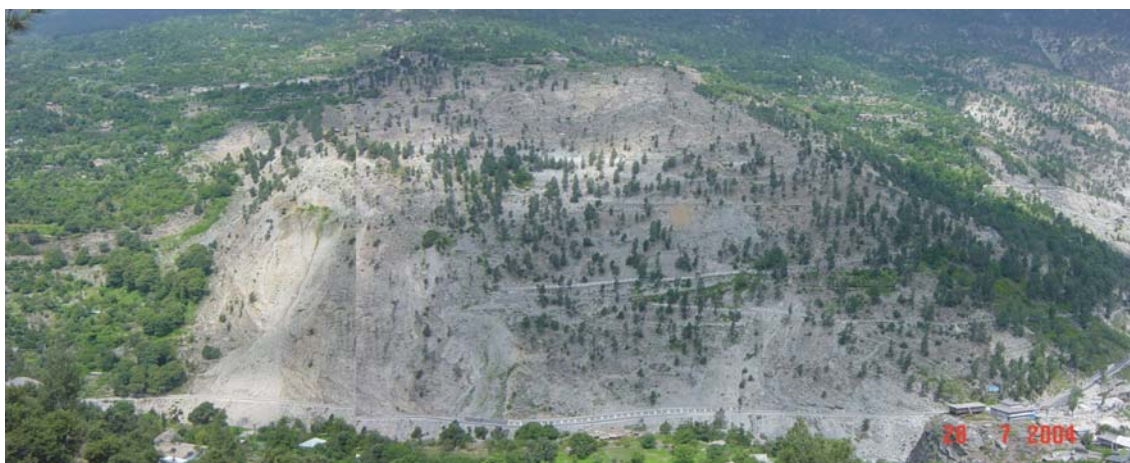
**Figure 8** View of the Pawari landslide in 2005. It is a complex landslide involving different movements in different parts of the landslide. The landslide greatly increases the width from 500 m to 1200 m during 1990 ~ 2005.

The Pawari landslide ( $78^{\circ}16'00'' \text{E}$ ;  $31^{\circ}33'30'' \text{N}$ ) is one of the largest landslides located on the lower valley hill slope along the right bank of the Satluj River near the Pawari Village. The exact date of the initiation of this landslide is not known. However, 1962 Survey of India, toposheet (53J/2), possibly surveyed much earlier, shows the existence of a small landslide. The greater part of the landslide occurred during the construction of Pawari-Pio link road in 1975 and since then it occurs almost every year particularly during the rainy or snow melting season. The landslide has been studied in great details for its geological, geomorphological and geotechnical characteristics by BARTARYA et al. (1996), GUPTA (1998) and YADAV (2000). It was also monitored for surface and sub-surface movements during 1992 ~ 1994 (YADAV 2000).

In 1991, the landslide measured about 1000 m in length, 500 m in width and about 25 m in depth. Many mitigation measures like the construction of retaining walls in the toe and in the main body of landslide proved to be of little help to mitigate the movement. In 2006, the landslide was about 1200 long, 1200 m wide and 25 ~ 30 m deep (Figure 8), thereby increasing the surface area from  $0.5 \text{ km}^2$  to  $1.5 \text{ km}^2$  from 1991 to 2006 and drastically increasing the width by 140 %. Anthropogenic factors in the form of interference of slope within the main body of landslide as well as improper drainage of the entire Pio township, located just upslope, in the crown portion of the landslide, are the main causes for the increase in spatial coverage of this landslide. The microzonation mapping using lichen coverage has clearly shown three different types of movements within the main body of the landslide (GUPTA 2005).

The Pawari landslide is a typical example of complex landslide, with number of subsidence zones and debris slides within the main body of the planar landslide. The landslide, since its inception, continues to pose threat to the NH-22, particularly during the rainy season. It also greatly affects the subsidence of the Pawari-Pio link road and frequently causes its blockade.

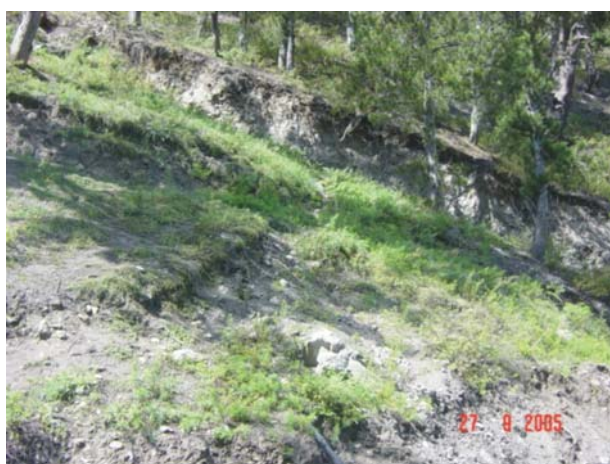
**Figure 9** Scarp of the Telangi Farm House Landslide which is about 3 m high.

The exact date of the initiation of the landslide is unknown, however, the activity of this landslide was more pronounced after 2000. It is a translational debris slide with slip surface trending due east. Number of subsidence zones within the main body of landslide has been observed. The total length of the landslide stretching from the HT road section to the Satluj River is about 700 m, whereas the width is about 200 ~ 250 m, covering

a surface area of about 0.25 km<sup>2</sup>. The scar of the landslide is located at 2590 m. The height of the scar varies from 3 m to 5 m (Figure 9). Transverse cracks are observed at an elevation of 2413 m, 2404 m and 2396 m. These cracks are segmented and run almost N-S direction along the width of the landslide. The cracks are about 15 ~ 20 m long, 1 ~ 1.5 m wide and about 3 ~ 3.5 m deep. In order to avoid any infernal happenings, most parts of the cracks have been grouted by the local people. The landslide continues to pose a threat to the Telangi-Pangi link road, horticultural fields along with few residential buildings of the Telangi Village.

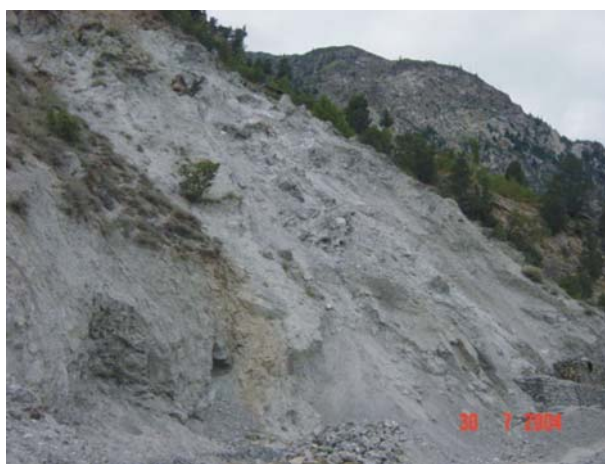
**Figure 10** Translational debris landslide located near the Pangri Village in the middle valley hill slope. The landslide involved highly fractured and sheared biotite gneisses and greatly affected the road traversing the main body of the landslide.

The Pangi Village landslide (78°17'00"E; 31°35'42"N) is located very close to the Pangi Village in the middle, east facing valley slope (Figure 10). The general hill slope gradient is about 40° with the middle slope gentler than the lower and upper slopes. The lower slope is barren exposing jointed and sheared micaceous rocks belonging to the Vaikrita Group. The general slope gradient in this section is about 70° ~ 90°. The middle slope is covered with agricultural and horticultural fields, and also with thin veneer of soil extracting from fine grained gneisses with bands of biotite gneiss. Three prominent sets of joints trending 70° due NW, 45° due NE and 70° due SW along with the 60° due S70°E foliation joint are present in the area. The joints are tight and the spacing between joints varying from 25 cm to 100 cm has made the entire rock mass weak. The rock mass crumbles as it comes in contact with water because of the presence of high mica content.

2004 possibly because of the widening of the road, and has been active since then (Figure 10). The widening of the road was done by conventional method of drilling and uncontrolled blasting, resulting breakage of the entire rock mass into smaller pieces. It is a typical translational debris slide with slip plane dipping 55° towards east. The landslide measures about 800 m long, 400 m wide and about 7 ~ 10 m deep, covering a surface area of about 0.35 Km<sup>2</sup>. The extension of the landslide is visible on the NH-22 affecting about 400 m long stretch.

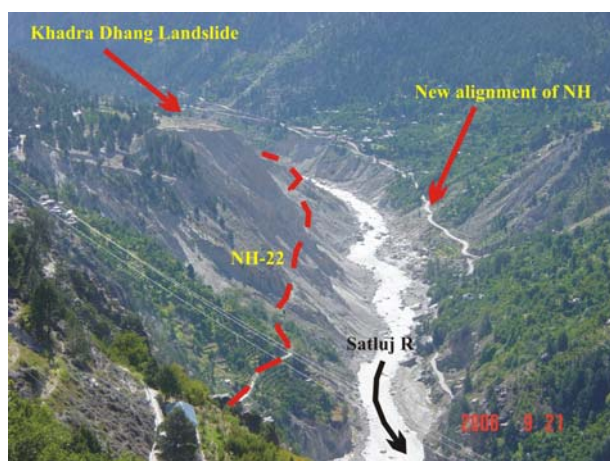
**Figure 11** Khadra Dhang landslide located on the right bank of the Satluj River. The new alignment of the NH-22 on the left bank of the river, has made the entire hill slope unstable.

The Khadra Dhang landslide (78°22'21"E; 31°35'23"N) is one of the major landslides on the right bank of the Satluj River near the Akpa Village (Figure 11). The landslide first triggered in early 1960s, and since then it has taken place almost every year during the rainy season, damaging the NH-22 passing through the toe portion of the landslide. It is a typical translational debris slide that occurs in the lower and middle hill slopes. The general gradient of the lower and middle hill slopes is 30°, and these are covered with agricultural fields, whereas the upper slope is about 40° and is covered with open forest. In 1991, the landslide measured 75 m in long, 1300 m wide and about 10 ~ 15 m deep, covering a surface area of about 0.1 km<sup>2</sup>. The material involved in the sliding is semi-consolidated glacial debris. The thickness of this debris is about 40 ~ 45 m as is evident in the cut section. The entire material is highly prone to landslide due to bank erosion. However, during 2005 ~ 2006, the width of the landslide increased to about 2000 m with increased number of subsidence zones in the main body of the landslide. The bank erosion in the form of toe cutting by the Satluj River is the main cause of the spatial increase in landslide coverage.

In order to avoid the landslide, the National Highway was diverted on the left bank of the Satluj River by constructing two bridges near the Kharo Village and the Akpa Village. The valley slopes between Kharo and Akpa are also comprised of semi-consolidated glacial debris. The road is cut through this material at the toe of the slope making the entire slope unstable and series of small scale landslides have been generated in this section (Figure 11). However, the massive bank erosion during 2000 and 2005 LLOFs has been reported in

this section that damaged both the bridges and the entire 2 km road section between Kharo and Akpa. The bridges were rebuilt at the same location and the new road was made by cutting the hill. In the present scenario, because of the continuous bank erosion by the Satluj River, the entire lower valley slopes are unstable, posing serious threat to the people living in the area.

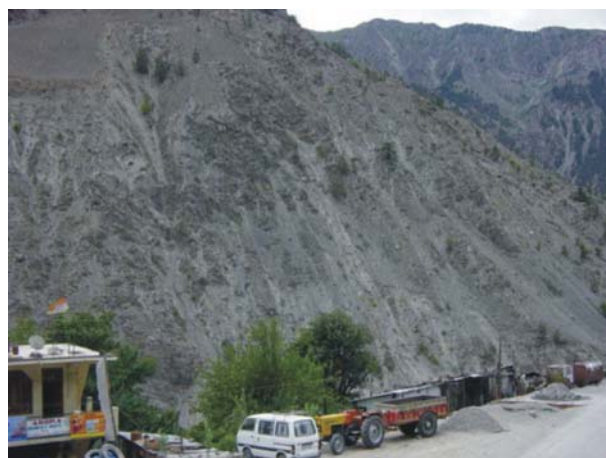
**Figure 12** Unstable hill slope showing the initiation of landslide near Spilo in the Morang-Pooh section.

There was a marked difference in the landslide activity in the Morang-Pooh section between 1990 and 2006. This is primarily because of the shift in the climatic patterns in the area. During 1990s, this section was completely dry and not affected by rainfall. The slopes were steep and stable under the dry condition. However, in the recent years, rainfall has invaded the area towards north and northeast direction, showing its influence upto Pooh. The rainfall data collected at Pooh for the years of 2000 ~ 2005 shows that the area received about 120 mm of annual rainfall dominantly between March ~ May and August ~ September. This renders the entire stretch between Morang and Pooh highly unstable (Figure 12). Number of new landslides in the area have been observed. Each year, new small-scale landslides in the area are added. Most of these landslides are in the form of rockfall, rock and debris slide, endangering the NH-22 passing through the lower hill valley slope. The entire valley slopes in the area are unstable under the wet condition, and will continue to slide down, until an equilibrium is achieved.
