Landslide Hazard and Community-based Risk Reduction Effort in Karanganyar and the Surrounding Area, Central Java, Indonesia

Abstract: Karanganyar and the surrounding area are situated in a dynamic volcanic arc region, where landslide frequently occurs during the rainy season. The rain-induced landslide disasters have been resulting in 65 fatalities and a substantial socio-economical loss in last December 2007. Again, in early February 2009, 6 more people died, hundreds of people temporary evacuated and tens of houses damaged due to the rain-induced landslide. Accordingly, inter-disciplinary approach for geological, geotechnical and social investigations were undertaken with the goal for improving community resilience in the landslide vulnerable villages. Landslide hazard mapping and community-based landslide mitigation were conducted to reduce the risk of landslides. The hazard mapping was carried out based on the susceptibility assessment with respect to the conditions of slope inclination, types and engineering properties of lithology/soil as well as the types of landuse. All of those parameters were analyzed by applying weighing and scoring system which were calculated by semi

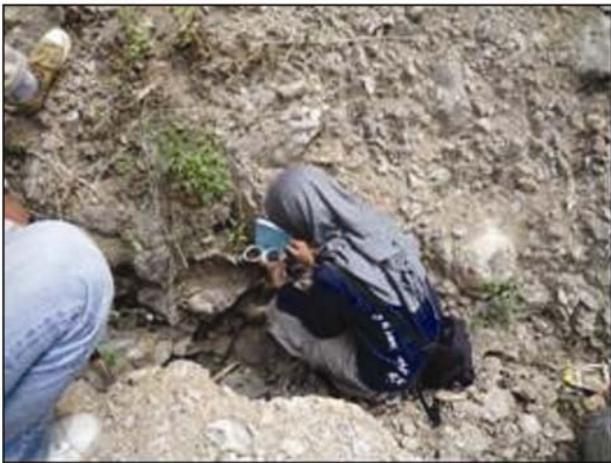
Figure 3 Bedrock of jointed andesitic breccia covered by the weathered material of sandy clay (exposed at the foot of susceptible mountain slope). Contact between the breccia and sandy clay performs as the sliding surface.

2). It was apparent that the failure surface was the contact between andesitic breccias and the moving mass of loose sandy clay weathered from the underlain andesitic breccias (Figure 3).

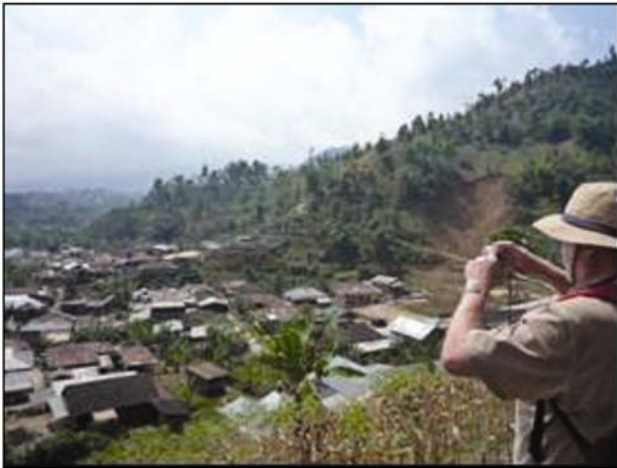
Figure 4 Un-appropriate landuse management, where many houses of situated immediately at the lower part of susceptible slope.

This landslide occurs mainly due to the conditions of slope steepness (exceeding 500 in association with a break-slope) and the inducement of heavy rainfall exceeding 100 mm precipitation. Uncontrolled landuse management at the lower part of susceptible slope, which was developed as settlement area, seriously increased the risk of landslide (Figure 4).

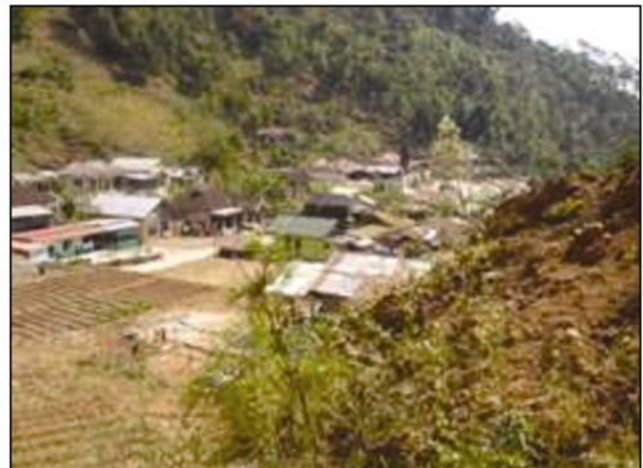
Figure 6 Selected sites for the installment of early warning system.

Finally, one site was selected at Ledokasari Village in Tawangmangu area (Figure 6).

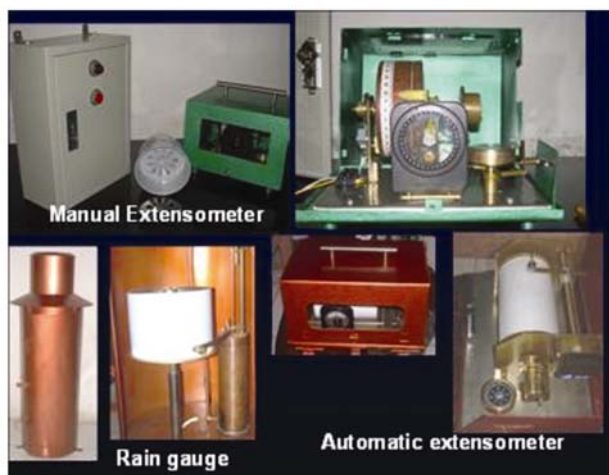
Figure 7 Early warning system equipments consisting of a) manual extensometer with the control panel and siren and b) rain gauge, developed by Fathani et al. in 2008.

The early warning system consists of several sets of equipment listed below (Figure 7):

1. Rain gauge (1 set).

Manual extensometer (5 set) with the siren alarm worked based on dry battery (accu)

2. Solar panel (2 set) to recharge the dry battery.

The rain gauge was installed in the open space to record the rain precipitation which may induce landsliding. The alarm warning was also set to start if the accumulative rain infiltration exceeds 100 mm. This threshold of rain infiltration was defined based on the previous research conducted by Karnawati (1996) and Su Su Ky (2007). The alarm due to rain gauge warning was designed to raise community alert to be ready to move any time when the alarm of extensometer had been on.

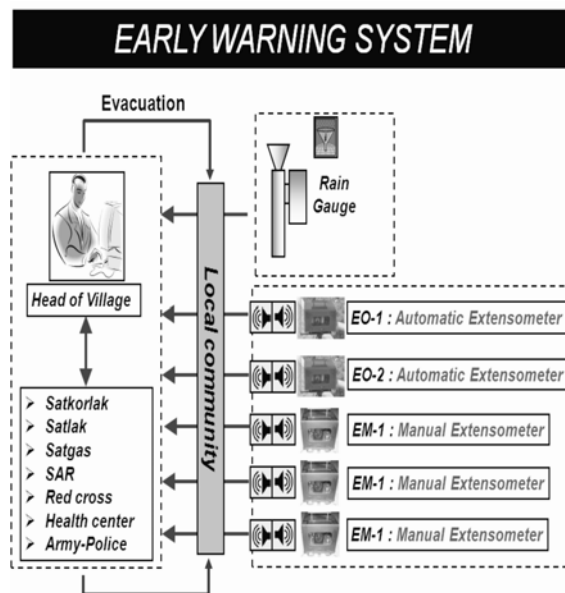
Figure 9 Integration of technical and social system of landslide early warning and disaster risk reduction in Ledokasari Village, Karanganyar Regency, Indonesia (Karnawati et al. 2009 and Karnawati et al. 2010).
