A catastrophic debris flow in the Wenchuan Earthquake area, July 2013: characteristics, formation, and risk reduction

Citation: Hu T, Huang RQ (2017) A catastrophic debris flow in the Wenchuan Earthquake area, July 2013: characteristics, formation, and risk reduction. *Journal of Mountain Science* 14(1). DOI: 10.1007/s11629-016-3965-8

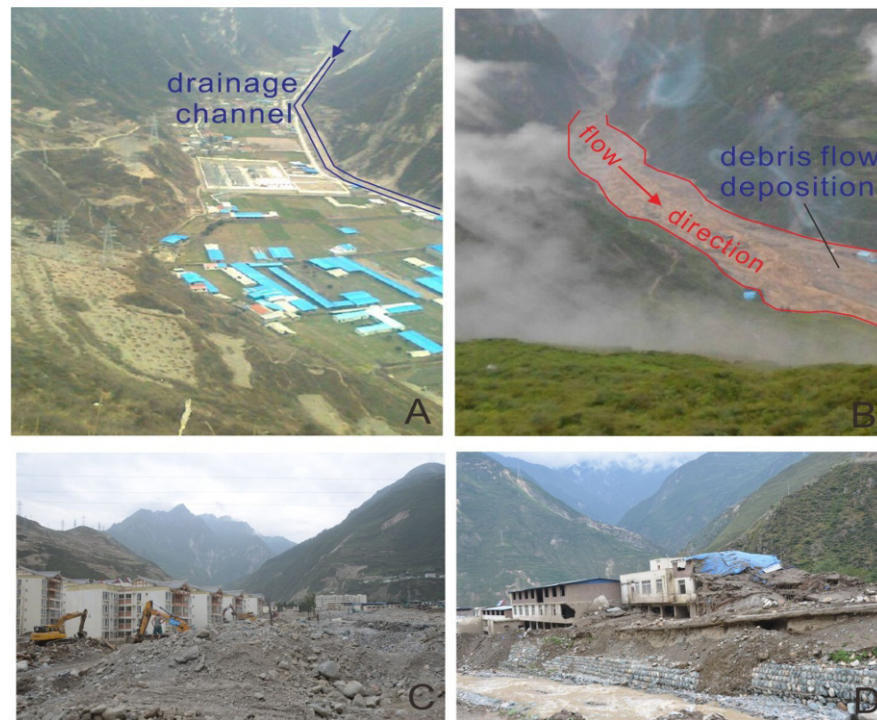
Figure 5 (A) a few buildings of local residents and factories located in the downstream gully before the 11 July debris flow event; (B) almost all the buildings were destroyed after the 11 July debris flow event; (C), (D) debris deposition on the alluvial fan and buildings destroyed by the debris flow.

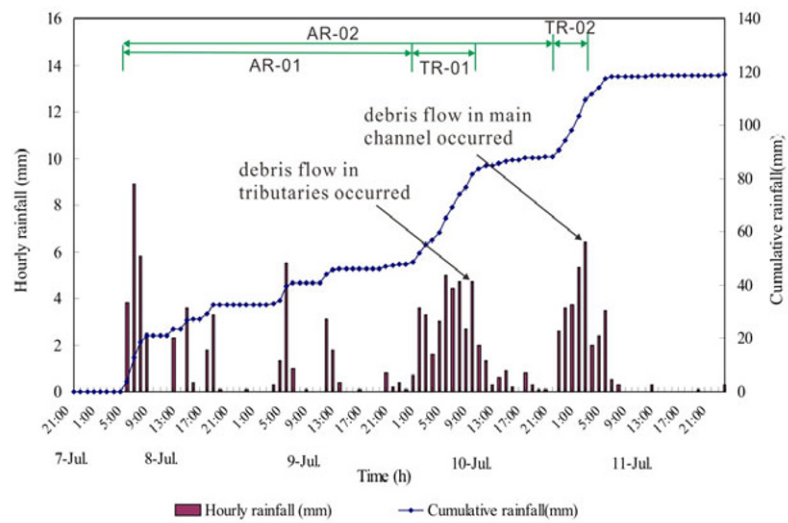
Figure 6 Distribution of hourly and accumulated rainfall on July 7–11, 2013.

The rainfall data for the 11 July event (Figure 6) show that the 3-d, 24-h, and 1-h rainfall amounts that triggered the Qipan Gully debris flow were 114.0 mm, 54.3 mm, and 8.9 mm, respectively. We examined the relationships between the triggering rainfall and the magnitude of the debris flow of the historical events (Table 1) and the 11 July event (Figure 7). To determine the relationship between the rainfall and the magnitude of the events (Figure 7), we used data from 6 historical events with 3-d rainfall, 10 historical events with 24-h rainfall, and 5 historical events with 1-h rainfall (Table 1). The 3-d, 24-h, and 1-h triggering rainfall amounts are positively correlated with the magnitude of historical debris flow events (Figure 7). While the R^2 values are not so high, ranging from 0.62 to 0.65, there is an obvious positive trend. However, when added to the analysis, the data for 11 July 2013 stood out as a

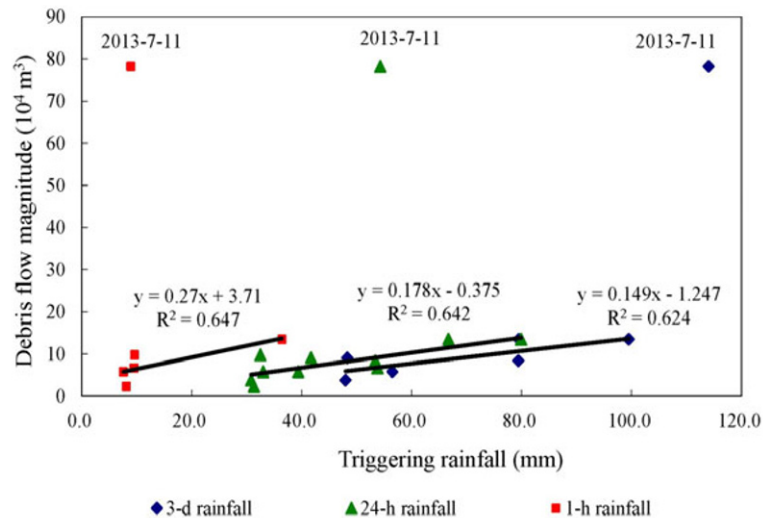
Figure 7 The relation between triggering rainfall and debris flow magnitude of historical events and the 2013-7-11 event.

single point and did not fit the pattern of the historical events. This indicates that, because of the abundant supply of source material for debris flows supplied by the Wenchuan Earthquake, post-earthquake debris flows in the study area can be triggered by lower rainfall intensities (Tang et al. 2011).

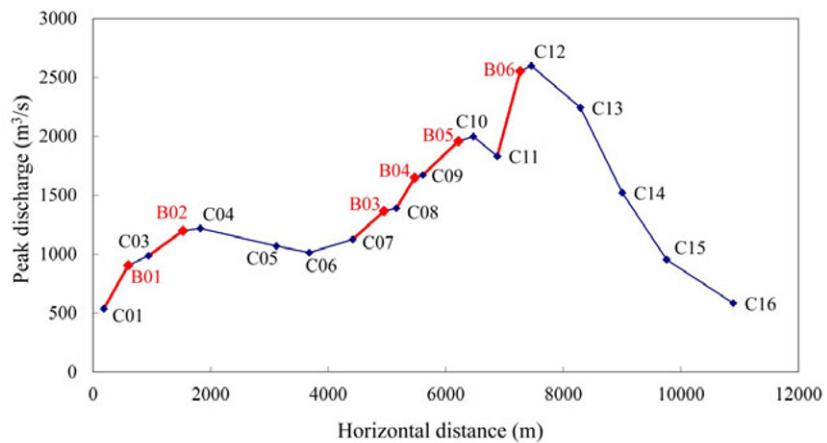
Figure 10 Changes in the peak discharge of the debris flow along the main channel through the 11 July event in the Qipan Gully. Red line shows the peak discharge amplification of the 6 channel blocking –bursting process.

We identified and measured six blocking dams in the main channel during field investigations to back-calculate the peak discharge during the 11 July debris flow event. The bursting of these cascading blocking dams, from upstream down, amplified the scale of the debris flow and was the key cause of the catastrophic damage in the 11 July event. The debris flow first occurred in the tributaries, and then, the six blocking dams in the main channel burst one-by-one from upstream to downstream. Calculations of the debris flow peak discharge at different cross sections of the main channel show that the peak discharges after the dams burst were 1.17–1.69 times greater than the upstream peak discharge. After the last blocking site (the Laoyingyan blocking dam) in the main channel burst, the peak discharge of the debris flow reached 2552.6 m³/s (Figure 10, Bo6) which was amplified to 4.76 times compared with the initial peak discharge (Figure 10, Co1) in the upstream.

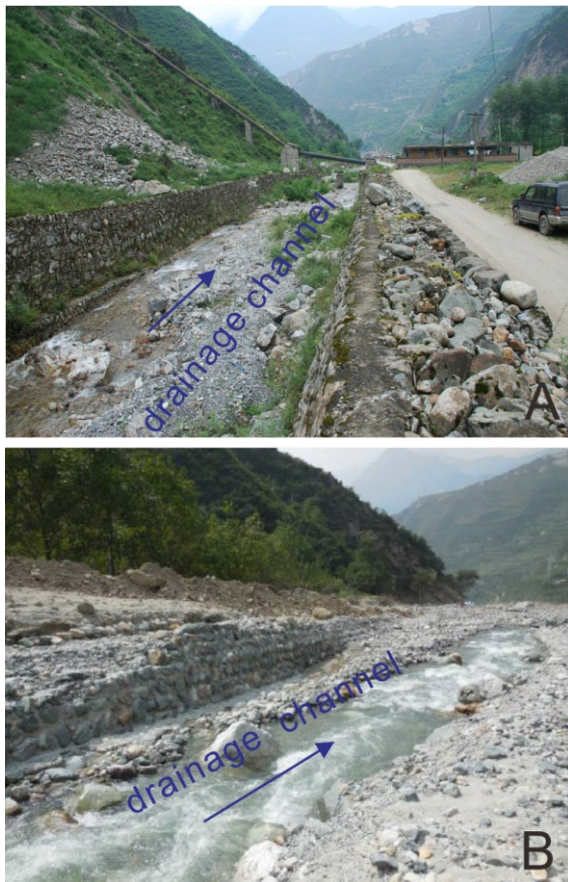
Figure 11 The drainage channel before and after the debris flow event.

A drainage channel was constructed in the downstream channel on the alluvial fan of the Qipan Gully in 1980 (Xu 1985) and was repaired in 2009 after 29 years of service. The total length of the drainage channel was 3256 m. The channel had a trapezoidal-shaped cross section that was 2.5–3.0 m deep and 12.0–15.0 m wide, and was able to drain the debris flow at a rate of 250 m³/s. The old drainage channel was almost completely destroyed in the 11 July event (Figure 11, A and B). Because all of the cascading channel blocking dams had burst, the peak discharge of the debris flow at the entrance of the drainage channel was much larger than its drainage capacity. In addition, the cross section shape (trapezoid shape) of the drainage

channel was not suitable for draining debris flows from gentle channel slopes, such as the slope of the alluvial fan area in the Qipan Gully, which had a gradient of 8%.

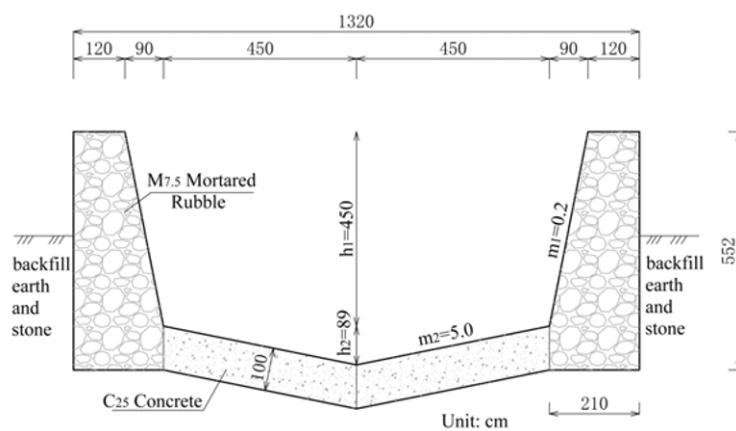
Figure 12 Diagram of the structure of the debris flow drainage channel in the Qipan Gully.

the gully, a new drainage channel should be constructed between the Laoyingyan landslide and the Minjiang River. A trapezoidal V-shaped cross section has been chosen to replace the trapezoid shaped cross section of the drainage channel. The characteristic lengths (h_1 and h_2) under optimal hydraulic conditions were calculated as 4.50 m and 0.90 m, respectively, using the design method for the cross section of the debris flow drainage channel.
