Flood events and their effects in a Himalayan mountain river: Geomorphological examples from the Buri Gandaki Valley, Nepal

Citation: Tombrink G (2017) Flood events and their effects in a Himalayan mountain river: Geomorphological examples from the Buri Gandaki Valley, Nepal. *Journal of Mountain Science* 14 (7). DOI: 10.1007/s11629-016-4154-5

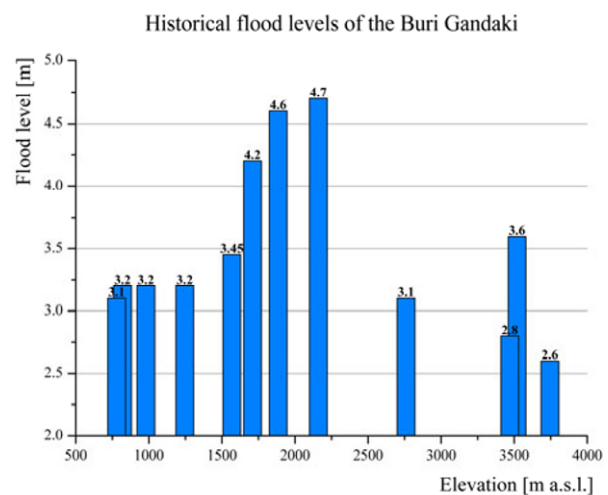
Figure 3 This bar chart illustrates the arithmetic average of measured flood stages at different elevations. These flood stages were measured with a folding yardstick at 12 cross-sectional survey sites in the upper- and middle-stream portions of the Buri Gandaki.

In the upper reach of the Buri Gandaki, flood level heights in the past were minor and the measured discharge was low. At an altitude of 3745 m a.s.l., the historical flood levels reached 2.6 m above the riverbed, and the measured discharge achieved a value of 4 m³/sec (Figures 3, 4 and measurement number 11 in Appendix 1). Further downstream, at an altitude of 3520 m a.s.l. near the Samagaun settlement, the flood level rose to 3.6 m above the riverbed (Figure 3; measurement number 9 in Appendix 1). This high flood level can be explained by the floods that occasionally occurred here during the field investigation and were induced by snow and ice avalanches falling into the Birendra Kund glacial lake. Consequently, these processes generated a surge that resulted in high water marks. Additionally, the small width (6 m and 8.5 m) and high depth (2 m and 1 m) of this river section create conditions for high flood water levels during a surge period (Figure 5). Nearly two hours after an avalanche, a discharge of 18 m³/sec was measured at this cross section (Figure 4).

The reconstructed historical flood level downstream at an altitude of 3470 m a.s.l. reached a value of 2.8 m (Figure 3 and measurement number 14 in Appendix 1). At this cross section, a river width of 14 m and a river depth of 1 m were measured (Figure 5 and measurement number 14

The local flood level at measurement point 6, which is located between measurement numbers 5 and 16, was found to be 4.6 m (Figure 3). The discharge of the river at this cross section increases during monsoon events and through the upstream confluence with the Seran Khola River (ca. 28°30'37.69"N, 84°51'22.63"E; ca. 1963 m a.s.l.). Moreover, the measured discharge data show that the discharge at these localities increased first at 2160 m a.s.l. to 43 m³/sec then at 1885 m a.s.l. to 75 m³/sec. Downstream, it decreased at 1710 m a.s.l. to 36 m³/sec (Figure 4). Naturally, the highest measured discharge of 75 m³/sec could have arisen from the increasing river width (22 m) and depth (2.0 m) at this cross section (Figure 5). As a consequence of this cross-section morphology and the small floodplain, the paleoflood level of measurement point 6 could have occurred (Figure 3).

Further downstream, the paleoflood stage was found to be lower. At an elevation of 1568 m a.s.l., a flood level of 3.45 m (Figure 3 and measurement number 17 in Appendix 3) was reconstructed. This flood level may have resulted from additional

Further downvalley, at an altitude of 780 m a.s.l., the historical water levels decreased to ca. 3.1 m (Figure 3 and measurement number 21 in Appendix 5) and the discharge achieved a value of 32 m³/sec (Figure 4). In this wide river reach, the floodplain is well developed and the river is wider (26 m; Figure 5), lowering the risk of flooding.

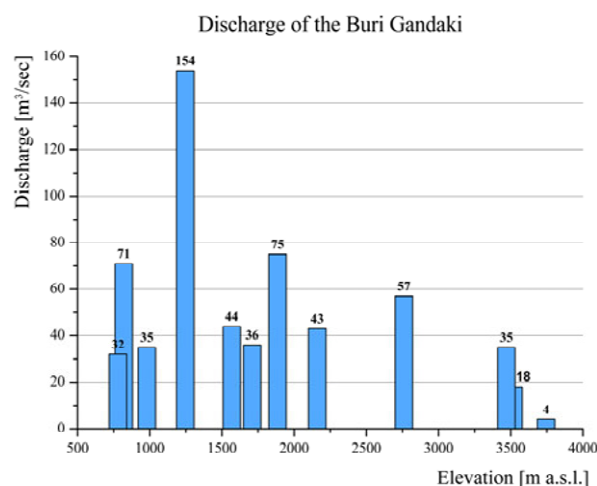
Figure 4 This bar chart illustrates the measured discharge at different elevations along the river during the expedition in April 2008. These measurements were conducted with a buoy-like bag as a float-and-sinker device at 12 cross-sectional survey sites in the upper- and middle-stream portions of the Buri Gandaki.

in Appendix 1). As a result of this morphology, the discharge rose and achieved a value of 35 m³/sec during the field studies (Figure 4). Further downstream, the paleoflood levels increased. At an altitude of 2760 m a.s.l., a flood level of 3.1 m and a discharge of 57 m³/sec were measured (Figures 3, 4 and measurement number 7 in Appendix 2). The highest flood levels in the Buri Gandaki stream were reconstructed between 2160 m and 1710 m a.s.l., and the values fluctuated between 4.2 m and 4.7 m (Figure 3 and measurement numbers 5, 6 and 16 in Appendix 2 and 3). As a result of the low river depth (1.5 m and 1.2 m) and narrow river width (14 m and 18 m) at two of these localities (Figure 5 and measurement numbers 5 and 16 in Appendix 2 and 3), the water level increased during high flood events.

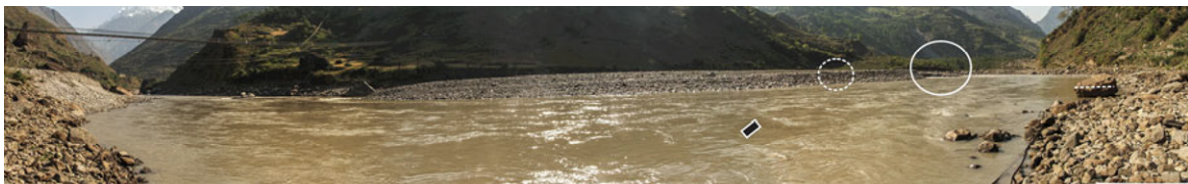
Figure 6 Photo 1 on April 27, 2008, at measurement point 17 at 1568 m a.s.l., facing the Buri Gandaki: Fluvial erosional processes on the boulder (---) and the sorted and relocated sediments on the floodplain (○) illustrate the strength of past floods in this area. The riverbed morphology transitions from a plane bed (◆) into a pool-riffle pattern (○).

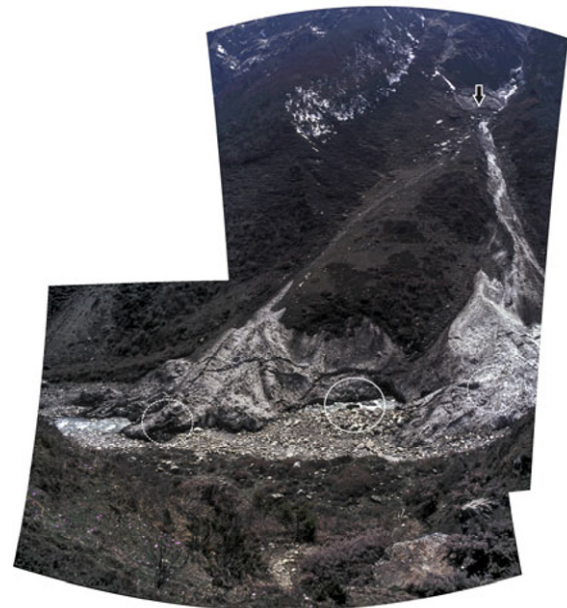
Figure 7 Photo 2 on April 21, 2008, at 3770 m a.s.l., facing west-southwest: The Larke Khola was invaded by an avalanche (○), which initiated above the thalweg (↓). However, the fluvial erosion reduced the development of a dam (○).

avalanche crossed the Larke Khola headwater stream, which flows into the Buri Gandaki. This mass movement was induced above the thalweg on the river-right side (Figure 7). As a result of fluvial erosion processes, this superimposed river accumulation could be undercut. Consequently, the risks of dam development naturally decreased (Figure 7).

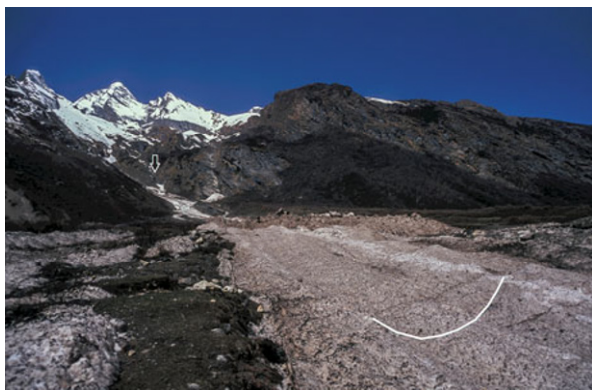
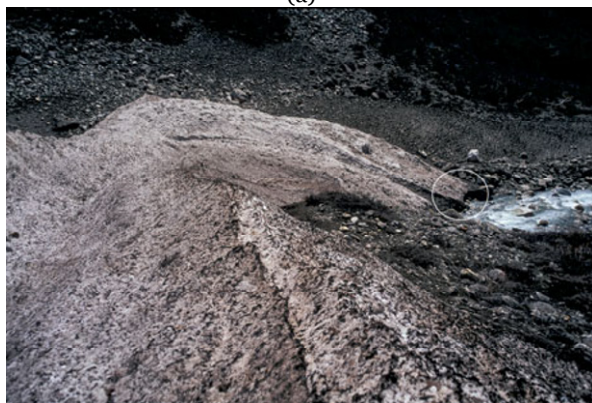
Figure 8 On April 21, 2008, south of measurement point 11 at 3720 m a.s.l. a) Photo 3 Facing west: The avalanche slid down from the orographic right slope (↓) and built a ridge-like formation about 40 m wide (○); b) Photo 4 Facing east: The Buri Gandaki River system (○) and trekking path were covered by an avalanche.

North of Samagaun on the river-right side of the Buri Gandaki upper valley at 3720 m a.s.l. (Appendix 1), the stream and a portion of the infrastructure were covered by an avalanche. The width of this avalanche was ca. 40 m (Figure 8a), and the observed avalanche slid down from the river-right slope. The accumulation consisted of firn, alluvium and boulders, and the historical slide path and frozen rock roll were clearly identifiable (Figure 8a). The bordering Buri Gandaki River was also covered by the ice and snow mass (Figure 8b). As a result of the river burial, the stream could have become dammed, which would have increased the risk and intensity of flooding within the upper Buri Gandaki system.

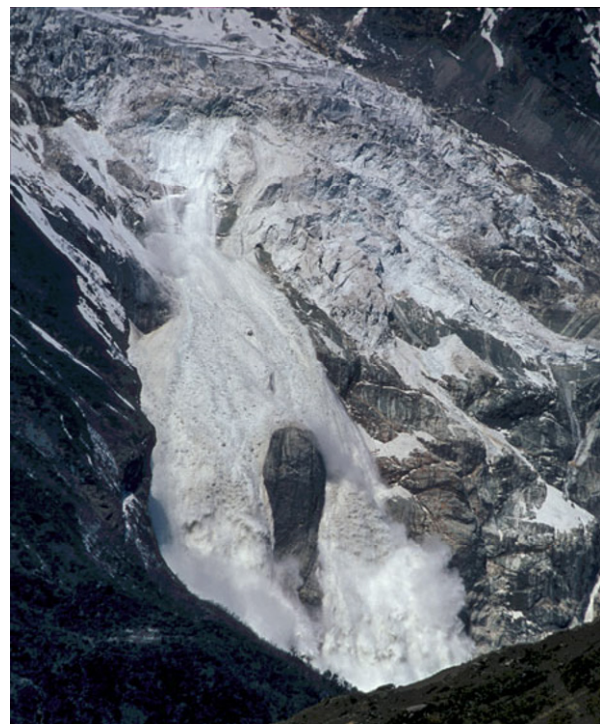
Figure 9 Photo 5 on April 20, 2008, at 10:05 am on the river-left flank of the valley facing the Manaslu glacier: A snow and ice avalanche slumped from the Manaslu glacier into the glacial Birendra Kund Lake. The momentum produced a surge that was diverted into the Buri Gandaki stream and destroyed a nearby bridge.

During field research on 20.04.08 at 10:05 am (Figure 9), a naturally triggered ice and snow avalanche that slid down from the Manaslu glacier to the glacial Birendra Kund Lake (Appendix 1) was observed. These high-energy dynamics induced a flood and pressure wave that spread out into the proglacial Birendra Kund Lake and the adjacent section of the river. These processes led to the destruction of a wooden bridge (Figure 10). Even after two hours, the flow dynamics and discharge of this cross profile were extremely turbulent (see Section 3.1).

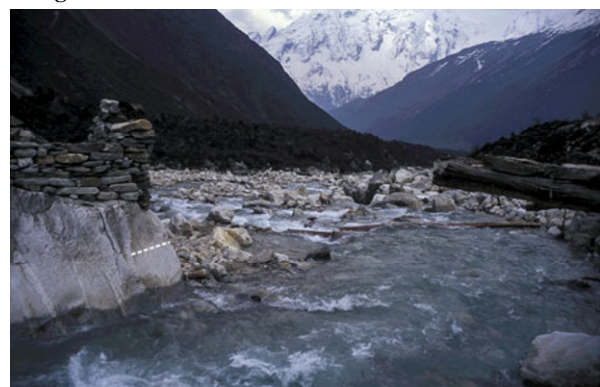
Figure 10 Photo 6 on April 20, 2008, at measurement point 9 at 3520 m a.s.l., facing southeast: The bridge was destroyed by an avalanche surge on April 20, 2008. The weathering effects and erosional processes on the boulder (---) are indicative of past floods.

Therefore, flood events with similar or higher intensities can destroy downstream infrastructure, including bridges and trails (Figure 10). Such natural hazard events are characteristic of high mountain valleys (Hewitt 1997; Kuhle et al. 1998).

waves generated in the Birendra Kund glacial lake can flood the adjacent river plain and can damage infrastructure (Figure 10). Consequently, they use the local landscape and landforms for protection against normal and intense flood events (Figure 18).

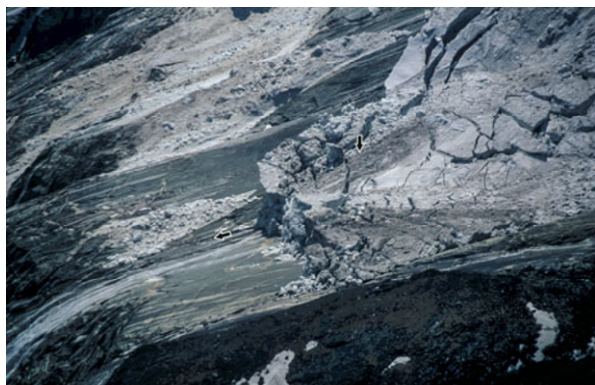
Figure 11 Photo 7 on April 23, 2008, at ca. 4500 m a.s.l., facing south-southeast: Crevasses have formed along shear surfaces due to the plasticity of the ice (↓). As a result of the steep glacial slope, a portion of the glacier tongue broke off (←), producing ice and snow avalanches.

glacial slope (Figure 11) and suggested that shear stress was dominant over shear strength (Winkler 2009). However, several crevasses were formed by the brittle behaviour of the ice in the shear surfaces (Figure 11). The steep glacial slope caused a section of glacial tongue to break off, creating a snow and ice avalanche. This material slid down the slope

(Figure 11) and fell directly into the glacial Birendra Kund Lake at an elevation of ca. 3636 m a.s.l. (ca. 28°35'47.11" N, 84°37'43.16" E; Figure 12 and 13). As a result of these accumulation processes, the water level of the proglacial lake rose and increased the discharge of the glacier stream. Even higher water levels in recent decades have been verified by paleoflood indications on the Birendra Kund glacial lakeshore (Figure 12 and 13) and along the proximal riverbed.

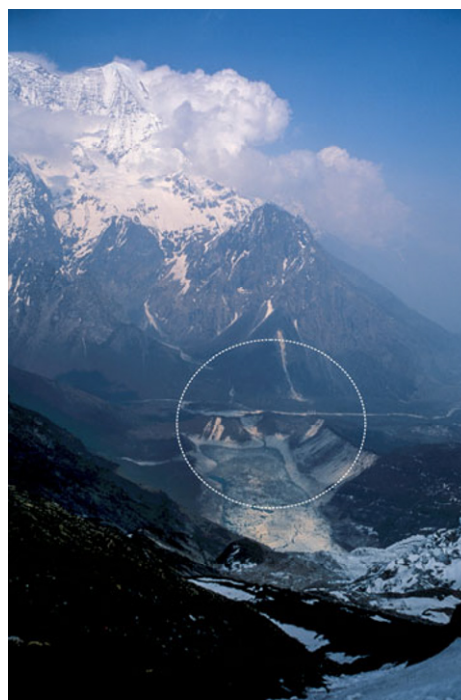
Figure 12 Photo 8 on April 22, 2008, at 4450 m a.s.l., facing east: Ice and snow avalanches generated by the Manaslu glacier increase the risk of local floods (○). However, the moraines protect the neighbouring regions from laterally induced flood waves.

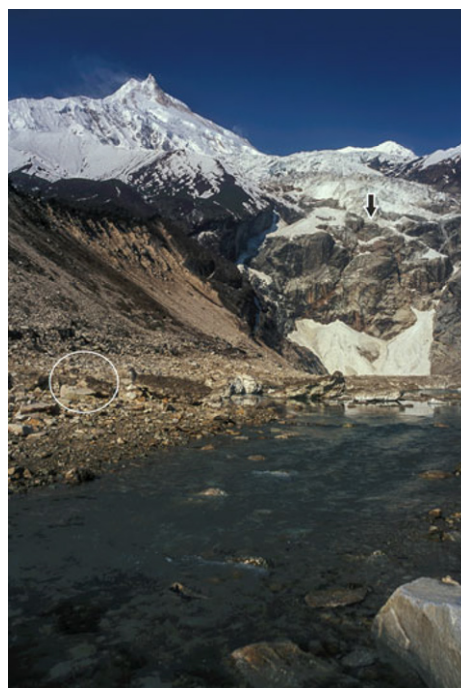
Figure 13 Photo 9 on April 22, 2008, at 3618 m a.s.l., facing west: Ice and detritus accumulated 2 m above the recent glacial lake level of the Birendra Kund (○). This material slumped down from the Manaslu glacier (↓) as an ice and snow avalanche (see Figure 9).

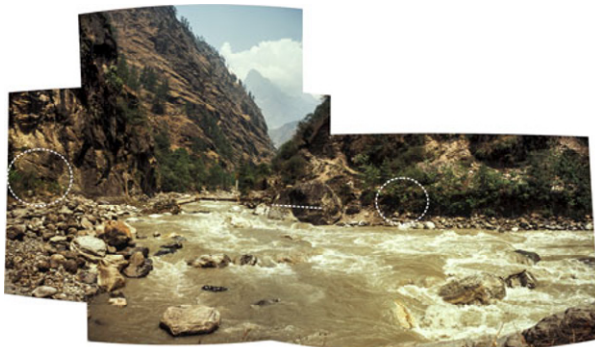
Figure 14 Photo 10 on April 26, 2008, at measurement point 6 at 1885 m a.s.l., facing upstream: The erosional effects on the boulder (--) and plant cover near the riverside (○) are indicative of the Holocene river stages. The bridge was previously destroyed by flooding and was temporarily repaired.

floods in this river reach (Figure 14). Furthermore, the vegetation cover at the riverside clarifies the limitation of past flood lines in recent decades (Figure 14). The high water levels are localised at approximately 2.40 m to 2.80 m above the recent water line (Figure 14). The sum of the recent water level during the field investigation (2 m) and the high water levels varies from 4.40 m to 4.80 m, with an arithmetic average of 4.60 m.

The paleoflood levels illustrate historical flood events in the Buri Gandaki at an altitude of 1885 m a.s.l., and the destroyed bridge (which was flooded in 2008 before the fieldwork occurred), accumulated cobbles on the right side of the river, and fluvial erosion of the boulders are all indicative of the significant discharge of past floods (Figure 14).

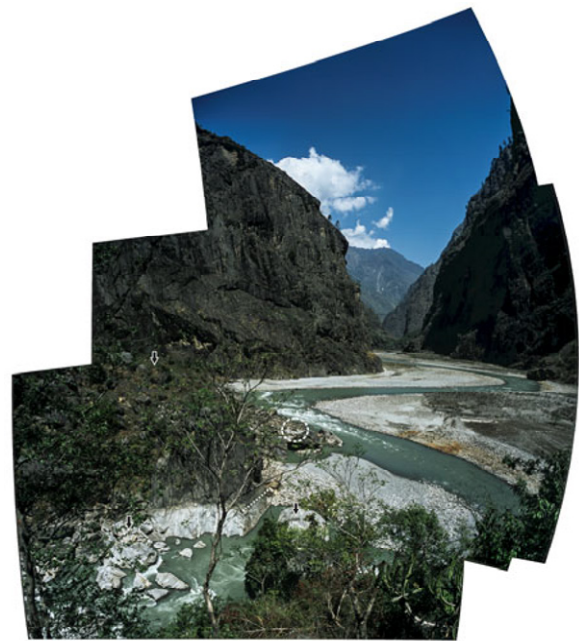
Figure 16 Photo 12 on April 14, 2008, at measurement point 4 at 1246 m a.s.l., facing upstream along the Buri Gandaki: The Buri Gandaki deposits sand and gravel between previously deposited boulders (○) during paleoflood events. The morphology of the riverbed illustrates the meandering patterns and pool-riffle sequences, which result from varying discharge. Rockslides have occurred on the orographic right side of the river (↓). In the past, these processes likely induced damming.

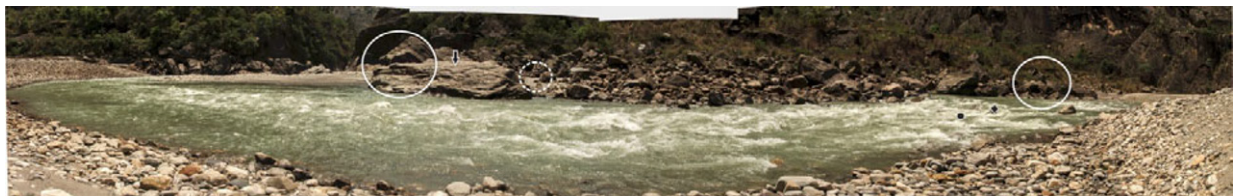
Figure 15 Photo 11 on April 14, 2008, at measurement point 4 at 1246 m a.s.l., facing downstream along the Buri Gandaki: Fluvial erosion marks on the boulder (○) and accumulated sand and gravel above the recent water level (○) illustrate the paleoflood levels attained during floods. The fluvially polished boulder (↓) indicates the minimum level of past flooding. The pool-riffle riverbed morphology is composed of detached step-pool formations (step: ■ pool: ●).

floodplains of the meandering Buri Gandaki. The accumulated boulders within this riverbed were eroded during paleofloods (Figure 15). As a result of these past floods, cobbles and finer sediments accumulated on the riverbed floodplain, and the solid rock on river right became eroded (---) and weathered (Figure 16). These morphological features indicate evidence of paleoflood events. Therefore, the paleoflood level was likely approximately 1.6 m to 2 m above the existing water level (Figure 15). The sum of the observed

water level (here 1.4 m) and the paleoflood levels ranges between 3 m and 3.4 m. Consequently, the arithmetic average of 3.2 m represents the paleoflood stage. Furthermore, a meandering channel shape was observed. At the end of this valley, the meander-forming processes cease, and the valley becomes narrower, which increases the water level within this short river reach. Moreover, the relief results in rockfall that accumulates within the riverbed on the river-right side of the transition into this narrow valley. Consequently, these processes build a natural dam that can block the stream (Figure 16). The water level can rise at this survey site during higher discharge events. In the first step of these related processes, the floodplain minimises the risk of rising high water by serving as a flood buffer. However, if the water level continues to increase during such an event, the terraces bordering this river reach can be flooded. The accumulated and sorted sediments of these terraces testify to the strength of the paleoflood dynamics (Figure 15).

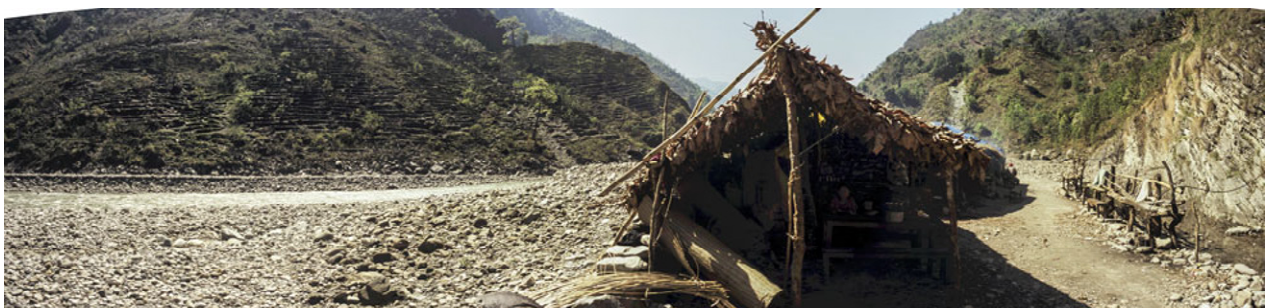
Figure 17 Photo 13 on April 13, 2008, at ca. 820 m a.s.l., south of the Macha Khola settlement, facing downstream: In the non-monsoon season, the local people settle by the riverside of the Buri Gandaki and build a market stall and food stand for the transient porters and trekking tourists.

South of the Macha Khola settlement (ca. 839 m a.s.l.), meanders and wide floodplains along the Buri Gandaki were investigated (Figure 17, Appendix 5). These meandering, pool-riffle and floodplain patterns depend on a high frequency of fluvial discharge and sedimentation changes (Buffington and Montgomery 2013), which illustrate the high-water dynamics of this river reach. During high-water events, which mostly occur during the monsoon season, the water levels of this river reach increase. Consequently, the bordering floodplain becomes submerged.

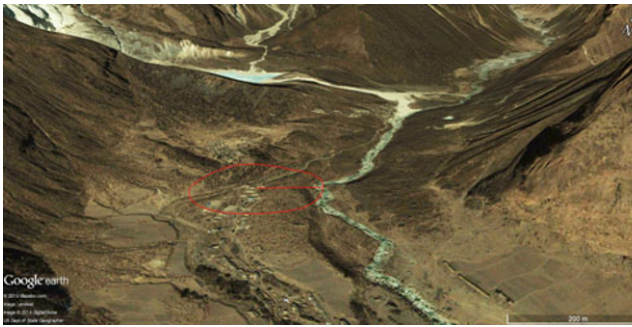
Figure 18 Satellite image of the Samagaun settlement and adjacent Buri Gandaki River (ca. $28^{\circ}35'24.69''$ N, $84^{\circ}38'29.93''$ E) at 3542 m a.s.l. The red line that starts at the riverside and ends at the centre of the circle represents the distance between the Samagaun settlement and the Buri Gandaki River, i.e., approximately 165 m. The approximately 80-m-high river-right Birendra Kund lateral moraine forms a natural dam. This glacial landform protects the adjacent valley, including Samagaun village, from splash waves generated in the lake. Therefore, the potential flood waves cannot flow southeastward, and the flow must follow the course of the river.

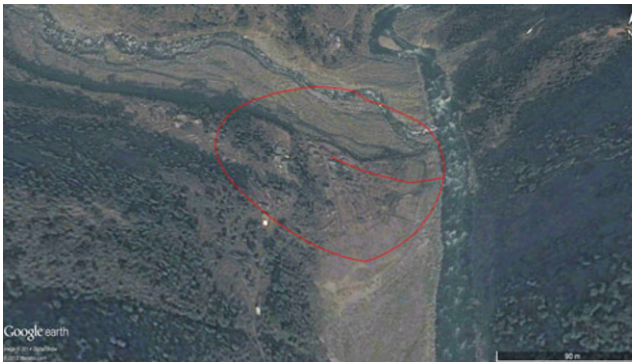
Figure 19 Satellite image of the riverbed adjacent to the Macha Khola settlement (ca. $28^{\circ}13'44.31''$ N, $84^{\circ}52'27.99''$ E) at 839 m a.s.l. The red line that starts at the riverside and ends at the centre of the circle represents the distance between the Macha Khola settlement and the Buri Gandaki River, i.e., approximately 130 m.

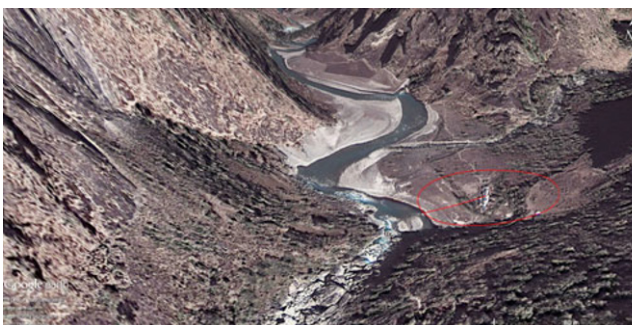
Figure 20 Satellite image of the meandering river and floodplain between the settlements Dhoban and Jagat (ca. $28^{\circ}19'40.36''$ N, $84^{\circ}54'21.73''$ E) at 1248 m a.s.l. The red line that begins at the riverside and ends at the centre of the circle represents the distance between the wooden huts and the Buri Gandaki stream, i.e., approximately 76 m.

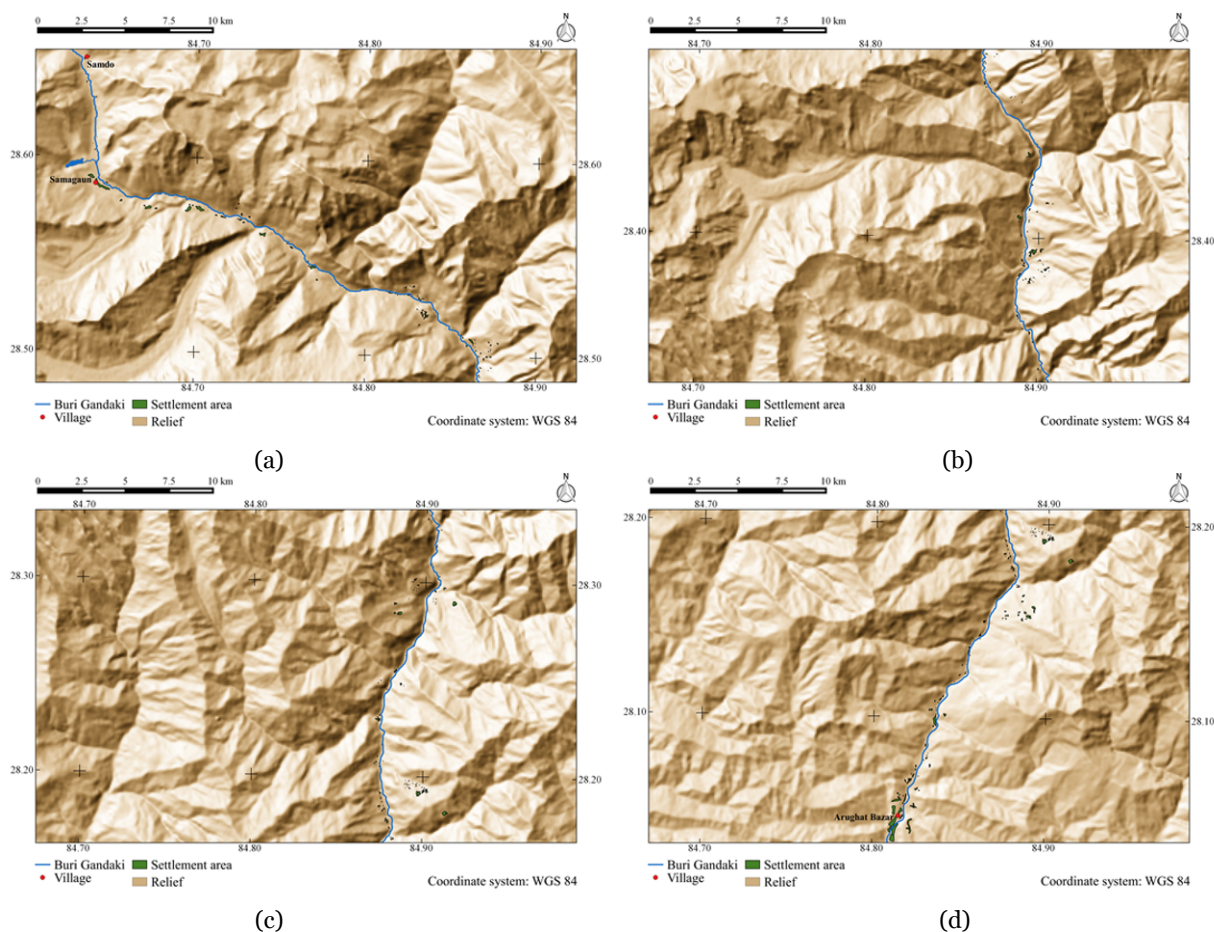
Figure 21 Map of the Buri Gandaki stream and settlement areas, which were mapped via GIS in 2014. The digital elevational model (DEM) is based on SRTM datasets.

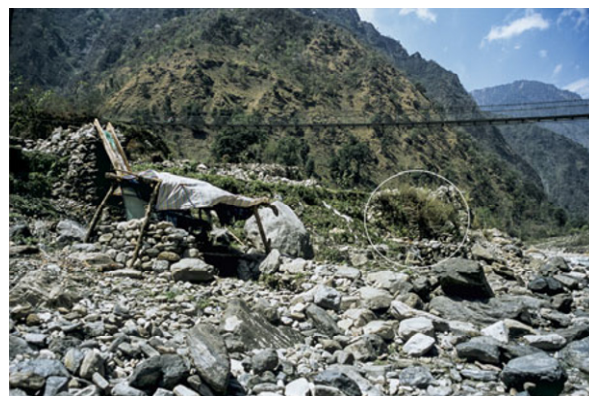
Figure 22 Photo 14 on April 13, 2008, at measurement point 19 at 820 m a.s.l., facing the riverside of the Buri Gandaki: The vegetation cover near the floodplain (○) indicates the maximum level of past flood events over the last several years. During rare intense flood events, the working hut could be destroyed.
