Centrifuge model test of an irrigation-induced loess landslide in the Heifangtai loess platform, Northwest China

Citation: Cui SH, Pei XJ, Wu HY, et al. (2018) Centrifuge model test of an irrigation-induced loess landslide in the Heifangtai loess platform, Northwest China. *Journal of Mountain Science* 15(1). <https://doi.org/10.1007/s11629-017-4490-0>

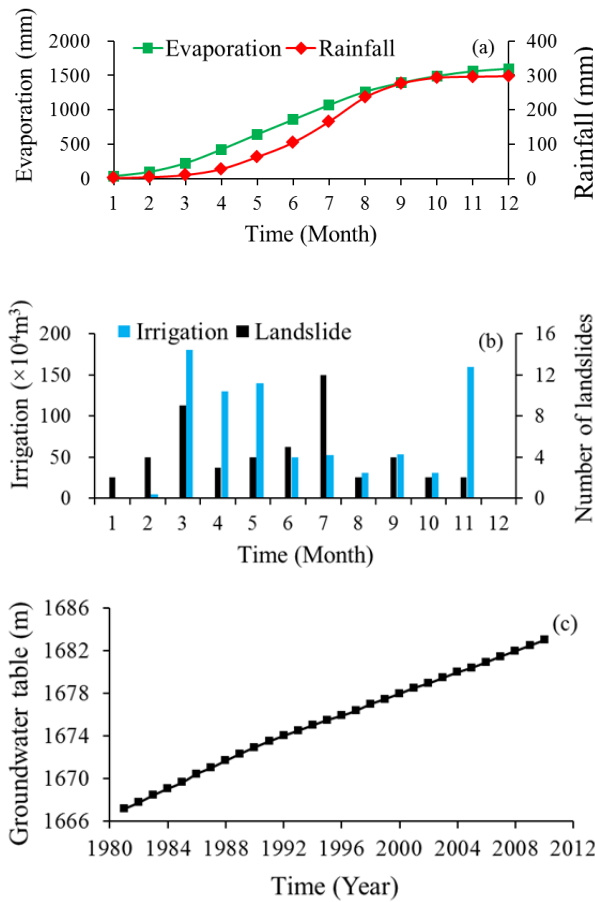
Figure 2 (a) Variation of evaporation and rainfall in each month, (b) irrigation volume and number of landslides in each month, and (c) changes of groundwater table from 1980 to 2009 (landslide data from Wang et al. (2004); irrigation data from Xu et al. (2010)).

et al. 2004), and the groundwater table has risen by approximately 16 m since 1980 (Wang 1997; Derbyshire et al. 2000) (Figure 2c). Springs can commonly be observed at the foot of platform edge slope. The 15 km² platform in Heifangtai is famous for irrigation-induced loess landslides in the world (Derbyshire et al. 2000). More than 120 failures have occurred over the past three decades. From 1977 to 2010, the platform cliff retreated by 126 m. Dense cracks are located around the edge of the platform.

In this area, March and November are the months with largest amount of irrigation (Figure 2b). Large numbers of landslides would occur during and after the period. Irrigation-induced loess landslides occurring after the peak irrigation time indicates time-dependent water infiltration. A new loess landslide, i.e. the 13th Jiaojiayatou landslide occurred on April 27, 2011. This landslide is situated on a steep slope (approximately 45°) on the northeast flank of the Heifangtai platform (location: N 36°05'00", E 103°18'00") (Figure 1b, c). It was a flow-like failure with 75 m long and 120 high. Its deposition buried the highway at the foot of the slope, further flowing into the Yellow River

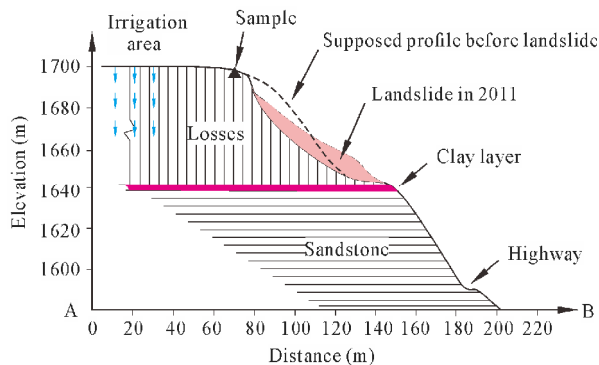
Figure 3 Longitudinal section along the line A-B as shown in Figure1b.

(Figure 1c). The upper layer of the slope is composed of upper Pleistocene loess that is approximately 25 to 60 m thick, and the bedrock is composed of lower Cretaceous mudstone. There is a thin layer of clay overlying the bedrock (Figure 3). Several open tension cracks and steps were observed along the edge of platform after the landslide. The head scarp of the landslide is a cliff showing loess joint fissures.

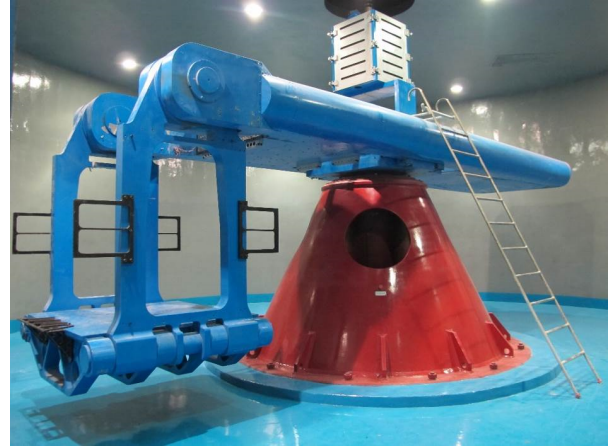
Figure 4 Photograph of the centrifuge machine.

The test was conducted using the TLJ-500 geotechnical centrifuge facility at the State Key Laboratory of Geological Hazard Prevention and Geological Environment Protection (SKLGP) in Chengdu University of Technology (CDUT) (Figure 4). The TLJ-500 has an effective radius of 4.5 m and a rectangular rigid soil box with internal dimensions of 100 cm in length, 100 cm in width and 60 cm in height. One of the sides of the box is equipped with transparent lucite material that forms a window to view the soil model during test.

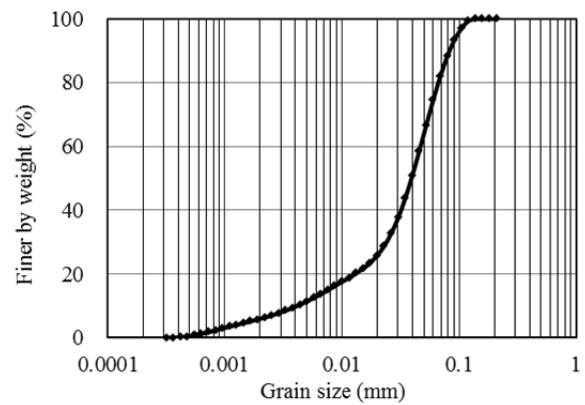
Figure 5 Grain size distribution of the loess sample.

To retain the original structure of the loess, a cubic loess block with 1 m in length of side was taken from the source area of the study landslide. It was carefully carried to laboratory. Figure 5 shows the particle size distribution of the loess material.

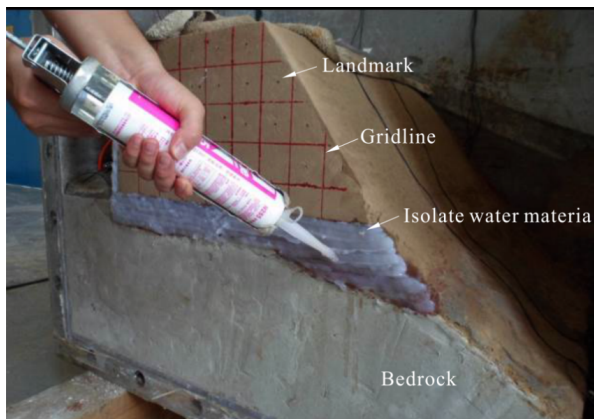
Figure 6 Model preparation (grid lines, landmarks and isolate water material).

The centrifuge model was constructed in a rigid box. The lower part of the model was modeled using concrete to represent the bedrock (Figure 6). The 2-cm-thick clay layer on the bedrock was modeled using clay obtained from the landslide site. The upper loess layer was constructed using the cubic block. First, the loess block was whittled to a model with outside dimensions of 50 cm × 60 cm × 60 cm, and then the semi-finished model was placed on the clay layer in the model box. It was then whittled into the final slope geometry as shown in Figure 6. The gap (1 cm) between the soil model and the wall of the box was filled with dense dry loess. Waterproof material was painted on the model boundaries as shown in Figure 6.

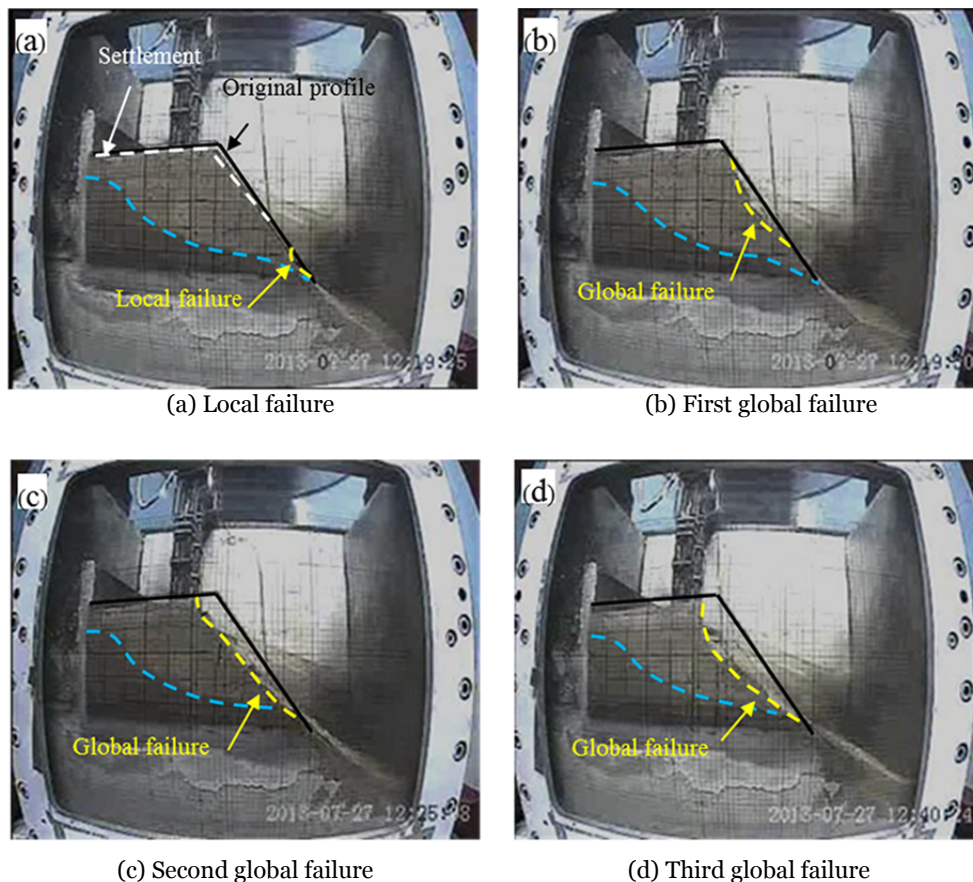
Figure 8 Photos taken by image-capture system. Time is (a) 987 s, (b) 1045 s, (c) 1407 s, (d) 1681 s respectively.

The slope subsided gradually during the centrifuge spinning (Figure 8). The subsidence increased rapidly as the acceleration increased

The observed failures were divided into local (shallow) failures and global (large) failures. A local failure was firstly triggered at the foot of the slope at an acceleration of approximately 120 g (Figure 8a). When the 150 g acceleration was reached, a global failure (first large failure) with an arc-shaped sliding surface was occurred in the middle of the slope (Figure 8b). The second global failure was occurred as the acceleration increased from 150 g to 200 g (Figure 8c). This failure was originated at the upper part of the slope and extended to a relatively flat failure surface. This failure caused regressing of the platform edge. During the stage of 200 g, the third global failure was triggered in the source area of the second one. The scarp height of the centrifuge model was largely enlarged due to this failure (Figure 8d). It is worth noting that two of the three global failures were triggered during constant acceleration stages with little subsidence. The other one occurred during the transition from 150 g to 200 g, when only slight subsidence was occurred. This information suggests that irrigation-induced slope failures might be triggered after the slope subsidence.

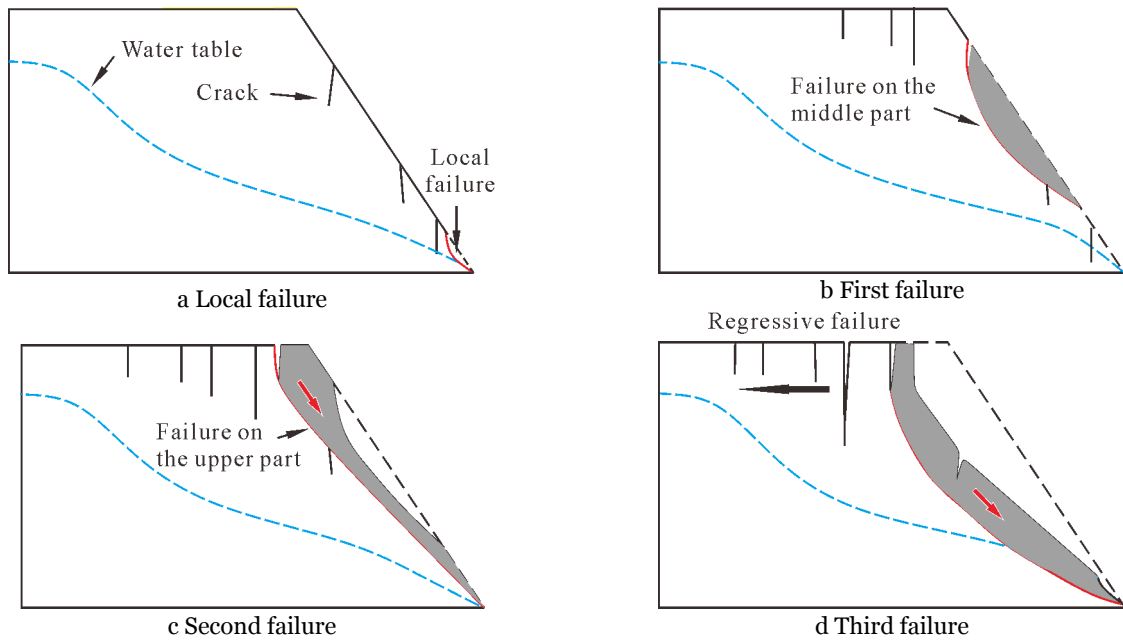
Figure 9 Showing the cracks, failure and water table of the slope at different failure times. (a) Spring was observed at the foot of the slope where a local failure formed. Cracks were starting to develop upward. (b) Cracks extended to the top of the model, and a global failure was occurred at the middle part with increasing water table. (c) Cracks developed backward, and an open tension crack formed the back boundary of a large failure. (d) More open tension cracks developed, and another global failure was triggered with increasing water table. These failure processes had the characteristics of regressive failure.

Cracks and water table in the model during test were detected from the video image. There sketches were drawn as shown in Figure 9. Cracks developed at the foot of the slope firstly where following a local failure. And then, the cracks formed upward. After the first global failure on the middle part of the slope, cracks parallel to the edge of the model developed. It can be found that the open tension cracks formed the boundaries of the second and third failures. The failure processes was characterized by regressive failures. It should be noted that the water table in front of the slope increased prior to each global failure, while the water table in the middle and the back of slope was almost constant (Figure 9).

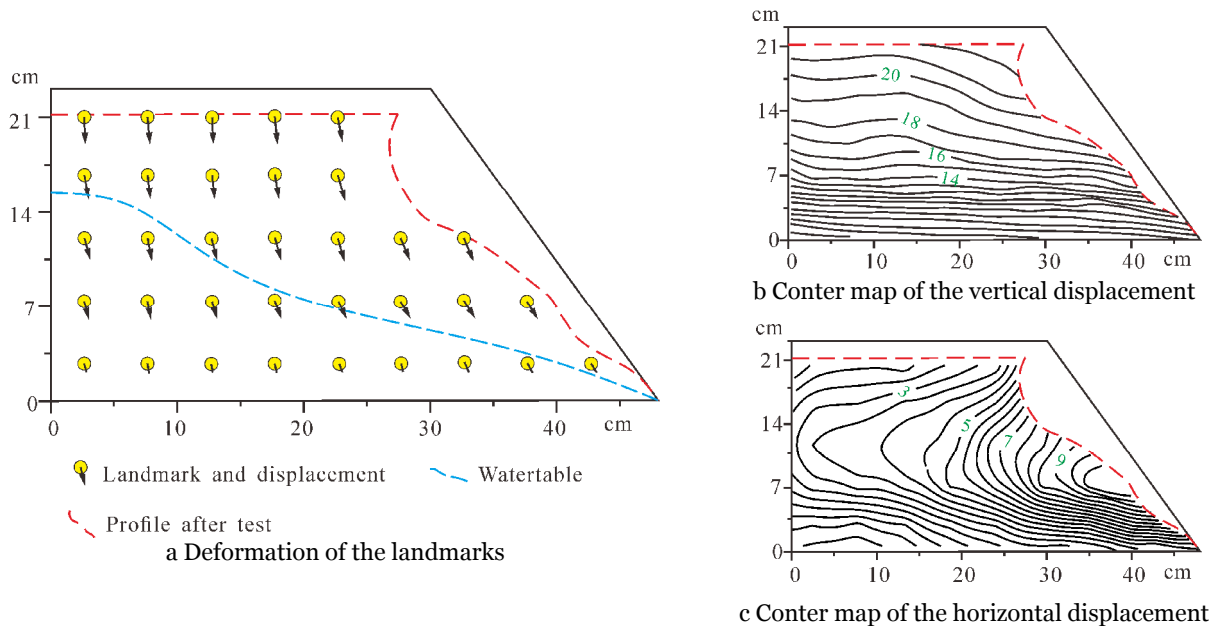
Figure 10 Final deformation of the model.

The markers displacements were calculated in the image analysis subsystem. The results are shown in Figure 10a. The vertical and horizontal displacement contours are shown in Figures 10b and c. The contour lines at the base in both directions are nearly parallel, which indicates a linear distribution of displacement. However, both the vertical and horizontal deformations are concentrated around the water table suggesting non-uniform strain due to possible soil creep.

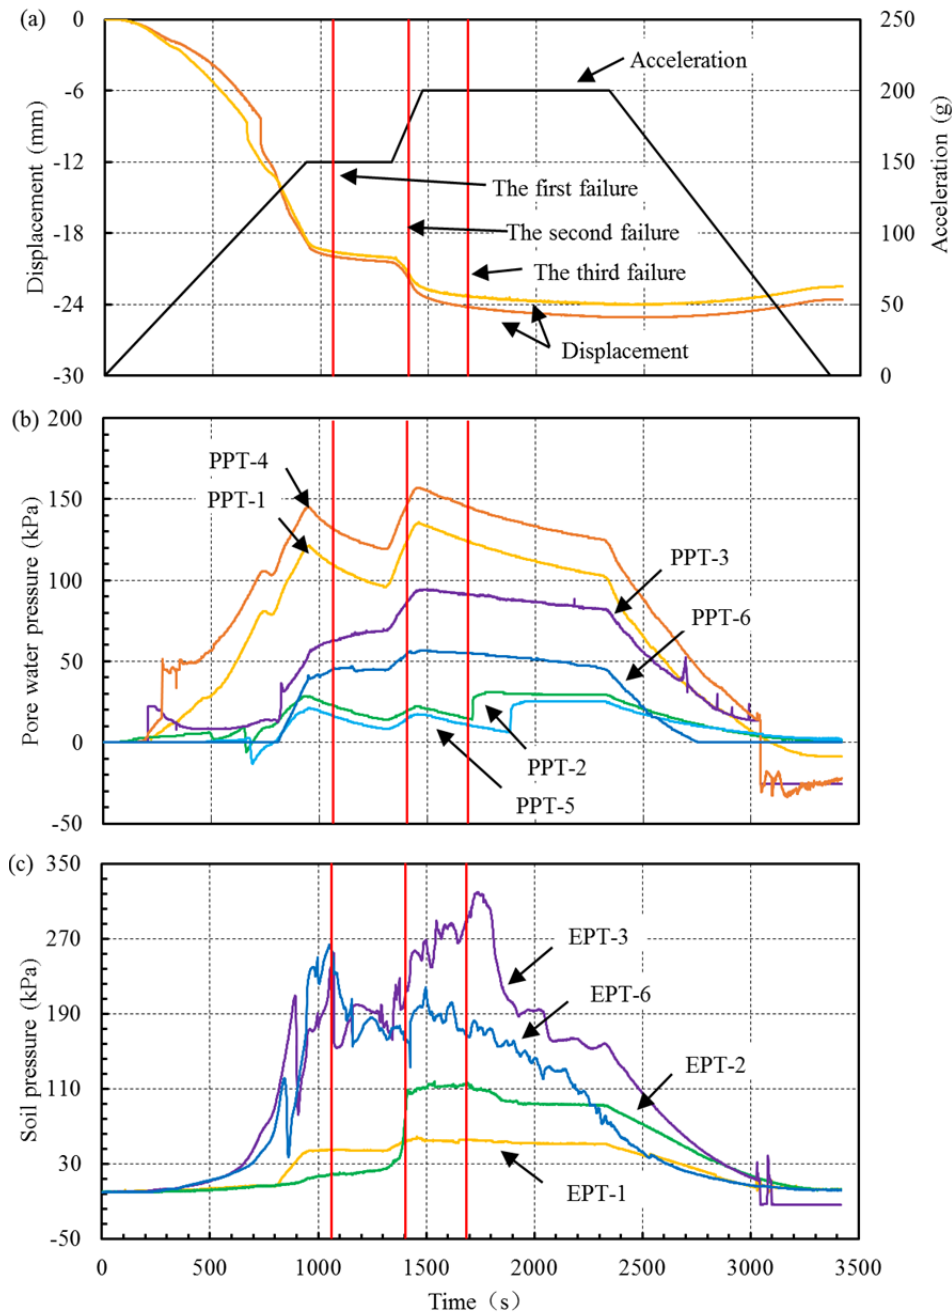
Figure 11 Time series data of centrifuge test. (a) Control signal for acceleration of model and measured displacement, (b) measured pore pressure and (c) earth pressure.

from approximately 120 g to 150 g. During the 150-g acceleration the subsidence curve converged, which indicated that the model had reached a new equilibrium. The subsidence increased by 3 mm as the acceleration increased from 150 g to 200 g. There was little subsidence after reaching the acceleration of 200 g. The detected total subsidence was approximately 23 mm. The subsidence decreased by approximately 1 mm as the centrifuge was stopped (Figure 11a).

The pore pressure data are shown in Figure 11b. The pore pressures at pore pressure transducers PPT-1 and PPT-4 began to increase after spinning for approximately 200 sec, which indicates arriving of the irrigation water. The pore pressures at PPT-3 and PPT-6, which were located at the foot of the slope, increased rapidly after approximately 800 sec indicating the arrival of irrigation water at the front portion of the slope. During the 150 g, the pore pressures at PPT-1, PPT-4, PPT-2 and PPT-5 decreased firstly and then increased, which indicates the change of pore pressure generation and dissipate. However, the pore pressures at PPT-3 and PPT-6 continued to increase gradually. When the 200 g acceleration was maintained, the pore pressures of all pore pressure transducers decreased. Except the third failure which resulted in a rapid 16-kPa-increase pore pressure at PPT-2 and PPT-5, the pore pressure transducers did not response obviously to the failures. It is because all the failures were triggered above the pore pressure transducers.

Two earth pressure transducers (EPT-4 and EPT-5) did not work. Therefore, earth pressure data were obtained from the other four transducers (Figure 11c). The earth pressures at transducers EPT-3 and EPT-6 increased to approximately 110 kPa with increasing acceleration at the beginning of the test, while the earth pressures at transducer EPT-1 (in the upper part of the slope) and EPT-2 (in the middle part) did not change significantly. After that, the pressures at EPT-3 and EPT-6 increased unsteadily, which indicated the occurrence of the local failure at the foot of the

slope. When the first global failure occurred, EPT-2 had a sudden increase of 48 kPa, but EPT-1 had no response. After the first global failure, the earth pressure at the foot of the slope (EPT-3 and EPT-6) decreased unsteadily until the acceleration increased from 150 g to 200 g. When the second

failure occurred, EPT-2 had a rapid increase by approximately 80 kPa. As the 200 g acceleration was maintained, the pressure at EPT-3 continued to increase. It had a rapid increase by approximately 45 kPa due to the third global failure. After the third failure event, the pressure at

EPT-3 decreased abruptly by approximately 125 kPa. When acceleration decreasing, the earth pressures decreased at all of the transducers. It is important to note that EPT-3 and EPT-6 were shallow embedded at the foot of the slope, but very high earth pressures were recorded by them. And they responded to all failures during test.

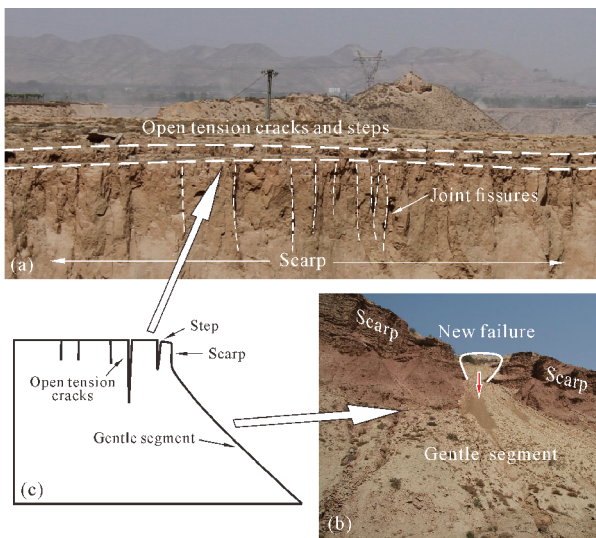
Figure 12 Comparison of slope failure model between field case and test result. (a) Scarp and (b) failure profile of the field case, (c) slope failure model of centrifuge test result.

effects of cracks under the combination of irrigation and precipitation in the stability studies of irrigation-induced loess landslides. After our test, cracks were widely developed along the edge of the model. In site, a lot of open tension cracks and steps were observed at the edge of platform. The head scarp of our case is a cliff showing loess joint fissures (Figure 12). Although our centrifuge model

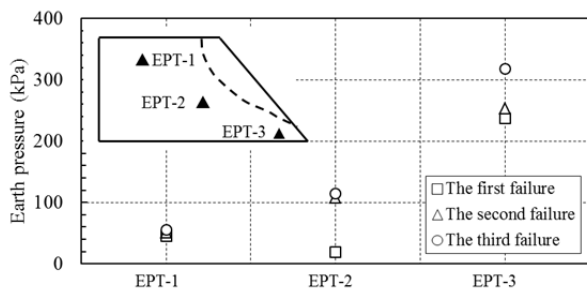
Figure 13 Earth pressure data of EPT-1, EPT-2 and EPT-3 at each failure time. The earth pressure at the foot of slope is the highest, suggesting that there is a stress concentration area before each failure.

Figure 13 shows the earth pressure value at each failure time of EPT-1, EPT-2 and EPT-3 respectively. It can be found that the earth pressure

at the foot of slope is the highest suggesting an area of stress concentration before failure. It should be noted that additional earth pressure should be applied to the lower part of the model during centrifuge test. The cause of pressure concentration may be creeping of upper part. After slope failure, the earth pressure decreased immediately until the next failure. Figure 14c shows that the pore pressure at the foot of the slope (PPT-3 and PPT-6) increases with increasing earth pressure, but this feature is not be found at the other two locations (Figures 14a and b). In addition, Figure 11b shows that the pore pressures of PPT-1 and PPT-4 decrease around the first global failure even, while PPT-3 and PPT-6 increase consistently, PPT-2 and PPT-5 were almost constant. These evidences suggest that water might be accumulated at the foot of slope due to the local variation of the hydraulic conditions in base layer. There might be

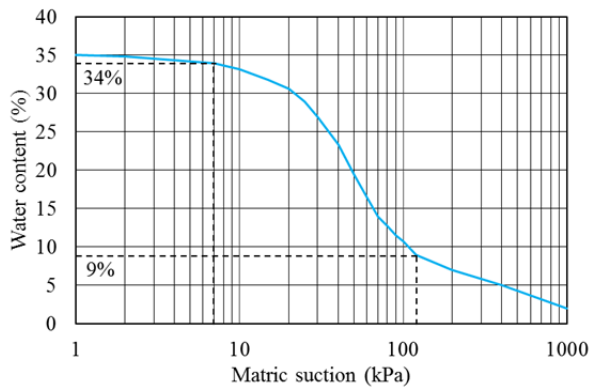
Figure 15 Relationship between the matric suction and water content of the studied soil.

As shown by our centrifuge test, the failures mainly occurred in unsaturated part of the model, suggesting that matric suction of soil is important for slope stability. The relationship between the study soil suction and water content was investigated (Figure 15). The result shows that the matric suction decreased rapidly with increasing water content. With water content increasing from 9 % to 34 %, the suction decreased from 120 kPa to 7 kPa. The suction decreased rapidly to almost zero with further increasing water content. In a loess slope, there should be an unsaturated zone above water table. Due to suction decreasing, creeping occurs in the unsaturated zone. The vertical and horizontal creeping deformations in the unsaturated zone may be responsible for the slope failure above water table and the cracks on slope and along edge of platform. Cascini et al. (2010) outlined the existence of slide, flow-like slide, and slide to flow. Slide is a slope failure occurring under pore-water drained conditions, while a flow-like slide occurs under partially or totally undrained conditions. And flow-like slides are associated with increase of pore-water pressures. Their classification was consistent with our study. The first and second failures in our test were slide events in unsaturated zone.

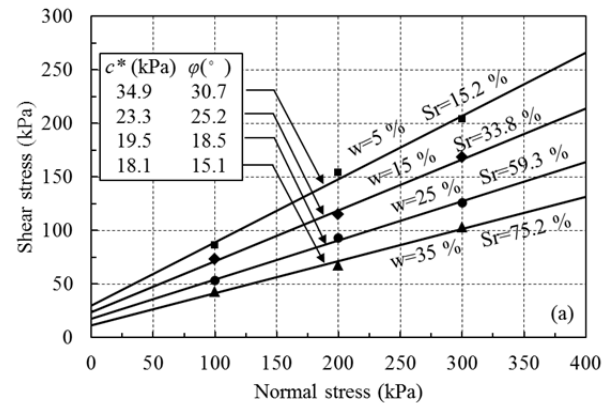
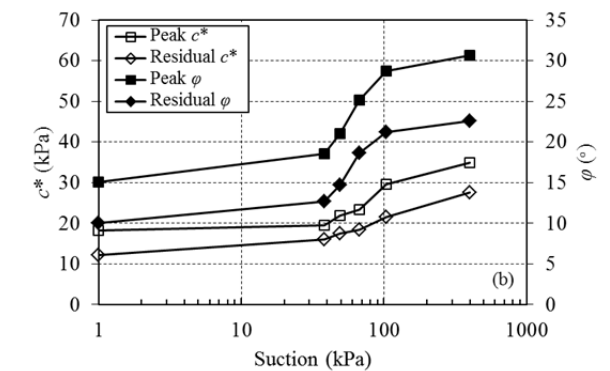
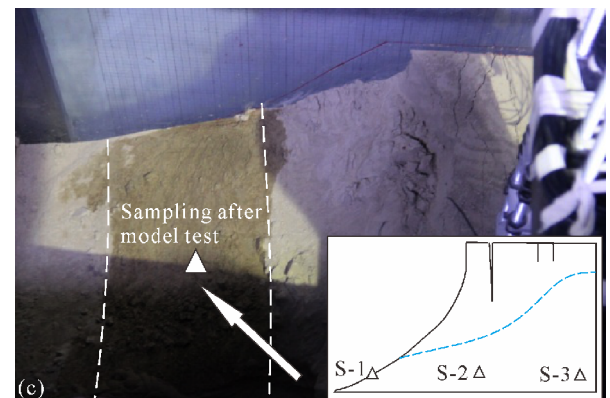
Figure 16 (a) Effects of moisture content on direct shear strength of soil, (b) relationships between suction and shear strength parameters, and (c) sample locations after centrifuge test.

were identical to the centrifuge model soil. The tests were conducted on the specimens with different moisture contents, including 5%, 15%, 25%, and 35%. The results of peak shear strength were shown in Figure 16a. It shows that the soil at the 5% moisture content have an apparent cohesion of 34.9 kPa and an internal friction angle of 30.7° (Figure 16a). However, the apparent cohesion and internal friction angle decrease to 18.1 kPa and 15.1°, respectively when the moisture

content increases to 35%. After the centrifuge test, three samples (S-1, S-2 and S-3) under wetting front were collected to test their properties ((Figure 16c). Their water contents ranged from 20.4% to 20.7%. The apparent cohesion and internal friction angle of S-1 were 16.8 kPa and 14.7°, respectively, which almost equal to the residual strength parameters of the undisturbed loess under same water content condition (Figure 16b). Its void ratio is only 0.89. However, the strength parameters of S-2 (19.7 kPa and 19.1°) and S-3 (21.8 kPa and 21.2°) trended to the peak strength parameters of

the undisturbed loess. And their void ratios increase to 1.05 and 1.12, respectively. It is reasonable to infer that the irrigation water in the slope changed not only the effective stress but also the structure of the loess. The creep and structure collapse of the loess reduced its void ratio that may result in water table uplift. The increase of water table, time dependent collapse of soil structure and creep may trigger static liquefaction in the basal layer of loess slope. They were responsible for the instability of loess slope.
