Distribution and features of landslides in the Tianshui Basin, Northwest China

Citation: Zhang ZL, Wang T, Wu SR (2020) Distribution and features of landslides in the Tianshui Basin, Northwest China. *Journal of Mountain Science* 17(3). <https://doi.org/10.1007/s11629-019-5595-4>

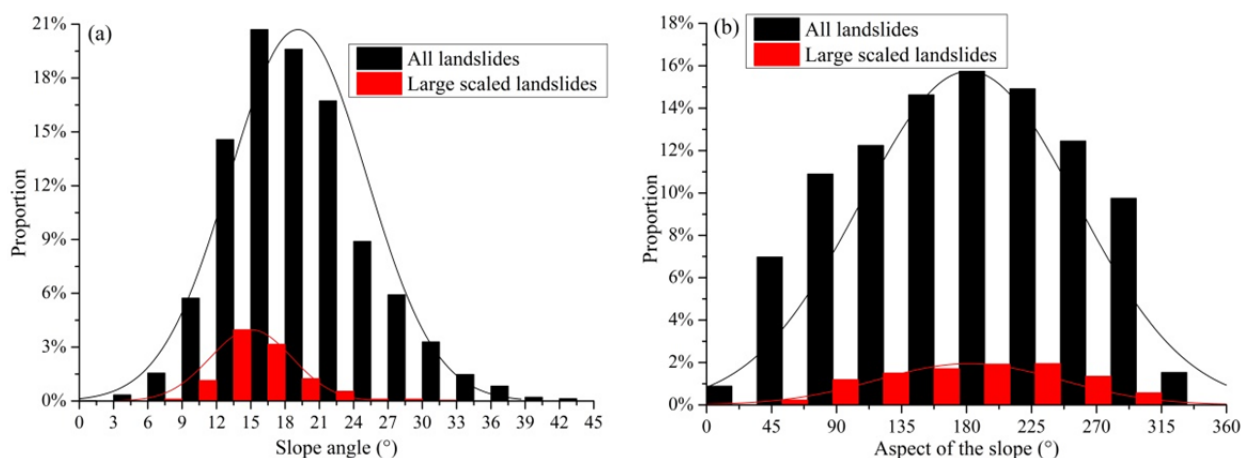
Figure 5 Landslide statistics about (a) the slope angle and (b) slope aspect.

The landslides are distributed mainly along the West Qinling faults (Figure 4a). Some of these landslides were caused by earthquakes (Li et al. 2009; Harp and Jibson 1996; Lin and Tung 2004; Owen et al. 2008; Sato and Harp 2009) that were generated by fault motion. The landslide database includes the orientations and gradients of the landslides; the angles of slopes in the region are illustrated in Figure 4b. Statistical analysis indicates that the landslides occur mainly on slopes with gradients ranging from 10° to 25° and on southeast- and southwest-facing slopes (Figure 5).

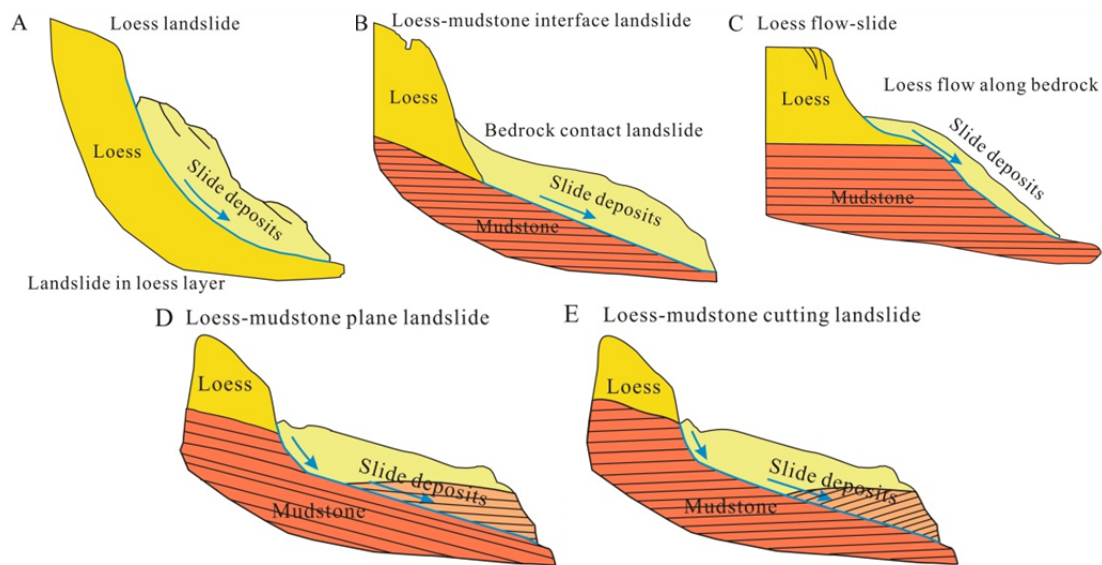
Figure 6 Loess landslides types in Tianshui Basin. (A, loess landslides; B, loess-mudstone interface landslide; C, loess flow-slide; D, loess-mudstone plane landslides; and E, loess-mudstone cutting landslides).

1. Loess landslide (Figure 6A): for this landslide type, the failure surface is in the loess layer, and the landslide occurs entirely in the loess. The sliding surface suggests rotational sliding, and cracks in the loess influence the slope stability. This kind of landslide often exhibits small-scale failure and short-distance sliding (runout). Human engineering activities, rainfall and earthquakes are the main triggers of this type of landslide.

2. Loess–mudstone interface landslide (Figure 6B): for this type of landslide, the failure surface lies along the interface between the bedrock and the overlying loess. Failure occurs as the loess slides along the bedrock; the sliding surface

suggests translational sliding. This kind of landslide often presents as a medium-scale failure with a long sliding distance (runout). Rainfall and earthquakes are the main triggers of this type of landslide.

3. Loess flow-slide (Figure 6C): for this landslide type, the sliding surface is along the bedrock. Failure occurs as the loess flows along the bedrock, implying flowing and sliding motion. This kind of landslide often manifests as a thin layer of flowing–sliding loess with a long runout distance. Rainfall is the main trigger of this type of landslide.

4. Loess–mudstone plane landslide (Figure 6D): in this type of landslide, cracks develop in the loess layer and extend down along the bedding plane of the bedrock, causing failure. Failure occurs in both the loess and the bedrock, and the slide

surface suggests initial rotation followed by translational sliding. This kind of landslide often presents as deep-seated large-scale failure with a long sliding distance (runout). Rainfall and earthquakes are the main triggers of this type of landslide.

5. Loess–mudstone cutting landslide (Figure 6E); in this type of landslide, cracks develop in the loess layer and extend downward, cutting into the bedrock. Failure occurs in both the loess and the bedrock, and the sliding surface suggests roto-translational sliding. This kind of landslide often presents as deep-seated large-scale failure with a long sliding distance (runout). Earthquakes and rainfall are the main triggers of this type of landslide.

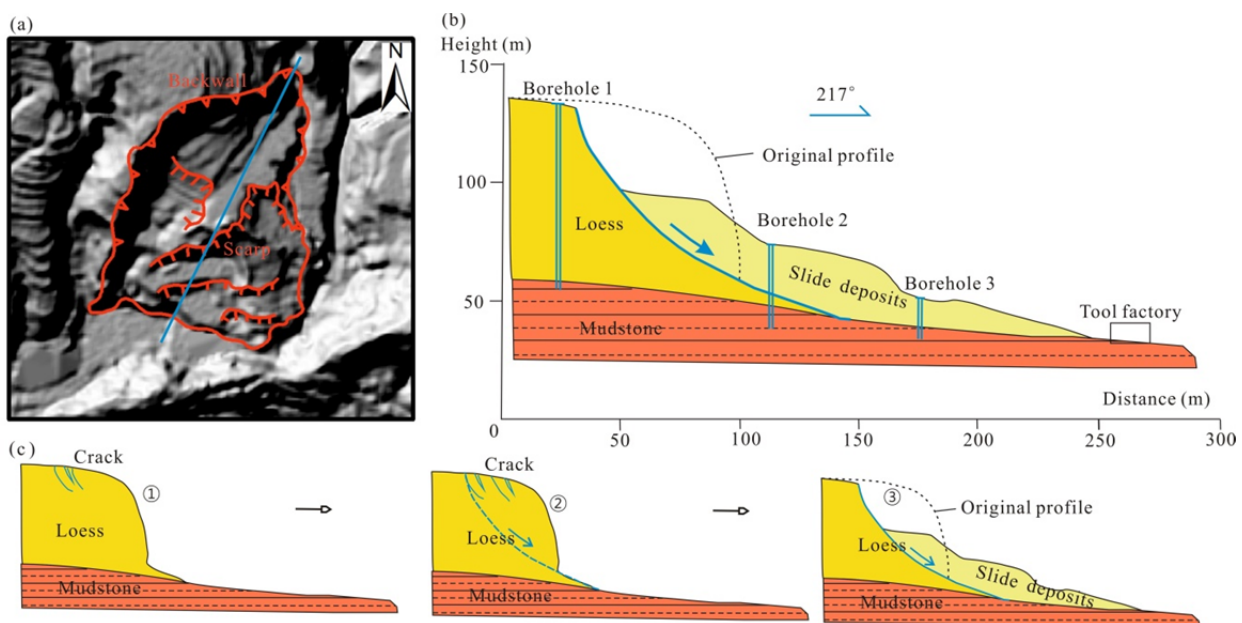
Figure 7 A typical rotational loess landslide. (a) planar map; (b) profile map; (c) failure pattern.

A total of 593 landslides in the study area are loess landslides, in which the failure surface occurs in the loess. A typical example is the Tool Factory landslide located in Tianshui City (Figure 7). The main sliding direction of the landslide is 210° and the average slope gradient is 16° . The landslide has a length of 350 m, a width of 280 m, an average thickness of ~ 20 m, and a volume of $\sim 1.4 \times 10^6$ m³. Field studies of the sliding body indicate that the slide deposits are loess and the sliding surface is cambered. The bedrock exhibits horizontal stratification. The landslide is medium-sized with a

The failure pattern of loess landslides is presented in Figure 7c. In stage 1, cracks and joints develop at the slope crest, caused by toe excavation and rainfall. In stage 2, the cracks at the crest gradually extend downward and a concave sliding surface is formed. Stage 3 is the failure stage, in which the unstable block slides along the concave failure surface. This process is common in landslides in the Chinese Loess Plateau with small-to medium-sized failure.

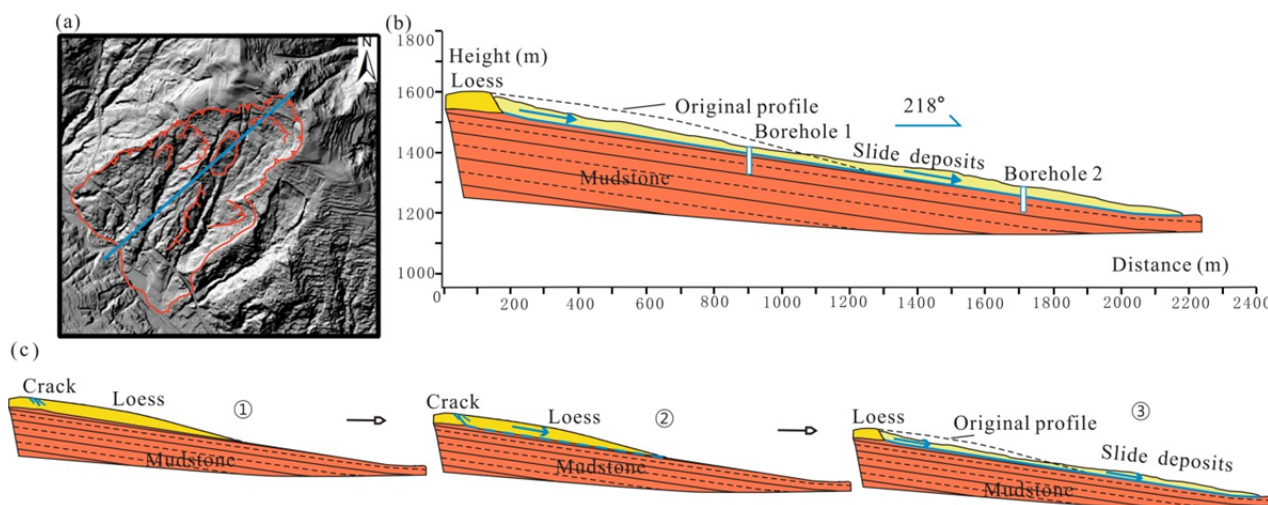
Figure 8 A typical translational loess-mudstone landslides. (a) planar map; (b) profile map; (c) failure pattern.

The failure pattern of a loess–mudstone interface landslide is presented in Figure 8c. In stage 1, cracks develop in the slope crest and

gradually extend through the loess when rain infiltrates the slope. In stage 2, the cracks extend toward the bedrock and a translation slide surface forms along the bedrock interface. In stage 3, the cracks continue to propagate, causing deformation in the slope, and the slip mass begins to slide along the translation sliding surface. The failure is often on a large to medium scale with a long runout.

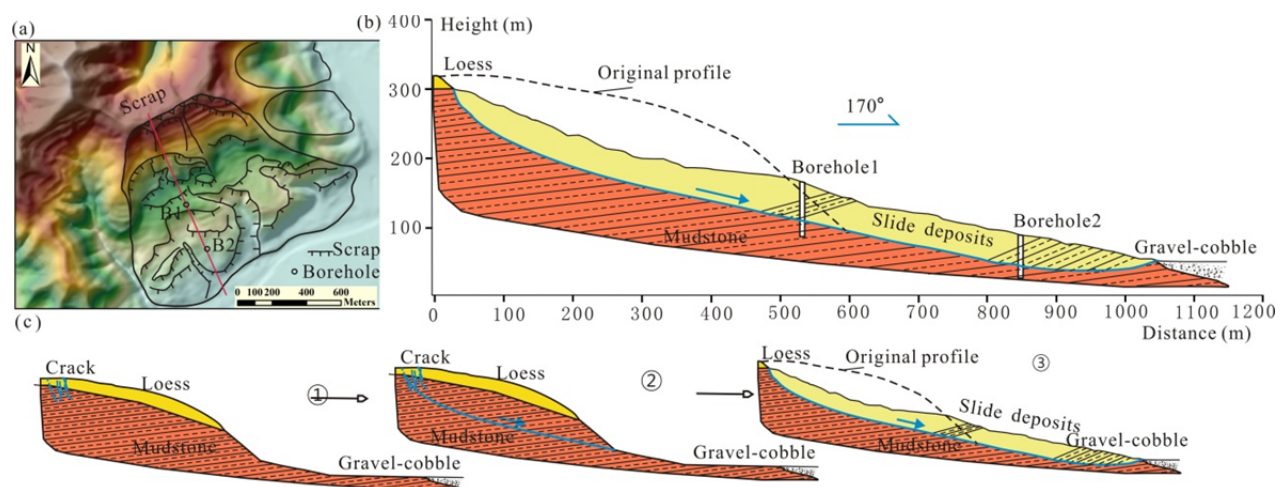
Figure 11 A typical loess-mudstone cutting landslide (mixed, cutting landslide). (a) geomorphologic picture; (b) profile map; (c) failure pattern.

The failure pattern of a loess–mudstone

cutting landslide is presented in Figure 11c. In stage 1, cracks develop at the crest. In stage 2, the cracks at the crest gradually extend deep downward. A cambered slide surface forms in the loess. Weak interlayers develop in the cracked bedrock, until a continuous translational plane is formed. The slope deformation suggests the occurrence of creep in the deep-seated interlayers. In stage 3, failure occurs after a strong earthquake and the unstable parts slide along the translational plane in the bedrock. The sliding surface is roto-translational. The deposits are deep-seated over a long runout. Large-scale earthquake-induced landslides in the Chinese Loess Plateau usually belong to this category.

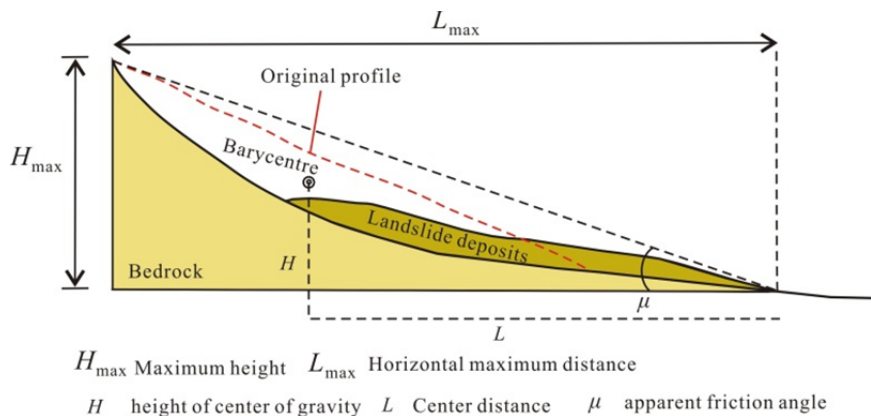
Figure 12 Landslide motion characteristic parameters.

$$\mu = H_{max}/L_{max} \tag{1}$$

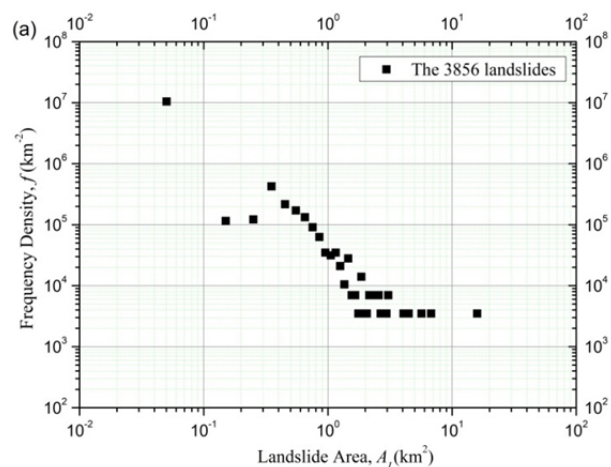
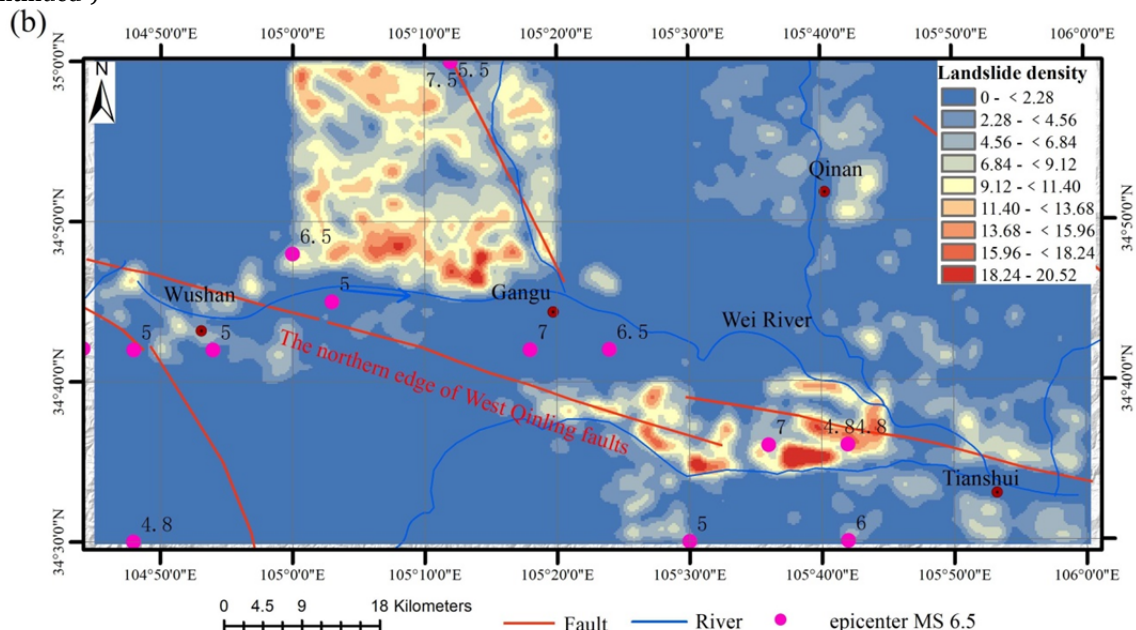
Figure 15 Landslides area relational graph (a) Dependence of the landslide frequency density f on landslide area A_L . (b) Landslide area density map. (-To be continued-)

Figure 15 Landslides area relational graph (a) Dependence of the landslide frequency density f on landslide area A_L . (b) Landslide area density map.

Landslides frequency density area is plotted for a total of 3856 landslides in the study area (Figure 15a). Landslide frequency ranges from 3×10^3 to $4 \times 10^5 km^{-2}$ for landslide areas of 0.1 to 20 km^2 . For landslide area of 1 to 7 km^2 , landslide frequency is between 2×10^3 and $3 \times 10^4 km^{-2}$. Landslides are more intensive in this statistical range. The distribution map of landslide density in the study area is provided in Figure 15b. The districts with the highest landslide density are located in Tianshui city and Gangu town. The high-density area (index 11.4-15.96) is in the southern

part of Gangu town along the river, and a much higher-density area (index 15.96-20.52) is situated in the northwestern area of Tianshui city along the river.

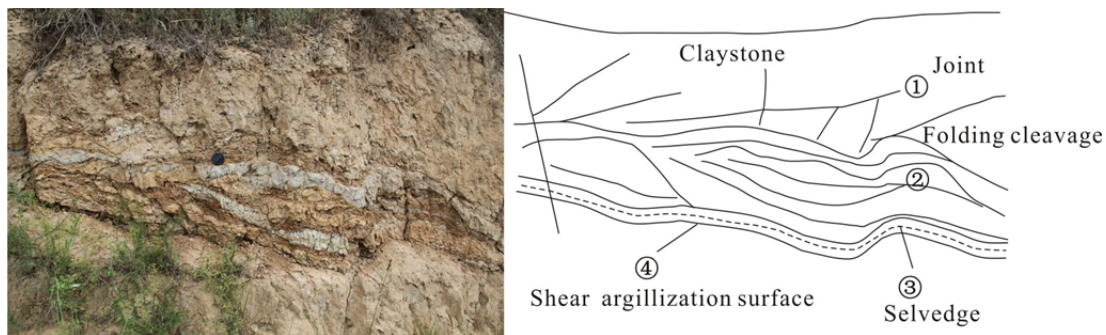
(A) Complete shear - folding cleavage shear zone

(A) Complete shear–folding cleavage shear zone: this type of shear zone is developed along the primary claystone, with a wavy bedding pattern and cleavage around the shear zone. Clear tectonic zoning characteristics can be observed, such as an argillized zone, a sheared argillized surface, a cleavage folding zone and a joint zone (Figure 16A).

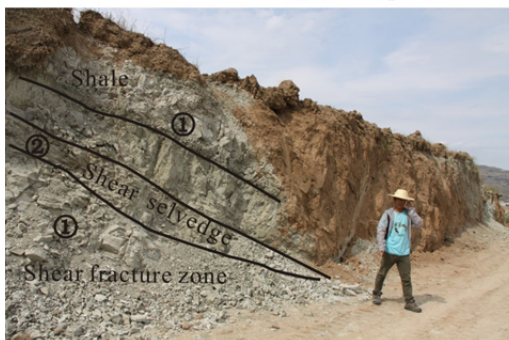
(B) Complete shear - shear fracture zone

(B) Complete shear–shear fracture zone: this type shows interlaminar shear brittle fractures, and develops in the stratification of the medium-bedded mudstone. The weak intercalated layer in the mudstone is obvious, forming a continuous shear plane and exhibiting tectonic zoning. The

rock mass around the main shear plane has collapsed from shear failure with low-angle dip joints (Figure 16B).

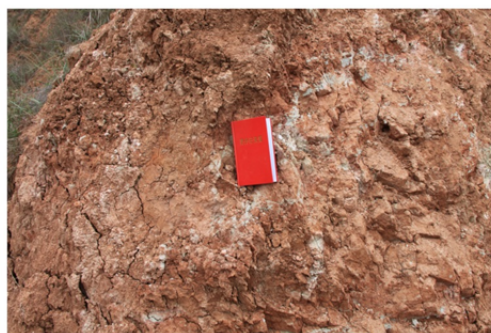
(C) Complete shear - shear scrambled zone

(C) Complete shear–shear mixed zone: in this type, the mudstone interlayer has undergone shear fracturing in a random tectonic setting with disordered joints and a disorderly argillized layer. Such disturbed shear fracture zones are usually formed by strong seismic forces (Figure 16C).

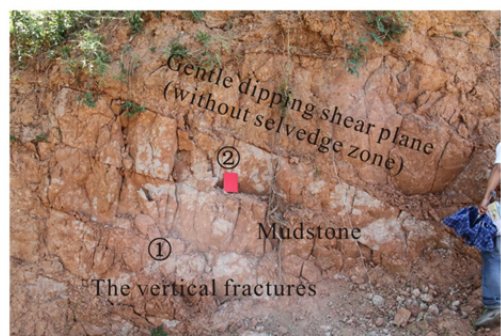
(D) Incomplete shear - fissure shear zone

(D) Incomplete shear–fracture shear zone: because of the boundary conditions and rock properties, a continuous, stable shear plane is not formed inside the interlayer. The shear displacement is not obvious and there are many joint fissures around the weak interlayer (Figure 16D).

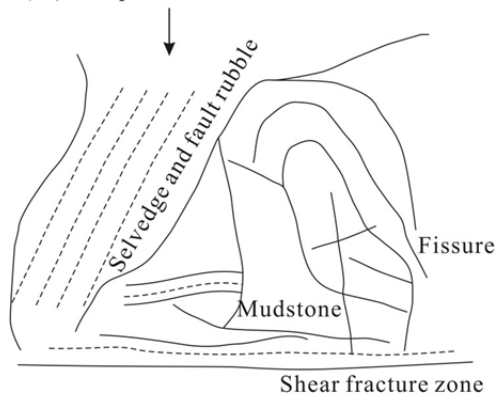
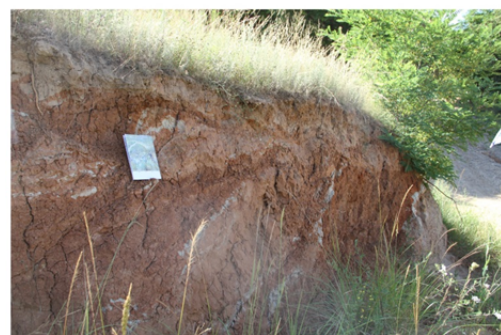
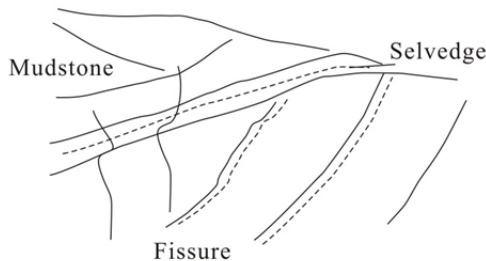
(E) Incomplete shear - fissure tracking shear zone

Figure 16 Shear zone characteristics in the study area.

(E) Incomplete shear–fissure tracing shear zone: this is a further development of (D). Under continuous shearing action, a wavy shear plane forms. Argillization can be observed locally, and tectonic zones are not obvious (Figure 16E).

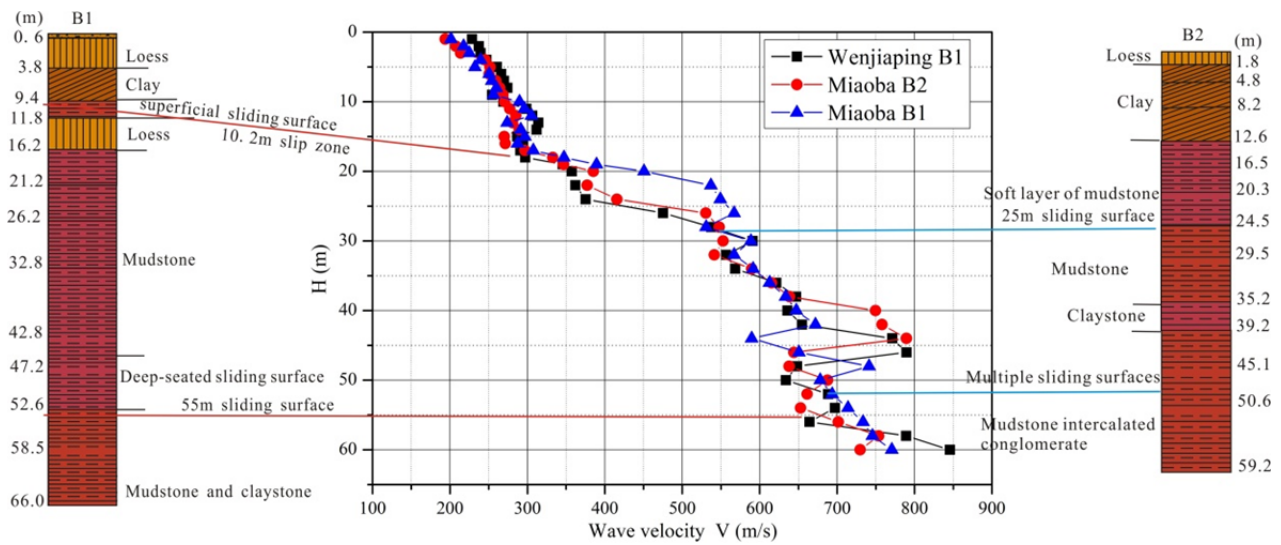
Figure 17 Borehole log of large-scaled landslide (Wenjiaping village, Tianshui, 2015).

As part of the field survey of the Miaoba landslide in the study area, boreholes were drilled and shear-wave velocity tests were conducted inside the borehole (Figure 17). The Miaoba

landslide is a loess–mudstone cutting landslide (Figure 6E). The shear-wave velocity corresponds well with the hardness of the rock and soil. The shear-wave velocity of the rock and soil in the

borehole increases with depth, reflecting the greater rock hardness with depth. The shear-wave velocity reveals the position of the sliding surface in the survey area. In the zone where the shear-wave velocity is abruptly reduced, the rock mass is weak, indicating the position of the shear surface. As shown in Figure 18, the shallow slip surface of the Miaoba landslide is located at depths of approximately 9.4–16.2 m, the mid-depth slip surface is at 25–35 m, and the deep slip surface is at 42.8–55 m.
