# Deformation mechanism and collapse treatment of the rock surrounding a shallow tunnel based on on-site monitoring

**Citation:** Qiu HZ, Chen XQ, Wu QH, et al. (2020) Deformation mechanism and collapse treatment of the rock surrounding a shallow tunnel based on on-site monitoring. *Journal of Mountain Science* 17(12). <https://doi.org/10.1007/s11629-020-6026-2>

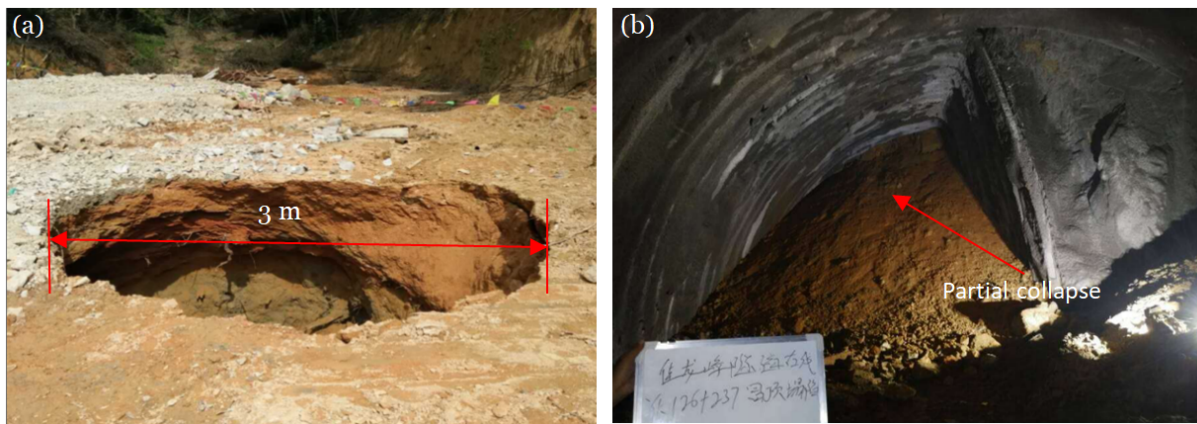
Figure 4 Collapse field of section YK126+237; (a) Tunnel roof fall. (b) Collapse of tunnel crown.

An advanced two-layered ductile support system was used in the construction of the shallowly buried section. The materials used in the initial supporting scheme were as follows: I20a steel arches with 0.6 m pitch spacing, twenty-five 3.5 m long hollow grouting anchors per ring with a 1 m × 0.6 m pitch spacing, and a 26 cm thick concrete layer. A 50 cm thick layer of reinforced concrete was used for the secondary lining. A vault collapsed 78 m from the right tunnel exit at 1:00 am on June 27, 2017, and the position of tunnel collapse is shown in Figure 2. Then, the vault continued to collapse intermittently. When the roof partially collapsed, it formed a circle with a diameter of 3 m in the ground at 16:00 on the same day, and the volume of the collapsed rock was

approximately 180 m<sup>3</sup>. The scene is shown in Figure 4.

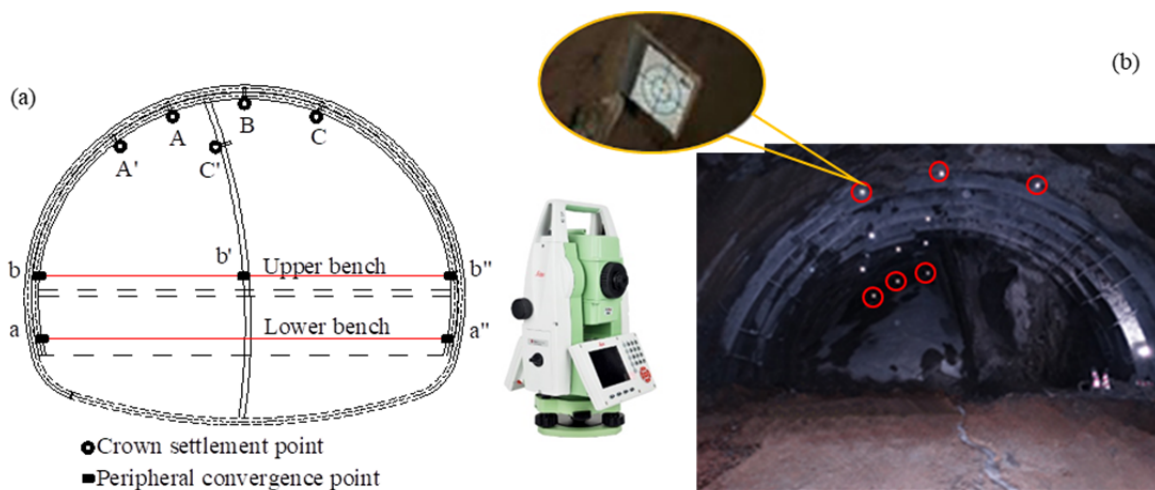
Figure 5 Layout of measuring points of tunnel deformation; (a) Layout of measuring points in transverse section. (b) In-site measuring points.

requirements of the engineering experience method, the interval of the monitoring section for vault settlement in the tunnel must be 5 m to 10 m (Q/CR 9218-2015; JTG F60-2009), and the monitoring sections of the surface and vault are arranged at the same mileage in the tunnel. One comparison section is set at chainage YK126+260, which is 16 m from the starting point of the shallow area. The corresponding surface settlement and vault settlement are represented by H1 and D1, respectively. Five monitoring sections are set at chainages YK126 + 244, YK 126 + 239, YK 126 + 210, YK 126 + 205 and YK 126 + 197 to monitor the deformation of the surrounding rock in the shallow tunnel. The corresponding surface settlement and vault settlement are represented by H2-H6 and D2-D6, respectively. The point layout is shown in Figure 3, and the point layout of the vault is shown in Figure 5. There are seven observation points in

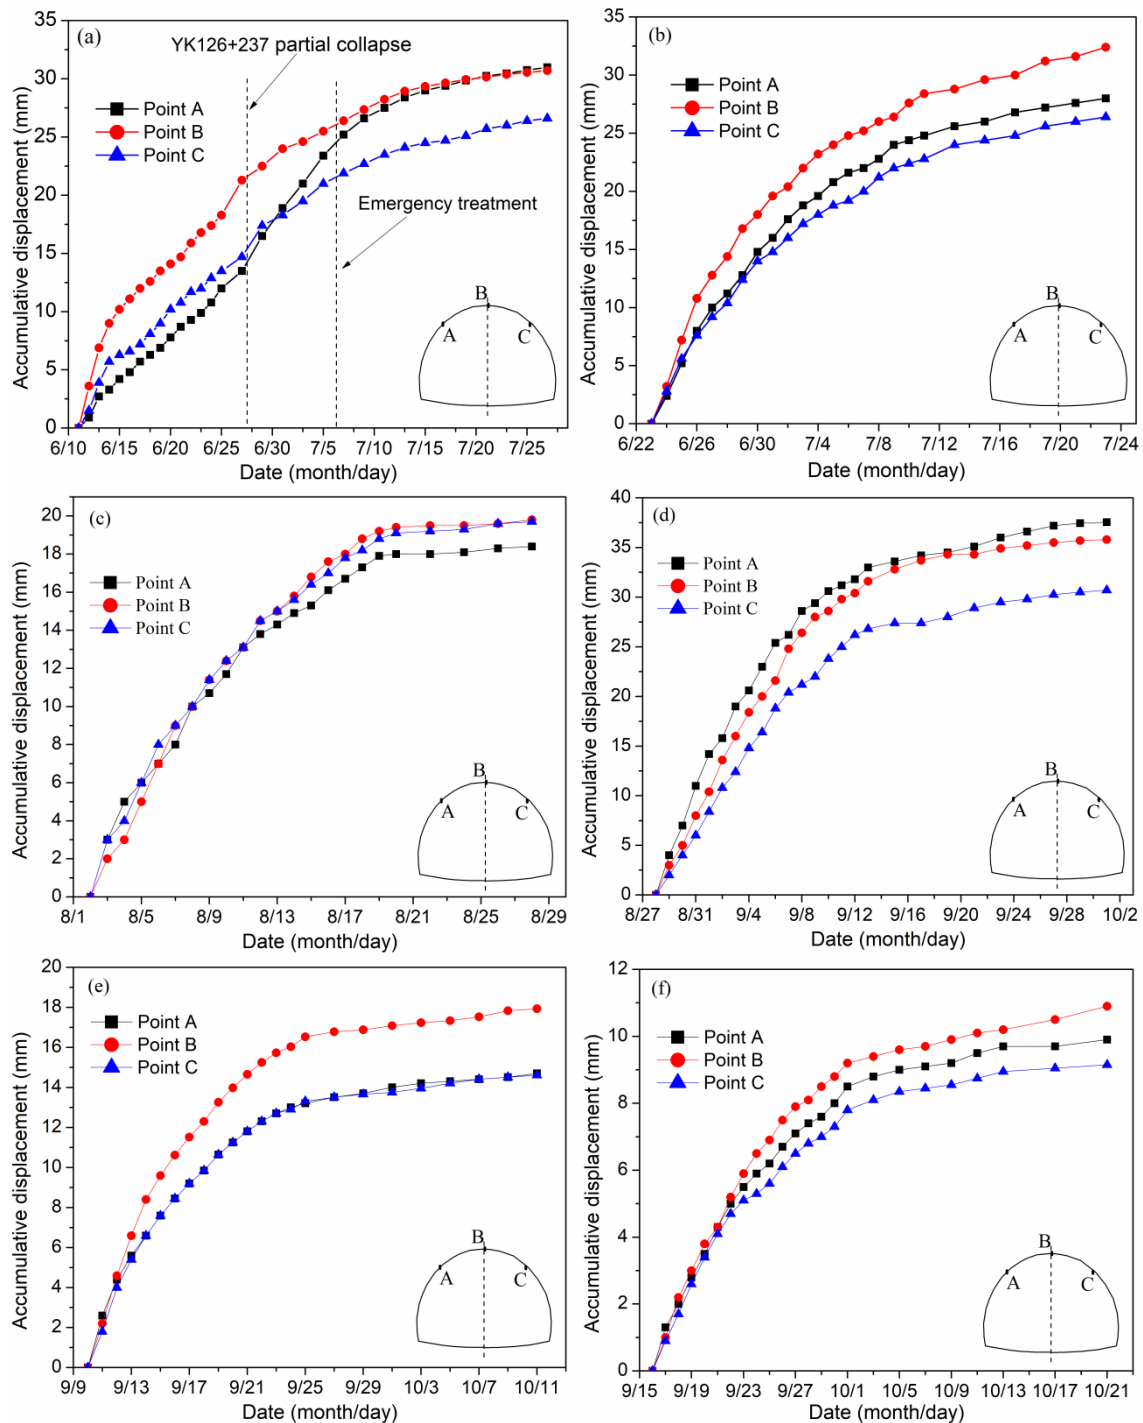
The cumulative vertical displacement and time curves of the six monitoring sections of the tunnel vault are shown in Figure 8. In this study, a majority of the monitoring sections exhibit the largest cumulative vertical displacement at point B in the vault center. When the collapse accident occurred, the maximum vertical displacement of monitoring section D1 was 21.3 mm, as shown in Figure 8 (a), and the maximum vertical displacement of monitoring section D2 was 12.8 mm, as shown in Figure 8 (b). In contrast, the reserved vertical displacement of the loess tunnel

vault was 700 mm to 800 mm (Lai 2015). The results of the monitoring data show that the maximum vertical displacement of the tunnel vault was 37.55 mm in the stable state of the surrounding rock, which exceeded the relative displacement limit of the primary support (Q/CR 9218-2015); only the vertical displacement of 10.9 mm in monitoring section D6 (Figure 8 (f)) did not exceed that of the surrounding rock.

Figure 8 (a) shows that the gradient of the displacement curve tends to decline after 20 June, indicating that the stability of the surrounding rock and support structure is increasing. However, the gradient of the displacement curve increases to a certain extent before the collapse of the tunnel, and the gradient of the displacement curve tends to decrease again until emergency treatment is taken. Compared with that in Figure 8 (a), the displacement curves of Figure 8 (b) to Figure 8 (f) show that the deformation of the surrounding rock is normal, which indicates that the support system used after disposal is effective.

**Figure 8** Accumulative vertical displacement and time curve of tunnel crown settlement; (a) Section YK126+260; (b) Section YK126+244; (c) section YK126+239; (d) section YK126+210; (e) section YK126+205; (f) section YK126+197.

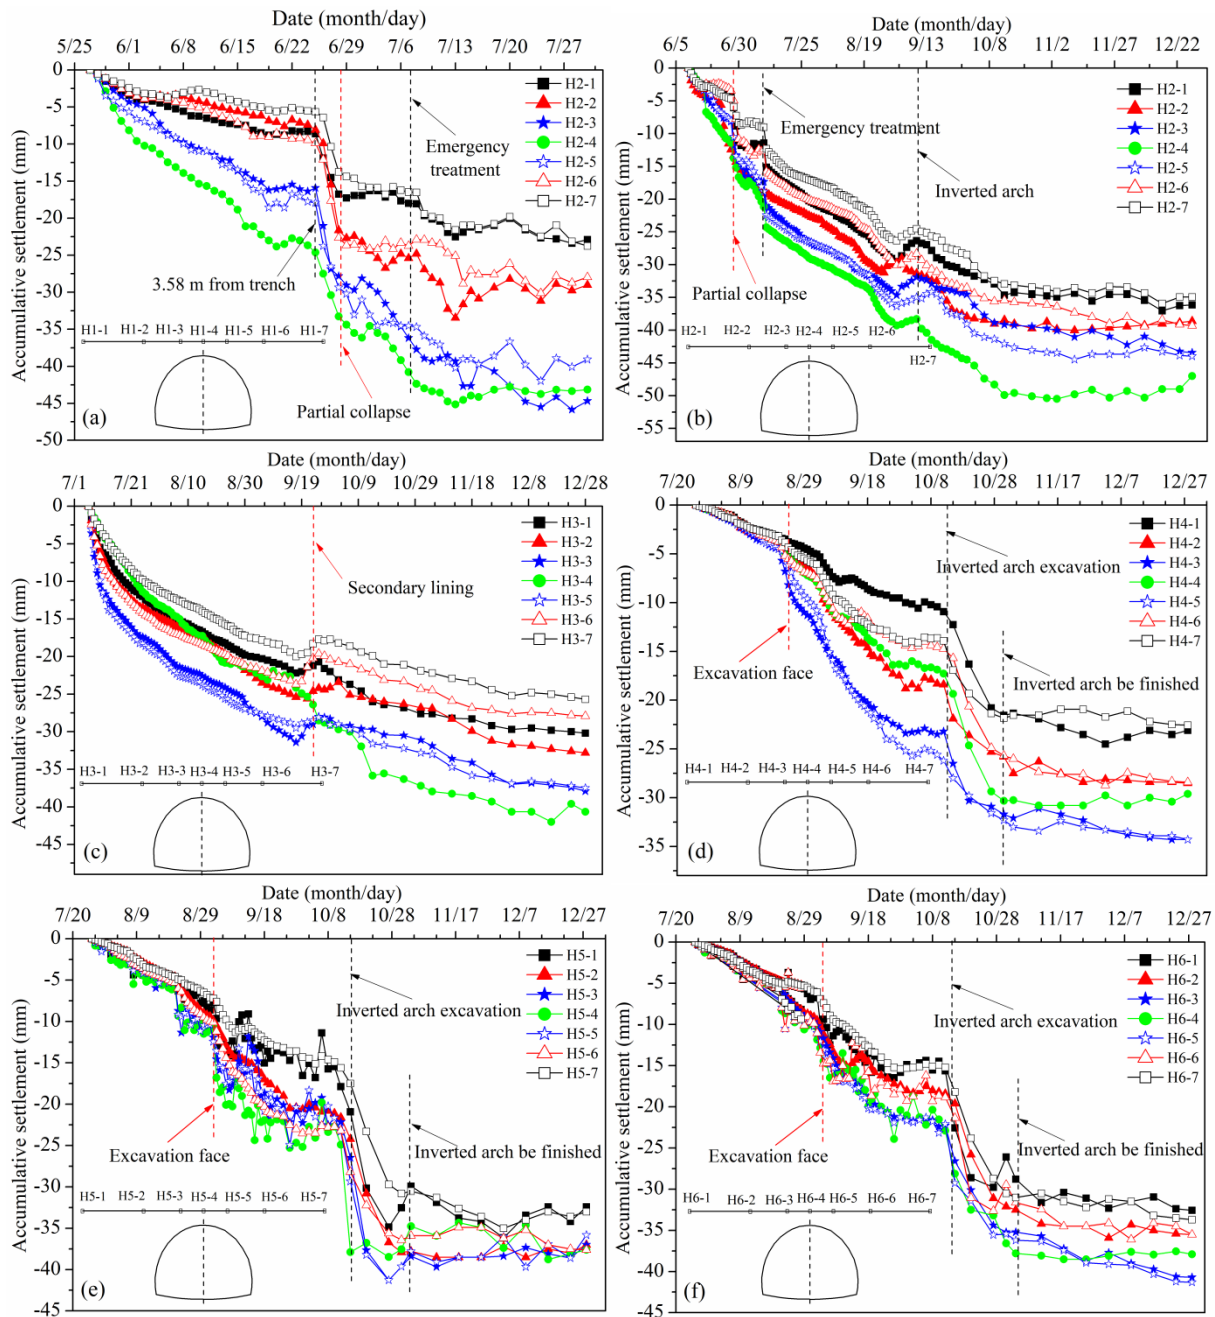
The monitoring instrument at H2, located at chainage YK126+244, was installed on 9 June 2017, and the curve shows that the surface settlement changed greatly with time until emergency treatment was taken. After that, the ground settlement increased uniformly until the invert construction was completed. The monitoring data

from H3 were collected after emergency treatment, and the previous data were lost, mainly because of the collapse of the ground above the tunnel. The cumulative settlement curve appears to be relatively smooth until the end of the construction of the secondary lining structure, and then the deformation of the surface decreases and gradually

**Figure 9** Surface settlements at seven observation points in section H1. (a) Section YK126+260; (b) Section YK126+244; (c) section YK126+239; (d) section YK126+210; (e) section YK126+205; (f) section YK126+197.

becomes relatively stable. In addition, the surface settlement-time curves show that the monitoring data of other sections were collected after reinforcement of the surrounding rock, optimization of the excavation method and strengthening of the support structure. The figures show that the surface settlement fluctuated slightly after the tunnel excavation, and the largest deformation occurred during the period of excavation from the inverted arch to the closed ring.

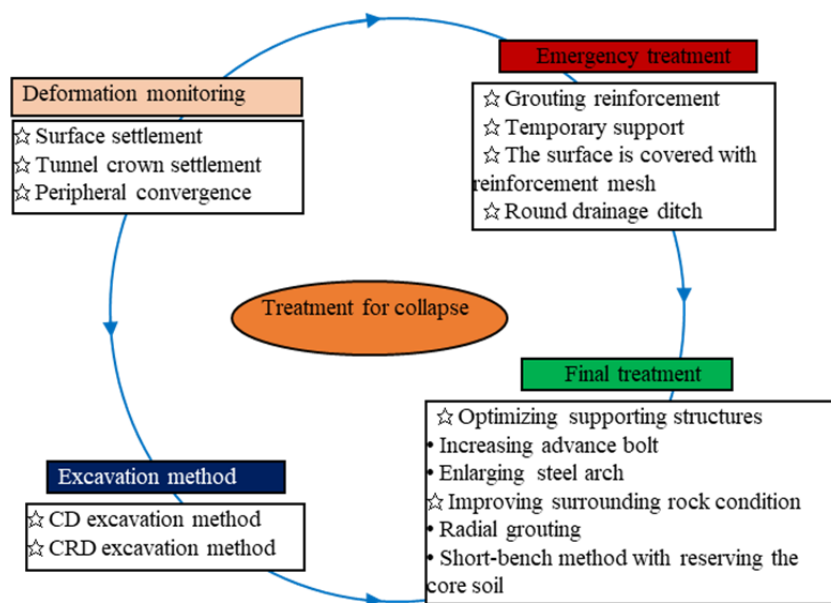
Figure 10 The scheme for treatment of collapse.

During excavation, once a collapse event occurs, measures should be urgently taken to avoid serious secondary disasters. The selection of the excavation method should be beneficial to the control of the surrounding rock deformation. In general, the CD excavation method and CRD excavation method have been shown to be effective in tunnel excavation in poor geological conditions. After excavation, the final treatment for collapse can be performed through two measures: increasing the bearing capacity of the support structures and improving the stability of the surrounding rock. Deformation monitoring of the rock surrounding a tunnel is important in the treatment of tunnel collapse. In the process of tunnel excavation, the monitoring data can show the deformation of the surrounding rock; by considering these data, engineers can implement effective emergency measures to prevent the tunnel from collapsing further and can then choose appropriate methods for further excavation and optimization of the support structure scheme. The treatment measures are shown in Figure 10.

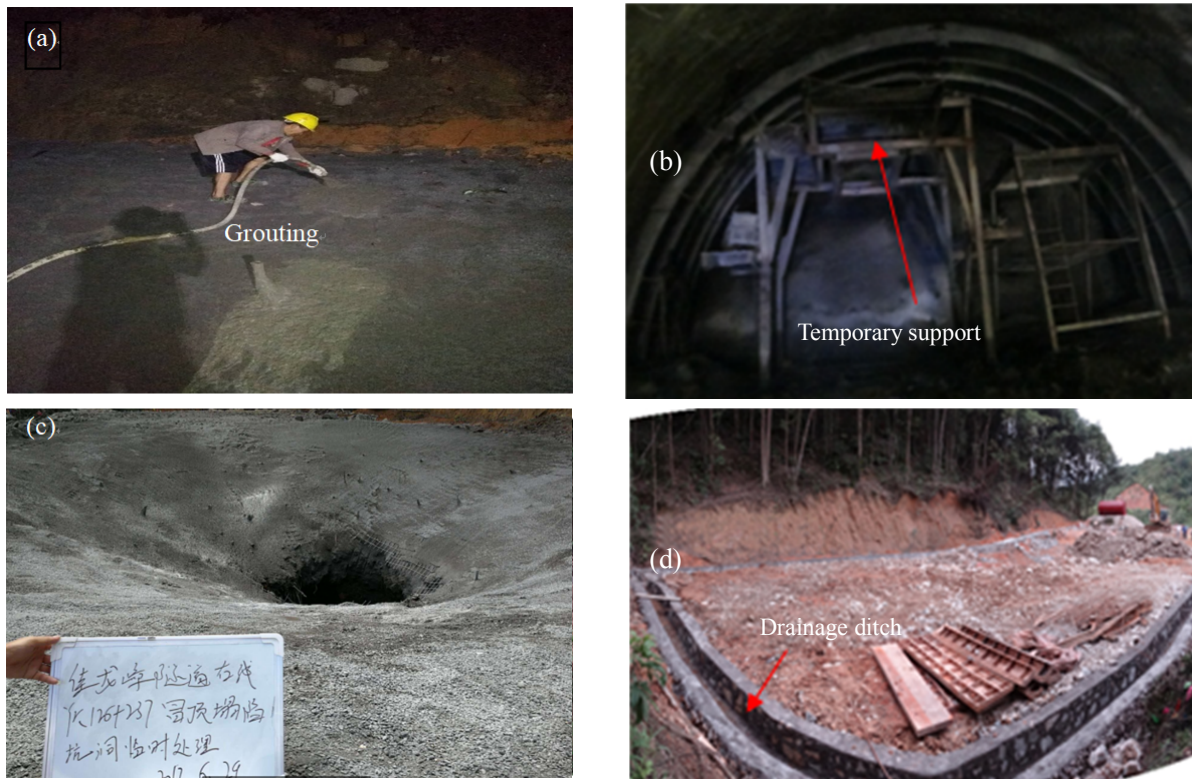
Figure 12 In situ photographs showing implementation of the countermeasures. (a) Grouting reinforcement; (b) Temporary support; (c) The surface is covered with reinforcement mesh; (d) Round drainage ditch.

This process started with the clearing of the loose soil around the roof collapse and the wall cavity. Steel mesh with an 8 mm diameter was hung in the cavity, and then a 20 cm layer of C25

concrete was sprayed to reinforce the surface. In the next stage, injection pipes were used to grout the rock around the cavity 5 m above the vault. In addition, efficient measures were required to reduce the impact of rainfall and groundwater on fractured rocks. In this case, some drains with dimensions of 60 cm×60 cm were dug, and a 26 cm thick layer of M7.5 mortar rubble was added around the cavity, as shown in Figure 11 and Figure 12. Next, residual material was backfilled on the tunnel face, and pipes with a 42 mm radius and 6 m length were inserted into the tunnel face with a 120 cm pitch spacing. A layer of C20 concrete 15 cm thick was applied to the backfilled surface in

the next step. Then, I20a steel arches were used for temporary support to control the deformation of the surrounding rock to a distance of 10 m from the tunnel face. The cavity 5 m above the vault was filled with C20 concrete, and the remaining part of the cavity was backfilled with the residual material and packed down.

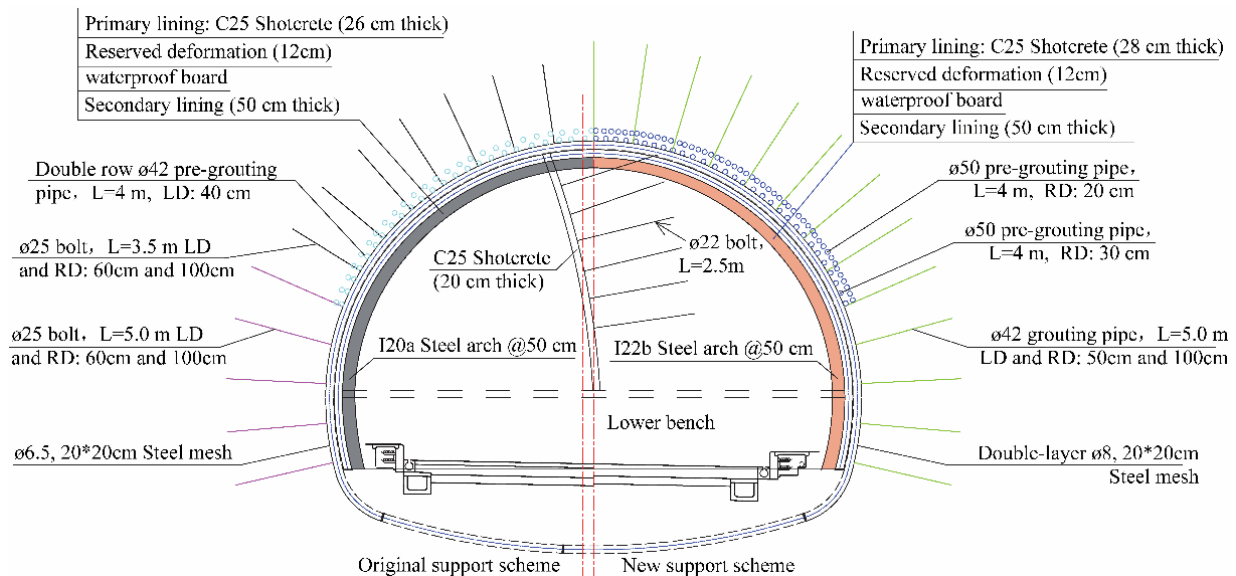
Figure 13 Sketch map before (left) and after (right) treatment. Note: in this figure, all units of diameter are written in mm; L represents length, LD represents lateral distance, RD represents radial distance.

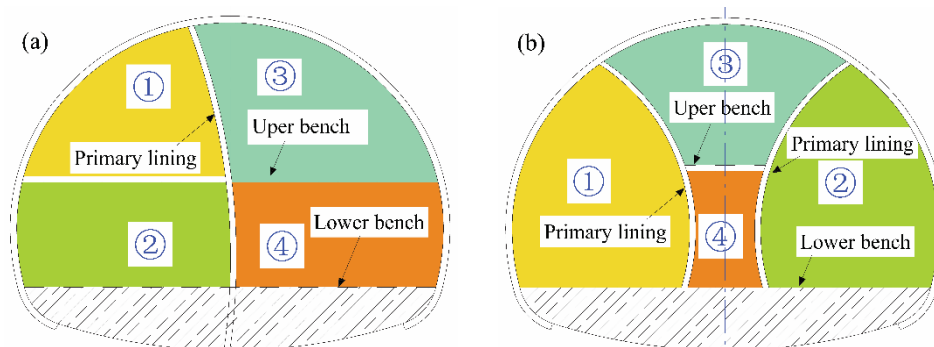
**Figure 14** Sketch of excavation method. (a) Center diaphragm excavation method; (b) Cross diaphragm excavation method.

In the chainages of YK126+244 to YK126+234, the CD excavation method was performed. During the excavation of the fractured surrounding rock, based on the bench method, the tunnel section was divided into left and right parts, and each part was excavated and supported to form an independent closed unit using the CD excavation method. The excavation of the tunnel surface was performed using the procedure shown in Figure 14a. The excavation methods were adjusted according to monitoring data and the properties of the surrounding rock. During the weak surrounding rock excavation process, the CRD method was used. In this case, both sides of the tunnel were excavated in a few steps so that the short bench and tunnel cross-sections were covered and supported by temporary inverted arches in each step. The last step in the process was to excavate the remaining rocks of the center section to maintain a soil core and reduce the deformation of these rocks, as shown in Figure 14b. In addition, the tunnel was excavated by workers and machines that removed 0.5 m of material in each working cycle. The inverted arch closely followed the lower bench with a length range of 3 m to 5 m and was closed in time to form a stable support system.
