## Mountain highway stability threading on the fragile terrain of upper Ganga catchment (Uttarakhand Himalaya), India

**Citation:** Sati SP, Sharma S, Kothyari GC, et al. (2022) Mountain highway stability threading on the fragile terrain of upper Ganga catchment (Uttarakhand Himalaya), India. *Journal of Mountain Science* 19(12). <https://doi.org/10.1007/s11629-022-7496-1>

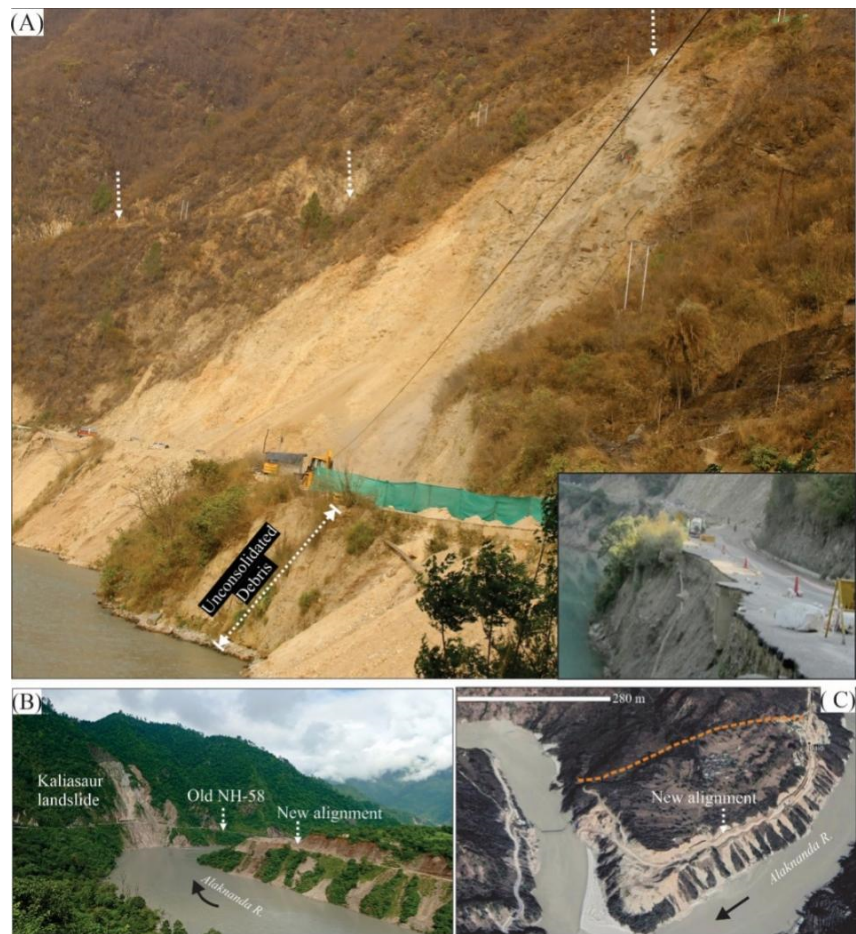
**Fig. 4** (A) Photograph of Pharsu landslide developed on highly sheared quartzite on NH-58. The white arrows indicate the new road alignment proposed before the commissioning of the road which was not completed. The subsidence and lateral erosion of NH-58 caused due to the Reservoir Drawdown effect near the Srinagar hydropower dam (shown in the inset). (B) The chronic landslide of Kaliyasaur could not be treated despite several engineering measures over the years and had to be bypassed. (C) Google imagery of the newly aligned NH-58 built on unconsolidated fluvial terrace gravels indicates the new road's susceptibility to subsidence and toe erosion. Field investigations indicate that the road alignment above the village over solid bedrock (orange dashed line) would have been safer.

A small segment (<0.5 km) of the NH-58 is suffering from a combination of landslide and road subsidence (Fig. 4A). The landslide is in the vicinity of

This is one of the oldest landslides in sector-3 (NH-58) which is comparable with the Bisoriya landslide in sector-1 (NH-125). The landslide is developed on highly sheared and fractured quartzite rocks of varying composition, shale, and variably weathered metavolcanic (Velayudham et al. 2021). Shearing of the rocks can be ascribed to the presence of NAT and the local Kaliyasaur fault. Archival data indicate that the landslide was initiated in 1920, whereas a major rock fall blocking the Alaknanda river occurred on 19th September 1969 (<http://www.crridom.gov.in/content/documentary-kailasaur-landslide>). Since then, the landslide remained intermittently active, for which besides the geological and geomorphological causes, the repeated back-cutting (essential for restoring the road width) could be a potential trigger (e.g., Jangpangi et al. 2019; Singh et al. 2017). Repeated efforts made to prevent this landslide failed which finally compelled the road building department to bypass this landslide by constructing a new road along the right bank of the Alaknanda river on fluvial terrace gravels which, unfortunately, is also prone to subsidence (Figs. 4B and 4C).

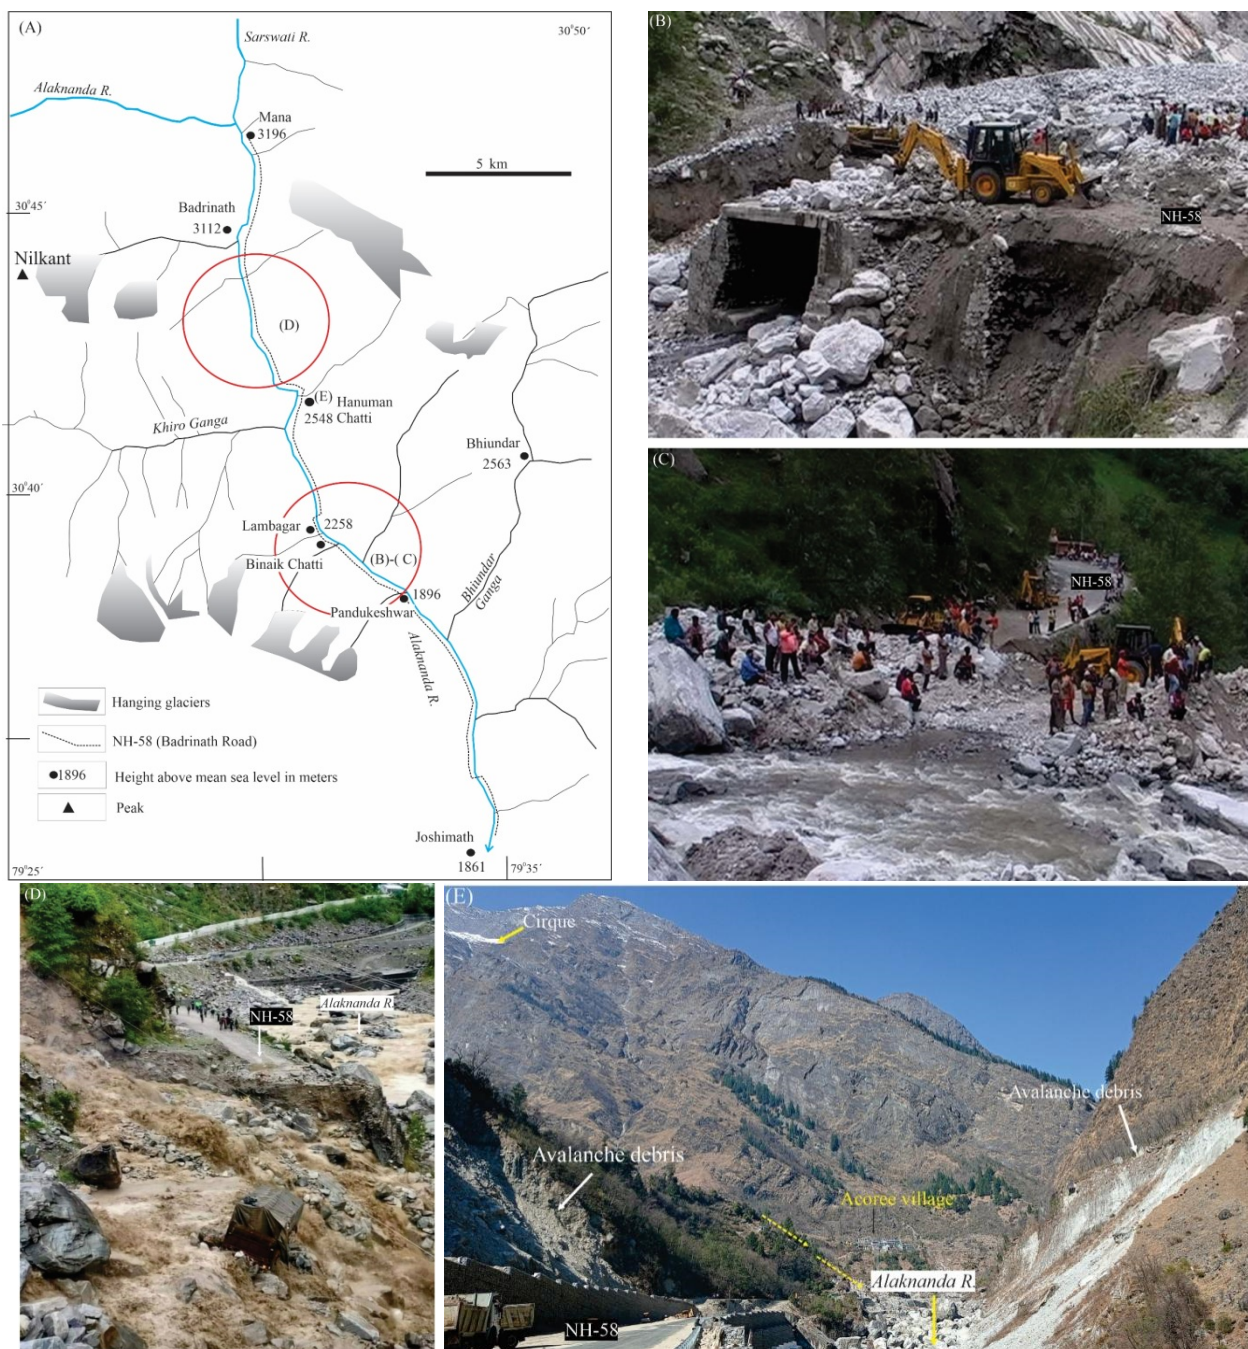
**Fig. 6** (A) Geomorphological map of sector-3 between Binayak Chatti and Lambagar showing many hanging glaciers. Glacial erosion generates (para)glacial sediments in the valleys which frequently damage the road. For example, (B) and (C) show the damaged NH-58 near Binayak Chatti after the summer rainfall of 2009. (D) On 21st May 2021 NH-58 was completely washed away near Lambagar by paraglacial sediments transported by a glacial-fed stream Khiro Ganga (E) A new buttress wall near Binayak Chatti was built recently to protect the road which was frequently damaged by the mobilization of unconsolidated para glacial sediment particularly during monsoon season. Height above mean sea level and village name (black dot) and peak (black triangle) are also marked.

paraglacial zone (discussed below) wherein in a stretch of <10 km, four glacial-fed streams meet the Alaknanda River from the north-western flank (Fig. 5B). The slopes are very steep and covered with highly porous old landslides and unconsolidated avalanche debris, which readily get saturated during the spring melting of snow and summer rainfall. Although debris-laden slopes make road widening relatively easy, stabilization of the vertical cut faces of unconsolidated sediment is extremely challenging. The area also experiences frequent snow and debris avalanches. For example, a glacial-fed stream near Lambagarh (between the Acoree and Pargasi villages), frequently transports debris and snow avalanches. These avalanches are generally generated from poorly defined cirques and many times have damaged the villages and NH-58, besides obstructing the Alaknanda River (Figs. 6A to 6E). One such avalanche, considered to be the largest since 1948, occurred on 14<sup>th</sup> April 1983 and was triggered from a cirque located on the north-western slope (Fig. 6E). It destroyed houses, road and temporarily obstructed the Alaknanda River at Lambagarh (Bhatt et al. 1985). In addition to this, a sudden surge in the debris-laden meltwater discharge from glacial-fed streams frequently destroys the road and culvert as happened recently during May 2021 (Fig. 6D). In view of the threat posed by the debris flow and landslide, ~200 m long buttress wall was constructed to protect the NH-58 in this area (Fig. 6E).

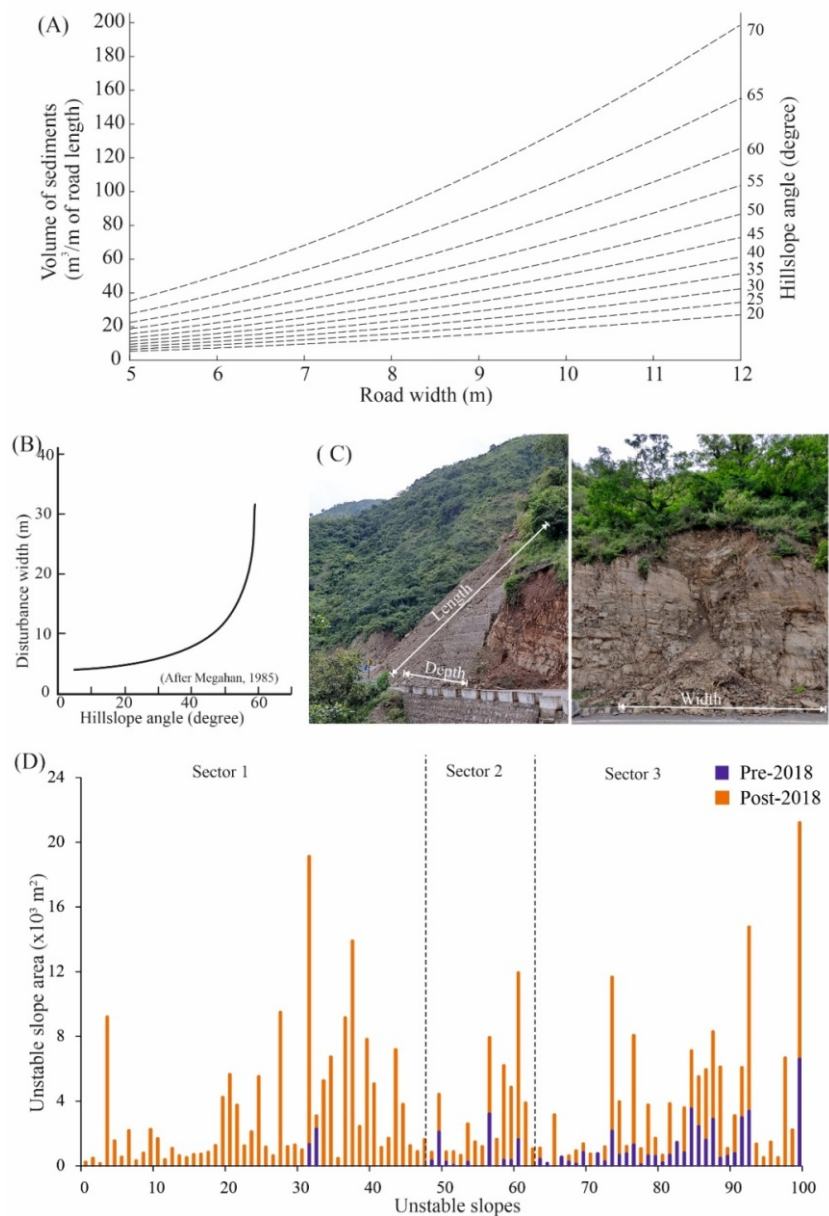
**Fig. 7** (A) The graph shows an exponential increase in the volume of sediment generated on steeper and wider roads. (B) The road width disturbance (collateral damage) concerning slope increases abruptly after 30 degrees (Megahan 1985). (C) Field photographs of debris flow measured along the NH-58 in September 2021 (post-monsoon). The attributes used for volume calculation are marked. (D) A comparative plot for pre- and post-2018 major road widening project showing landslide area estimated for ~100 locations in all the three sectors. A significant increase is seen both in the number and extent of the unstable slope activity.

It is observed that the extension of hillslope disturbance due to road width exponentially increases with the slope angle. Also, the sediment output shows a strong dependency both on the slope angle and road width. The graphical presentation of the data shows a significant increase in the volume of rock mass for an increase of each meter width of the road. The increased curve (70°) is characterized by the power trend line ( $y=1.3737x^2$ ) that indicates an increase in volume with a specific rate or we can say that the volume of excavated rock mass is directly proportional to the square of the width of the road. For example, in less steep slopes (between 20° and 30°) there is not much increase in sediment yield irrespective of road width (within 40 m<sup>3</sup>/m; Fig. 7A; Appendix 5). However, as the slope increases (>30°) there is an exponential increase in the sediment yield

with increasing road width, which in turn would also increase the width of disturbance. According to Megahan (1985), the total width of disturbance by a road 4 m wide increases from about 7 m on a 40° slope to 16 m on a 60° slope; on a 65° slope the width increases to 32 m and so on (Fig. 7B).

The instability of slopes is indicated by an increase in the number and area of post-2018 active hillslopes, which have exponentially increased in comparison to pre-2018 imageries (Table 1; Appendix 7; Fig. 7D). The increase in the area is owing to the generation of fresh landslides/debris flows as well as an increase in the area/number of existing minor landslides/debris flows (Fig. 7D). Further, due to muck dumping from the excavation on the forested slopes, the initiation of debris flows on forested slopes was also observed, which remains unaccounted for in the present study.

We observed a positive correlation between the increase in valley slope and sediment yield (Fig. 7A). Similarly, the unprotected and untreated cut slopes along the road may not only lead to significant sediment contribution but also create chronic landslide zones along the highway. Another major threat to the roads is the flash floods induced by the bursting of landslide-dammed lakes, which are common in the terrain (Wasson et al. 2008; 2013; Rana et al. 2013; Sundriyal et al. 2015). Also, high-magnitude flash floods in the Higher Himalayas are often initiated from the paraglacial zones. Such floods are the major culprit for the destruction of roads, such as the July 1970 Alaknanda flood, August 2012 Asi Ganga flood, June 2013 Mandakini flood, April 2021 Rishi Ganga flood, and May 2021 Lambagarh flood. Therefore, it is important that road alignment takes into consideration the likely inundation caused during extreme weather events in the Himalayas. Besides the historical flood records (Wasson et al. 2013), the projected increase in the magnitude and frequency of Himalayan flash floods due to rising global temperature (Sabin et al. 2020) must be accounted for before any widening or re-alignment.

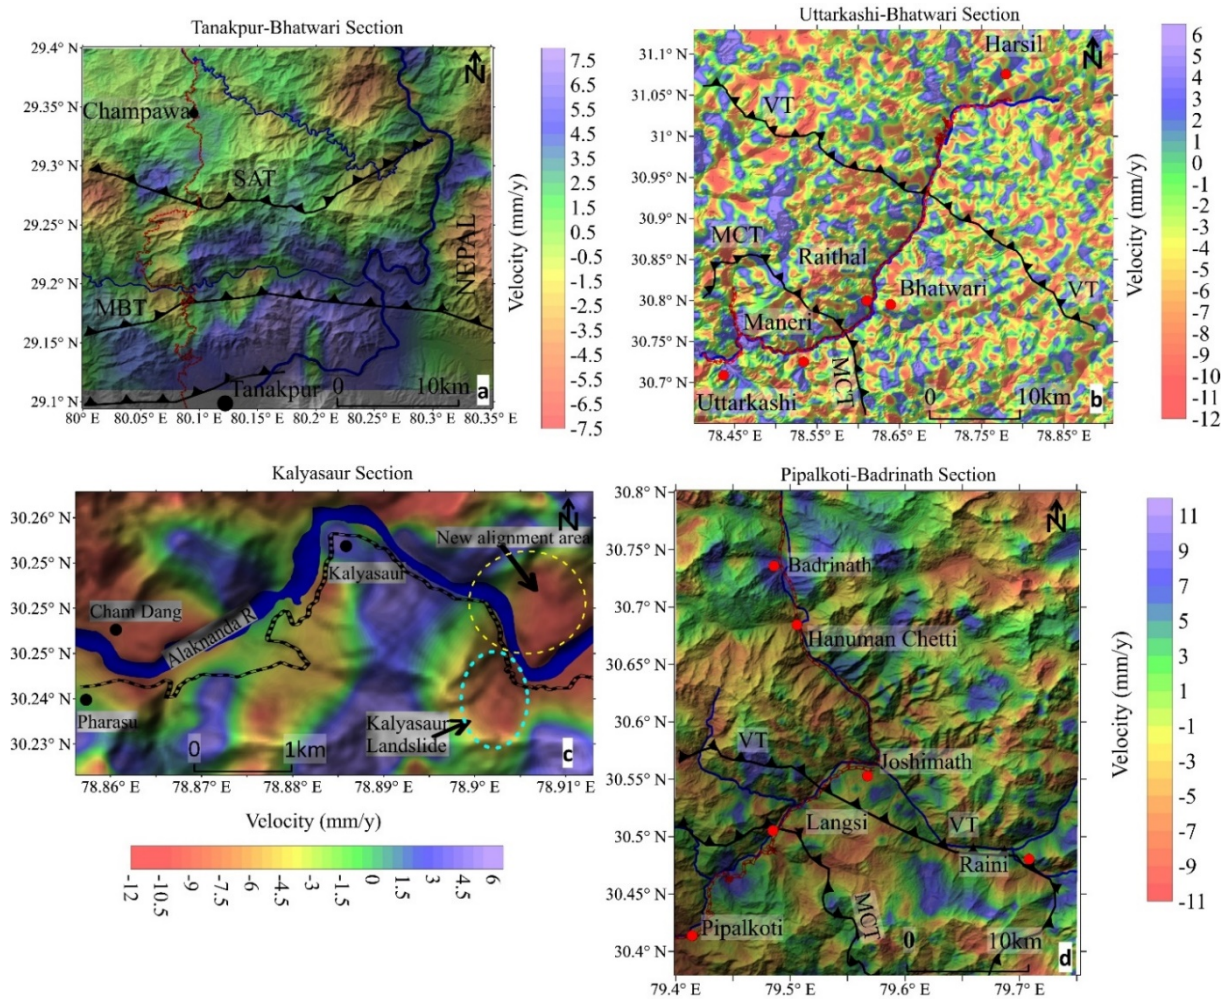
**Fig. 8** The panels show PSInSAR base Line of Sight (LOS) mean surface deformation velocity in (A) sector-1 for the Tanakpur-Champawat segment, and (B) sector-2 for Uttarkashi and Harsil, Bhagirathi valley. For sector-3 (C) in Pharasu and Kalyasaur segment, Alaknanda valley, where Kalyasaur landslide shows clear subsidence (cyan ellipse) along with re-aligned road cut (yellow ellipse); (D) Pipalkoti-Joshimath-Badrinath, the values vary upto  $\pm 11$  mm/year. SAT- South Almora Thrust, MBT-Main Boundary Thrust, MCT-Main Central Thrust, VT-Vaikrita Thrust.

In sector-1 (between Tanakpur and Champawat), the road cuts across the major thrusts HFT and South Almora Thrust (SAT). In this sector (Fig. 8A), the average rate of change in the surface elevation is  $\pm 7$

mm/yr with ~52% area showing positive velocity and the rest showing negative velocity. The high positive velocity segment is located between the HFT and MBT whereas, low to negative velocity is observed around Champawat and in the vicinity of the road,
