The Fatigue and Fracture Resistance of a Nb-Cr-Ti-Al Alloy

D.L. DAVIDSON and K.S. CHAN

The microstructure, fatigue, and fracture behaviors of a cast and heat-treated Nb-Cr-Ti-Al alloy were investigated. The microstructure of the cast alloy was manipulated by annealing at a temperature ranging from 500 °C to 1500 °C for 1 to 24 hours. The heat treatment produced Cr₂Nb precipitates along grain boundaries in all cases except in the 500 °C heat-treated material. Fracture toughness tests indicated low fracture resistance in both the as-cast and heat-treated materials. Fatigue crack growth tests performed on the 500 °C heat-treated material also indicated a low fatigue crack growth resistance. Direct observations of the near-tip region revealed a cleavage-dominated fracture process, in accordance with fractographic evidence. The fracture behavior of the Nb-Cr-Ti-Al alloy was compared to that of other Nb-Cr-Ti alloys. In addition, theoretical calculations of both the unstable stacking energy (USE) and Peierls–Nabarro (P–N) barrier energy are used to elucidate the role of Al additions in cleavage fracture of the Nb-Cr-Ti-Al alloy. The results indicate that an Al alloying addition increas

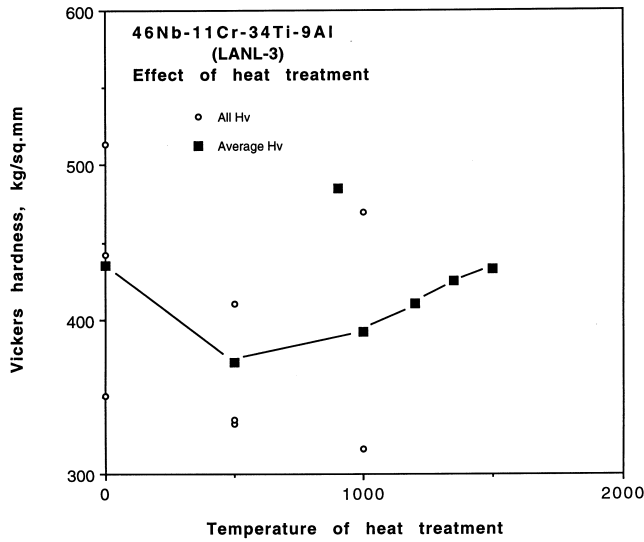
Fig. 2—Hardness vs. heat-treatment temperature for the 46Nb-11Cr-34Ti-9Al alloy, designated as LANL-3. Each data point represents the average of ten hardness readings.

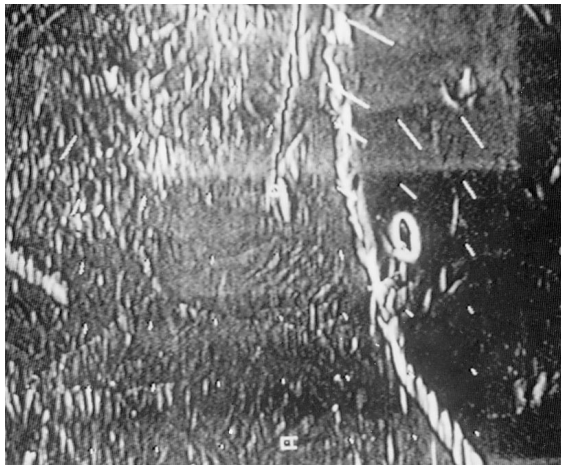
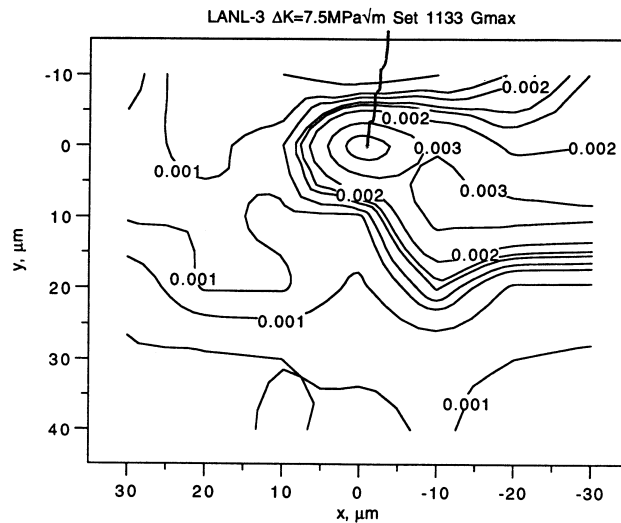
Fig. 6—Fatigue crack growth through LANL-3 at $\Delta K = 7.5 \text{ MPa}\sqrt{\text{m}}$, approximately parallel to a grain boundary and $12 \mu\text{m}$ from it. Microanalysis indicated that the grain on the right was deforming easier than the grain containing the crack tip.

Figures 6 through 8 show micromechanical analyses of the crack region at two interesting locations. The analysis shown in Figure 6 is for a crack growing approximately parallel to a grain boundary. Apparently, the grain on the right-hand side is more-favorably oriented for slip; thus, the plasticity within that grain is greater than in the grain containing the crack. The crack tip seen in Figure 7 is at

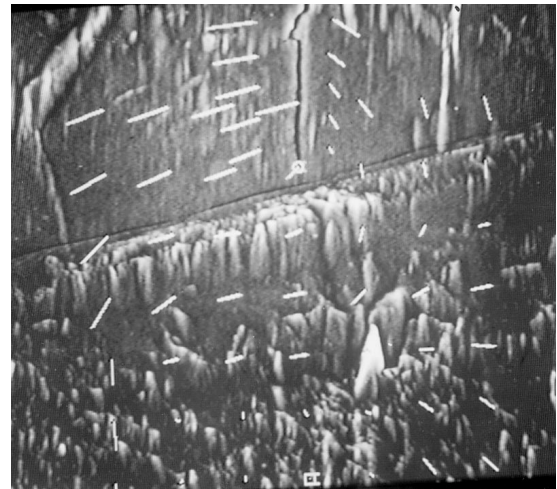
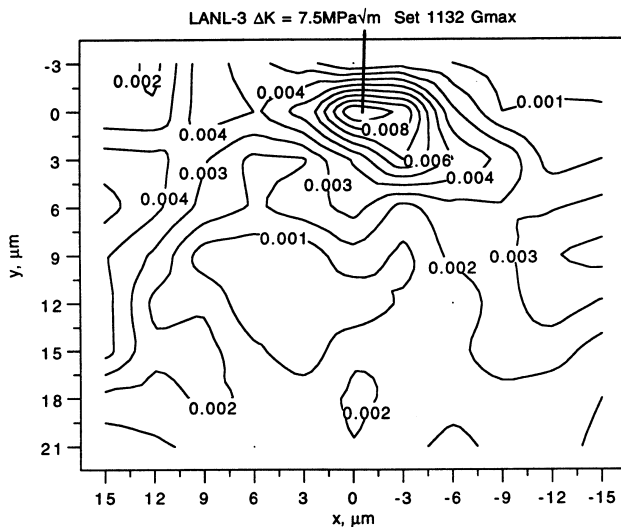
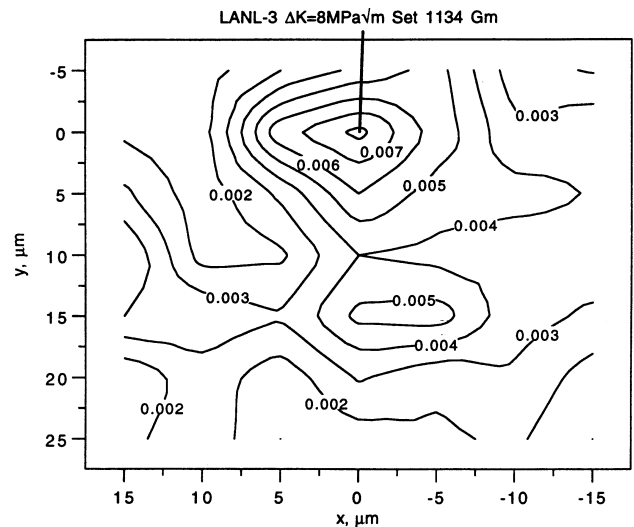
Fig. 7—A more detailed analysis of the crack tip shown in Fig. 6. A shear band emanates from the crack tip on the right side.

Fig. 8—Fatigue crack growth through LANL-3 at $\Delta K = 8.0 \text{ MPa}\sqrt{\text{m}}$. The crack tip is approximately $2 \mu\text{m}$ from a grain boundary, and the crack is growing nearly perpendicular to it. There appears to be a crack parallel to the grain boundary; however, it did not open when the specimen was loaded. Microanalysis indicated that the strain distribution was disrupted by the differences in slip characteristics between the two grains.

the same location, but the analysis is at higher resolution, showing that within the grain containing the crack tip, the strain distribution is relatively smooth, with two shear bands emanating from the tip at high angles to the direction of crack growth, which is typical for a blunted crack tip. The grain boundary does not appear to cause a disturbance in the strain distribution.

The crack tip in the analysis shown in Figure 8 is within

2 μm of a grain boundary that is about 80 deg to the direction of the crack growth. Stereoimaging indicated that what appears to be a crack parallel to the grain boundary was not opening due to the applied load. However, the misorientation of slip systems between the two grains has affected the distribution of strain much more than shown in the other samples.

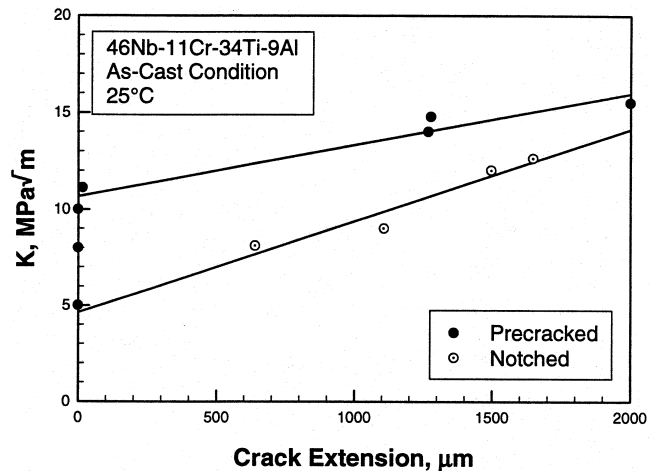
Fig. 12— K -resistance curves of 46Nb-11Cr-34Ti-9Al.

The fracture-toughness values for several microstructures of the LANL-3 material are listed in Table II. The K_R resistance (K_R) curves for the as-received material are shown in Figure 12 for notched specimens with and without a fatigue precrack. The two K_R curves show that the onset of crack extension occurred at low K values (5 to $11 \text{ MPa}\sqrt{\text{m}}$) with moderate slopes, indicating that the material is brittle and that plastic flow at the notch root is limited. For the cracked specimen, the onset of crack extension occurred at $11 \text{ MPa}\sqrt{\text{m}}$. The fracture resistance increased to $14 \text{ MPa}\sqrt{\text{m}}$ with a crack extension of $\approx 1300 \mu\text{m}$. At

$14.8 \text{ MPa}\sqrt{\text{m}}$, the crack propagated and caused ultimate fracture at $\approx 15.5 \text{ MPa}\sqrt{\text{m}}$. For the notched specimen, crack initiation occurred at a K level that is less than $8 \text{ MPa}\sqrt{\text{m}}$, and the fracture resistance increased with crack extension to $\approx 12.6 \text{ MPa}\sqrt{\text{m}}$ at the onset of ultimate fracture.

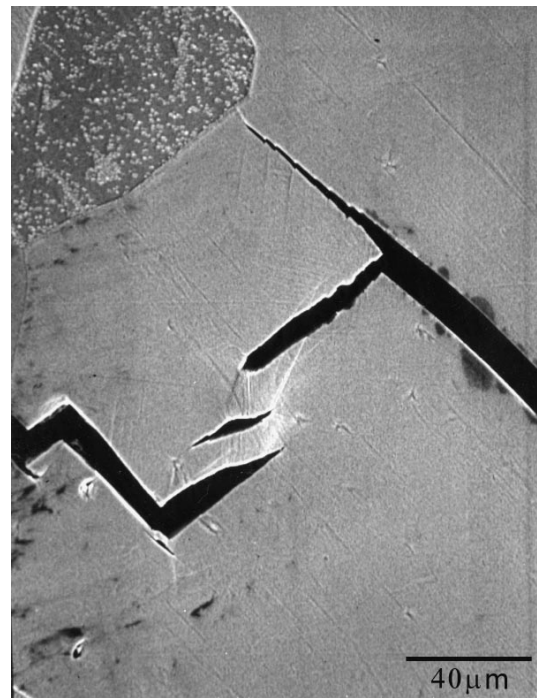
Fig. 14—(a) and (b) Plastic deformation in a ligament located between two parallel cleavage cracks. The crack-wake ligaments are responsible for the resistance-curve fracture behavior.

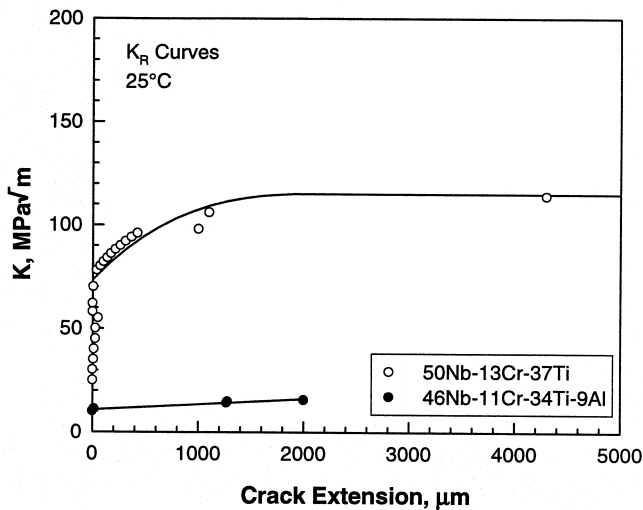
Fig. 17—A comparison of the K -resistance curves of Nb-Cr-Ti-Al and Nb-Cr-Ti solid solution alloys.

A comparison of the fracture-resistance curves of the Nb-Cr-Ti-Al and Nb-Cr-Ti solid-solution alloys is presented in Figure 17, which indicates that the Nb-Cr-Ti-Al alloy is less fracture resistant than the Nb-Cr-Ti alloy. In particular, the plane-strain initiation toughness of the Nb-Cr-Ti alloy is reduced from 34 to 14 $\text{MPa}\sqrt{\text{m}}$ with a 9 at. pct Al addition. The present result is consistent with the fracture toughness of 23 $\text{MPa}\sqrt{\text{m}}$ reported for Nb-40Ti-10Cr-10Al.^[3,16]
