An Examination of the Tin Pest Phenomenon Over a 10-Year Period

Abstract

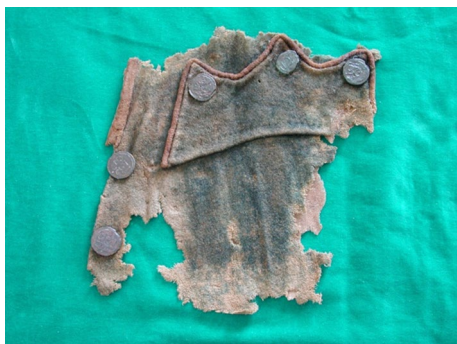
Fig. 1 Fragment of Napoleon's army soldier uniform. Photo credit: Dr. Rimantas Jankauskas, Vilnius University.

of 1867 were reported to have completely disintegrated.⁴ Tin pest has even generated its own urban myth: namely that Napoleon's defeat in Russia has been blamed in part on the disintegration of tin buttons on the soldier's uniforms, thereby reducing their effectiveness in cold weather. Documented archeological evidence has shown that the soldier uniform buttons were actually composed of pewter, copper, or brass and the officer uniform buttons were either silver or gold (Fig. 1).⁵ The regimental uniform records have no documentation of tin buttons, thus disproving the myth.⁶

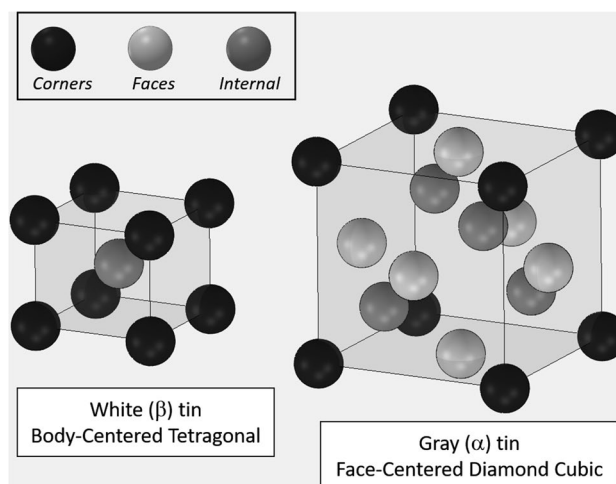
Fig. 3 Tin allotropic crystallographic structures.

Tin pest is caused by an allotropic transformation, which is the occurrence of an element in two or more crystalline forms. Six elements are known to exhibit allotropic transformations at one atmosphere of pressure and in the temperature range of -40°C to $+60^{\circ}\text{C}$: carbon, cerium, phosphorus, sulfur, yttrium and tin.¹⁰ The tin allotropic transformation is from β -tin (“white” tin, metallic, body-centered tetragonal crystallographic lattice) into α -tin (“gray” tin, semiconducting, face-centered diamond cubic lattice) and occurs at or below 13.2°C . Figure 3 illustrates the crystallographic structure differences between the α -tin and β -tin.

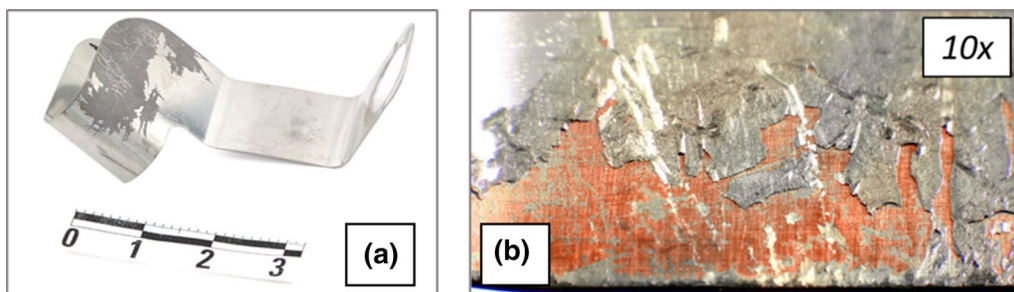
Fig. 2 Tin pest on an international space station ground strap bracket; (a) full strap, (b) close-up view. Photo credit: NASA.⁹

In 2019, tin pest was reported on the international space station.⁹ The tin pest was located on a tin-plated copper beryllium grounding strap bracket (Fig. 2).

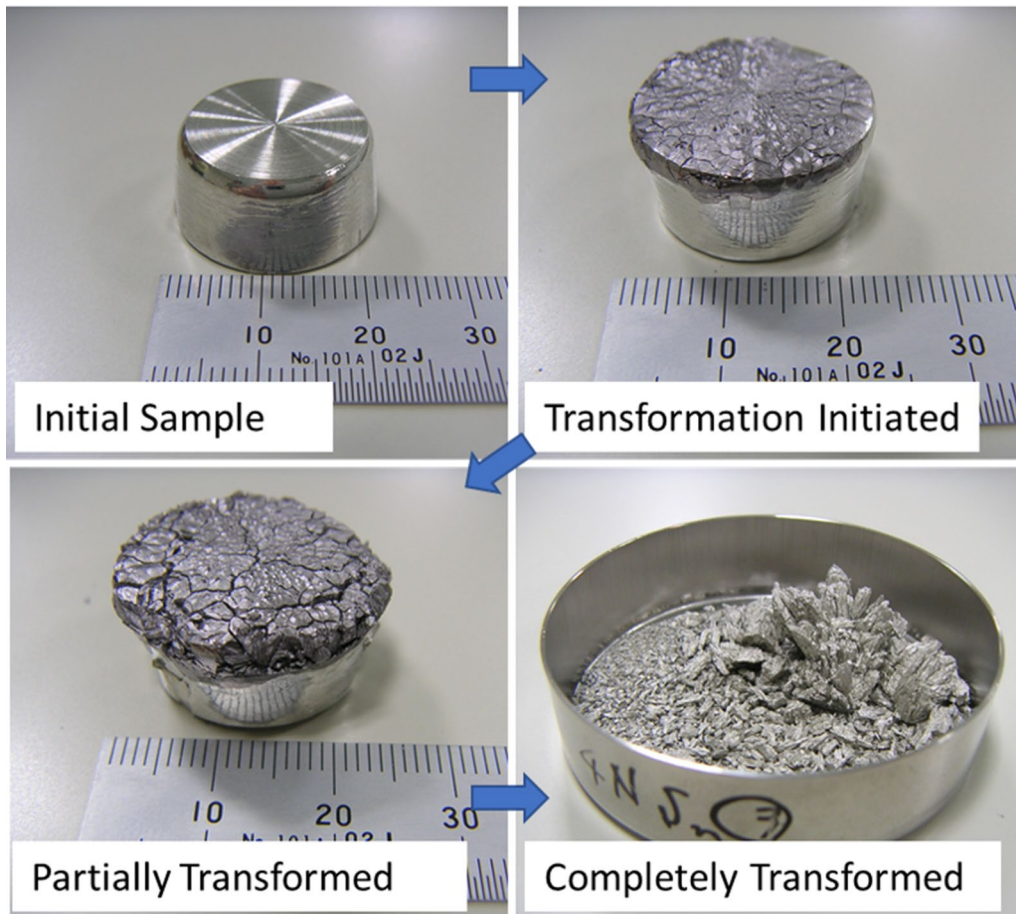
Fig. 4 Tin pest transformation example reprinted with permission from K. Sweatman.¹²

This large volume change causes the naturally brittle gray tin to transform into a powder. Figure 4 illustrates the tin pest allotropic transformation.¹² Tin's maximum allotropic transformation rate occurs around -40°C .¹¹

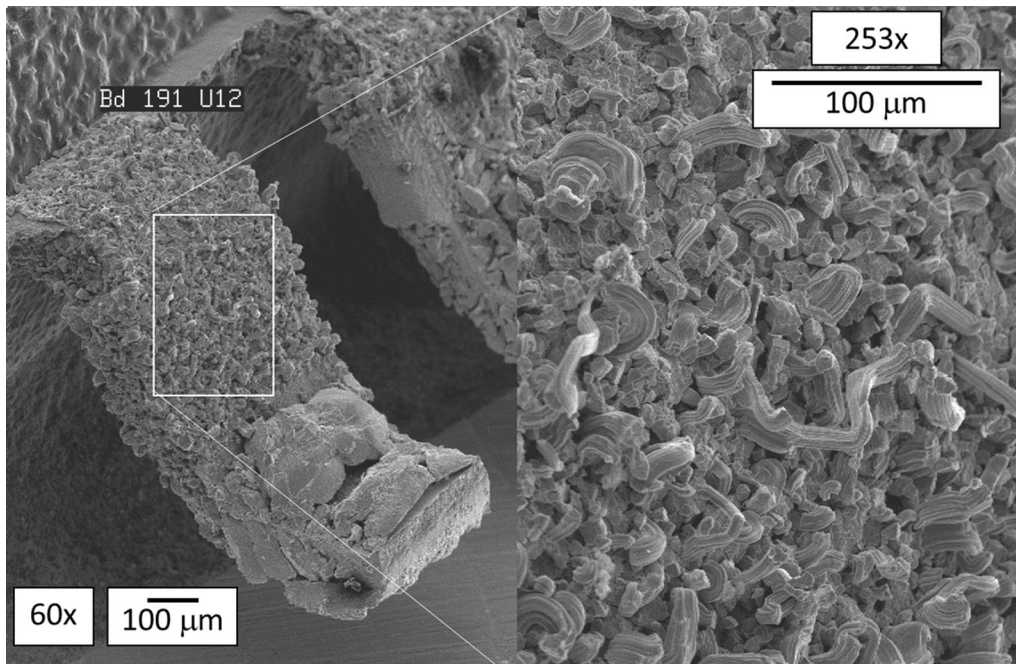
Fig. 5 Tin whiskers on a TSOP component.¹⁵

Industry investigations have documented another important crystallographic phenomenon associated with tin: the formation of tin whiskers.¹³ Tin whiskers are single crystal filament structures that extrude from tin surfaces and can cause electrical failure of printed wiring assemblies. Other metals such as zinc and cadmium have also been shown to produce whiskers.¹⁴ The specific root cause parameter set that induces whisker growth is not yet fully understood by the electronics industry. Figure 5 illustrates tin whiskers on a pure tin surfaced finished component. Pure tin materials are defined as tin plating or solder alloys that contain a minimum of 99% tin and 1% of other constituents. Tin whiskers and tin pest phenomena are both related to pure tin materials and have therefore received considerable attention over the past two decades due to the transition to lead-free electronics. However, it is important to recognize that tin pest and tin whiskers are due to two completely different mechanisms. Tin pest is the result of a well-understood change in the

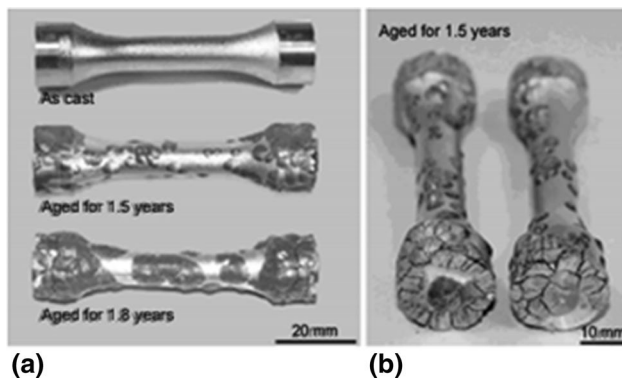
Fig. 6 Tin pest allotropic transformation on bulk solder samples, reprinted with permission from Plumbridge.¹⁷

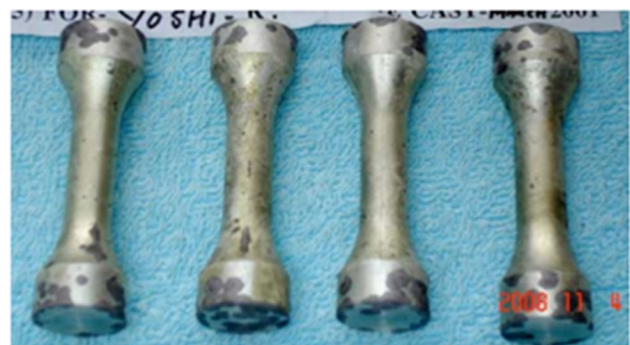
Fig. 7 Tin pest allotropic transformation on Sn-0.5Cu bulk solder samples, reprinted with permission from Plumbridge.¹⁷

that illustrated continued tin pest progression of bulk sample transformation (Fig. 7). In contrast, a Sn-Zn-3Bi alloy in the investigation had no signs of tin pest formation after 6 years of -18°C exposure. Plumbridge expressed concerns about products using lead-free solders with a design life of 25 years or more. He addressed the fact that many experiments rarely exceed 1 year, and in his study, it took 7 years before tin pest warts were visible in a majority of the solder alloys. He stated that there was, “a complacency that exists among much of the [electronics] industry regarding the significance of tin pest formation for reliability of solder joints.”¹⁹

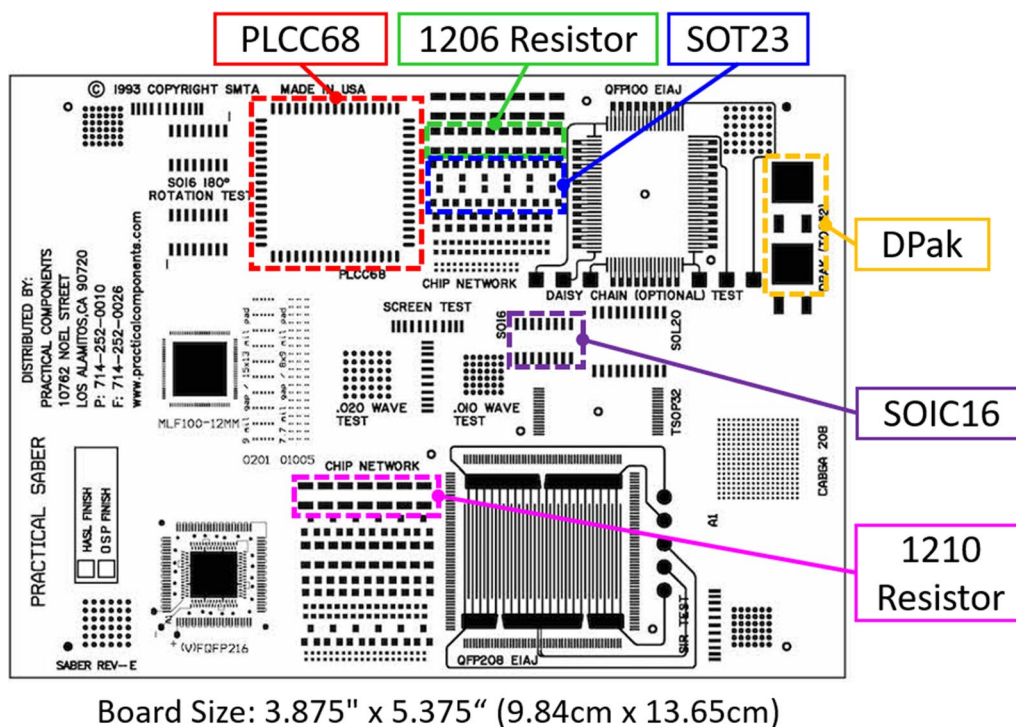
Fig. 8 Tin pest test vehicle (SMTA Saber Evaluation Board): Outlined areas indicated primary component test population regions (SOT-23, SOIC16, PLCC68, 1206, 1210, DPak).

components, 20 1206 resistors, and 14 1210 resistors in the locations indicated on Fig. 8. The 912 solder pad deposits were applied in multiple areas on unused test board pads.

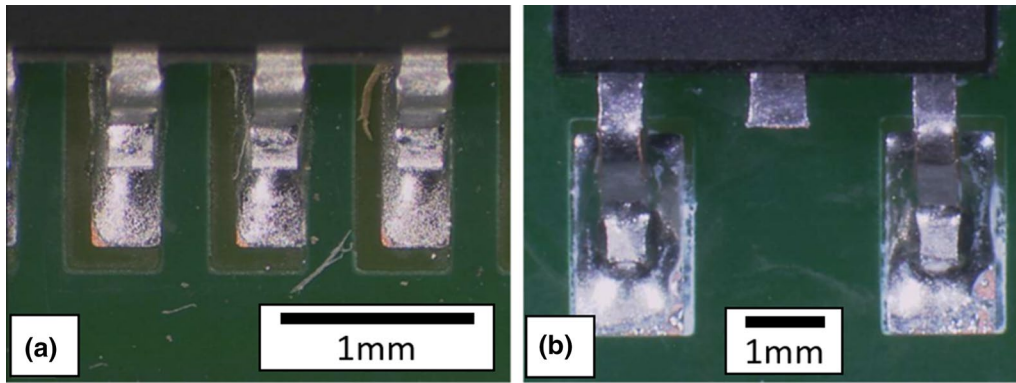
Fig. 9 Optical images of solder joints after 3000 thermal shocks: (a) SOIC16 with tin/lead finish, (b) DPak with matte tin finish.

- Set 1 test vehicles: Optical microscopy inspection found no indications of tin pest on any components or solder pad deposits after 3000 thermal shocks had been accumulated. Figure 9 illustrates post-thermal shock components with both tin/lead and matte tin finishes. Figure 10 illustrates a solder pad deposit after 3000 thermal shocks.
- Set 2 test vehicles: None of the optical microscopy inspections conducted over the 10-year period of static cold-soak conditions revealed any indications of tin pest. Figure 11 shows examples of solder joints after 10 years while Fig. 12 shows solder deposits.

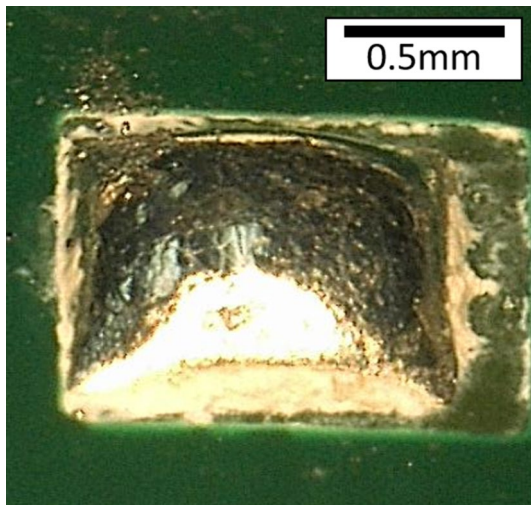
Fig. 10 Optical image of solder pad deposit after 3000 thermal shocks.

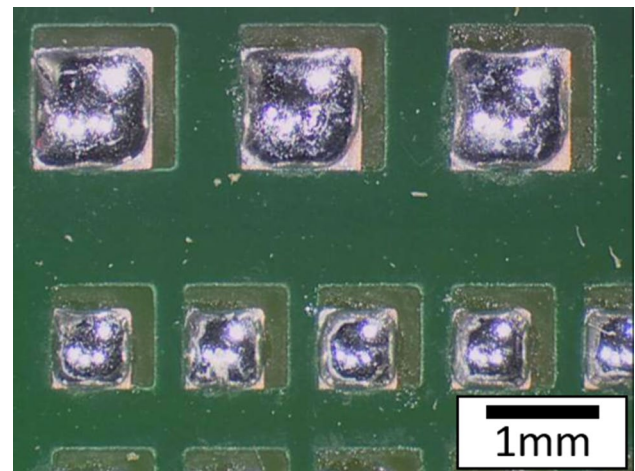
Fig. 12 Optical image of solder pad deposits after 10-year static soak @ -40°C .

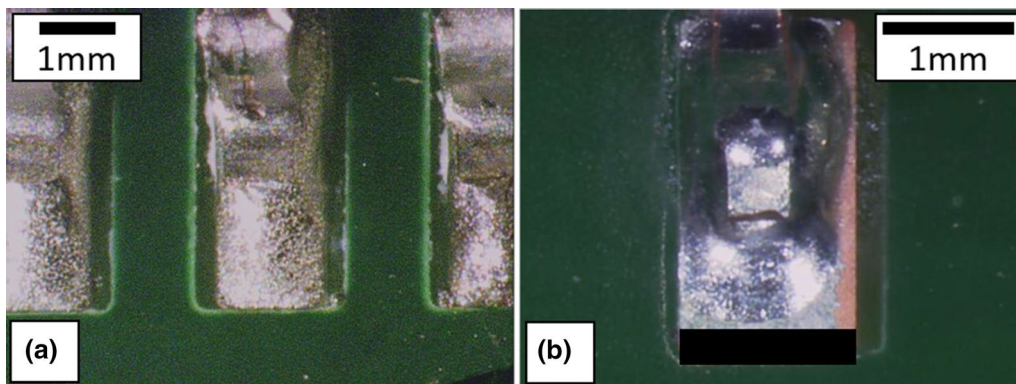
Fig. 11 Optical images of solder joints after 10-year static soak @ -40°C : (a) SOIC16 with tin/lead finish, (b) DPak with matte tin finish.

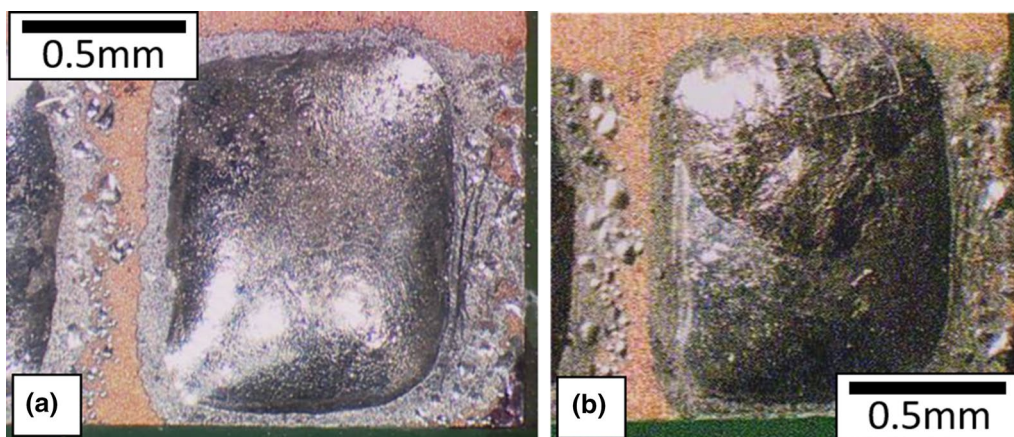
Fig. 13 Optical image of inoculated solder pad deposit after 10-year static soak @ -40°C : (a) no tin pest at 7 months, (b) tin pest transformation initiated at 10 months.

- Set 3 test vehicles: During the first 7 months of static cold-soak conditioning, optical microscopy inspection revealed no indications of tin pest. However, starting with the 10-month inspection period, tin pest transformation was first observed on “inoculated” locations, and the phenomenon continued to progress over time. Figure 13 illustrates a single solder pad deposit before and after tin pest was observed, while Fig. 14 shows the substantial damage incurred on these inoculated solder deposits after 10 years of cold temperature soak.

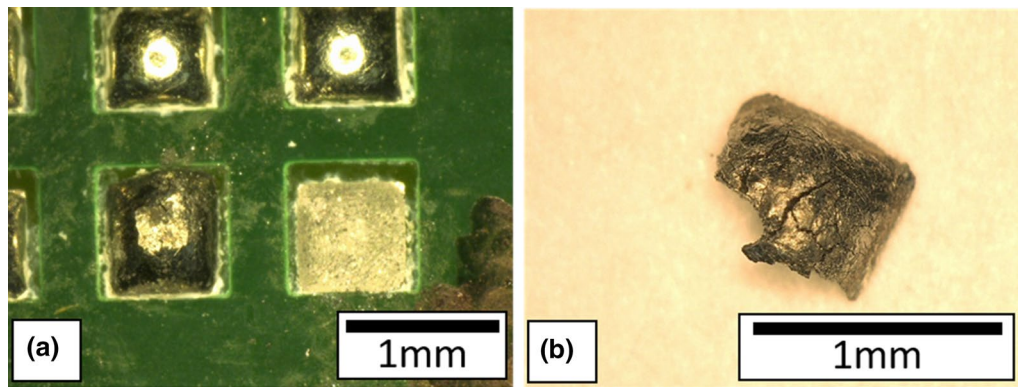
Fig. 14 Optical image of inoculated solder pad deposit after 10-year static soak @ -40°C : (a) inoculated pad that is missing solder deposit, (b) portion of solder pad deposit that fell off.
