# Exfoliation Corrosion Behavior of 2B06 Aluminum Alloy in a Tropical Marine Atmosphere

**In this study, corrosion behavior of 2B06 aluminum alloy was investigated after exposure to a tropical marine atmosphere for up to 4 years. After 6 months, the specimen showed exfoliation corrosion as well as rapid increase in thickness loss and corrosion rate. Exfoliation corrosion was found to initiate from hydrogen-assisted intergranular cracks and propagate extensively due to the wedge effect of the corrosion products. During the exposure test, corrosion on the groundward surface was considerably more severe than that on the skyward surface, which could be attributed to the different exposure conditions on the two surfaces.**

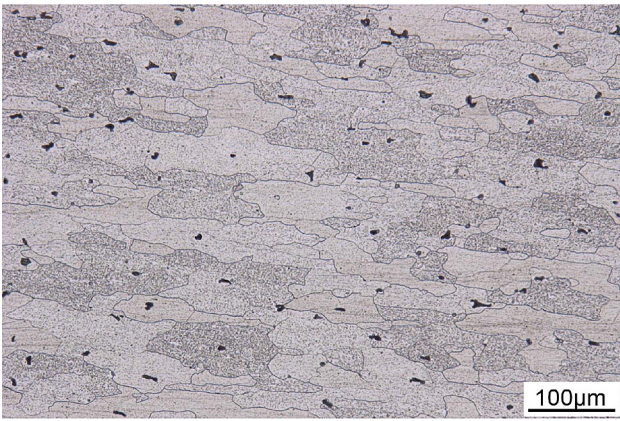
**Fig. 1** Microstructure of the longitudinal section (L/ST plane) of 2B06 aluminum alloy

after etching in Keller's reagent (1 mL HF + 1.5 mL HCl + 2.5 mL HNO<sub>3</sub> + 95 mL H<sub>2</sub>O) (Fig. 1). It showed that the grain structure was highly elongated parallel to the sample surface with some second phase particles located in the interior of grains and grain boundaries. The distributions and compositions of the intermetallic (IM) particles were examined with scanning electron microscope (SEM, Quanta 250) and energy dispersive x-ray spectroscopy (EDS) techniques. Figure 2 shows that the IM particles are mainly consisted of two phases: the elongated particles are Al (Fe, Mn, Si) phases (marked by arrows in Fig. 2b); and the rest of the particles, composing of elements Al, Cu, and Mg, is identified as S-phase (Al<sub>2</sub>CuMg).

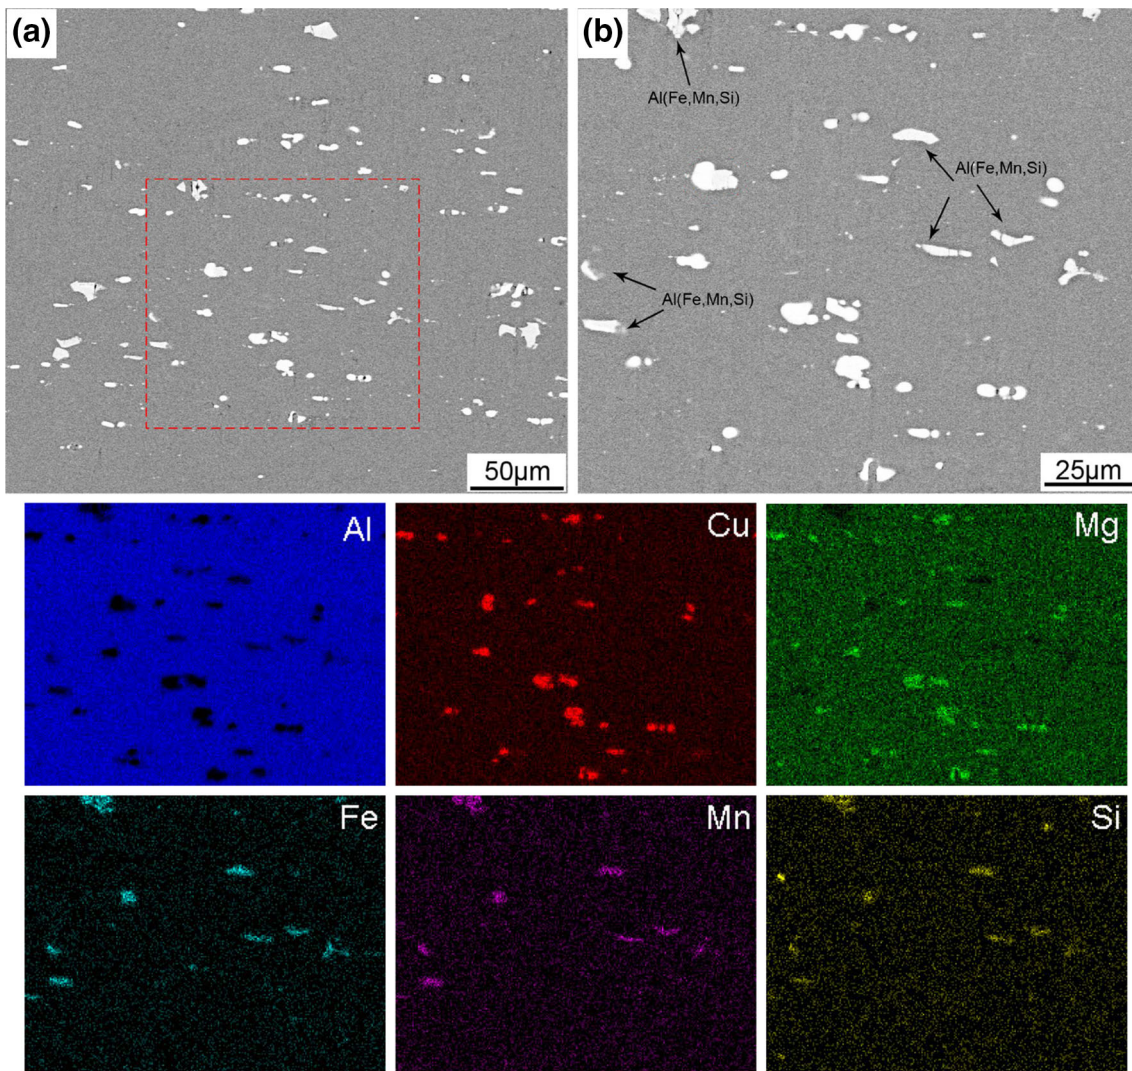
**Fig. 2** SEM observation and element distributions of the intermetallic particles in 2B06 aluminum alloy (b is the magnification of the marked area in a)

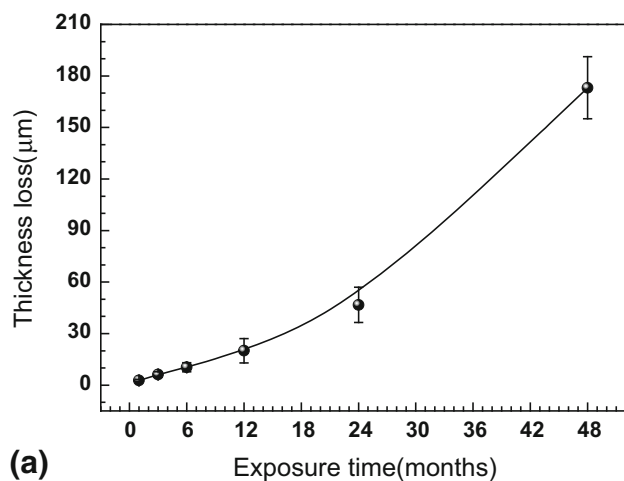
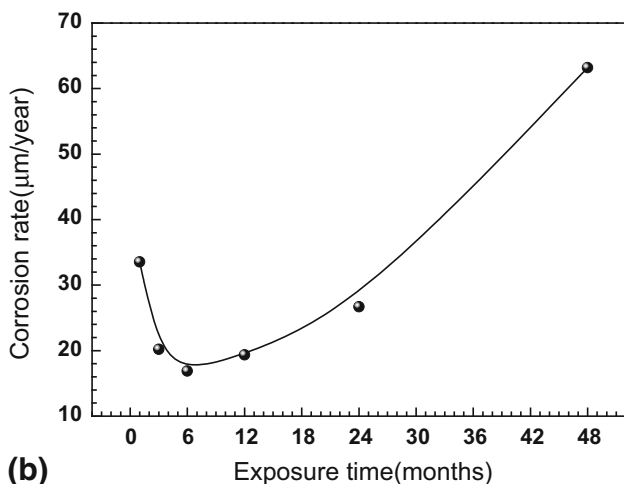
**Fig. 3** Thickness loss and corrosion rate of 2B06 aluminum alloy during the exposure test: (a) thickness loss, (b) average corrosion rate

Figure 3 shows the thickness loss (a) and the corrosion rate (b) of 2B06 aluminum alloy during the 4-year exposure in Xisha atmosphere. The increase in thickness loss as a function of the exposure time can be divided into two stages: the initial 6 months during which the thickness loss grows slowly, and the rest of the exposure period which shows a more rapid, parabolic growth of the thickness loss. This phenomenon can be clearly explained by the variation of corrosion rate during the exposure test (Fig. 3b). From 1 month to 6 months, corrosion rate of 2B06 aluminum decreases from 33.5 to 16.9  $\mu\text{m}/\text{year}$ . On the contrary, a significant acceleration of the corrosion rate can be observed after 6 months of exposure, indicating that the specimen has suffered severe deterioration in this stage. Typically, corrosion rate after 1 year of exposure is usually used to characterize the corrosivity level of the material at a certain exposure location. In Xisha islands, corrosion rate of 2B06 aluminum after exposure for 1 year is 20.05  $\mu\text{m}/\text{year}$  (54.74  $\text{g}/\text{m}^2 \text{ year}$ ) which is much higher than the  $2\times\times\times$  aluminum alloys in salt lake (Ref 4), industrial, and costal atmospheres (Ref 5) in China.

As shown in Fig. 6, intergranular corrosion initiates on the aluminum surface after 1 month of exposure and exfoliation corrosion occurs after 12 month based on the fact that the uncorroded sheets has been peeled off. This phenomenon agrees with the reversed trend of corrosion rate curve at 6 months of exposure (Fig. 3b). Therefore, the process of

exfoliation corrosion on 2B06 aluminum in Xisha tropical marine atmosphere can be divided into two stages, i.e., the initiation stage and the propagation stage. The initiation stage is the first 6 months during which intergranular corrosion starts at fragile sites and propagates along grain boundaries. During this stage, corrosion consumes only a small amount of the material, corresponding to the slow increase in the thickness loss in Fig. 3(a). In the propagation stage, the original sheet was seriously corroded until exhausted. Here, the thickness loss is not only attributed to the metal dissolution, but also to the non-corroded grain detachment, which explains the rapid increase in the thickness loss and corrosion rate in Fig. 3.

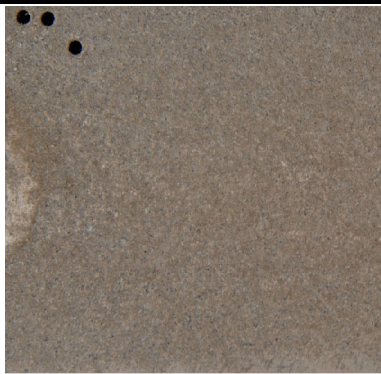
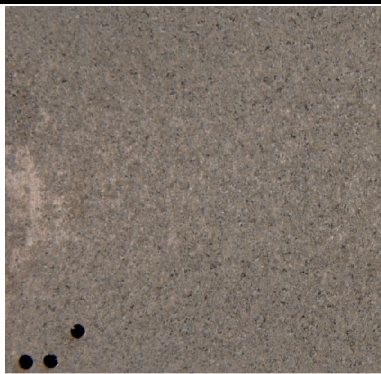
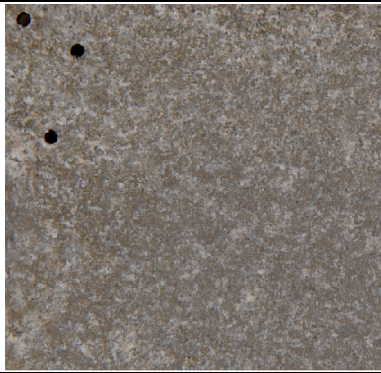
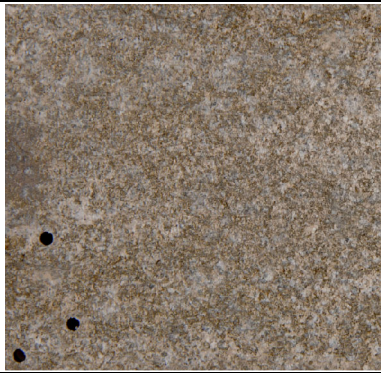
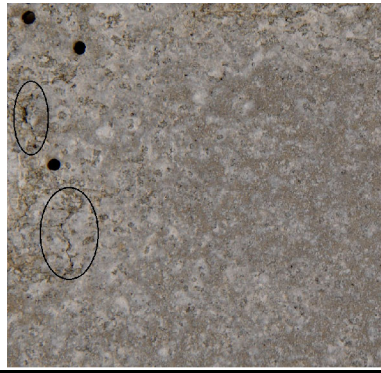
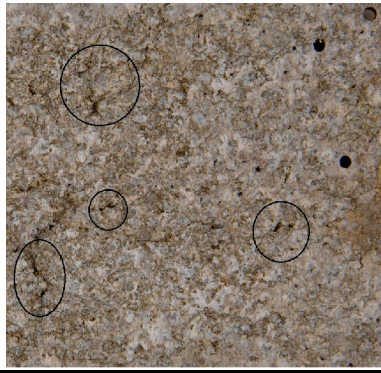
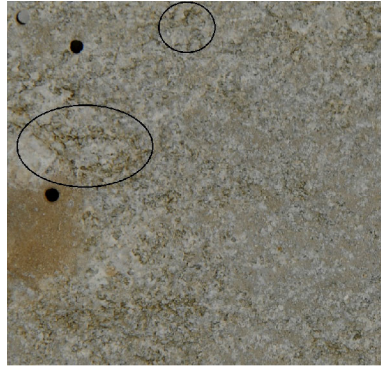
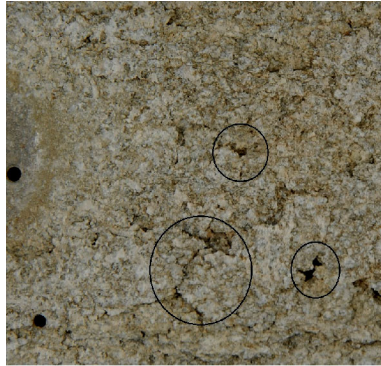
**Table 2** Macroscopic corrosion morphologies of 2B06 aluminum during the exposure test

Table 2 shows the macroscopic appearances of the samples' surfaces prior to the removal of corrosion products, after exposing for 1, 12, 24, and 48 months. After 1 month of exposure, both the skyward and the groundward surfaces of the

specimen are covered with gray corrosion products, and the original metallic luster is lost. As the exposure time increases to 12 months, more corrosion products can be observed, forming a thick layer. At this point, no visible exfoliation is detected with naked eye on both surfaces of the samples. After exposure for 24 and 48 months, some obvious cracks and pores (marked with the black circles) appear on the specimen surface and the corrosion products begin to delaminate and fall off, indicating the occurrence of exfoliation corrosion. Comparing with the skyward surface, the groundward surface exhibits more severe deterioration as a result of less radiation by sun and minor removal of the aggressive pollutants by rain.

In this work, Table 2 and Fig. 6 to 8 reveal that corrosion of the groundward surface is considerably severe than the skyward surface, showing a thicker exfoliation layer and a more serious flaking of the grain structures. These phenomena can be

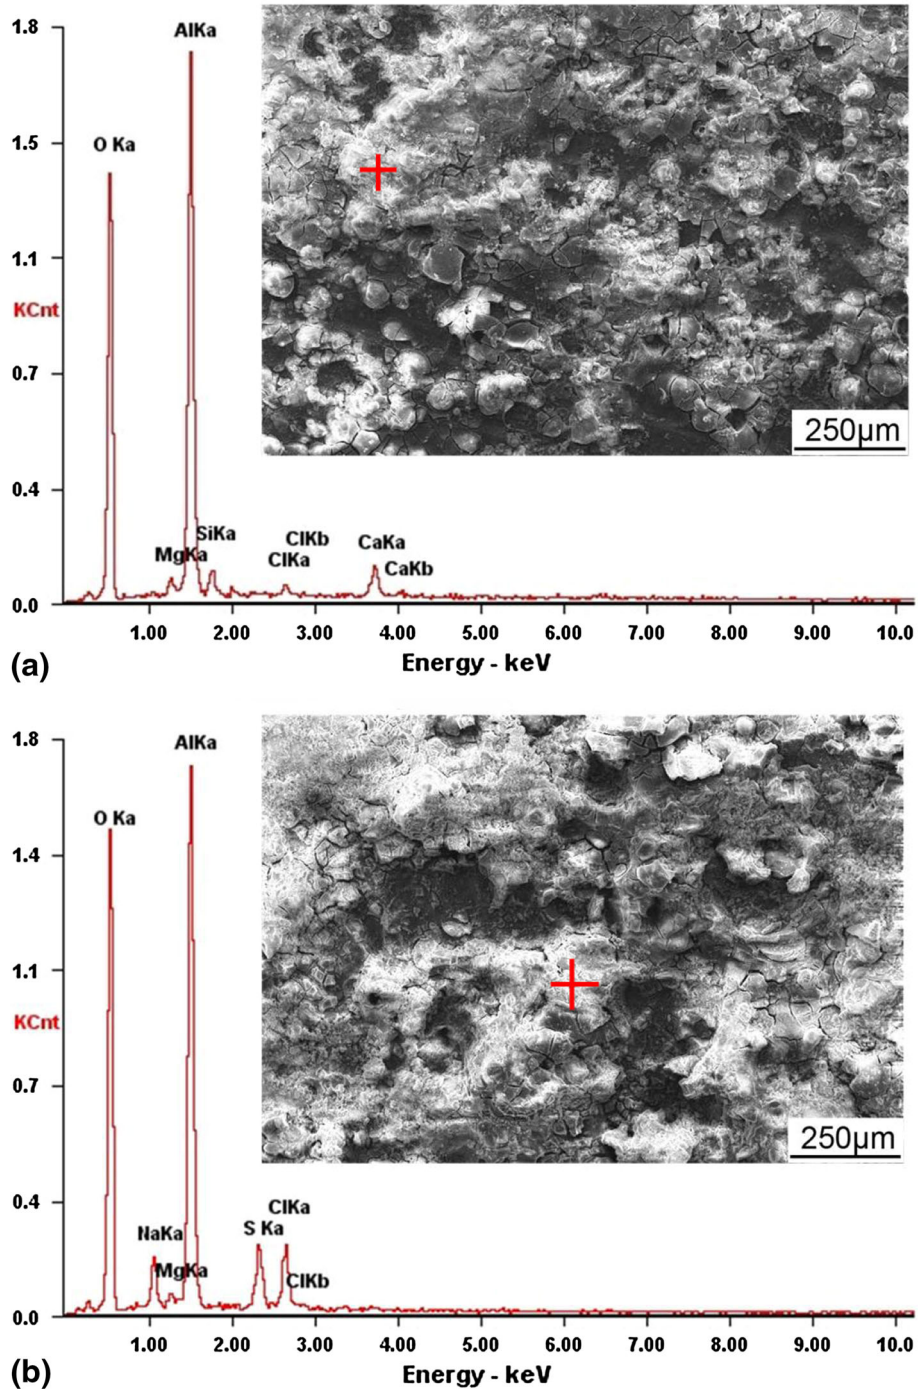
**Fig. 4** Surface morphologies of 2B06 aluminum after exposure for 1 month (a) and 24 months (b) observed by SEM as well as the chemical composition of the marked site determined by EDS

In Fig. 4, the skyward surface morphologies of 2B06 aluminum after 1 and 24 months of exposure observed by SEM and the chemical composition of the marked site was determined by EDS. It is seen that morphology of the corrosion product shows minimal change with longer exposure. The EDS spectra reveal the presence of Al, O, Mg, Si, Cl, Ca, Na, and S in the corrosion products. The elements Al and O are possibly from the corrosion scales such as  $\text{Al}_2\text{O}_3$ ,  $\text{Al}(\text{OH})_3$ , and  $\text{AlO}(\text{OH})$ , and the rest of the elements are mainly from the deposited salt particles from marine atmosphere.

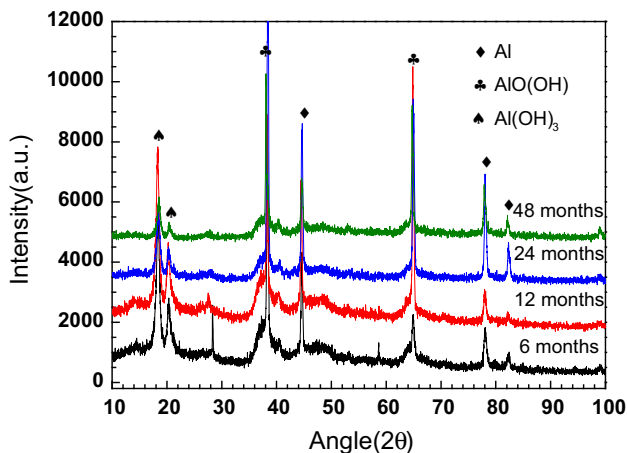
**Fig. 5** XRD patterns of the corrosion products formed on 2B06 aluminum alloy after different exposure time

Figure 5 shows the XRD patterns of the corrosion products on 2B06 aluminum exposed for different time. The major crystalline phases are identified to be  $\text{AlO}(\text{OH})$  and  $\text{Al}(\text{OH})_3$ , which are the principle corrosion products formed on aluminum after long-term atmospheric exposure (Ref 9).

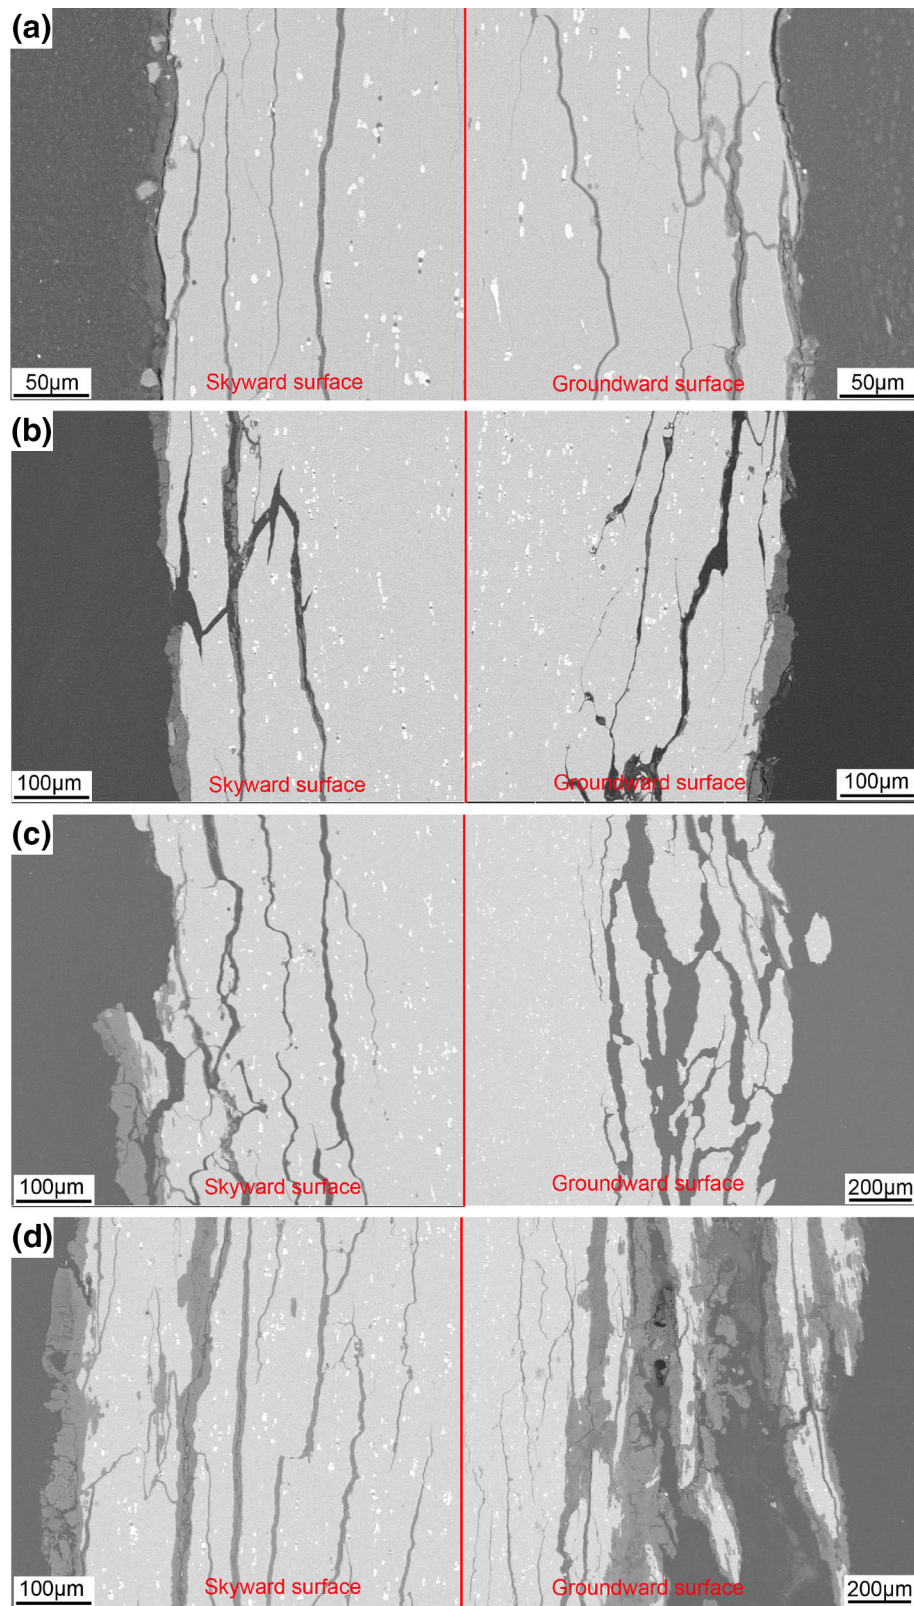
**Fig. 6** Microscopic cross-sectional morphologies of L/ST plane of 2B06 aluminum exposed for various periods: (a) 1 month; (b) 6 months; (c) 12 months; (d) 24 months

Cross-sectional morphologies of L/ST plane of 2B06 aluminum exposed for various time are shown in Fig. 6 in which the left side is the skyward surface and the right side is the groundward surface feature. After exposure for 1 month (Fig. 6a), a number of thin and long cracks are observed across the whole micrograph beneath the sample surface. All cracks are parallel to the metal surface and part of them are filled with corrosion products, while no trace of corrosion product can be discerned at the crack tip of some extremely thin cracks. In addition, the sign of intergranular corrosion, which may have occurred prior to the exfoliation, is also found on the groundward surface of the specimen. The cracks widen with increasing exposure time and some of the corrosion products fall off from the gap, leaving a vacuous crevice (Fig. 6b). As the exposure test continues, many non-corroded grains begin to peel off due to the wedge forces created by the precipitation of corrosion products which have higher molar volumes than the aluminum (Ref 30). After 24 months of exposure, even more severe exfoliation can be observed, especially on the groundward surface where the metal matrix is swelled or pried open by corrosion scales (Fig. 6d).

As shown in Fig. 6, there are obvious corrosion products located along the grain boundaries, suggesting that wedge effect from the corrosion scales plays a critical role in the exfoliation process of aluminum. In addition, there also exists some thin intergranular corrosion cracks with no evidence of corrosion product. To further investigate the exfoliation mechanism, the element distribution across the thin intergranular crack tip is examined and displayed in Fig. 10. The element composition at the crack tip is consistent with the aluminum matrix which is mainly composed of Al, Mg and Cu. This scenario verifies the absence of corrosion products at or close to the crack tip, thus suggesting the possibility of a hydrogen effect in the initiation of intergranular cracks, which is in accordance with the fact that long and thin cracks are observed far from the corrosion location (Fig. 6). Therefore, it is reasonable to speculate that exfoliation corrosion of 2B06 aluminum in tropical marine atmosphere initiates from hydrogen-assisted intergranular cracks. The volumic effect of the corrosion products, often suggested as a critical mechanism in exfoliation corrosion, subsequently lifts the cracks to create large openings.

to induce crack initiation. Once such cracks have initiated, they may propagate extremely fast, creating sudden contact between the aggressive medium and the fresh metallic surface, which in turn, facilitated the dissolution of the aluminum substrate. In this case, corrosion products composed of aluminum chloride/oxygen complexes which have higher molar volumes than that of aluminum could form along the grain boundaries. The corrosion products exert a significant wedging pressure between the layers of sheets to pry them apart (Fig. 6c and d).

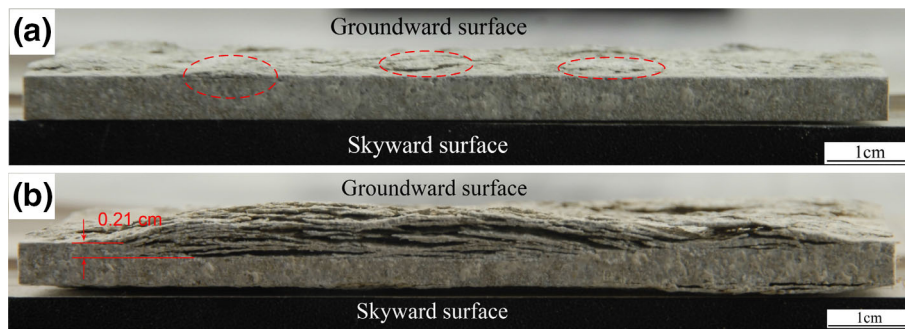
Fig. 7 Macroscopic cross-sectional morphologies of the specimens after exposure for 24 months (a) and 48 months (b)

As the exposure test lasts for 48 months, exfoliation of 2B06 aluminum exhibits qualitative change where the corroded layer can be clearly seen by naked eyes (Fig. 7). Exfoliation traces are visible on the groundward surface of the specimen after 24 months of exposure (Fig. 7a), indicating the occurrence of severe exfoliation corrosion. On the sample exposed for 48 months, the groundward surface shows more serious deterioration to the depth of 2.1 mm, almost half of the sample thickness (5 mm) (Fig. 7b). In this case, the mechanical strength and service life of aluminum have decreased significantly and the materials may experience sudden risks.

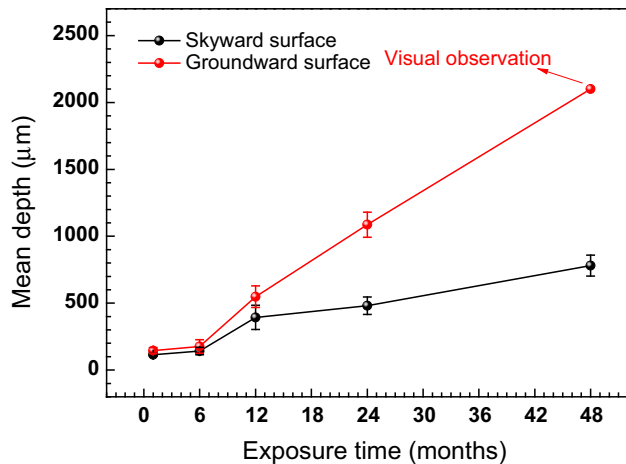
Fig. 8 Variation of the mean exfoliation depth on the skyward and groundward surfaces as a function of the exposure time

A statistical analysis of the average corrosion depth, measured from the cross sectional surfaces, is shown in Fig. 8. It appears that the exfoliation layer begins to enlarge

after 6 months of exposure, which agrees with the corrosion rate in Fig 3(b). Noticeably, the mean depth of the corrosion on the groundward surface is higher than the skyward surface and

the differences become more obvious as the exposure time extends, which further confirms the different exfoliation susceptibility of the two surfaces as demonstrated in Fig. 6 and 7 and Table 2.

explained by the dissimilar exposure conditions that the skyward and groundward surfaces have experienced. Because of the sunlight and washing effect of the rainfall, wet-dry cycles would be evidently established on the skyward surface (Ref 39). In contrast, without washing effect and sun radiation, the groundward surface has a larger amount of polluted particles and a longer time of wetness, which results in a continuous absorbed electrolyte layer. Firstly, the uninterrupted exposure of the groundward surface to the salt electrolyte layer allows the chloride ions to remain in contact with the specimens whenever possible, permitting the initiation of pits and the formation of intergranular cracks during the entire exposure. On the skyward surface, however, the dry cycles inhibit the penetration of corrosion into the interior of the aluminum alloy due to the lack of corrosive medium, leading to a relatively mild exfoliation behavior. With increasing exposure time, the swelled exfoliated layer on the groundward surface can easily absorb more aggressive electrolyte which further advances the corrosion and deteriorates the metal matrix. As a result, the difference in the corrosion depths between the two surfaces becomes more obvious as shown in Fig. 8.

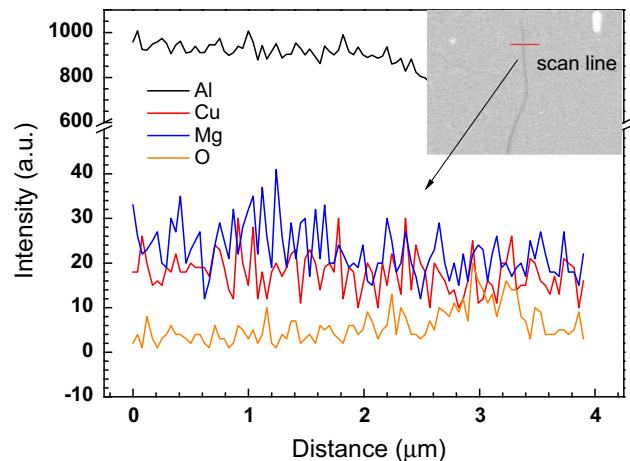
Fig. 10 Element composition near the tip area of the long and thin cracks

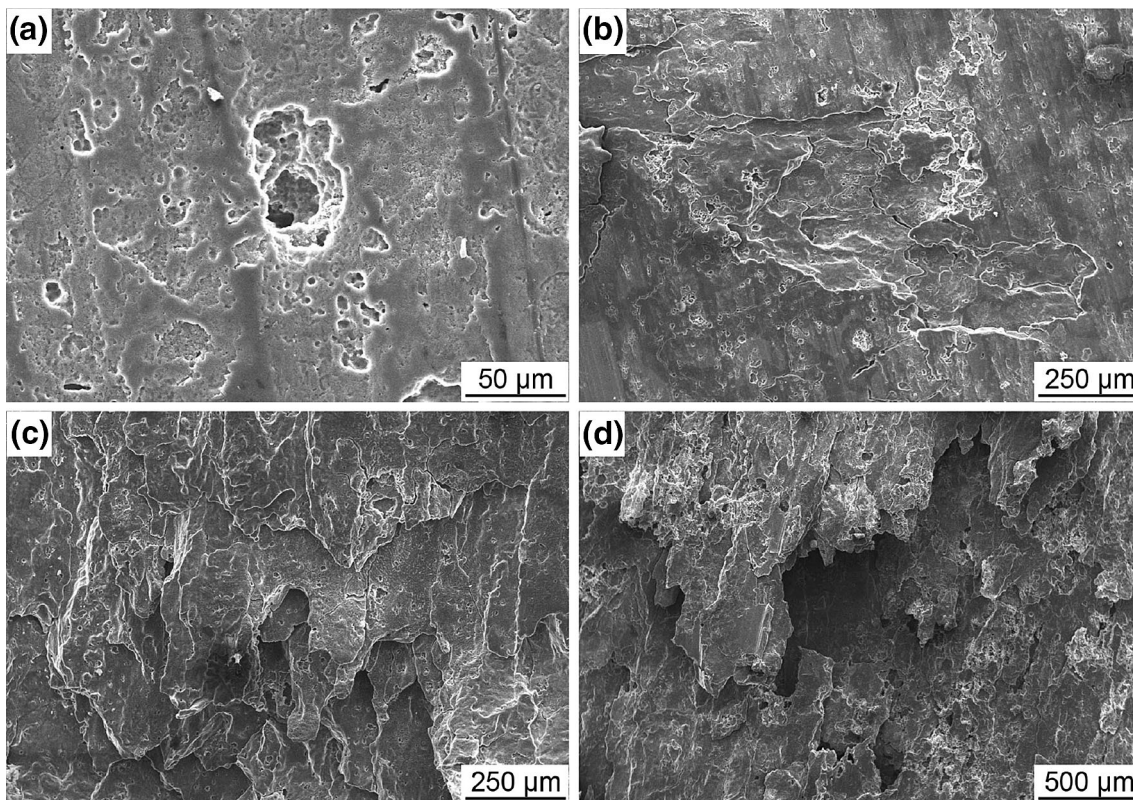
Fig. 9 Corrosion morphologies without corrosion products of the specimens after exposure for 1 month (a), 6 months (b), 12 months (c) and 24 months (d)

Figure 9 shows the typical corrosion morphologies after removing corrosion products from the specimens exposed for different time. Corrosion pit with a diameter of approximately 50  $\mu\text{m}$  is observed on the specimen after 1 month of exposure (Fig. 9a). After 6 months, few lamellar aluminum grains begin to peel off from the substrate, leaving some cracks penetrated into the matrix (Fig. 9b). Further increasing the exposure time, ladder-laminated morphology is detected after fracturing the exfoliated structure and removing the corrosion scales (Fig. 9c and d).
