# Tensile and Fatigue Properties of Single and Multiple Dissimilar Welded Joints of DP980 and HSLA

Q.L. Cui, D. Parkes, D. Westerbaan, S.S. Nayak, Y. Zhou, D.C. Saha, D. Liu, F. Goodwin, S. Bhole, and D.L. Chen

(Submitted July 6, 2016; in revised form November 1, 2016; published online January 5, 2017)

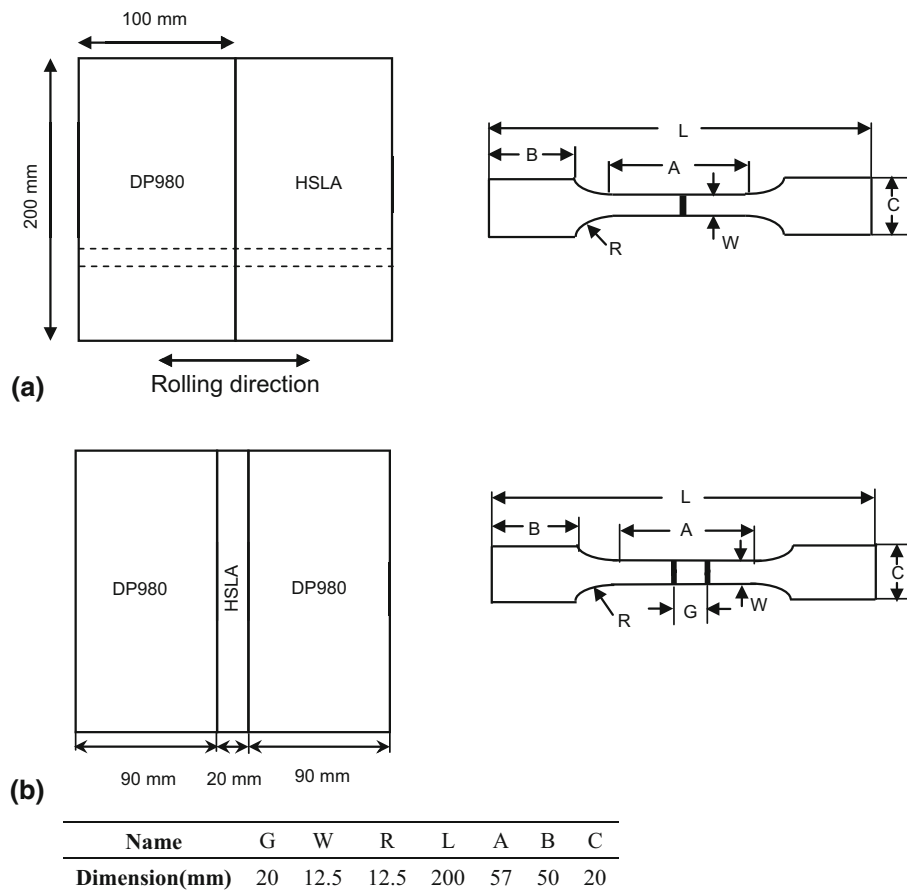
**Fig. 1** (a) Geometry of the single-line welded sheet, with transverse tensile joint machined from the dotted line, (b) geometry of the multiple-line welded sheet

Tensile and fatigue test specimens of DP980-HSLA dissimilar joints were machined from a blank welded together by two 100 mm × 200 mm sheets, as shown in Fig. 1(a). The geometry and dimensions of the specimens were in compliance with ASTM: E8/E8M standard. Specimens of DP980-HSLA-DP980 multiple joint were machined from a blank with three sheets welded together, as shown in Fig. 1(b). Tensile tests were conducted on a fully computerized uniaxial tensile testing machine at room temperature and with a strain rate of  $1 \times 10^{-3} \text{ s}^{-1}$ . An extensometer with a gauge length of 50 mm and a strain limit of 20% was used to measure the strain during the tensile tests. Load control fatigue tests were performed following ASTM: E466 on a fully computerized Instron 8801 servo-hydraulic testing system. Tension-tension cyclic loading was used to prevent potential buckling of the specimens; a stress ratio of 0.1 was selected. A load with a sinusoidal waveform and a frequency of 50 Hz were employed. A minimum of two duplicates were tested in the tensile test and in the fatigue test at each of the cyclic stress amplitude. The fatigue fracture surfaces were carefully examined using SEM to explore the fatigue fracture mechanism.

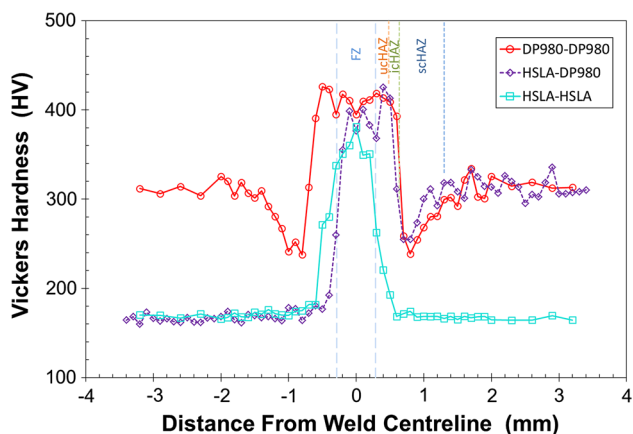
**Fig. 2** Vickers hardness measurements of similar and dissimilar welded joints

A typical hardness profile across a dissimilar joint between DP980 and HSLA is shown in Fig. 2. For comparison, hardness profiles of similar joints of DP980 and of HSLA are also presented. Two light-blue vertical dashed lines in the center of the graph indicated the typical width of a FZ, which was 0.57 mm as measured digitally from several SEM micrographs, as shown in Fig. 3. The measurement agreed well with the nominal laser spot size of 0.6 mm. The hardness of all three different joints was at or near their peak values in the FZ where full martensitic microstructure was obtained (Fig. 3e). The hardness of DP980 FZ was, however, higher than

On the outskirts of HAZ was the sub-critical HAZ (scHAZ) where the peak temperature was lower than Ac<sub>1</sub> yet high enough to cause the tempering of martensite (Fig. 3b). The tempering lowered the hardness and strength of martensite while improving its toughness. The softened zone of DP980 had a width of about 0.6 mm and is prominently shown in Fig. 2 and is marked by the darker blue vertical line. On the contrary, no apparent softening occurred to HSLA due to the lack of a martensitic microstructure. Note that the tempering effect in scHAZ was increasingly severe with a decreasing distance from icHAZ; a monotonic decrease in hardness was therefore expected. The increase in the measured hardness inside scHAZ near icHAZ (Fig. 2) was likely a result of

interference by the neighboring harder icHAZ, considering that the size of indentation was 40 μm at 240HV.

The hardness profile of the dissimilar HSLA-DP980 joint was, as expected, comparable to that of HSLA on the left-hand side of the joint while similar to that of DP980 on the right-hand side. In the FZ, the hardness value was higher than that of HSLA but lower than that of DP980, suggesting that the chemistry in the FZ was mixed. The highest hardness value was, unsurprisingly, recorded in ucHAZ of DP980 because its chemical composition was fully preserved.

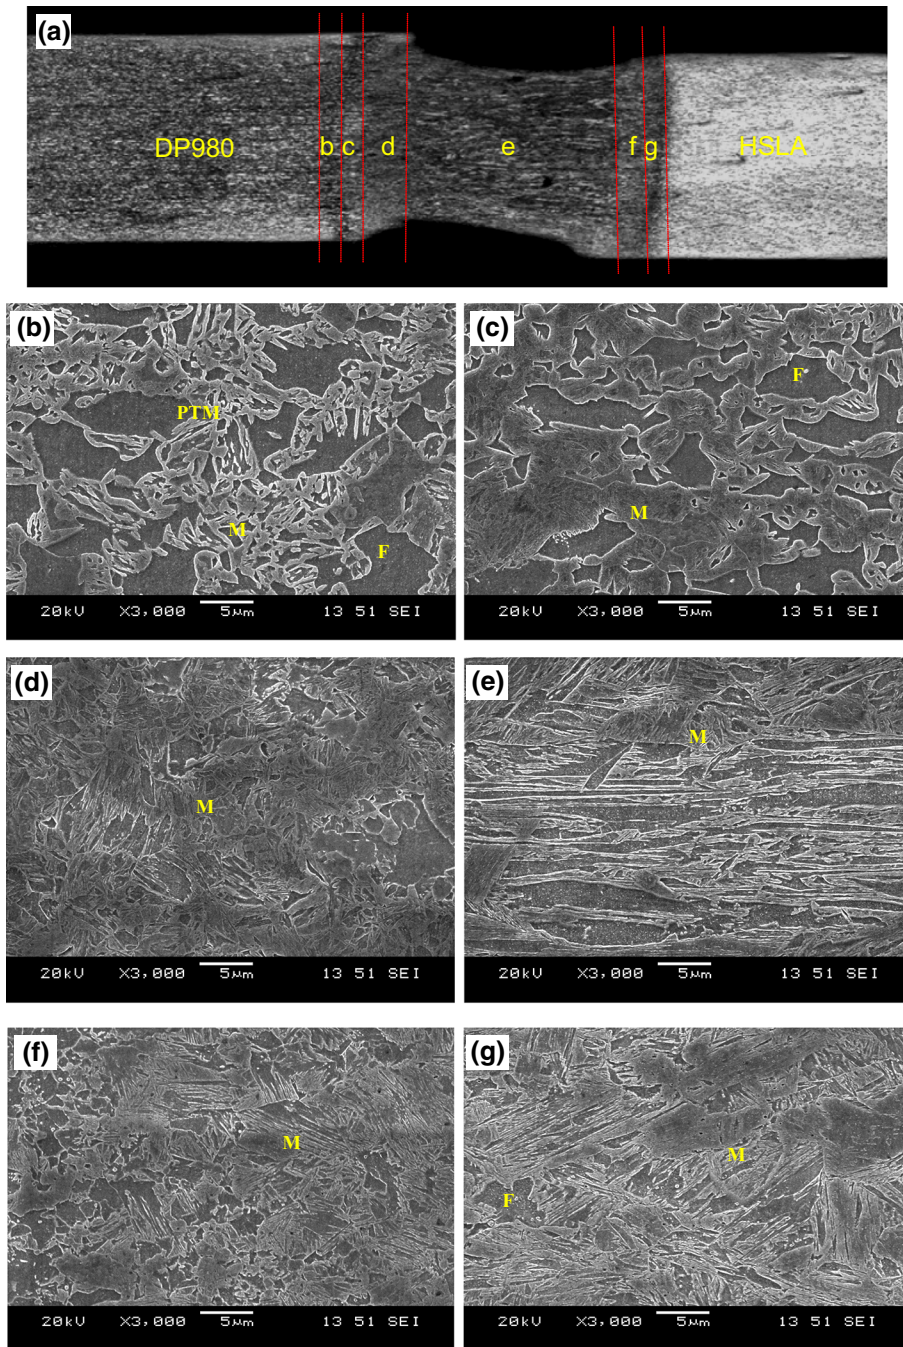
**Fig. 3** Microstructure of the DP980-HSLA dissimilar welding, (a) overall view, (b) DP980 sub-critical HAZ, (c) DP980 inter-critical HAZ, (d) DP980 upper-critical HAZ, (e) FZ, (f) HSLA upper-critical HAZ, (g) HSLA inter-critical HAZ (F: ferrite, M: martensite, PTM: partially tempered martensite)

The hardness of DP980 in the upper-critical HAZ (ucHAZ) was also high because a fully martensitic microstructure was obtained (Fig. 3d). Owing to a low Ac<sub>3</sub> temperature (822.9 °C for DP980 versus 873.8 °C for HSLA) and good hardenability, a relatively wide plateau of high hardness with a width of about 0.2 mm was obtained for DP980 as marked by an orange dotted line in Fig. 2 for that particular weld. The borderline between ucHAZ and the inter-critical HAZ (icHAZ) was distinctly defined by the respective absence and presence of ferrite grains and was easily distinguished by metallographic examination.

Outside of the ucHAZ was icHAZ where the peak temperature lays between Ac<sub>1</sub> and Ac<sub>3</sub> temperatures (Fig. 3c). A partial martensitic microstructure was thereby obtained (Ref 15). This microstructure was similar to the dual-phase microstructure in DP980 BM where a mixture of ferrite and martensite was achieved by inter-critical annealing. However, the martensite/ferrite ratio in icHAZ decreased with decreasing peak temperature as predicted by the phase diagram. Reflecting the change from an almost fully martensitic microstructure near Ac<sub>3</sub> to a microstructure containing a significant amount of ferrite near Ac<sub>1</sub>, the microhardness in the icHAZ decreased sharply from near the peak value to a low value near the valley as shown in Fig. 2 and marked by the green vertical line for the DP980 similar weld. As for HSLA, this partial martensitic microstructure was significantly harder than the all-ferrite microstructure in its BM.

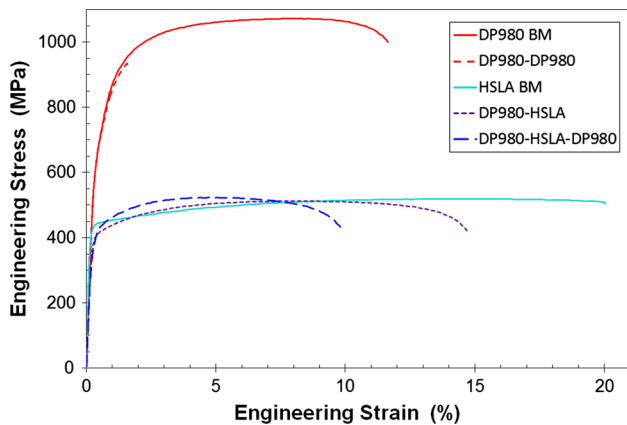
Fig. 4 Tensile curves of various types of welded joints between DP980 and HSLA

Like Vickers hardness test, the tensile test provides additional information about the welds of DP980 and HSLA. Plots of engineering stress versus engineering strain for DP980 BM, HSLA BM, DP980-DP980 similar joint, DP980-HSLA dissimilar joint and DP980-HSLA-DP980 multiple joint are displayed in Fig. 4. The plot for HSLA-HSLA similar joint is not presented because of its similarity to the plot for HSLA BM. The tensile properties of HSLA-HSLA similar joint are, however, listed in Table 2 together with the results of all other specimens. Although only one representative curve is shown in Fig. 4 for each type of specimen, at least two specimens were tested for each type and the averaged properties of the replicas are listed in Table 2.

Of all tensile curves shown in Fig. 4, the curve for DP980 BM has the highest ultimate tensile strength (UTS). The UTS of the DP980-DP980 joint was about 10% lower, as presented in Table 2. The average elongation of the welded specimens was only 3.0%, much lower than the 12.0% value of the BM. The elongation of the welded specimens showed a large standard deviation of 2.2% (see Table 2), contrary to the good repeatability (0.4%) exhibited by BM specimens. Fracture of the welded specimens initiated in the FZ near the BM where a sharp concavity often existed. Cracking then propagated into the softened zone (scHAZ) at about 45° angle in the thickness direction. The reduced plasticity and increased deviation were attributed to the concavity and other weld defects.

The tensile curve for HSLA BM, as shown in Fig. 4, exhibits excellent plasticity. The curve ended at 20% elongation simply because that was the range limit of the extensometer. Manual measurement gave an estimation of 24.7% elongation. The partial curve, however, included the peak stress (UTS = 520 MPa), which was reached at 13.5% strain. For HSLA-HSLA similar joint, the UTS and even the yield strength (YS) of the martensitic material in the FZ and ucHAZ were substantially higher than the UTS of HSLA BM. Because there was no softened zone, as shown earlier in Fig. 2, weldment did not present a weak location in tensile tests for HSLA. Moreover, as the applied stress was considerably lower than the YS of martensitic material, there was no plastic deformation in FZ and ucHAZ. The weldment thereby acted effectively as reinforcement in the specimen and prevented necking from occurring in its proximity. As a result, fracture always occurred in the HSLA BM away from the weldment. The tensile properties of the HSLA-HSLA similar joint were, therefore, very close to those of HSLA BM, with average UTS of 514 MPa and elongation of 22.3%.

when the HSLA segment reached its UTS. Tensile tests of those joint specimens were, thereby, essentially the tests of HSLA. Their tensile curves in Fig. 4 appeared different from that of HSLA BM simply because the extensometer measured both the deformed HSLA segment and the non-deformed DP980 segment. Assuming that the elongation of the HSLA segment remained at 24.7%, the apparent elongation for the DP980-HSLA and DP980-HSLA-DP980 joints can be calculated as 12.2 and 8.7%, respectively. These calculated values agreed reasonably well with experimental measurements of 13.8 and 9.7% in Table 2. As the nominal strain

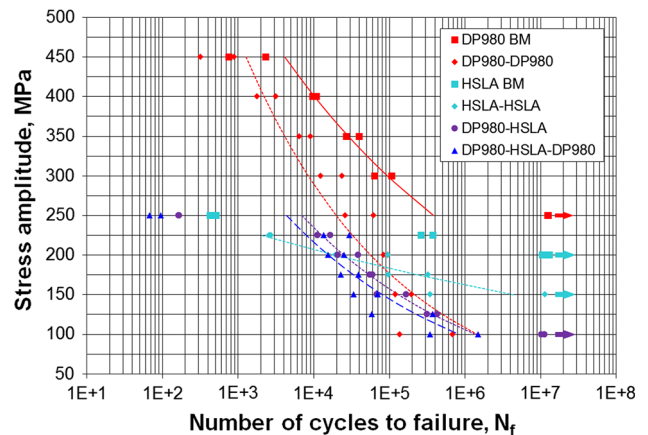
Fig. 5  $S-N$  curves of various types of welded joints between DP980 and HSLA

failure  $N_f$  (Ref 18). With the stress ratio fixed at 0.1, the stress amplitude equals 0.45 times of the applied peak stress. The resulting plot thus produced is better known as the  $S-N$  plot. The  $S-N$  plots for DP980 BM, HSLA BM and four types of joints are shown in Fig. 5. As the graph is crowded with six groups of data points, adding trend lines helps to improve the clarity. The trend lines displayed in Fig. 5 represent the best fits to the Basquin equation (Ref 21),

Note that the Basquin equation models the high-cycle fatigue where the nominal strain is elastic. Taking DP980 BM for instance (red squares in Fig. 5), the pair of data points at the highest  $\sigma_a$  of 450 MPa had a peak stress of 1000 MPa which was greater than the YS of DP980 BM (Table 2). Excluding this set of data points resulted in better fitting (higher  $R^2$ ). For a relatively low  $\sigma_a$  of 250 MPa, the endurance limit of the material was higher than that stress level, meaning that no crack could initiate and grow to a critical length such that crack propagation would continue under the cyclic load. Therefore, no failure occurred when the test was stopped after twelve million cycles. This set of data points was also excluded from the fitting. The resulting fitting ( $\sigma'_f = 1451$  MPa and  $b = -0.130$ , as listed in Table 2), displayed as a solid red line in Fig. 5, represents the three intermediate sets of data very well ( $R^2 = 0.94$ , also listed in Table 2). The fatigue strength coefficient  $\sigma'_f$  is comparable to UTS, while the fatigue strength exponent  $b$  has a reasonable value for high-strength steel.

Limited simultaneously by low YS and high fatigue strength, only three sets of data points (cyan squares in Fig. 5) were available for HSLA BM. The highest  $\sigma_a$  employed

was 250 MPa, which corresponded to 556 MPa peak stress, exceeding not only the YS but also the UTS of HSLA BM. At such a high stress level, the specimen would rapidly enter the last stage of fracture. Specimens managed to endure over 400 cycles primarily owing to the excellent plasticity (24.7% elongation as discussed earlier). At the stress level of 200 MPa, no failure occurred when the tests were terminated at over ten million cycles. Excluding these two sets of data points, only one data point (225 MPa) was within the applicable range of Basquin equation. Of course, no trend line can be drawn for a lone set of data points. Hence, no trend line is illustrated for HSLA BM in Fig. 5.

With high YS and low fatigue strength, DP980-DP980 joint was tested in a large span of  $\sigma_a$  ranging from 450 MPa down to 100 MPa (red diamonds in Fig. 5). For all specimens, cracking initiated in the FZ near the FZ/HAZ interface where residual thermal stress was the highest and the stress concentration was the greatest due to concavity. Weld defects might also directly aid the initial cracking. Compared to DP980 BM, the DP980-DP980 joint had lower  $N_f$ , attributable primarily to convenient crack initiation. As the stress amplitude decreased, the crack initiation became increasingly difficult for DP980 BM and eventually became unattainable at the stress level of 250 MPa. In contrast, even at very low stress levels crack initiation occurred readily in the welded joint, as will be revealed in detail by the fractography done in the following section. Thus, the difference in  $N_f$  between DP980 BM and the welded joint increased with decreasing stress amplitude. Another important factor contributing to the difference between the BM and the welded joint was that much of the fatigue damage of the joint occurred in the FZ where a brittle martensitic microstructure prevailed. It was difficult for brittle microstructure to arrest the crack tip, thus resulting in more rapid crack propagation (Ref

Data points for HSLA-HSLA similar joint are shown as cyan diamonds in Fig. 5 together with a cyan dotted trend line ( $\sigma'_f = 350$  MPa and  $b = -0.053$ ). The slope of the trend line was very gentle ( $b = -0.053$ , typical for relatively soft materials) when compared to that of DP980-DP980 joint. These two trend lines thus crossed over. For  $\sigma_a \leq 175$  MPa or  $N_f \geq 10^5$  cycles, the HSLA-HSLA joint outlasted DP980-DP980 joint in the fatigue test. It is worth noting that for both types of similar joints, cracking initiated in FZ where martensitic microstructure was obtained for both HSLA and DP980. A major difference existed in the C content (0.08% for HSLA and 0.15% for DP980, as listed in Table 1); its effect was also reflected in Vickers hardness measurements as discussed earlier. The HSLA FZ might be slightly less brittle than the DP980 FZ, resulting in better performance at low stress amplitudes.

A DP980-HSLA dissimilar joint inherited the weakness from both types of steels. With the crossover of the trend lines of similar joints of these two steels, it was expected that the dissimilar joint would suffer a rapid fracture in the soft HSLA BM at  $\sigma_a \geq 250$  MPa while incurring failure in the FZ on the DP980 side at low  $\sigma_a$ . This was exactly what was observed in experiments. Experimental data plotted in Fig. 5 (purple circle dots with a purple dotted trend line) also confirmed the

The behavior of DP980-HSLA-DP980 multiple joint was related to that of the DP980-HSLA dissimilar joint. The fatigue life of DP980-HSLA-DP980 multiple joint (blue triangular dots with a blue dashed trend line in Fig. 5) was in general slightly shorter than the corresponding fatigue life of the DP980-HSLA counterpart, presumably attributable to the probabilistic feature of fatigue failure as the chance of having more severe weld defects increased with the number of weldments (one for the dissimilar joint and two for the multiple joint). For  $\sigma_a = 250$  MPa where the failure occurred solely inside HSLA BM and away from any weldments, the fatigue life of the multiple joint was slightly shorter than that of the dissimilar joint, which, in turn, was slightly shorter than that of HSLA BM. This trend might be explainable by the effective sample length (DP980 was rigid at that stress amplitude), which was 20 mm for the multiple joint, 28 mm for the dissimilar joint and 57 mm for the BM specimen. More localized straining exacerbated necking, thus accelerating the low cycle fatigue failure of the relatively soft HSLA steel (Ref 23).

The fracture surface was almost identical for the duplicate specimen also tested at  $\sigma_a = 100$  MPa ( $N_f = 3.5 \times 10^5$  cycles). One dominant crack initiated from the top of the weldment at the FZ/DP980 interface. Cracking then propagated in uHAZ of DP980 during its stage II growth. It is worth noting that whereas multiple cracks were activated from both DP980 side and HSLA side in dissimilar and multiple joint specimens at high  $\sigma_a$ , one dominant crack typically formed from the more brittle DP980 side at low  $\sigma_a$ . Moreover, the weakest path for crack propagation at low  $\sigma_a$  appeared to be the material with highest hardness (likely most brittle), which was the uHAZ of DP980. At high  $\sigma_a$ , cracks opted to propagate into the soft material, which was the HSLA BM. These observations agreed very well with the fatigue life of DP980 and HSLA at different  $\sigma_a$ , highlighted by the crossover of their trend lines shown in Fig. 5.

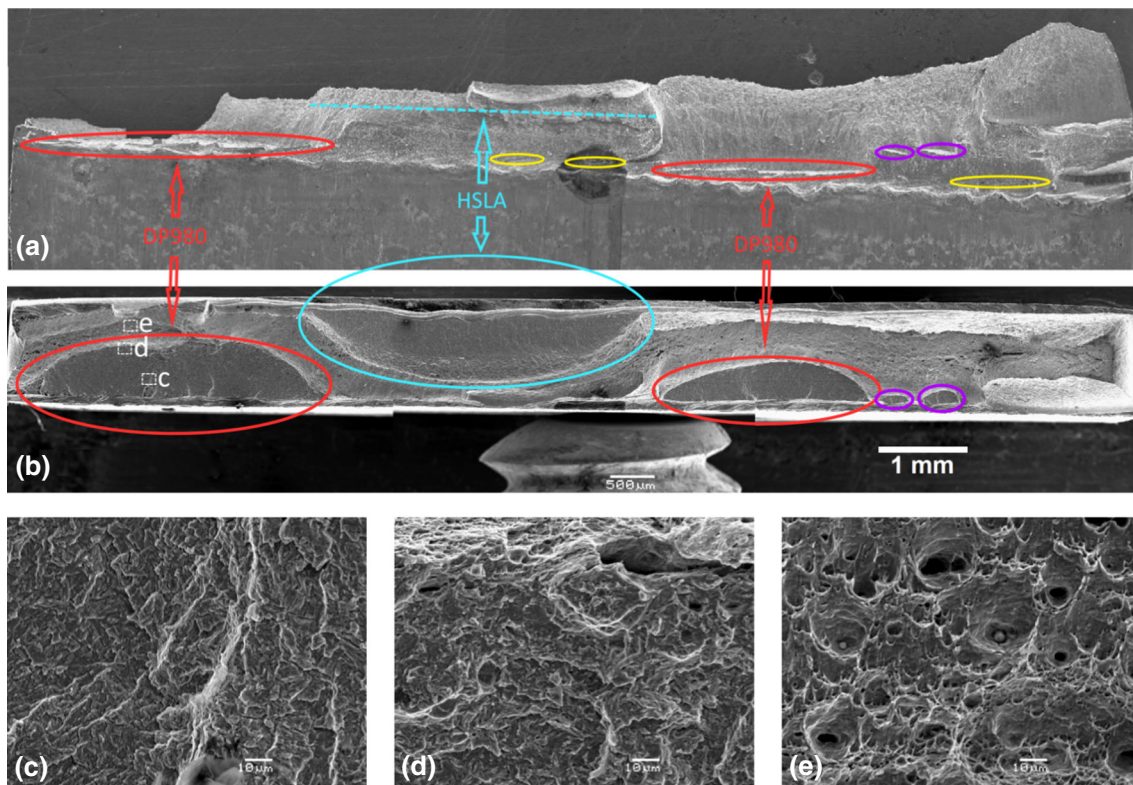
**Fig. 6** SEM images of fatigue fracture surface of a multiple joint tested at a stress amplitude of 225 MPa: (a) overall plane view, (b) overall cross-sectional view, (c) early stage II propagation region, (d) late stage II propagation region, and (e) rapid fracture region

The fracture surface of a DP980-HSLA-DP980 multiple joint specimen tested at  $\sigma_a = 225$  MPa ( $N_f = 29,660$  cycles) is shown in Fig. 6. Figure 6(a) shows the plane view of the fracture area with the top of the weldment facing the reader. The final rupture started from the left end of the weld close to DP980 and propagated to the right and slightly upward, first in the weldment and then entering the HSLA BM. The wavy FZ/DP980 border was easy to identify; the waviness was created due to the instability of the keyhole (laser was operated in continuous wavelength mode and was not pulsating). Much of the FZ/HSLA border was attached to the other half of the fractured specimen and is not displayed here. Only a short segment of the FZ/HSLA border can be seen at the right end of the weldment in Fig. 6(a). Figure 6(b) shows the cross-sectional view of the same fracture surface. It ought to be noted that the depth perception of SEM is often misleading. An experienced examiner relies on the work distance reading to judge the “altitude” of the fracture surface. In Fig. 6, the combination of the plane view and the cross-sectional view makes it easy to identify the locations of many important features. The most conspicuous features shown in Fig. 6 were three fatigue cracks. Each crack had a semi-oval shape with a length of a few millimeters and a width of about 1 mm. Two of these cracks (marked in red) were located in the FZ near the

DP980 border where weld concavity often caused stress concentration. These two cracks initiated from the top of the weld (front in Fig. 6a or the lower edge in Fig. 6b) and propagated toward the bottom of the weld as they widened. Conversely, the other crack initiated from the back (thus marked as a cyan dashed line in Fig. 6a) near the FZ/HSLA border. All three cracks propagated in planes perpendicular to the loading direction, bearing characteristics of stage II cracking. No crack initiation areas were found, probably because cracks could initiate readily from weld defects such as concavity. Easy crack initiation was in agreement with the low fatigue endurance limit (fatigue strength) of these welded specimens as shown previously in Fig. 5. Close examination of the two cracks marked in red revealed small ridges (Fig. 6b) close to the weld surface. These ridges were formed in early stage II propagation when small cracks initiated at slightly different levels merged to form a large crack. This is comprehensible by cross-examining the fine features in Fig. 6(a) and (b). More details of the boxed area marked as “c” in Fig. 6(b) are revealed in the micrograph shown in Fig. 6(c). No apparent fatigue striations are shown in the brittle martensitic material due to the absence of plastic blunting of the crack tip. Figure 6(d) shows the transition area from steady crack propagation to final rapid fracture. Figure 6(e) displays more ductile deformation with characteristic dimple features in the final rupture area. The final rupture proceeded from left to right (Fig. 6b) along the wavy corridor between three semi-oval

In addition to the three large fatigue cracks, two smaller cracks are marked with purple ovals in Fig. 6(a) and (b). Upon close examination, additional cracks that were not exposed on the fracture surface (Fig. 6b) are visible in the plane view (circled with yellow ovals in Fig. 6a). Cracks are also visible on the other weldment in this multiple joint specimen. Long before the specimen succumbed to final fracture, severe damage had incurred as multiple cracks substantially propagated at various locations.

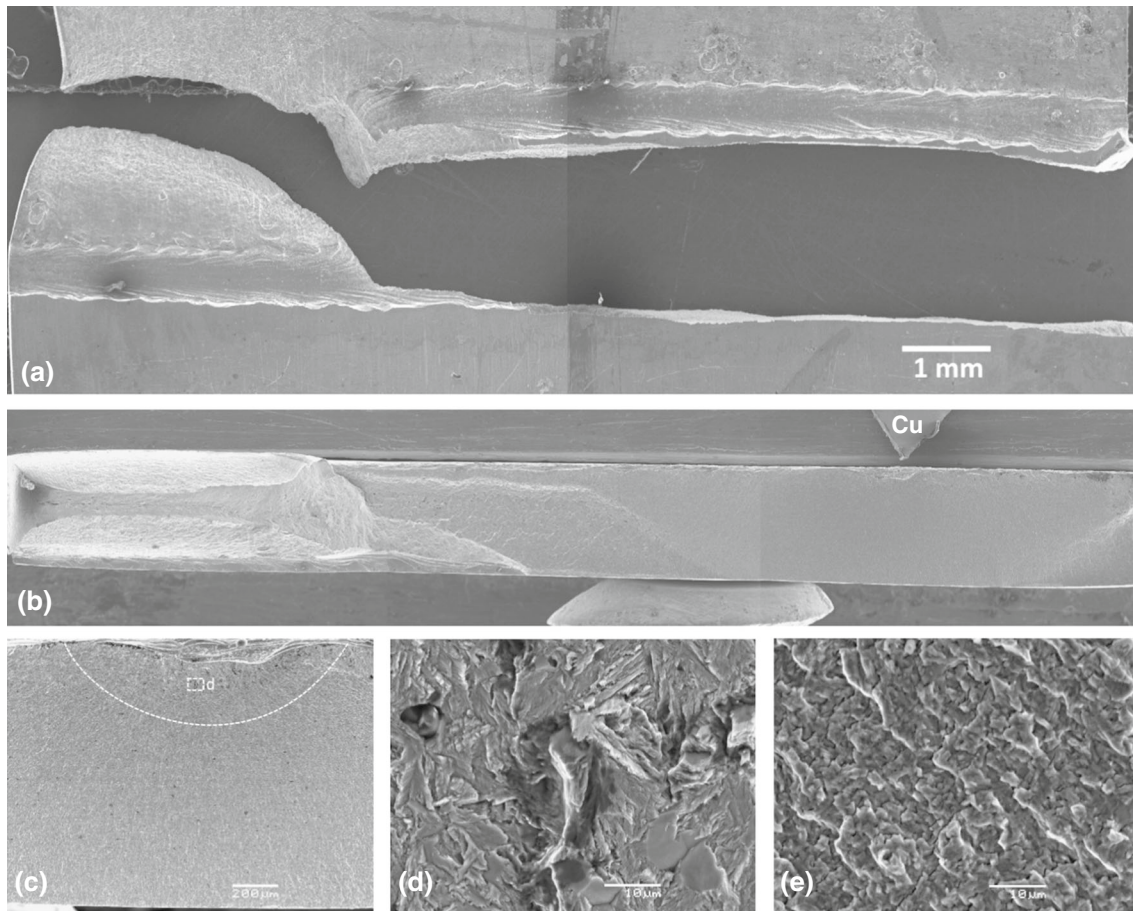
**Fig. 7** SEM images of fatigue fracture surface of a multiple joint tested at a stress amplitude of 100 MPa: (a) overall plane view, (b) overall cross-sectional view, (c) crack initiation area, (d) stage I crack growth, and (e) stage II crack growth

It is conceivable that a specimen tested at low  $\sigma_a$  can behave much differently from one tested at high  $\sigma_a$ . A DP980-HSLA-DP980 multiple joint specimen tested at a low  $\sigma_a = 100$  MPa ( $N_f = 1.5 \times 10^6$  cycles) was carefully examined. One large single fatigue crack was found at the FZ/DP980 interface as shown in Fig. 7(a) and (b), in sharp contrast to the many fatigue cracks found on the specimen tested at a high  $\sigma_a = 225$  MPa. Also, it was different from the specimen tested at high  $\sigma_a$  where no apparent crack initiation area was detectable; one crack initiation area was visible to the unaided eye on the low  $\sigma_a$  specimen. A Cu ribbon tape was placed next to this area for easy positioning under SEM, as shown in Fig. 7(b). A large weld defect was found and is shown in a higher magnification in Fig. 7(c). Note that the lower edge of Fig. 6(c) (also Fig. 7b) is the top side of the weldment, which is facing the reader in Fig. 7(a). Thus, the weld defect on the upper edge in Fig. 7(c) was on the bottom side of the weldment and might be produced by insufficient penetration of the keyhole at that particular location. Surrounding the weld defect is an area that appeared to the naked eye to have a lighter contrast; this reflection contrast was hardly cognizable under SEM probably because the secondary electrons (or backscatter electrons) bent their trajectories toward the electron detector. The approximate border of this lighter contrast area is marked with a dashed line in Fig. 7(c). The fracture surface in this area appeared rougher under SEM, likely resulting from the initial stage I propagation. Detail of a selected area in Fig. 7(c) is shown in Fig. 7(d). Although martensitic microstructure was ubiquitous in FZ, one bundle of lath martensite was particularly evident near the top center of the micrograph. Smooth planes intersecting at angles of about  $120^\circ$  near the bottom center of the micrograph greatly resembled the boundaries of prior austenite grains. The entire area was notably rougher than a normal area (stage II propagation, as shown in Fig. 7e) a couple millimeters away. The presence of the crack initiation and stage I growth area highlight the increased difficulty of crack initiation under low  $\sigma_a$ . The difficulty of crack initiation limited the number of cracks, explaining why single fatigue crack was found on specimens tested at low  $\sigma_a$ , whereas multiple cracks formed on specimens tested at high  $\sigma_a$ . Although the crack initiated in FZ, it propagated toward DP980 in stage I growth. Almost the entire stage II growth took place in uHAZ of DP980, which was even harder and likely more brittle than the FZ (Fig. 2). It is evidently shown in Fig. 6(a) that a thin slice of less than 0.2 mm of DP980 was attached to the FZ in the upper half of the fractured specimen. Referring to the thickness of uHAZ marked in Fig. 2, it can be concluded that the stage II crack propagation took place inside the uHAZ. It is worth noting that, for the test with  $\sigma_a = 100$  MPa, when the crack propagated to about one half of the cross section (Fig. 7b), the effective  $\sigma_a$

would double to about 200 MPa, which would be high enough to activate many fatigue cracks in the weldments. However, the stress intensity factor of the major crack would be much greater than that of nascent cracks due to the prominent length of the major crack. As a matter of fact, the stress intensity factor of the major crack had approached  $K_{IC}$  (critical stress intensity factor for type I cracks); the fatigue process thus started to enter the rapid fracture stage. As shown in Fig. 7(b), the fracture surface started to exhibit features of rapid ductile rupture. Cracking then abruptly broke through the weld and propagated deep into HSLA BM, as shown in Fig. 7(a).
