Failure Investigation of a Furnace Tube Support

Abstract A furnace tube support failed after 6 months service at 850 °C. The support was an HK alloy, a member of the heat-resistant cast alloy family (H-Series) steels. The H-series steels are widely used in the petrochemical industry for components requiring enhanced high-temperature properties. Microstructural changes occurring at high temperature clearly affect the mechanical properties. The property degradation in HK-40 steel furnace tube support subjected to high temperature was caused by the formation of sigma phase. The investigation included metallurgical analysis, materials characterization, and mechanical analysis.

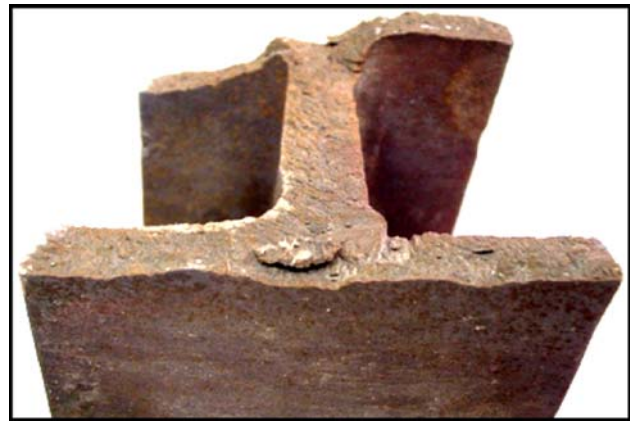
Figure 1 shows a fracture surface of one of the furnace tube supports. Clearly, the fracture surface exhibits characteristics typical of macroscopically brittle failure with large facets. There was no apparent corrosion, and surface appeared uniformly oxidized. In addition, there was no significant plastic deformation on the sample.

Fig. 1 Fracture surface of one of the furnace tube support samples-HK-40

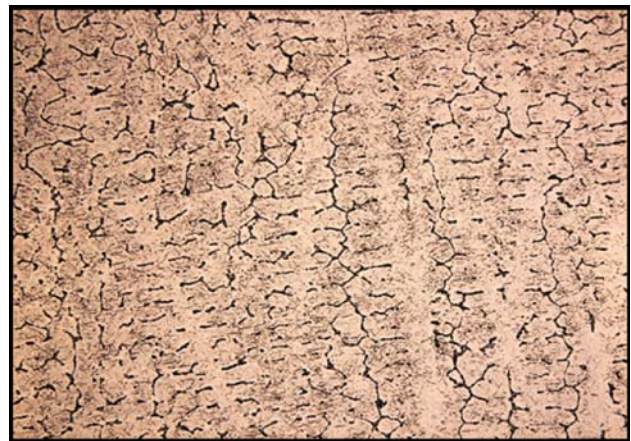
Fig. 2 Cross section of the HK-40 sample, etched, KOH

the phases were determined without standards using an energy-dispersive spectrometer (EDS) system that was attached to the SEM. Figure 2 shows an optical micrograph of a sample showing cross section of the fracture surface in the as-etched condition showing dendritic microstructure typical of cast materials.

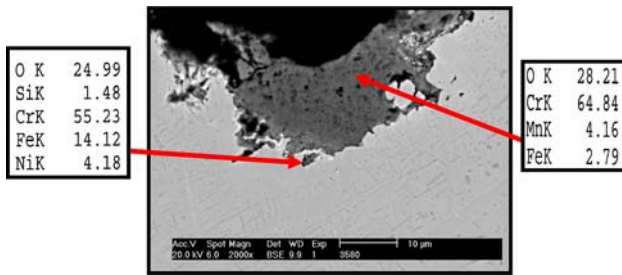
A SEM micrograph showing a location just below the surface of the fracture is shown in Fig. 3. The entire surface has been oxidized. In the area of the same figure, sigma- σ -phase has been identified with aid of EDS. Figure 4 shows an image of an area within the sample along with its identified phases and was again present.

Fig. 3 SEM optical micrographs showing cross section sample in the as-polished condition along with its EDS analysis. Elemental analysis indicates oxide formation

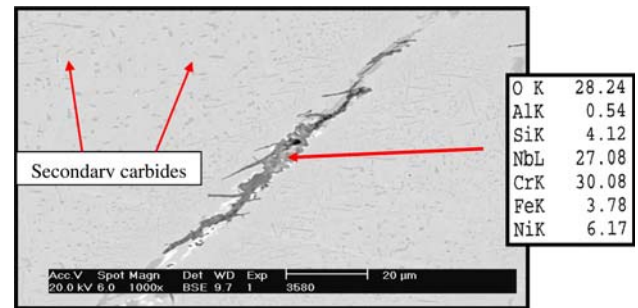
Figures 5–7 show different locations within the sample. These locations also contain σ -phases and secondary carbides precipitates. Cracks were observed in the samples, and these cracks were filled with oxides. Figures 8 and 9 are optical micrographs of a sample etched using a sigma-phase etchant. It is clear that the cross section of the fracture surface exhibited an excessive amount of σ -phases along grain boundaries and along the fracture surface itself.

Fig. 6 Scanning electron micrograph along with its EDS analysis showing cracking filled with oxides

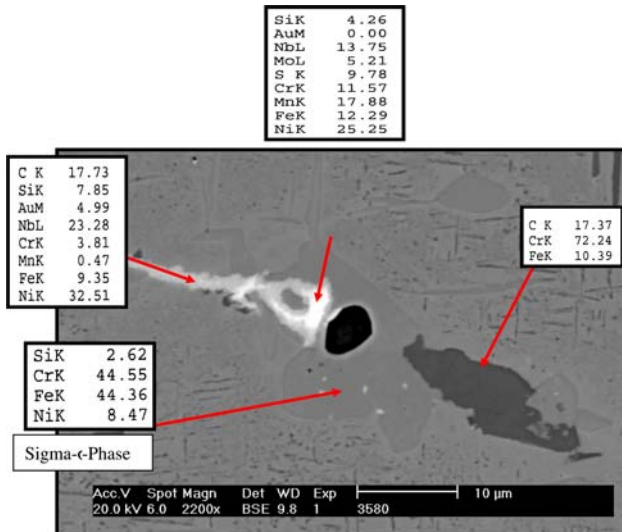
Fig. 4 Scanning electron micrograph of an inner section within a sample below the fracture surface along with EDS analysis. Composition of lower part is typical of sigma phase. High-temperature attack on σ -phase

Sigma (σ) phase (iron-chromium compound) developed in the steel as shown in Fig. 4 to 9. This phase is a hard brittle

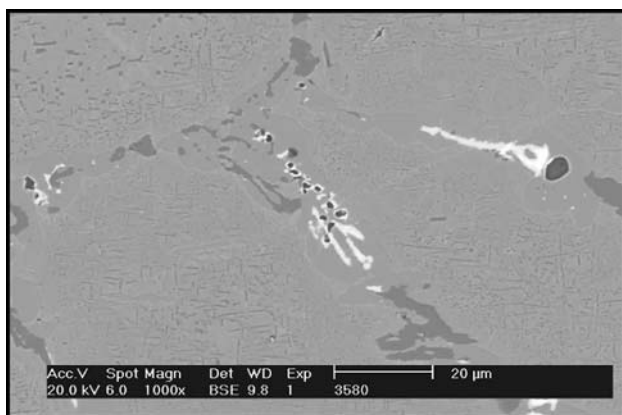
Fig. 5 Scanning electron micrograph showing signs of high-temperature attack mainly on sigma phase location

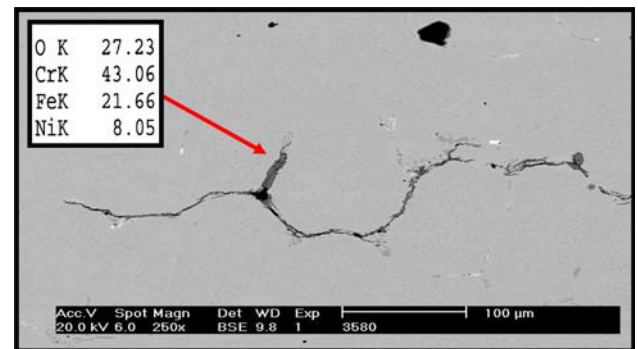
Fig. 7 Scanning electron micrograph along with its EDS analysis showing high-temperature cracking mainly following sigma phase locations

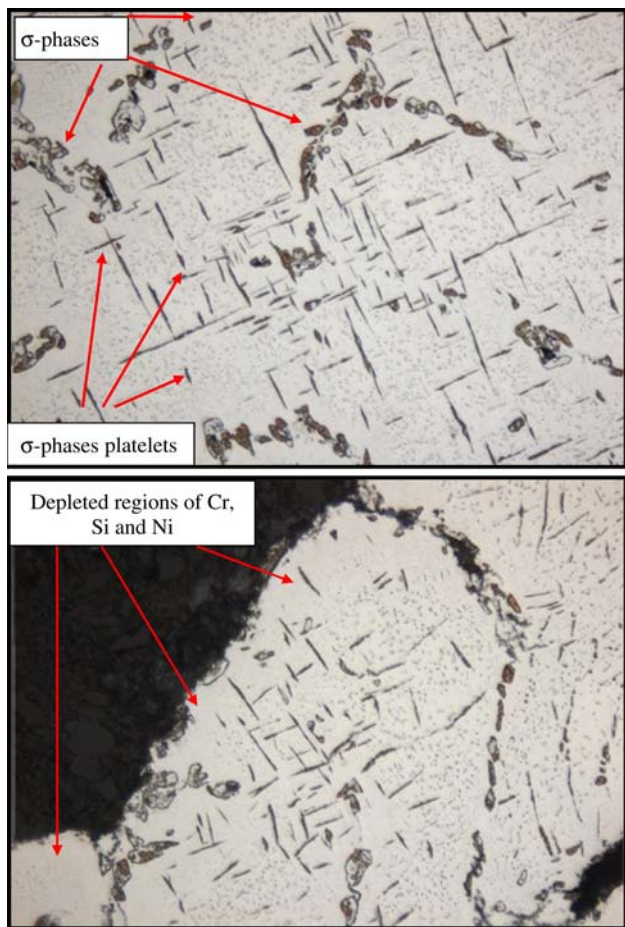
It is also clear that the areas adjacent and below σ -phases were depleted of Cr, Si, and Ni. This has prevented formation of SiO_2 and Cr_2O_3 , as clearly shown in Fig. 8 and 9

Fig. 8 Optical micrographs of the samples in the as etched condition, showing excessive amount of sigma phase. Sigma phase etchant was used

A lamellar (stringers) constituent tentatively identified as an austenite, carbonitride eutectoid resembling pearlite also is frequently observed in HK alloys [40]. If these phases are present in excessive amounts, the unbalanced composition of the alloy can lead to the presence of some ferrite in the austenite matrix. This will directly affect the local metallurgical and mechanical properties. This ferrite, given time, will transform to the brittle sigma phase if the alloy is held around 816 °C (1500 °F) with consequent weakening at this temperature and embrittlement [43]. The direct implication of sigma-phase precipitation and growth will cause Cr and Si depletion in the surrounding metallic matrix next to it (Fig. 8) and will further reduce HK-40 metal oxidation resistance [44].

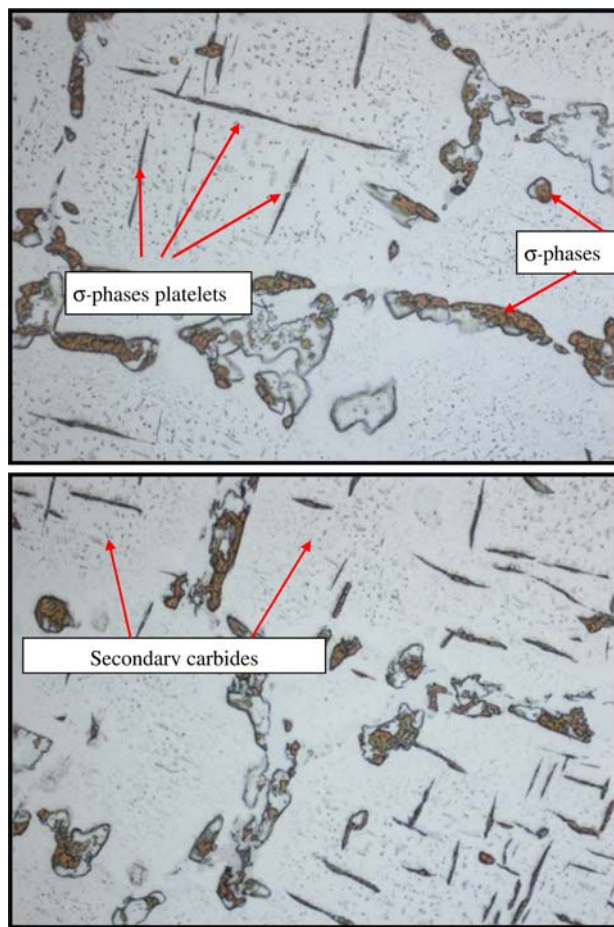
Fig. 9 Optical micrographs of the samples in the as-etched condition showing sigma phases and secondary carbides precipitates

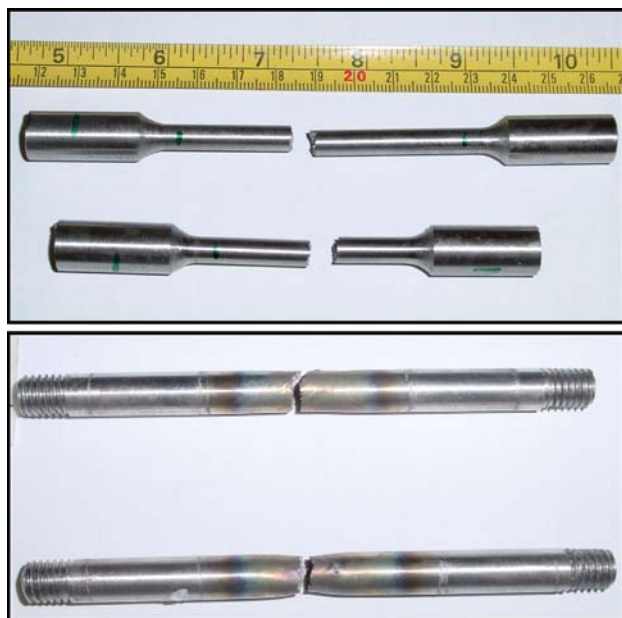
Results of the tensile samples are shown in Fig. 10 to 13. There is clearly only limited yield on most of the graphs (Fig. 13). The room-temperature samples broke with very little elongation. The two 800 °C samples, on the other hand, showed a little ductility, which is also reflected in the obvious reduction in area (%A).

**Fig. 10** Tensile samples at room temperature (RT-top) and at 800 °C after the test. The samples of the RT show no plastic deformation, indicative of brittle fracture; while slight necking is observed in the high-temperature tests

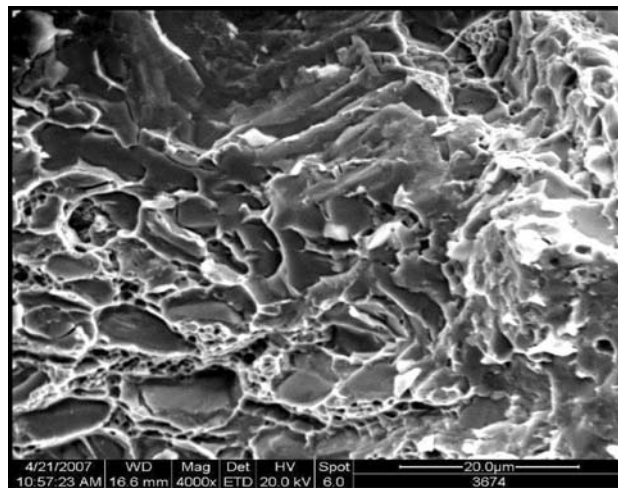
samples is really the result of the room-temperature brittleness of the material. The room-temperature samples broke very soon after yield, while the maximum strength for the 800 °C samples is close to the ultimate tensile strength of the material at that temperature. All of the fracture surfaces showed interfacial fracture; although the samples in the 800 °C test exhibited large areas of ductile rupture.

**Fig. 11** Fracture surface of the tensile sample after testing at room temperature, showing interfacial fracture along sigma phase precipitates

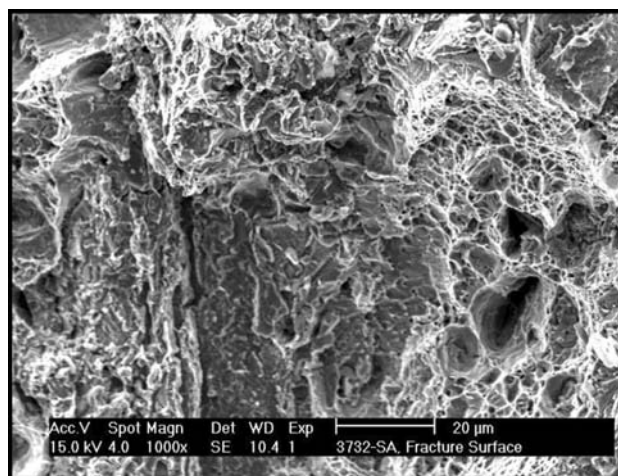
**Fig. 12** Fracture surface of the tensile sample after testing at 800 °C showing mixed-mode fracture and microvoids coalescence

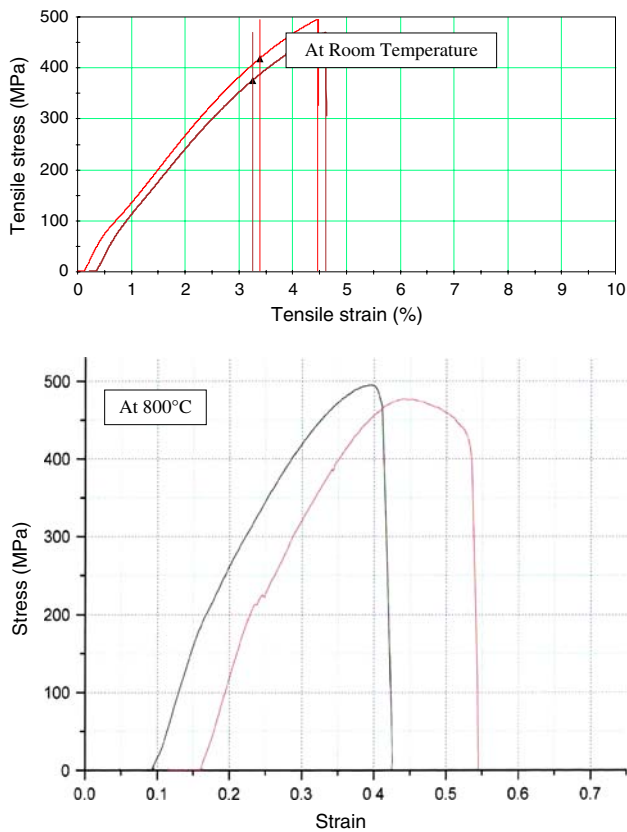
Fig. 13 Tensile tests stress and strain graphs of the samples tested at room temperature (top) and at 800 °C (bottom)
