## Challenges in Procurement of HIC Resistant Steel Pipes

**Abstract** Welded pipes ordered for wet sour service are required to be manufactured from hydrogen-induced cracking (HIC) resistant steel plates. Pipe manufacturers procure steel plates with HIC testing, and other additional requirements with respect to chemistry, mechanical testing, and non-destructive testing (NDT) to meet client requirements. There have been several worldwide instances when the pipes ordered for wet sour service have failed HIC test at the pipe mill resulting in significant project delays. The causes of HIC test failures range from deliberate mistakes to improper testing practices. Also, subtle changes in steel making and rolling practices contributed to the HIC test failure following the pipe fabrication. Saudi Aramco has established several lines of defense to prevent recurrence of similar failures. Saudi Aramco reservation on mandatory HIC test requirement on seamless pipes as per the latest API 5L 44th edition, is discussed.

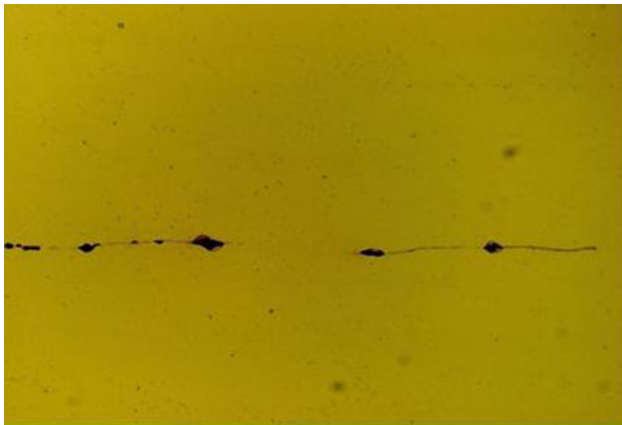
**Fig. 1** As polished cross section showing non-metallic inclusions in Pipe No. 4, heat no. A, Mag. 630×, untested sample

Elongated manganese sulfide inclusion, which is considered the most favorable trap site for hydrogen, is shown in Fig. 1. HIC observed in two metallographic cross sections from the tested 32" pipe is shown in Figs. 2 and 3.

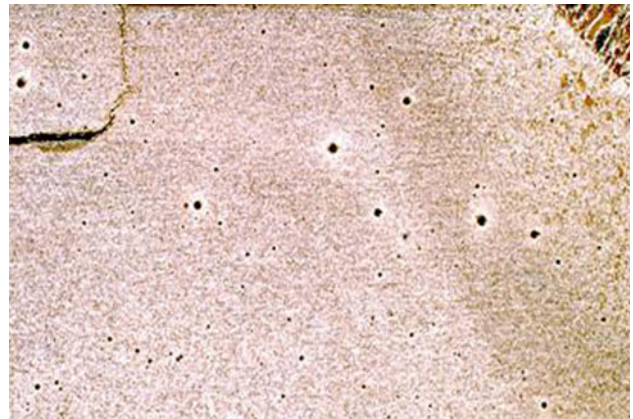
**Fig. 4** HIC located outside the heat-affected zone in specimen no. 7-W-A, heat no. E, Mag. 32×

Twenty-one pipes of the 32" diameter represented by five heats and manufactured using plates supplied from steel mill SM3, were HIC tested at Saudi Aramco and third party laboratory in Europe. The test results indicated that 19 out of the 21 pipes failed. Although welds are immune to HIC, the welded specimens shown in Fig. 4 failed the

HIC testing due to non-metallic inclusions in the plate adjacent to the weld. Figure 5 shows HIC due to centerline segregation.

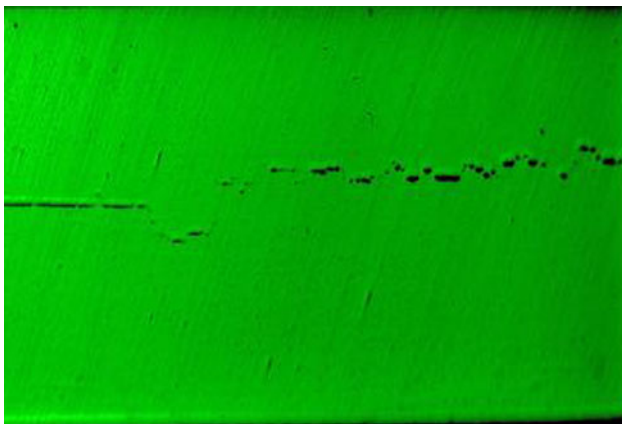
**Fig. 2** Stepwise cracking in specimen no. 6-1, heat no. A, Mag. 6.3×

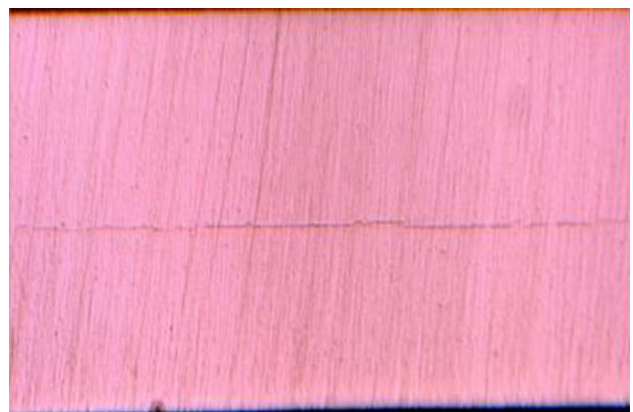
**Fig. 5** HIC due to centerline segregation in specimen U-B, Heat No. G

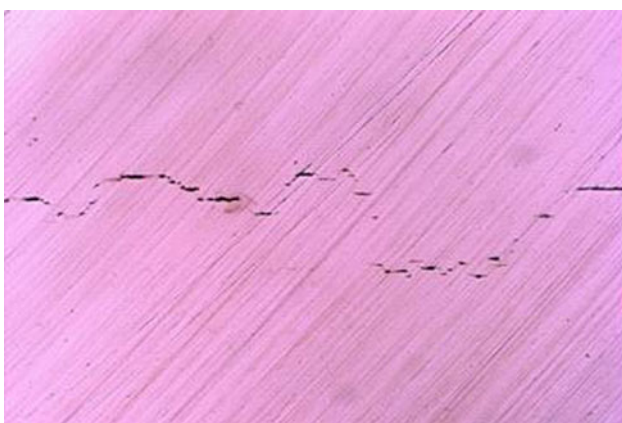
**Fig. 3** Stepwise cracking in Pipe No. 5, heat no. B, Mag. 20×

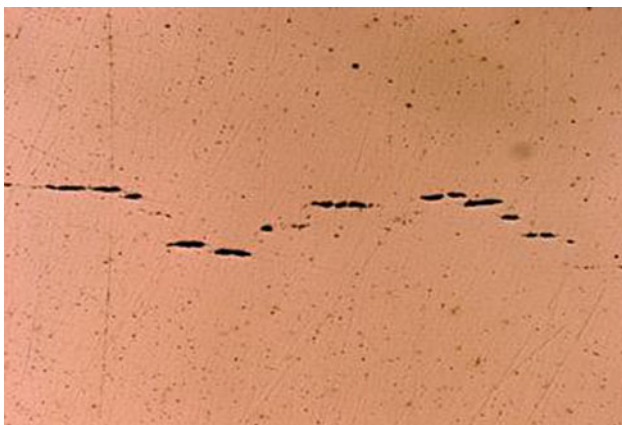
**Fig. 6** Stepwise cracking observed on specimen 11-W-A, heat No. P, Mag. 25×

Twenty-seven pipes of 28" diameter represented by seven different heats were tested for HIC susceptibility. Twenty-six pipes out of 27 failed the HIC tests. Figure 6

shows stepwise cracking (SWC) in one of the HIC-tested pipe samples.

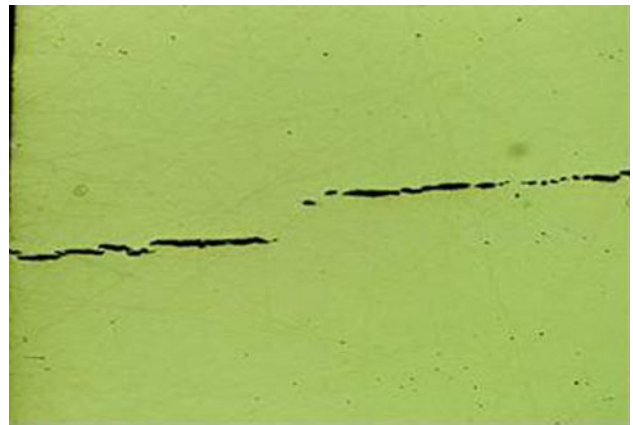
**Fig. 7** Stepwise cracking in Pipe No. D0307882, Heat No. V, Mag. 40×

Eight pipes of 24" diameter representing three heats were tested for HIC susceptibility only at Saudi Aramco laboratory. All eight pipes failed the HIC tests. Figure 7 shows SWC in one of the HIC-tested pipe samples. Although welds are immune to HIC due to cast structure, the welded specimens developed HIC apparently due to the presence of high density of non-metallic inclusions in the plate adjacent to the weld. Unexpectedly, two pipes from the same heat developed sulfide stress cracking (SSC) in the HIC specimens containing the weld. Figure 8 shows SSC on these specimens. Microhardness measurement using 50 g load carried out in the vicinity of crack ranged between 252 and 262 Vickers. As shown in Fig. 9, the SSC cracks propagated through the hard transformation microstructure, which is a characteristic of SSC.

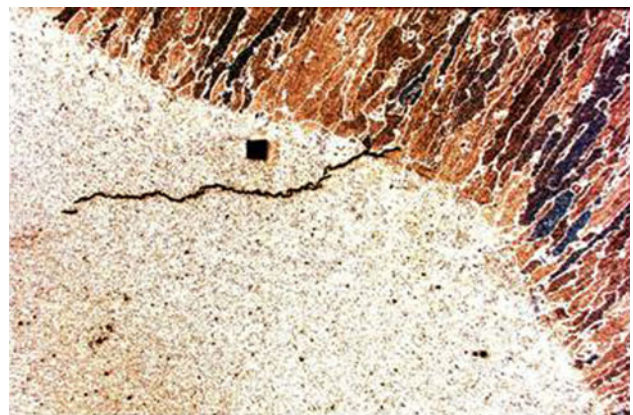
**Fig. 8** SSC in the HAZ terminating at the vicinity of the fusion line. Pipe No. D0307143, Heat No. X, Mag. 16×

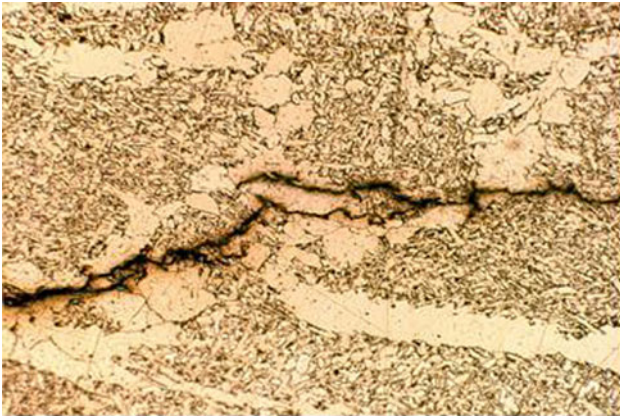
**Fig. 9** The cracks shown in the above figures follow the hard transformation structure

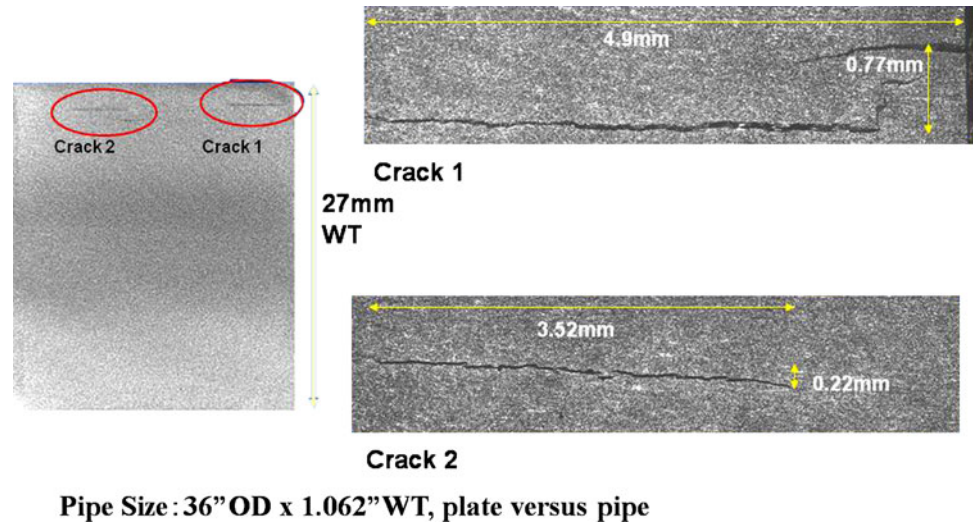
**Fig. 10** HIC observed closer to the outer surface of the pipe

All plates that passed the HIC tests failed after pipe fabrication. A detailed investigation was carried out by the steel and pipe mill. The metallurgical examination and steel mill records indicated that HIC failure was due to a lower final rolling temperature of the plates. This was supported by the fact that the HIC was observed closer to outer surface of the pipe. This location of HIC is shown in Fig. 10. The variation in through thickness microstructure is shown in Fig. 11. Low final rolling temperature resulted in a higher percentage of plastic deformation close to the surface as compared to the center of the plate. This in turn resulted in a relatively higher degree of strain in the grains close to the surface. The strain further increased in magnitude during the pipe formation. The amount of strain induced during pipe formation would depend on the wall thickness to diameter ratio ( $t/D$ ) of the pipe. The highly strained grains close to the surface resulted in non-conventional failure by HIC. It is noted that the HIC was observed only close to the outside surface of pipe because the outside surface is under tensile stress and the inside surface is under compressive stress. This would explain why the plates passed the HIC test whereas the same plates after rolling into pipes failed the same test. The possibility of excessive mechanical expansion contributing to the HIC failure of the pipe is not ruled out.

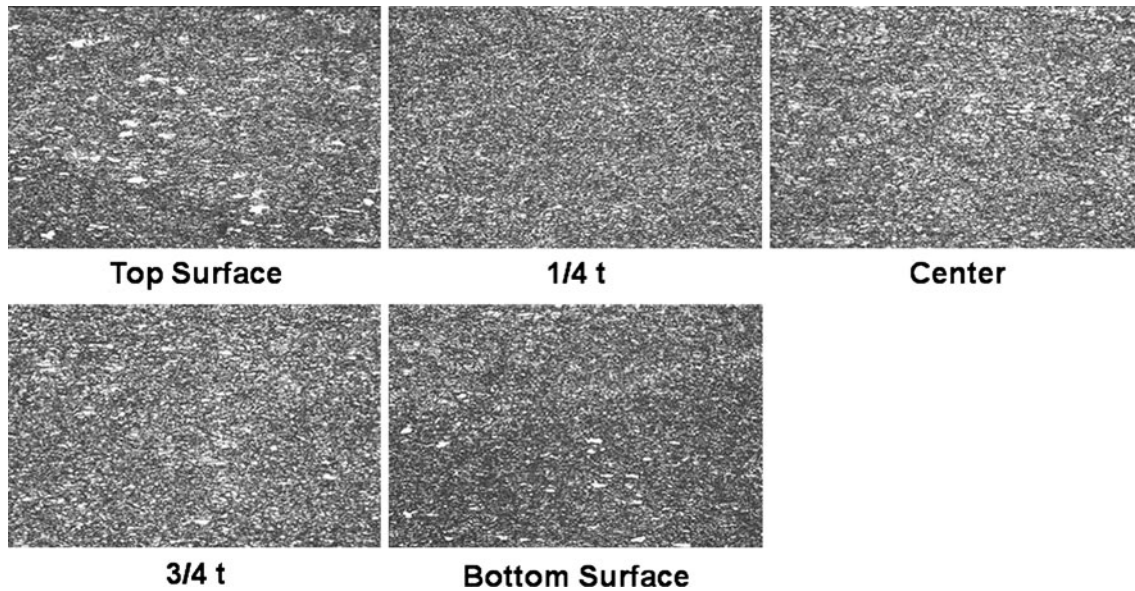
**Fig. 11** Variation in through thickness microstructure
