Failure Analysis and Improvement of Defective Clamping Pad During Leak Testing Process Using Kepner-Tregoe Analysis

Ravinder Jhorar · Vimal Kumar Pathak · Pooja Singh

Submitted: 20 May 2020 / Published online: 9 August 2020
© ASM International 2020

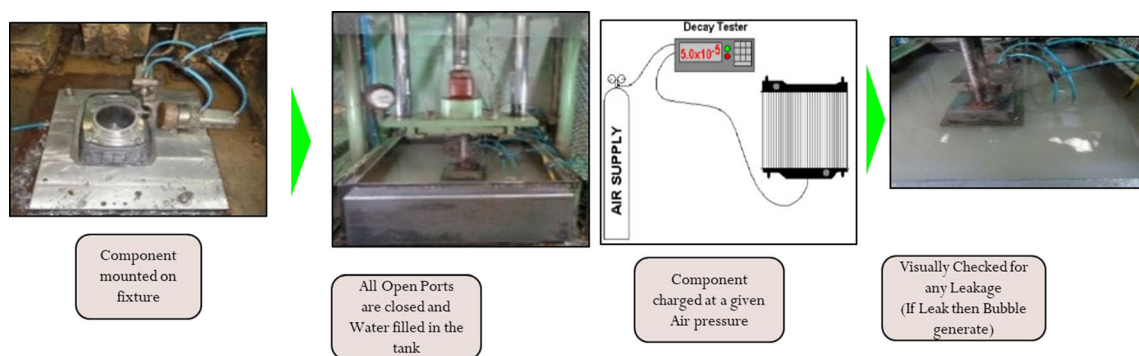
Fig. 1 Process flow chart for leak testing

The present work deals with performing cylinder block leak testing inspection in the industries by clamping and fixing it on the leak testing machine and performing leak bubble test. It is important to perform such test prior to its functioning, as it prevents poor/weak engine performance due to the formation of crack in cylindrical block by prohibiting leakage of fuel during operation. The cylinder block is mounted on a fixture and after closing all ports, air is pressurized into at a required level. If there is leak exit, it will lead to bubble generation. The process flowchart of leak testing process for cylinder block is depicted in Fig. 1.

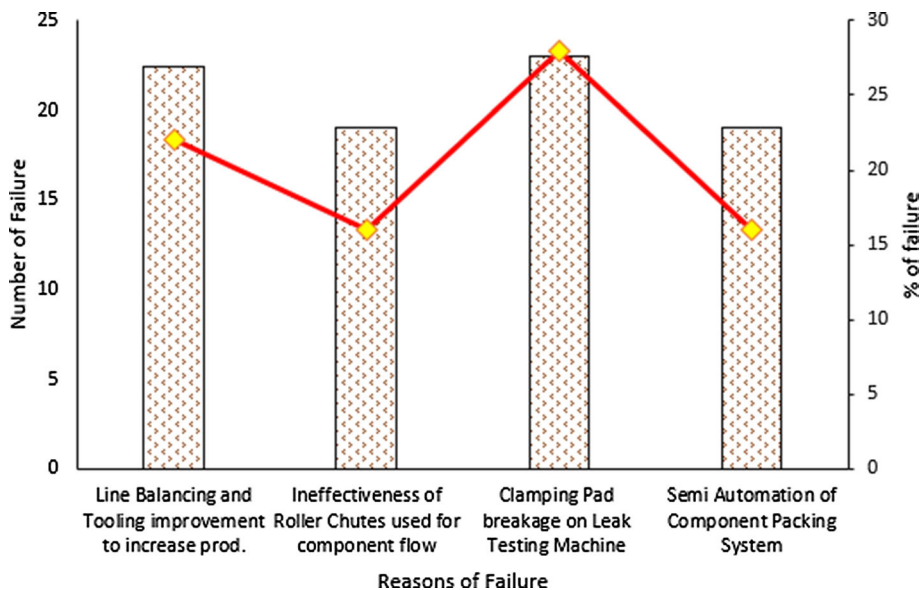
Fig. 2 Bar chart providing important concerns for major rejection

Based on the knowledge and experience of experts and workers, four important regions are selected for checking and further improvement, the line balancing and clamping pad breakage. From Fig. 2 and Table 1, it is evident that significant rejection is primarily because of the clamping pad breakage and poor line balancing that needs tooling improvement. The former reason can be dealt with K-T analysis as the latter concern can be dealt on production line itself. Based on the problem analysis, it becomes evident that breaking of clamping pad on leak testing machine has higher points as compared to other area. Therefore, the problem of clamping pad should be considered first, and further analysis must be performed.

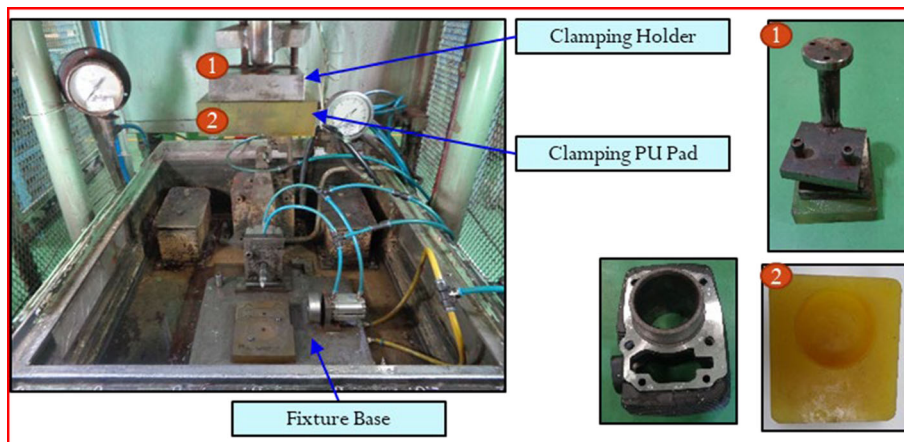
Fig. 3 Component clamping fixture

The QC team brainstormed and come up with root cause of clamping pad breakage in a leak testing machine and their probable solutions. During the engine cylinder block clamping process, two crucial components in fixture play important role in holding and stabilizing the component (see Fig. 3).

1. Clamping holder.
2. Clamping PU pad.

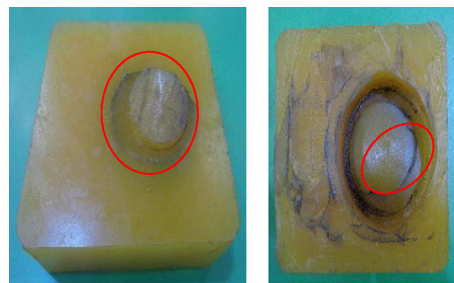
Fig. 4 Generated crack at clamping pad

After close look at the clamping pad part, it was clearly seen that cracks were generating as depicted in Fig. 4. While using this fixture and clamping pad during manufacturing and testing of cylindrical block, generated cracks at clamping pad were leading to imperfection in cylindrical block which was the primary reason for leakage testing failure. From further analysis, it was also realized that three different types of clamping pads are being used during the leak testing process for the effective results, leading to cost and time wastage in changing as per the different model. The problems and the adverse effects concerning these issues are explained in Table 2.

Based on the defined problem above, data were analysed over a period of time and it was observed that there were two reasons for clamping pad change. Either cracks were generated or there was need to change clamp pad because of wear. To compare both reasons, quantitatively data through check sheet were collected and analysed (see Table 3). From Table 3, it is evident that most (75%) of the clamping pads were changed due to the crack generation and less (only 25%) due to wear of the pads.

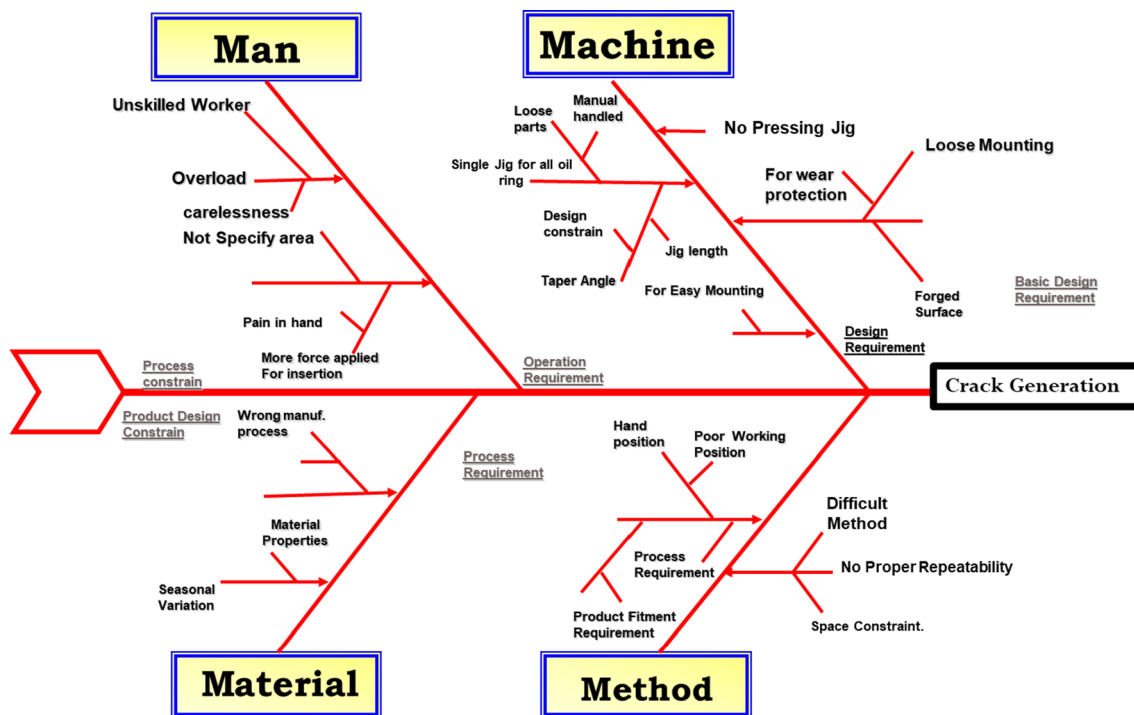
Fig. 5 Cause and effect diagram for validation of probable cause

Failure Analysis To identify root cause for crack generation in clamping pad, QC tool like cause and effect diagram is used. Figure 5 shows the cause and effect diagram prepared by quality circle team that sits together and by rigorous brainstorming under the four factors (man, machine, method, and material), and all probable causes are listed that may lead to crack generation and thus result in rejection of parts. Table 5 provides the inspection report for improper fitment, while, Table 6 shows the comparison between existing and new design.

In the cause and effect diagram, the QC team lists all possible reasons which may have led to crack generation. It is indispensable to test and validate these probable causes. We selected each of the listed probable cause and verified at the manufacturing line.

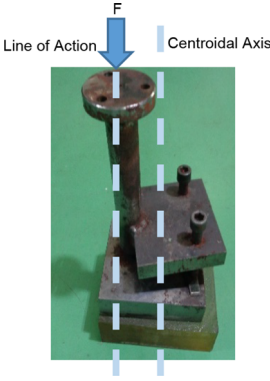
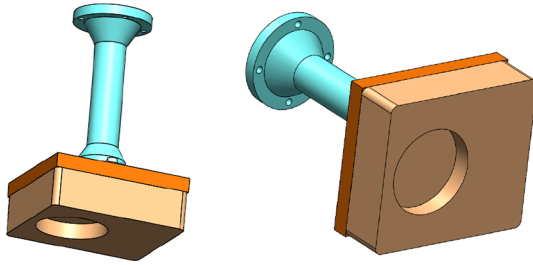
Table 6 Comparison of existing method with new design

Before (Eccentric Holder)	After (Centric Holder)
<p>An external load whose line of action is parallel but does not coincide with the centroidal axis of machine component</p>

<p>An external load whose line of action is parallel as well as coincide with the centroidal axis of machine component</p>

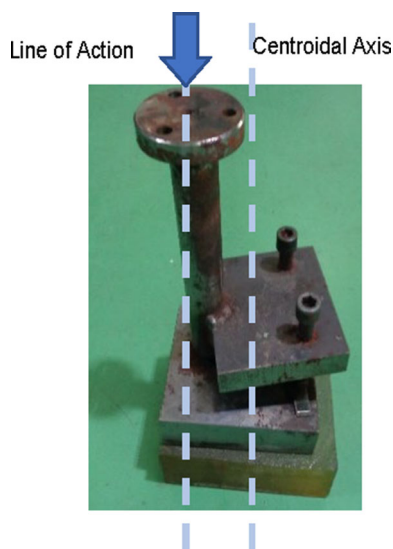
Fig. 6 Eccentric load at fixture

3. *Method* In method, it was checked whether the load applied by fixture on the clamping pad is even or not throughout the surface. Due to non-alignment of line of action, force by machine and axis of clamping pad alignment was not proper (see Fig. 6). Hence, counter measure was needed for this cause.

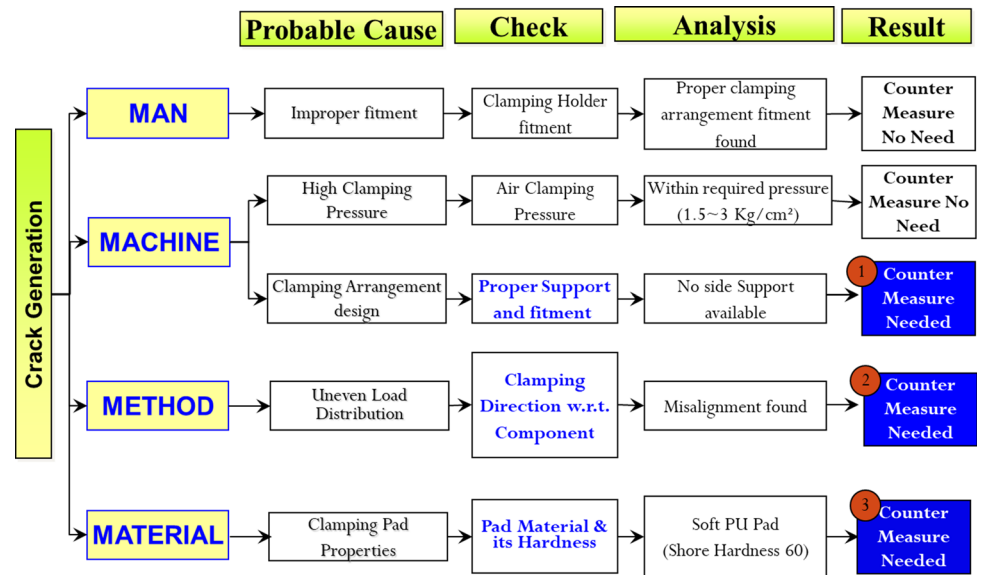
Fig. 7 Validation of probable causes

Therefore, after thorough investigation and analysis, it was found that there are mainly three regions where a remedial counter measure is required to prohibit the mode of crack generation and thus failure of the process. Figure 7 clearly illustrates the process flow beginning with defining

problem, their causes, essential checks, analysis, and results.

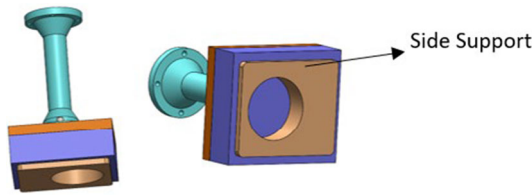
Fig. 8 Modified 3D concept

Countermeasure 2 In the second counter measure, developed 3D concept was lacking side support and there was a blind hole in PU pad. In the suggested counter-measure, side support was provided in the concept and through hole was generated at the place of blind hole in PU pad as depicted in Fig. 8.

Countermeasure 1 In clamping arrangement design, due to unavailability of side support, there was not proper fitment. After brain storming, a new design concept was developed which may provide side support and proper fitment. A 3D concept developed to visualize the idea.

Countermeasure 3 The soft PU material replaced with hard material having BHN 80 instead of 60.

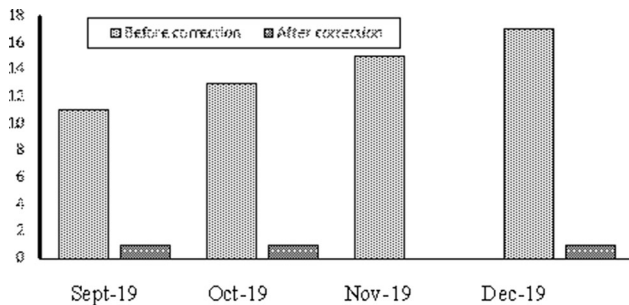
Fig. 10 Reduction in failure of clamping pad after implementing corrective measures

but also helps in reducing operator fatigue which was a non-tangible benefit. Data collected over a period of four months from September 2019 to December 2019. There was drastic reduction in rejection after the implementation of identified actions. Rejection rate is reduced by 90% (from 74 to 8) as reported in Table 7. The clamping pad change percentage is reduced significantly by 95%, and pad change due to wear and tear also reduced considerably due to use of hard PU material. Figure 10 shows the comparison of the number of clamping pad replacement before and after implementing suggestive measures. It is worth mentioning that reduction in clamping pad rejection due to

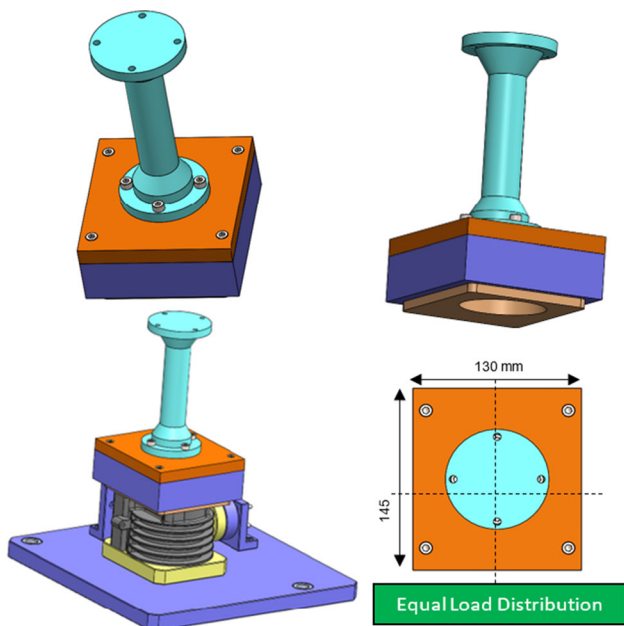
Fig. 11 Final standardized 3D concept

Developing standards for drawings and designs are an essential step for any industrial organization. With proper definition and implementation of standards, defects or failures can be prohibited in production line and at the same time constitute procedures to prevent the occurrence of other errors that could have an impact on production. It is therefore desirable to standardize all processes carried out in the manufacturing sector [3]. After successful trial of clamping pad on fixtures, standardization was done by allotting engineering drawing part code. The standardized clamping and fixture parts are shown in Fig. 11 that can be directly fed to a manufacturing line of any industry and will perform effectively and efficiently in a leak testing process.
