# Experimental Study on Frictional Pairs of Piston Pumps

**Abstract** To improve the service life and total efficiency of the piston pumps, an alloy steel of HMn58-2 manganese brass and 20CrMo are used as the material for a pin–disc, and the change in the coefficient of friction of the pin–disc is investigated via a friction/wear experiment. A Plint TE-92 tribometer is used to conduct dry and wet wear experiments on the pin–disc. After the experiments, the friction and macroscopic morphology of the sample are analysed. Results show that the wear in the dry friction experiment is not uniform, the coefficient of friction increases quickly, and the sample wears and fails. When using No. 46 anti-wear hydraulic oil as the lubricant in the friction test, the increase rate of the coefficient of friction is significantly lower than that in the dry friction test. At a rotational speed of 2,000 rpm and a load of 1.1 KN, the maximum coefficient of friction is 0.147. When the load is increased to 1,300 or 1,400 N and the speed is 1,600–2,000 rpm, the coefficient of friction is greater than 0.011. A higher rotational speed results in a smaller coefficient of friction, whereas a greater load re

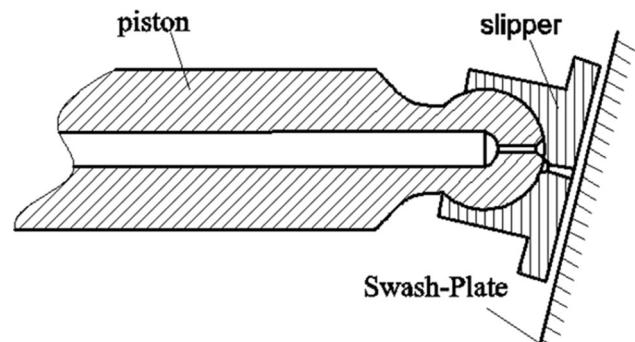
**Fig. 1** The structure of the slipper pair<sup>[20:P5]</sup>

and the compressive effect. The structure of the slipper pair is shown in Fig. 1. From the actual situation of pump damage, the burning of the slipper and the copper adhered onto the valve plate are main reasons contributing to pump failure [20]. The typical failure patterns of the slipper pair are shown in Fig. 2.

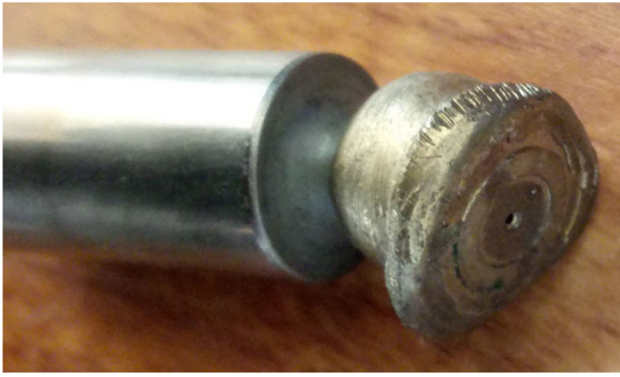
**Fig. 2** The failure of the slipper pair

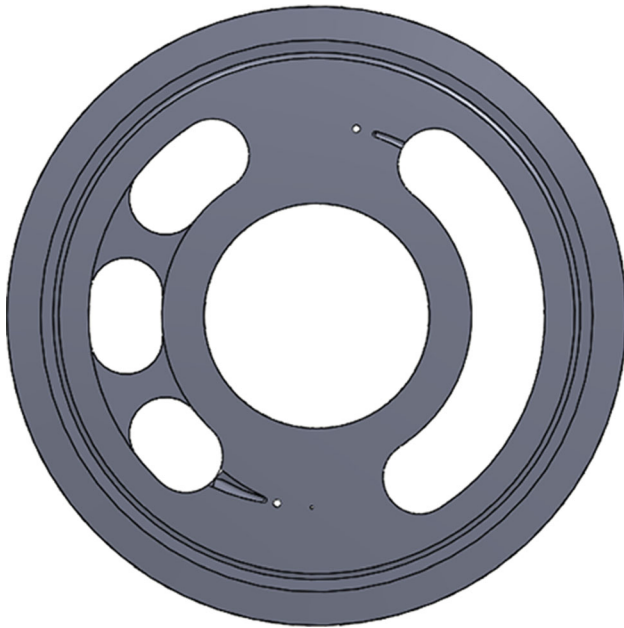
**Fig. 3** The valve plate

The valve plate distributes oil into high-pressure and low-pressure channels in the hydraulic pump such that the pump can output high-pressure oil when the piston in the pump is in operation. On the valve plate, the vane forms a triangular slot from the oil sealing region to the oil pressure window, as shown in Fig. 3. The triangular slot allows the sealing volume between adjacent vanes to gradually enter the pressure oil window, and the pressure increases gradually, thereby eliminating oil trapping and instantaneous flow pulsation and noise caused by abrupt pressure changes [21]. The basic structure of the valve pair is shown in Fig. 4, where the compression cylinder and valve plate are shown on the left and right, respectively.

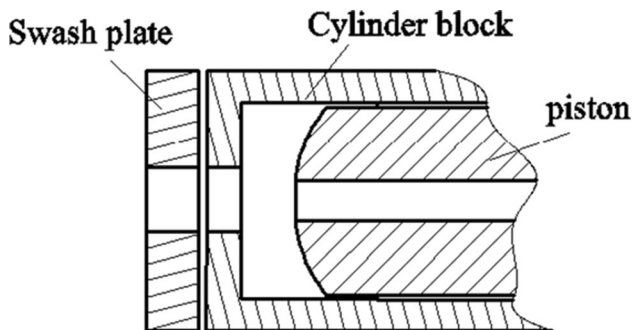
**Fig. 4** The valve pair<sup>[20-P5]</sup>

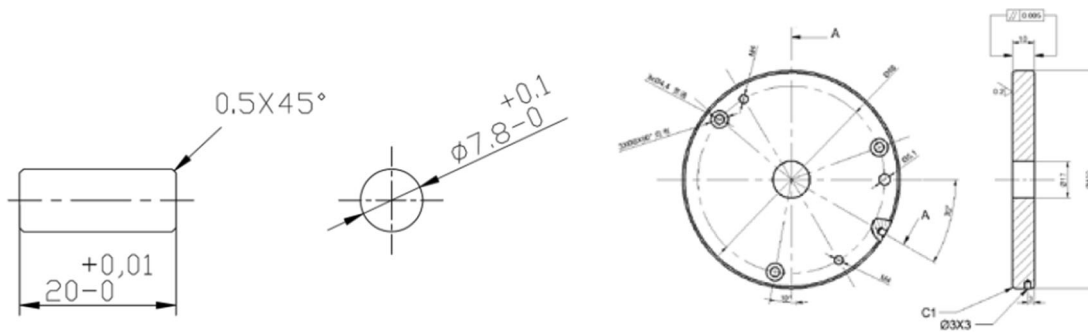
(a) The dimension of the pin sample

(b) The dimension of the disc sample

Fig. 5 The dimensions of the pin–disc sample

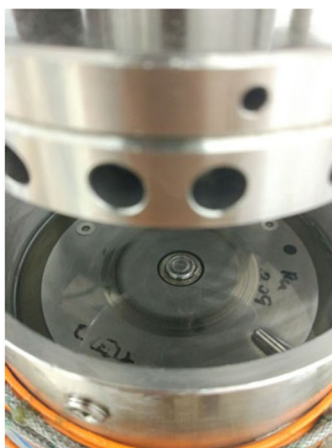
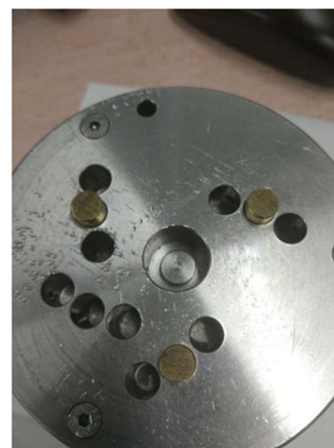
Fig. 6 The test equipment and disc sample

(a) The appearance of the test equipment

(b) The appearance of the disk sample

groups, which comprised one group for the dry friction test, and three groups for the lubricated friction test using no. 46 anti-wear hydraulic oil. The same processing technology was used for each group, and the sample radius was standardized to 30 mm. Figure 6 shows the test equipment with the Plint TE-92 tribometer and pin–disc, where Fig. 6a and b shows the appearance of the Plint TE-92 test equipment and disc sample, respectively.

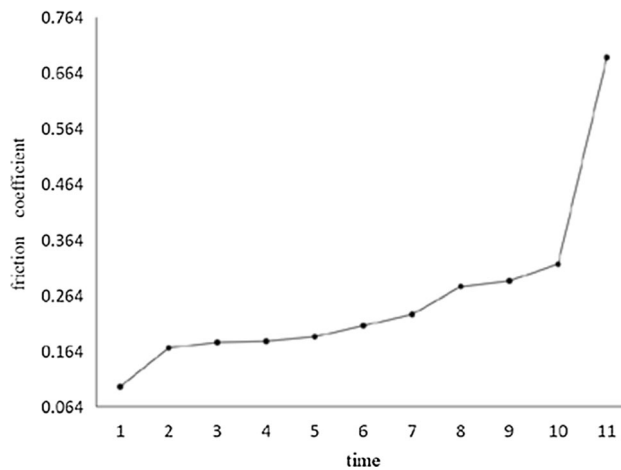
Fig. 7 The change in the coefficient of friction when the dry friction accordingly. As the testing equipment began to rotate, noise due to friction was audible during the acceleration process. At the 11th second, when the speed increased to

2,350 rpm and the pressure increased to 200 N, the coefficient of friction increased to 0.691, and the testing equipment generated a harsh friction sound. To avoid equipment damage and to ensure safety, the test was terminated.

The speed, pressure, and time of the pin–disc tests can be set through the Plint TE-92 tribometer. Figure 7 shows the change in the coefficient of friction during the test when the dry friction. In the dry friction test, the increase in pressure and speed will cause the frictional force to increase significantly and the coefficient of friction to increase

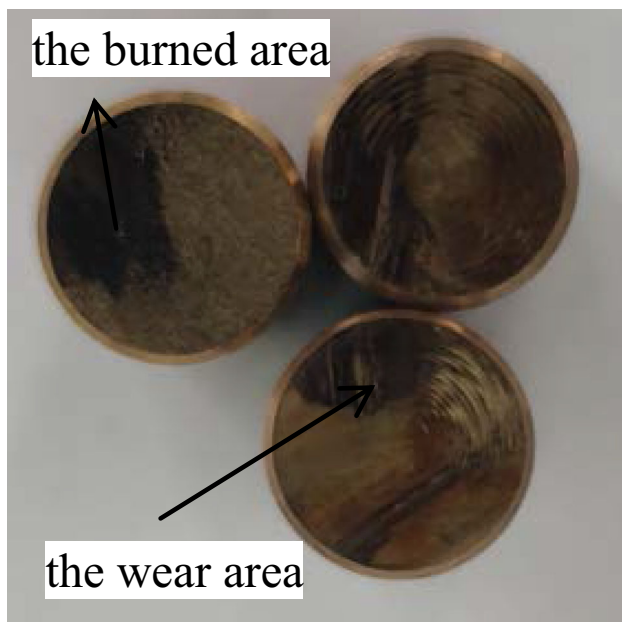
**Fig. 8** The wear map of three test pins

Photographs of the physically worn pin–disc are shown in Figs. 8 and 9. As shown in Fig. 8, the sample surface exhibited friction marks. The relatively high speed increased the temperature of the friction surface, and consequently, the friction pair became more prone to wear at high temperatures. The pin was made of brass. The high temperature of the experiment resulted in a few copper particles accumulating and adhering on the surface of the disc in the form of flakes; consequently, round marks with a slightly yellow circumference appeared because of friction. The wear of the three pins was not uniform.

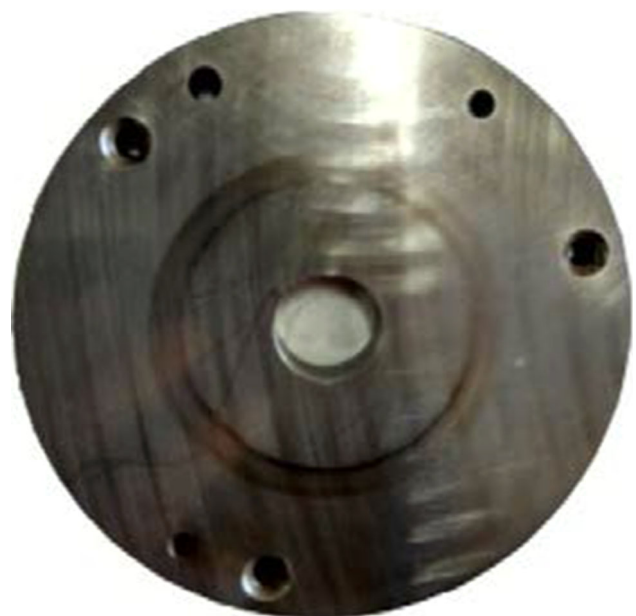
**Fig. 9** The wear map of test disc

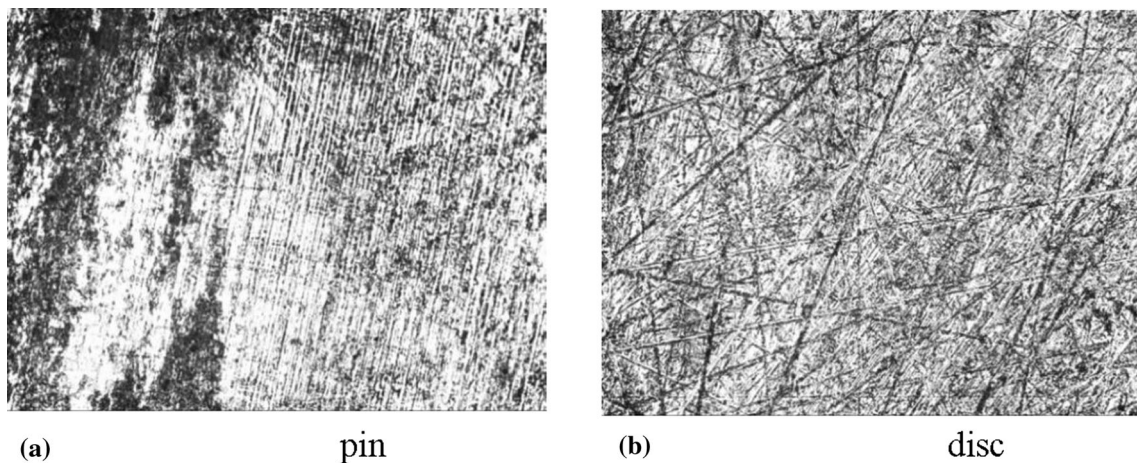
**Fig. 10** The photomicrograph of the pin–disc after the dry friction test (200X)

The surface morphology of the worn sample was observed using a Zeiss microscope. A furrow appeared on the contact surface of the copper pin, and scratches arranged in a regular pattern were observed. The abrasion increased the surface roughness of the disc, as shown in Fig. 10a. The contact surface was worn significantly, and the scratches were staggered. As shown in Fig. 10b, a few particles remained because of the copper pin. From the photomicrograph of the pin–disc after the dry friction test, as shown in Fig. 10, the scratches of the pin were lighter than those of the disc.

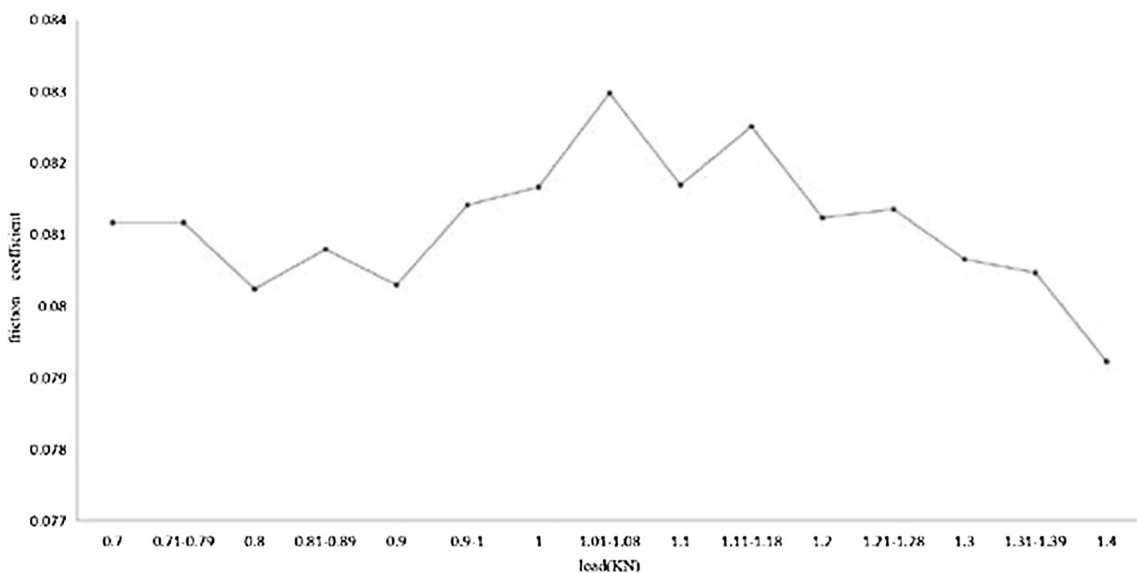
**Fig. 11** The change in the coefficient of friction when the rotational speed at 1,100 rpm

A lubricated friction test using No. 46 anti-wear hydraulic oil was first performed, and the speed was increased from 400 to 1,700 rpm. Figure 11 shows the change in the coefficient of friction during the test when the rotational speed was maintained at 1,100 rpm. The speed was fixed at 1,100 rpm, whereas the load was added incrementally; the coefficient of friction first increased and then decreased. When the load was 1120 N, the maximum coefficient of friction was 0.086. When the pressure was increased to 700, 1,100, 1,300, and 1,400 N, the average coefficient of friction values were 0.08116, 0.08169, 0.08065, and 0.07922, respectively. At the rotational speed of 1100 rpm, the difference in the coefficient of friction under different loads was insignificant. A greater load did not correspond to a larger coefficient of friction.

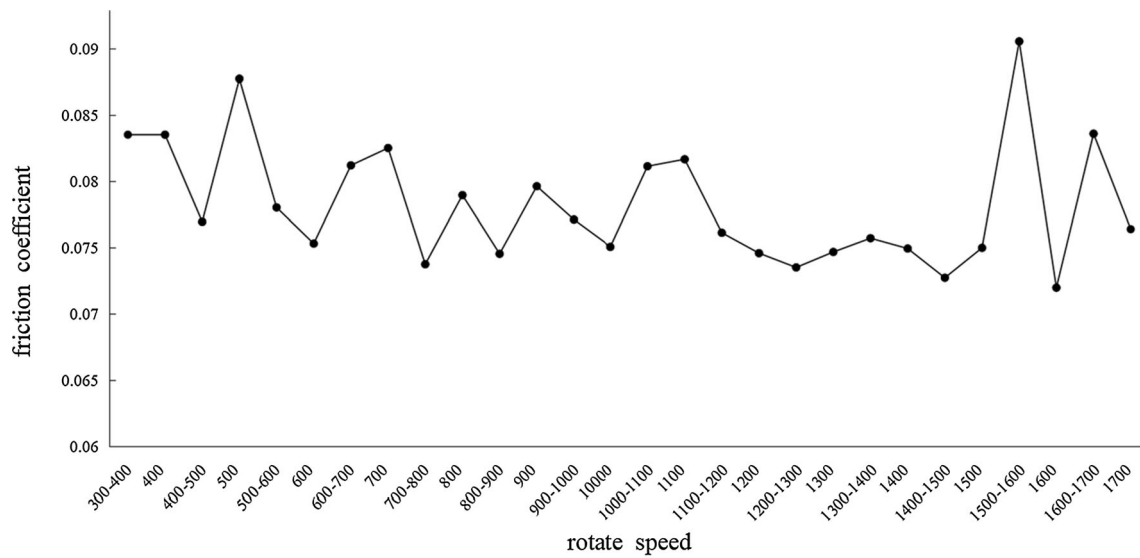
**Fig. 12** The change in the coefficient of friction with varied rotate speed

During the test, the load and speed were constantly changing with time. Figure 12 shows the change in the coefficient of friction with varied rotate speed, Fig. 13 shows the change in the average coefficient of friction at different speeds and loads over time during all tests. At the beginning of the test, the test equipment has not yet entered a stable state; hence, the measured coefficient of friction was relatively large and fluctuated significantly. After the equipment operated stably, the coefficient of friction stabilized and changed regularly. During the test, the speed was fixed first, and the load was added incrementally; subsequently, the speed was increased, and the load was added incrementally again. The experiment was performed as such reciprocally. As shown in Fig. 13, the coefficient of

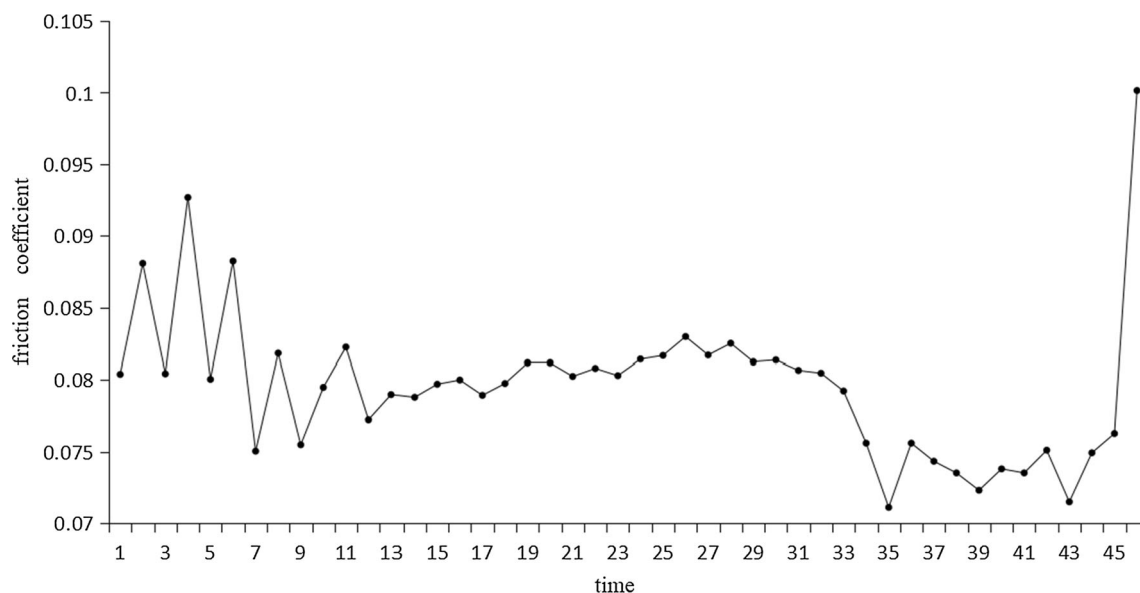
**Fig. 13** The average friction coefficient varied with load and speed throughout the test

friction showed a trend of first increasing and then decreasing, followed by increasing and then decreasing. When the test was about to be terminated, the speed and load decreased, and the coefficient of friction decreased as well. Furthermore, 5s before the equipment stopped operating completely, the coefficient of friction increased abruptly. It was speculated that the pin–disc may have been hit, causing the oil film between the pin and disc to be destroyed; therefore, the pin–disc contact surface resulted in dry friction in the absence of lubricating oil.

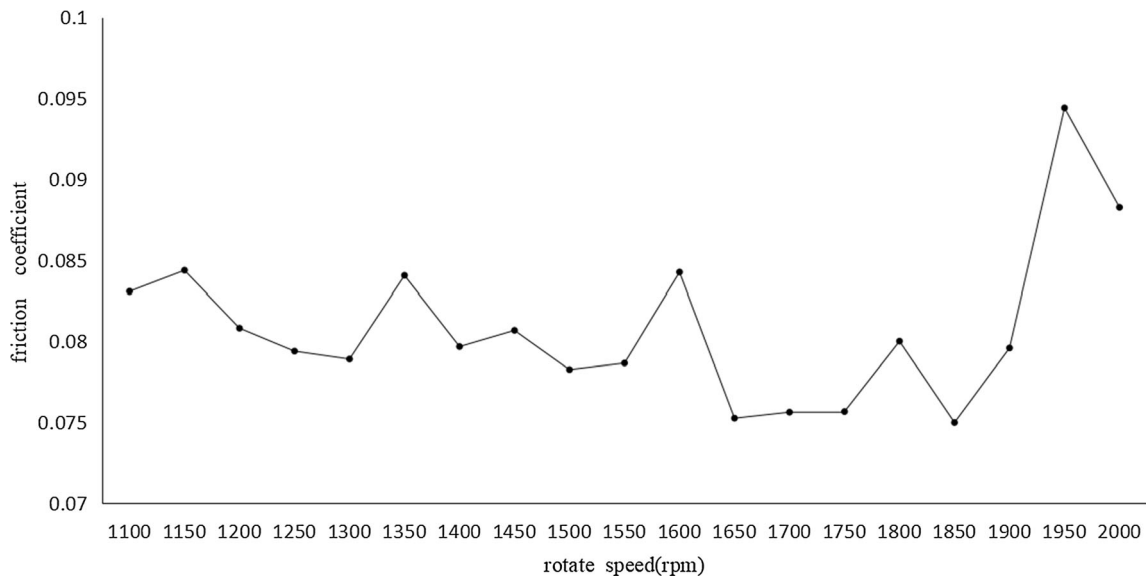
**Fig. 14** The change in the coefficient of friction when the load was maintained at 1,100N

In the second lubricated test using No. 46 anti-wear hydraulic oil, the load was increased from 1,100 to 1,410 N. Figure 14 shows the change in the coefficient of friction

during the test when the load was maintained at 1,100N. The load was fixed at 1,100 N and the speed was increased incrementally. When the speeds were 1,100, 1,300, 1,600, and 1,998 rpm, the average coefficient of friction values were 0.0804, 0.0789, 0.0842, and 0.1289, respectively, and the load reached the critical value at 1,200 N. When the load was fixed and the speed was increased, the coefficient of friction first decreased and then increased.

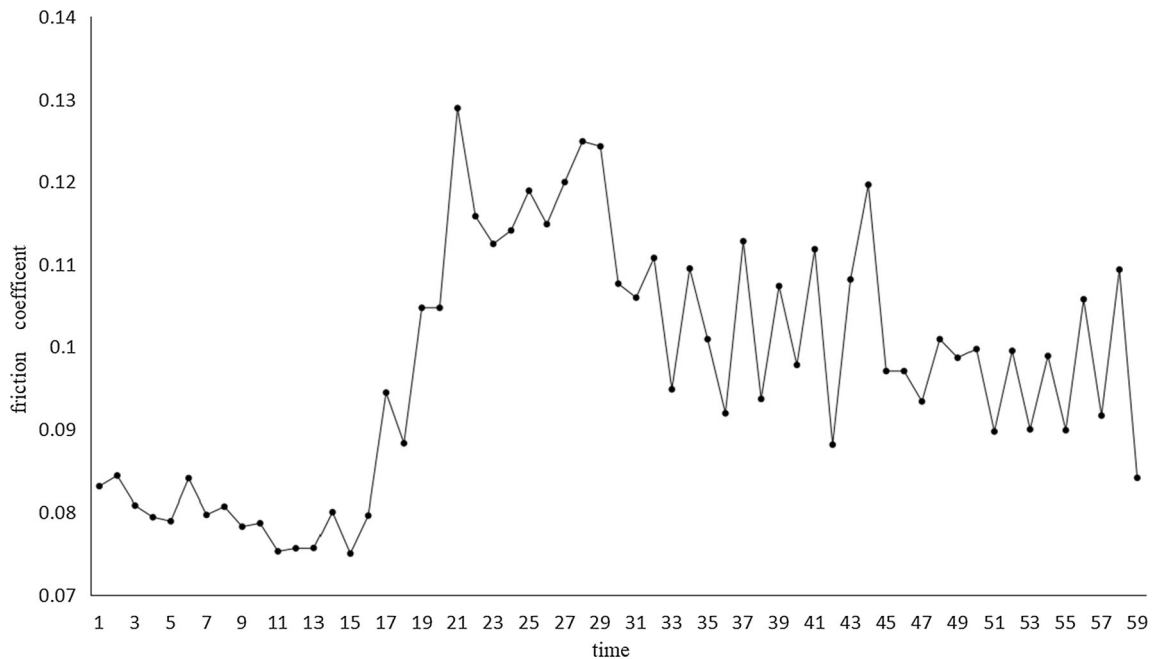
**Fig. 15** The change in the average coefficient of friction at different speeds during all tests

Figure 15 shows the change in the average coefficient of friction at different speeds over time during all tests. At the beginning of the test, owing to the relatively small load, the coefficient of friction was relatively small as well. When the load increased to 1,300 or 1,400 N, the coefficient of friction began exhibiting an upward trend. When the rotation speed was 2,000 rpm and the load was 1.1 KN, the maximum coefficient of friction was reached, i.e., 0.147. It

can be assumed that these conditions caused the onset of oil film damage. In practice, operating at a load of 1,300 or 1,400 N and a rotational speed of 1,600–2,000 rpm should be avoided. As the friction test progressed, the temperature of the test equipment and the sample material continued to increase; simultaneously, the speed continued to increase, causing the coefficient of friction to exhibit a downward trend.

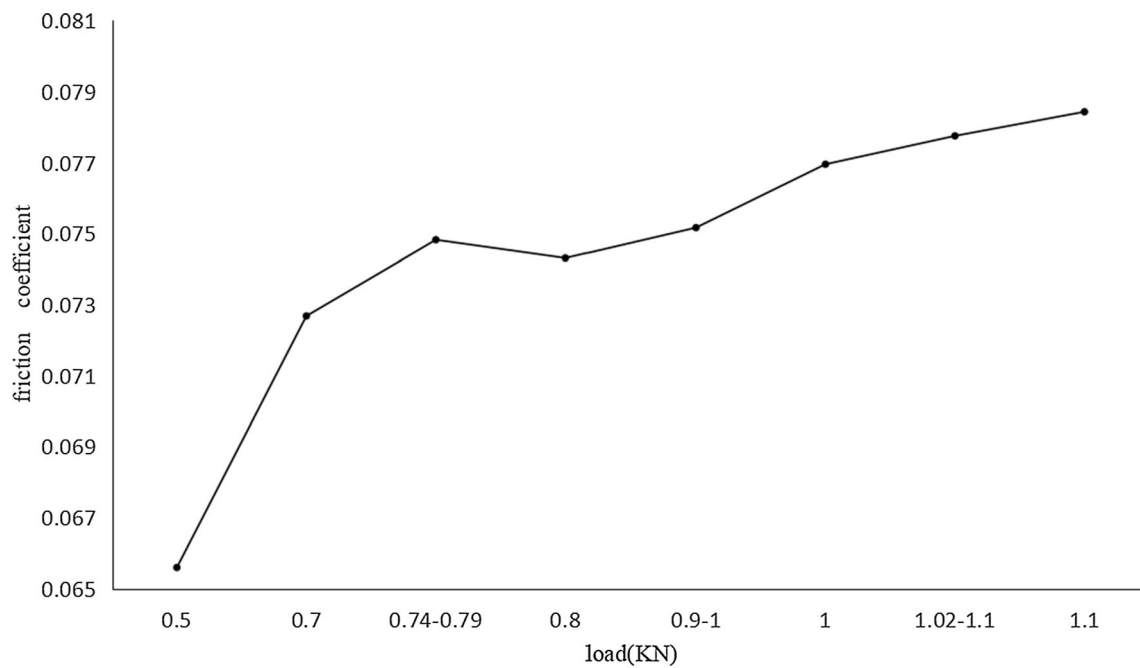
**Fig. 16** The rotational speed was maintained at 500rpm

speed was increased from 300 to 2,100 rpm. The rotational speed was maintained at 500 rpm, the load was added incrementally, and the coefficient of friction changed, as shown in Fig. 16. Because the overall time during the third test was shorter than the first test, the coefficient of friction increased overall with a fixed speed and increasing load.

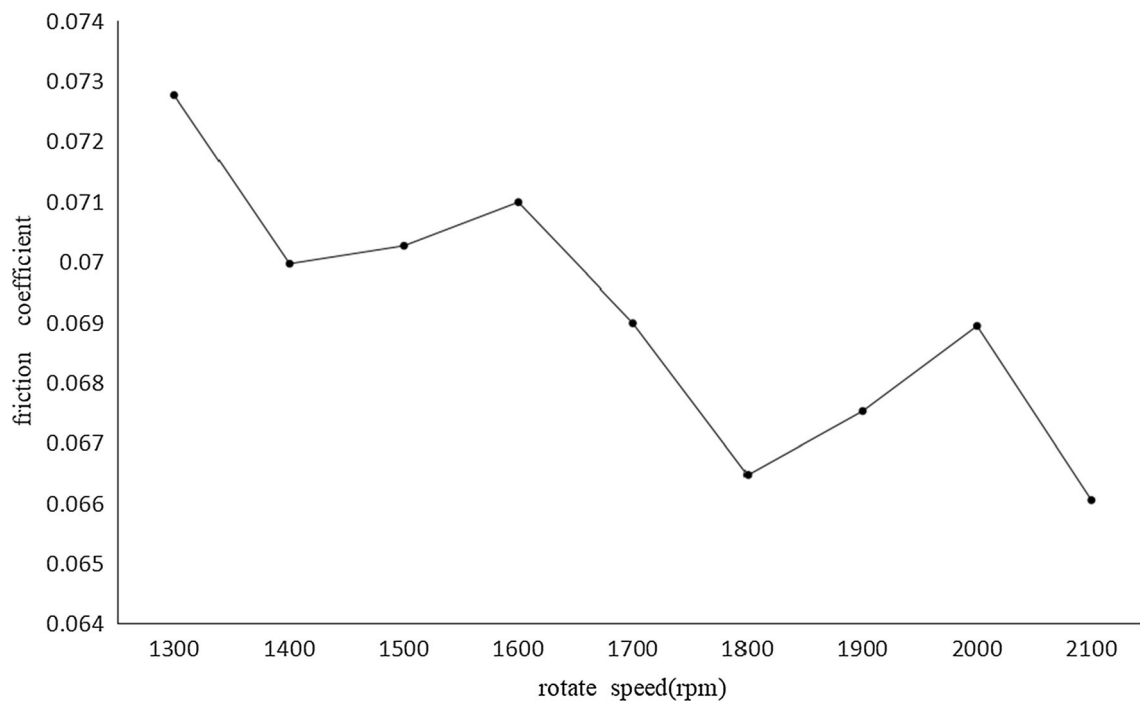
**Fig. 17** The load was maintained at 1,400 N

The load was maintained at 1,400 N, the speed was increased incrementally, and the coefficient of friction changed, as shown in Fig. 17. As the rotational speed increased, the coefficient of friction exhibited a downward trend, which is consistent with the second test.

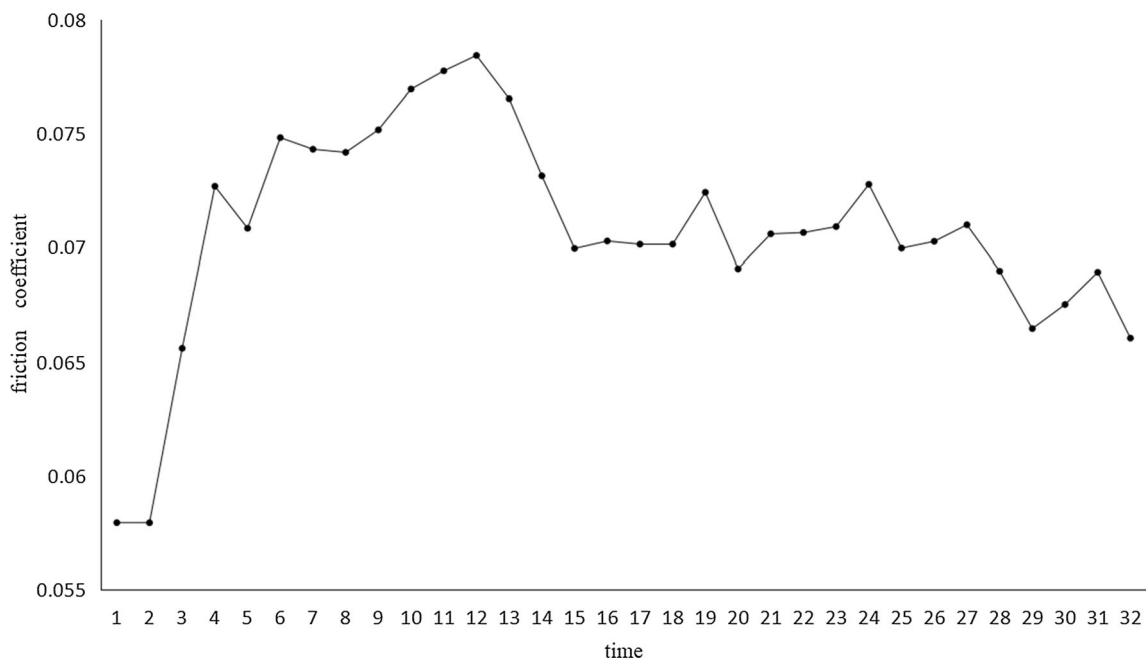
**Fig. 18** The change in the average coefficient of friction at different speeds and loads

Figure 18 shows the change in the average coefficient of friction at different speeds and loads over time during the

third test. The time required for the third test was much shorter than those of the previous two test; hence, the amount of test data corresponding to the load and speed were relatively small. It was observed from the figure that as the test progressed, the load increased, whereas the speed remain unchanged, and the coefficient of friction first increased significantly. When the test was continued for one third of the total time, the load and speed changed in the same manner as in test 1. The load remained the same, whereas the speed increased significantly, thereby

significantly reducing the coefficient of friction. Subsequently, the rate at which the rotational speed increased was greater than the rate at which the load changed, and the coefficient of friction tended to oscillate and decrease. Obviously, the change of friction coefficient in Fig. 18 was consistent with the speed change trend shown in Fig. 17, but there was a large gap with the load change trend shown in Fig. 16. It was reasonable to think that under the condition of hydraulic oil, the influence weight of speed on friction coefficient was higher than that of load. To reduce

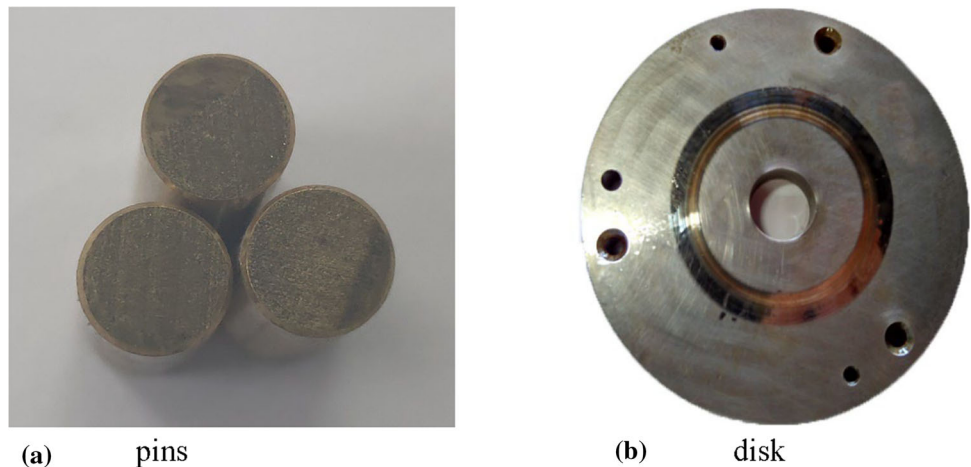
**Fig. 19** Photographs of the physical pin–disc after the friction test

A photograph of the physical pin–disc after the friction test is presented in Fig. 19. As shown in Fig. 19, a clear burn mark remained on the surface of one of the pins; however, it may be residue from the lubricating oil at high

temperature. In addition, one of the pins showed more serious wear, suggesting an uneven load distribution. As this pin experienced a large force in a small contact area, its wear was more severe. The light-coloured area in Fig. 19 shows the wear. The band in the friction zone on the surface of the disc presents a yellow colour, which was due to

the adhesion of copper, indicating that the temperature in this area was relatively high. The outer band showed a bright metallic colour. Based on the photomicrograph shown in Fig. 20, the wear marks were relatively regular and normal. The wear was primarily abrasive wear in the form of furrows, with supplementary adhesive wear.

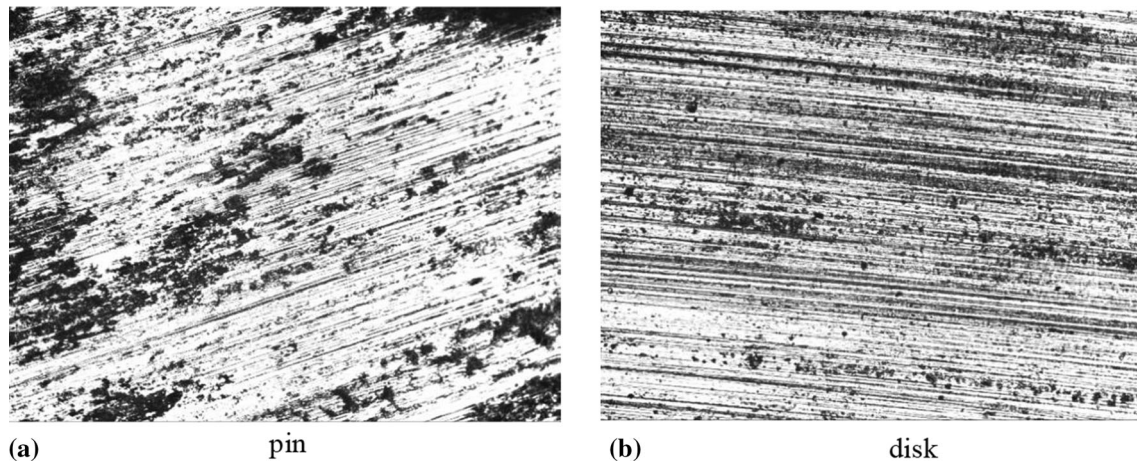
**Fig. 20** Photomicrographs of pin and disc (200X)
