The impact of Typhoon Lekima (2019) on East China: a postevent survey in Wenzhou City and Taizhou City

Abstract Typhoon Lekima (2019) struck Zhejiang Province on 10 August 2019 as a supertyphoon, which severely impacted Zhejiang Province. The typhoon killed 45 people and left three others missing, and the total economic loss reached 40.71 billion yuan. This paper reports a postdisaster survey that focuses on the storm precipitation, flooding, landslides, and weather services associated with Typhoon Lekima (2019) along the southeastern coastline of Zhejiang Province. The survey was conducted by a joint survey team from the Shanghai Typhoon Institute and local meteorological bureaus from 26 to 28 August, 2019, approximately two weeks after the disaster. Based on this survey and subsequent analyses of the results, we hope to develop countermeasures to prevent future tragedies.

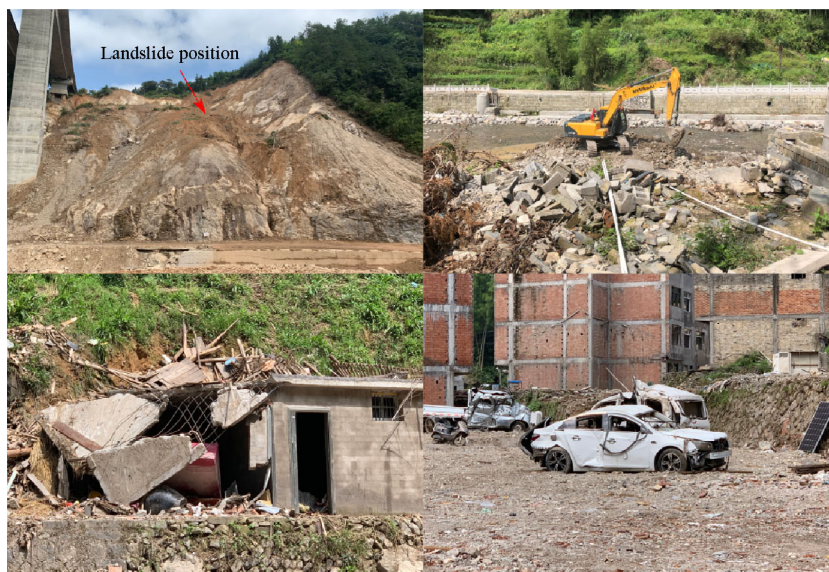
Fig. 2 Photographs of the disaster investigation field in Shanzao village, Yongjia county (Cong ZHOU, 2019-08-28 took photos). The red arrows indicate the position of the landslide.

Typhoon Lekima (2019) making landfall, the rainfall in Shanzao village exceeded 160 mm in 3 h, which caused a landslide at the entrance to the village. Figure 2 shows the landslide position and the surrounding environment. The landslide blocked a stream, which caused water levels to

rise 10 m in ten minutes, and approximately 120 people were trapped in the village. Suddenly, the water level exceeded the warning level, and the barrier lake burst. Many residents could not evacuate in time to avoid injury or death; most of them were older people and children. The

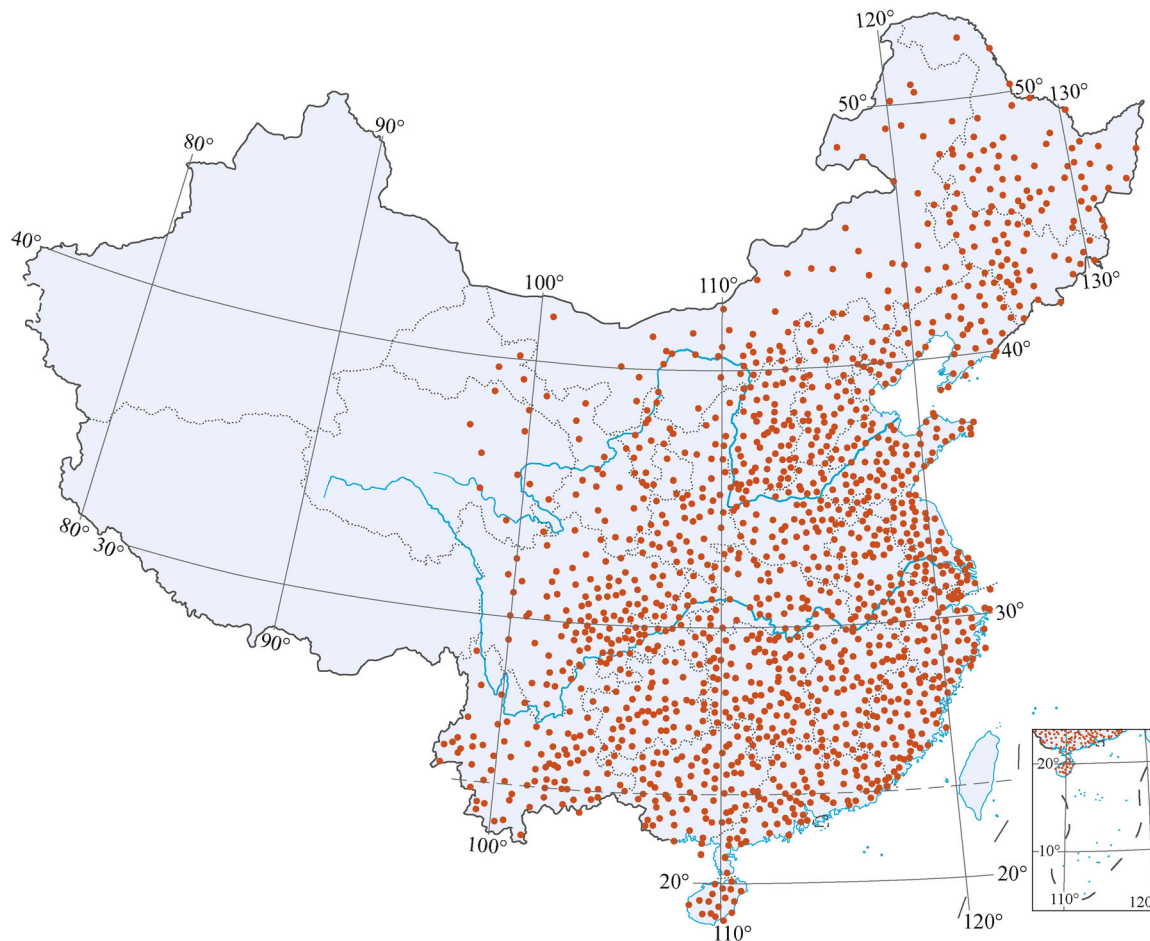
Fig. 5 Distribution of the 1401 stations chosen to analyze the precipitation and wind.

Chen et al. (2019) analyzed the relationships between TC precipitation, wind, and storm damage for Chinese mainland based on TCs over 1984–2013. The analysis shows that the maximum daily areal precipitation (MDAP) from stations with daily precipitation of 50 mm and the sum of gust wind speeds of 13.9 m/s can be used to estimate the direct damage caused by TCs. An index combining the precipitation and gust wind of a TC is defined to assess the severity of precipitation and wind (Chen et al., 2009, 2013, 2019). A total of 1401 meteorological stations were chosen to calculate the parameter based on the data completeness, representativeness, and homogeneous distribution. Figure 5 shows the locations of the 1401 stations. The combined impact index of precipitation and wind (*IPWT*) is defined as

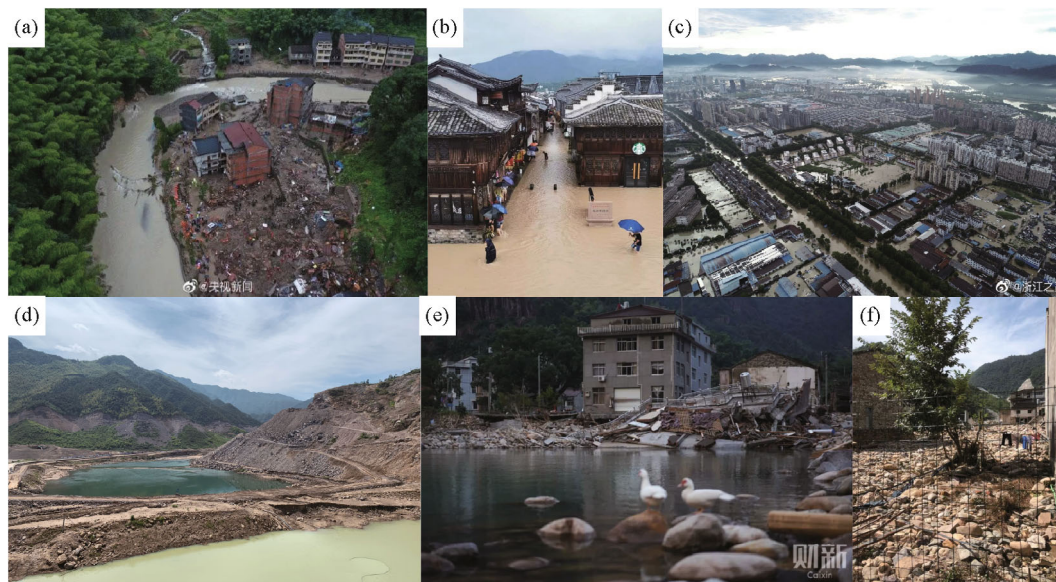
took place in Taizhou city and Wenzhou city. Here, we focus on 3 cases: Case 1 – Case 3. Figure 6 shows pictures of (a) an aerial photo of Shanzao village, Yongjia county (Source: Sina Weibo @CCTV News), (b) Linhai ancient city (Source: Website of The Paper News), (c) an aerial photo of Linhai city on 11 August (Source: Sina Weibo @The Voice of Zhejiang), (d) an unfinished reservoir, (e) collapsed buildings (Source: Website of Caixin News), and (f) exposed tree root and channel. As most survey sites were in the drone no-fly zone, we selected some photos from the Internet. Figure 7 and Figure 8 show satellite images of Linhai city before and after the flood.

Fig. 6 Pictures of (a) an aerial photo of Shanzao village, Yongjia county (Source: Sina Weibo @CCTV News), (b) Linhai ancient city (Source: Website of The Paper News), (c) an aerial photo of Linhai city on 11 August (Source: Sina Weibo @The Voice of Zhejiang), (d) an unfinished reservoir, (e) collapsed buildings (Source: Website of Caixin News), and (f) exposed tree roots and channel.

worst-hit area was located at the bend of the stream, an area near the entrance to the village with low topography (Fig. 6(a)).

Case 2: Torrential rains caused the Lin River to swell, which results in urban flooding in the ancient city of Linhai (survey site B in Fig. 1). The ancient walls of the city, facing the Lin River, were constructed in the Jin Dynasty (265–420) and have been barriers against floods since ancient times. At 3:00 pm on 10 August, the water level of the Lin River exceeded the warning level (Fig. 7), a flood wave reached the ancient walls, and the water level reached 1.5 m (Fig. 6(b)). In addition to the ancient walls, the entire city of Linhai experienced severe urban inundation (Figs. 6(c) and 8). It took at least two days for the city to recover initially. In the survey, we found that a more significant problem for residents suffering from urban inundation was isolation from the outside world caused by power failure. At night, the sense of helplessness was magnified when there was no power or mobile phone signal.

Case 3: A flash flood caused by torrential rains affected 41 buildings in Fangxi village, 20 km from Linhai (survey site B in Fig. 1). Fortunately, the villagers were evacuated early, and no people were in the homes when they collapsed into the stream. Fangxi village is a small village with approximately 500 people located in the lower reaches of the Fangxi River, a tributary of the Yonganxi River. An unfinished reservoir was located upstream of the river (Fig. 6(d)). On the evening of 9 August, a copious amount of rain fell in the reservoir in a short period. It was then discharged directly through two temporary drainage culverts, causing damage to the lower village, which was less than 500 m downstream. In the survey, we saw that houses on the upper side of the village, on the side next to the river, were almost thoroughly washed out and covered in rubble. A three-story building not far from the village council was tilted, with its foundation and steel bars visible. Large boulders covered much of the village, as did the rubble from many collapsed houses on the sides of the river (Figs. 6(e) and 6(f)). Based on the residents' interviews, the houses were destroyed by the rocks transported by the flood (Fig. 6(f)).
