# Impact of intensity and loss assessment following the great Wenchuan Earthquake

**Abstract:** The great Wenchuan Earthquake occurred on May 12, 2008 in the Sichuan Province of China, and had a magnitude of 8.0. It is the most serious earthquake disaster in China since the great Tangshan Earthquake ( $M_s=7.8$ , July 28, 1976). According to official reports, there were 69,225 deaths, 379,640 injuries and 17,939 missing as of Aug. 11, 2008. The China Earthquake Administration quickly sent hundreds of experts to the field immediately after the event, to investigate the damage and assess the economic losses. This paper emphasizes the impact of seismic intensity and presents a preliminary loss assessment. A brief description of the geological features of the affected region is provided, followed by a summary of the earthquake damage. An isoseismal map is developed that shows that the high intensity region is distributed like a belt around the seismogenic fault, and that the epicentral intensity reached XI (Chinese Intensity Scale, similar to the Modified Mercalli Scale). The direct economic loss resulting from the earthquake is 692 billions RMB (about 100 billions US\$).

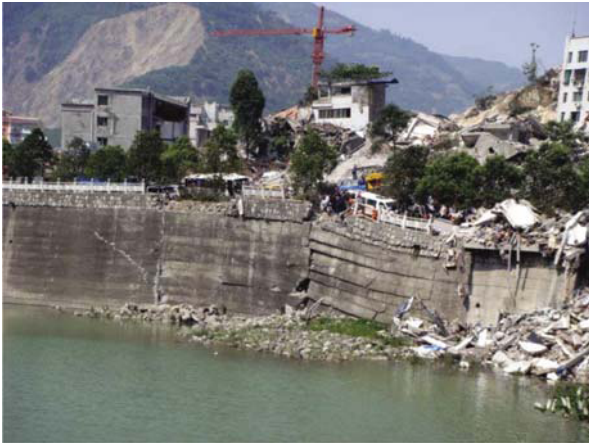
**Fig. 5** Building collapse and river bank damage caused by fault dislocation in Beichuan County town

Figure 5 shows buildings near the bank of the

Jianjiang River in Beichuan County town that were destroyed by the fault displacement.

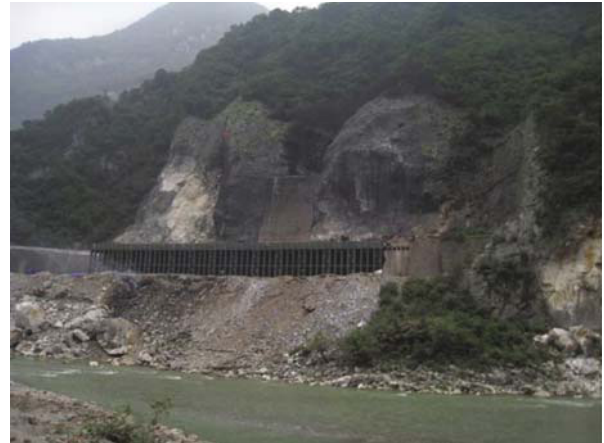
**Fig. 8** Landslide damaged railway, sealed tunnel and caused fire of oil train

Figure 7 shows a huge landslide that buried an entire village, causing many casualties, and Figure 8 shows a landslide that damaged a railway, sealed a tunnel and caused a fire on an oil train.

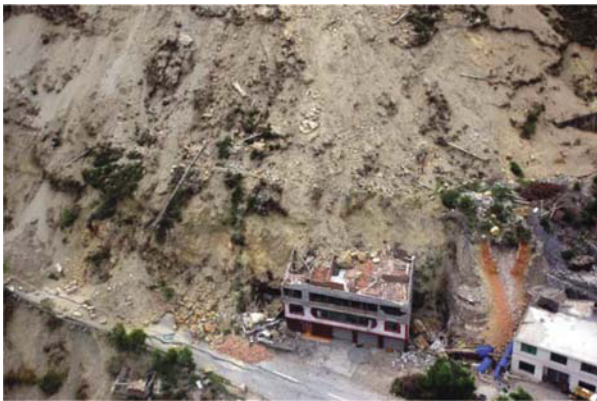
**Fig. 6** Landslide buried road and building in Wenchuan County

Figure 6 shows a large landslide that blocked a road and a destroyed building in the disaster area.

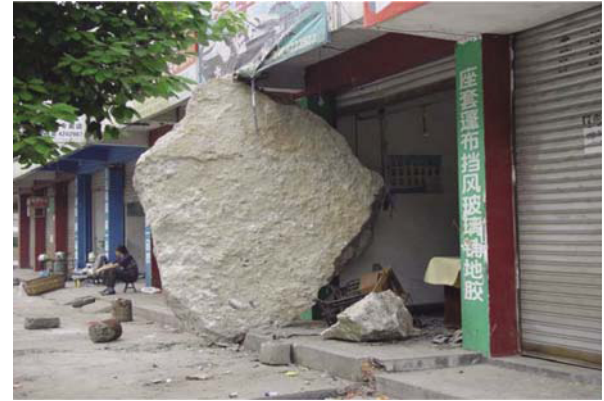
**Fig. 9** A big rolling rock killed 2 people and stopped at the front of a shop in Anxian Town

(3) Rockfalls occurred in many places, even in areas far from the epicenter, resulting in damage to building, houses and cars, in addition to many casualties (Fig.9).

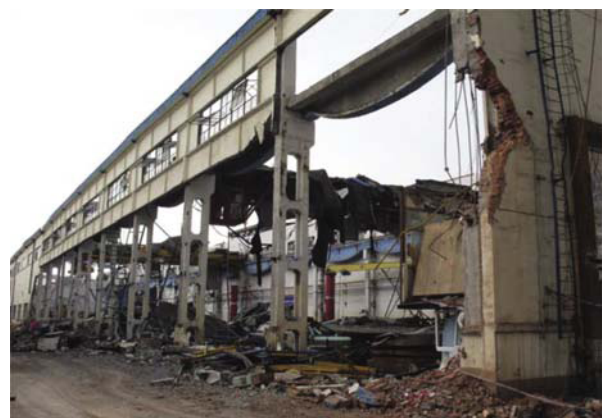
**Fig. 10** Damaged factory building of Dongfang Steam Turbine Works in Hanwang Town

Guangyuan, and Dujiangyan cities, where many well-known businesses in China are located. Many large factories suffered severe damage (Fig.10) and had to

relocate. Significant losses, including direct and indirect loss, resulted from damage to industrial buildings and equipments.

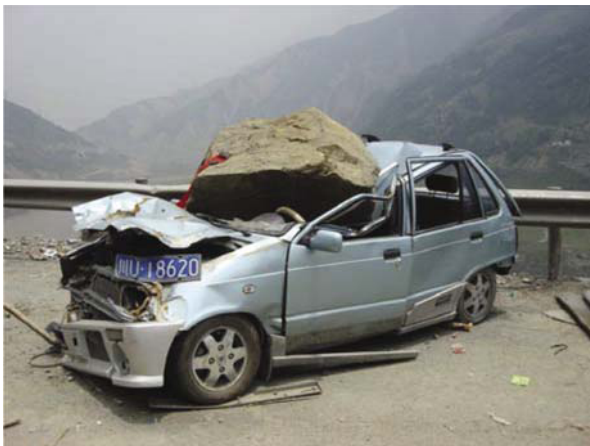
**Fig. 14** Rolling rocks hit houses, cars, and buses, killed people

that caused serious casualties, such as landslides that buried villages, and falling rocks that hit houses, cars and trucks (see Fig. 14). Some of these disasters occurred far from the epicenter, where rockfalls were the main cause of casualties.
