Rapid repair techniques for severely earthquake-damaged circular bridge piers with flexural failure mode

Abstract: In this study, three rapid repair techniques are proposed to retrofit circular bridge piers that are severely damaged by the flexural failure mode in major earthquakes. The quasi-static tests on three 1:2.5 scaled circular pier specimens are conducted to evaluate the efficiency of the proposed repair techniques. For the purpose of rapid repair, the repair procedure for all the specimens is conducted within four days, and the behavior of the repaired specimens is evaluated and compared with the original ones. A finite element model is developed to predict the cyclic behavior of the repaired specimens and the numerical results are compared with the test data. It is found that all the repaired specimens exhibit similar or larger lateral strength and deformation capacity than the original ones. The initial lateral stiffness of all the repaired specimens is lower than that of the original ones, while they show a higher lateral stiffness at the later stage of the test. No noticeable difference is observed for the energy dissipation capacity between the original and repaired

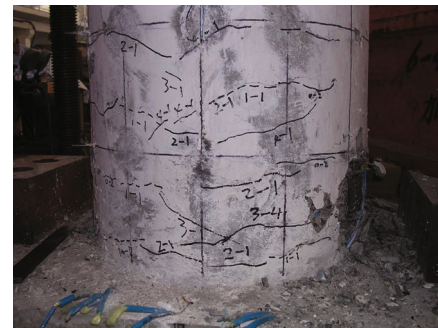
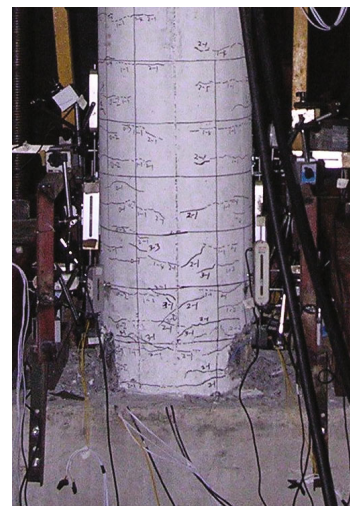
Fig. 4 Damage states of original pier specimens

Table 2 summarizes the damage details of original pier specimens before repair. It is observed that the concrete spalling damage concentrated at the specimen bottom and the spalling heights vary from 250 to 315 mm, corresponding to 0.6 to 0.8 times of the section depth. The maximum concrete crushing depths are between 45 and 52 mm, which are larger than 1/10 of the section depth. Although no longitudinal bar fracturing damage

is observed, the number of buckled longitudinal bars are 10 and 14 for each specimen, indicating that more than 40% of the longitudinal bars are severely damaged. Additionally, two spiral bars in specimen A12 are fractured, while no fracturing damage of spiral bars is observed in other specimens. Note also that horizontal flexural concrete cracking damage occurs up to a height of 1600 mm for all the specimens after the original test, indicating that about 2/3 of the height of all the specimens suffer concrete cracking damage.

Figure 4 shows the detailed damage to the original pier specimens. The damaged specimens are pushed back to the original position (zero lateral displacement) before the repair operation begins.

Before repairing the damaged specimen, the loose concrete in and around the plastic hinge region is removed, and the buckled longitudinal bars are straightened as much as possible. Subsequently, the specimens are repaired using three different techniques, and the details are depicted in Fig. 5 and illustrated as follows.

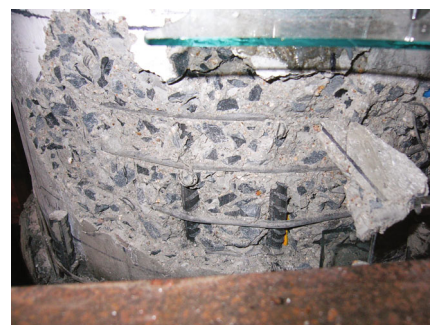
Fig. 8 Damage patterns of Specimen A10-R

The following phenomena are observed for the repaired pier specimens. For specimen A10-R, no visible new damage is observed during the initial loading stage until the 30 mm ($2\Delta_{ey}$) displacement cycles. When the specimen is pushed to the pre-defined lateral displacements, the old cracks above the repaired region (not repaired during the repair process) re-open, but no visible cracks are observed in the repaired region. During the 45 mm ($3\Delta_{ey}$) displacement cycles, new flexural cracks are observed above the repaired region, and the width of new and old cracks increase with the top displacement. During the 60 mm ($4\Delta_{ey}$) displacement cycles, a new plastic hinge forms above the repaired region, concrete spalling and longitudinal bar buckling damage is observed just above the repaired region of the specimen. Note that the repaired region is so strong that no visible damage to the solidified epoxy and CFRP

sheets is observed until completion of the test. Figure 8 shows the damage patterns of specimen A10-R.

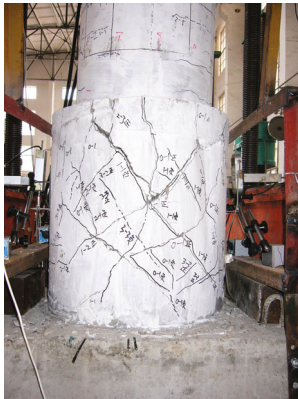
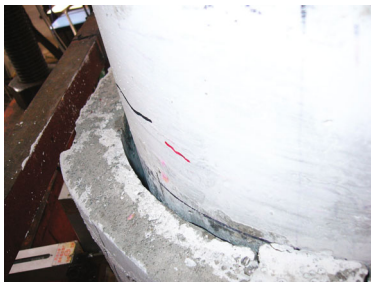
Fig. 9 Damage patterns of Specimen A12-R

For specimen A12-R, the damage is mainly concentrated at the repaired region. During the first lateral displacement cycle, vertical concrete cracks are observed in the concrete jacket. The reason for the premature vertical concrete cracks can be attributed to the high brittle behavior of the early-strength concrete without lateral confinement. Under a combined axial and horizontal load, the base section of the specimen expands laterally. As a result, vertical concrete cracks occur in the early-strength concrete. During the 40 mm ($2\Delta_{ey}$) displacement cycles, the maximum width of the vertical cracks in the concrete jacket reach 1.0 mm, and diagonal cracks are formed. During the 60 mm ($3\Delta_{ey}$) displacement cycles, the upper 30 cm part of the concrete jacket separates from the existing pier and the depth of the separated region increases during the next cycles. The new early-strength concrete jacket exhibits highly brittle behavior as lack of confinement. The concrete at the top of the jacketed region spalls off during the 80 mm ($4\Delta_{ey}$) displacement cycles, with the additional bars exposed. Figure 9 shows the damage patterns of specimen A12-R. Note also that all the additional longitudinal bars in specimens A10-R and A12-R perform well during the tests and no anchorage failure is observed.

which is much less than their yield strain, indicating that the additional longitudinal bar did not play a role in restoring the behavior of the repaired specimen. The test results from this specimen indicate that the proposed repair technique using an early-strength concrete jacket and additional longitudinal bars is not satisfactory. The early-strength concrete jacket without FRP confinement or interface treatment is not recommended for repair of earthquake-damaged bridge piers.

As specimen A12-R is damaged as a result of the debonding failure of the concrete jacket, this repair technique is not recommended in engineering practice. Cyclic analysis is conducted for specimens A10-R and A14-R. Note that both specimens A10-R and A14-R failed with a ductile flexural mode, and the quasi-static tests conducted by Lehman (1998) indicate that the contribution of the shear deformation to the total lateral displacement is less than 5% for piers with an aspect ratio larger than 4. Even for specimen A10-R with reduced effective height, the aspect ratio is 4.875 (effective height of 1950 mm divided by the section diameter of 400 mm). As a result, only flexural and longitudinal bar

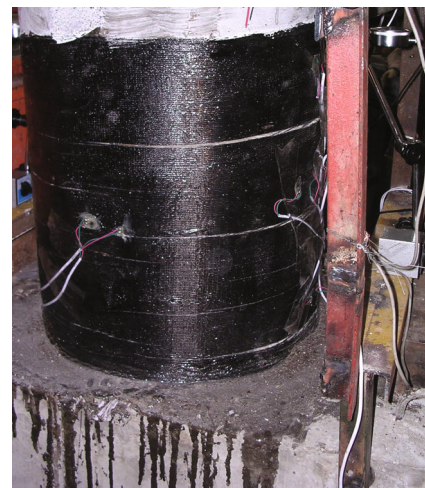
**Fig. 10 Flexural cracks of CFRP sheets in specimen A14-R**

displacement cycles, the old concrete cracks above the repaired region re-open but no visible new damage is observed. During the 60 mm ($3A_{ey}$) displacement cycles, new concrete cracks are observed above the repaired region, indicating that the repaired specimen has even larger lateral load carrying capacity compared to the original specimen. Also, flexural cracks on the CFRP sheets along the fiber direction are observed. At the end of the test, no apparent plastic hinge is formed and the failure pattern is dominated by the flexural cracks on the CFRP sheets along the fiber direction. Perhaps the concrete cracks are originally formed in the concrete, and the opening of these cracks result in splitting of the CFRP sheets. Note that no tension failure of the CFRP fibers is observed. The flexural cracking of the CFRP sheets is shown in Fig. 10.

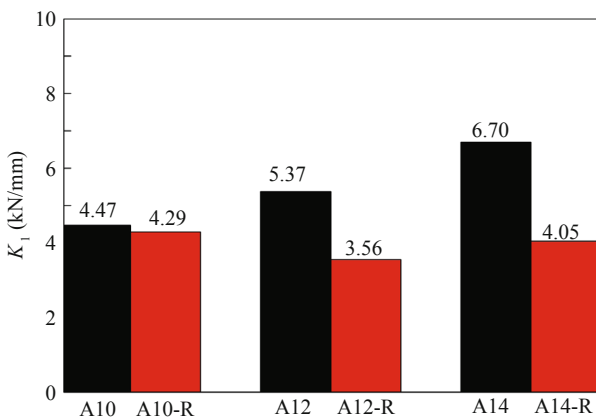
Fig. 13 Comparison of the initial lateral stiffness between original and repaired specimens

The initial lateral stiffness K_1 of the specimens is calculated by using the slope of the linear part of the skeleton curves (taking the average value in both the positive and negative directions), and the values of the original and repaired specimens are shown in Fig. 13. It is seen that when compared with the original ones, all repaired specimens exhibit lower lateral stiffness during the initial lateral load stage. For specimens A10 and A10-R, the stiffness of the repaired specimen is slightly lower than that of the original one. This is because although the damage existed in the repaired specimen, the solidified epoxy in the repair region is very strong and the effective height of the repaired specimen is reduced, which increases the lateral stiffness of the pier. For specimens A12 and A12-R, the initial lateral stiffness of the original specimen is 5.37 kN/mm, and reduces to 3.56 kN/mm in the repaired specimen. This is because the concrete jacketing and additional bars did not play an obvious role in restoring the behavior of the repaired specimen. For specimens A14 and A14-R, the initial stiffness of the repaired specimen is 4.05 kN/mm,

which is only 60% of that in the original specimen (6.70 kN/mm). This phenomenon is explained by the pre-existing damage in the repaired specimens, and the CFRP sheets wrapped in the circumferential direction had little influence on the lateral stiffness of the pier during the initial lateral load stage.

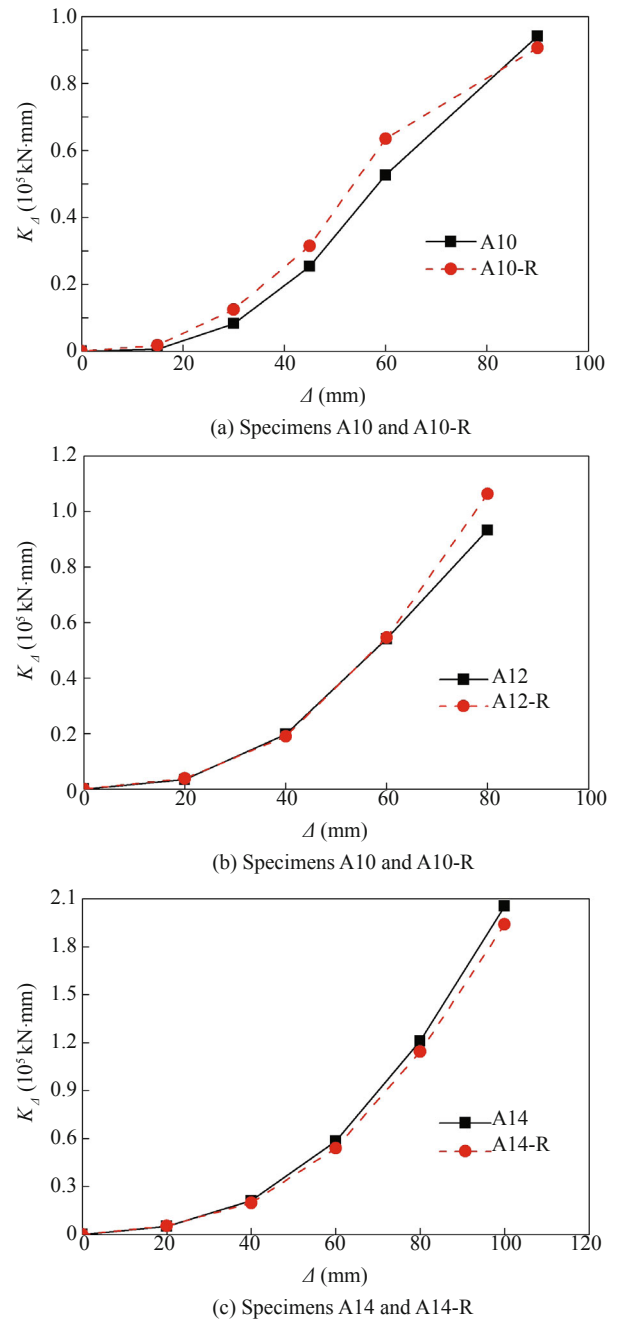
Fig. 15 Cumulative energy versus top displacement for the specimens

The energy dissipation, which is calculated as the area enclosed by a hysteretic loop, is commonly used to quantify the seismic energy absorption ability of RC structures. The cumulative energy E_{Δ} versus the top displacement Δ for the original and repaired pier specimens is shown in Fig. 15 and compared with each other. Generally speaking, each pair of specimens exhibits no noticeable difference with regard to their energy dissipation capacity. Specimen A10-R shows a larger cumulative energy when the top displacements are between 30 and 60 mm. However, the cumulative energy dissipated by specimen A10 is slightly larger than specimen A10-R when the top displacement reaches 90 mm. The cumulative energies dissipated by specimens A12 and A12-R are almost the same before the top displacement reaches 60 mm. However, specimen A12-R shows a larger cumulative energy than specimen A12 when the top displacement reaches 80 mm. For specimens A14 and A14-R, the repaired specimen shows a slightly lower cumulative energy than the original one during all the testing phases.

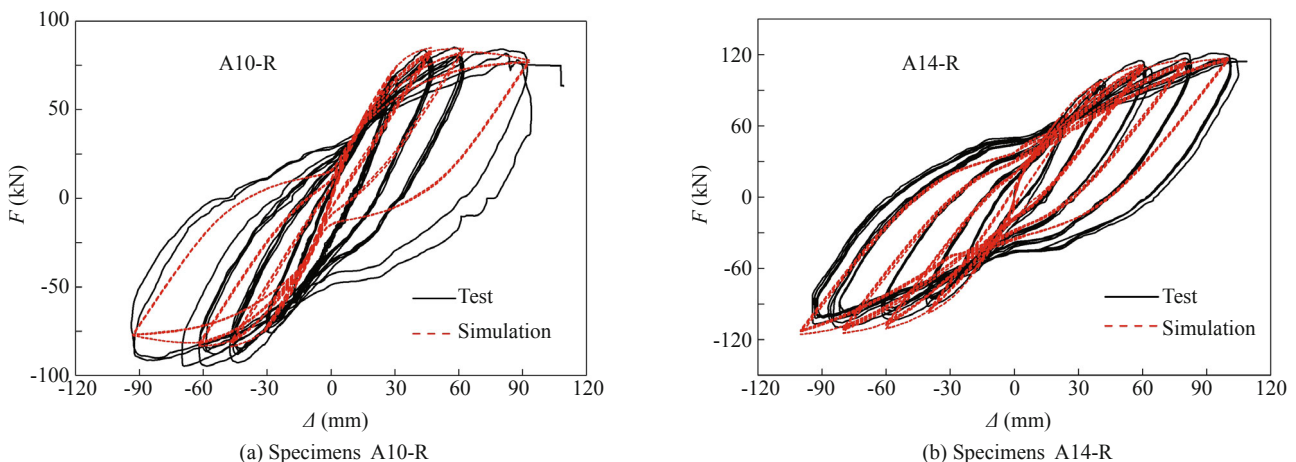
Fig. 18 Comparison of the hysteretic curves between simulated and tested results

Both the axial load and lateral displacement history adopted in the tests are applied to the analysis model. The simulated hysteretic curves for both specimens are compared with the test results, and are shown in Fig. 18. The results indicate that by the proposed numerical analysis model, the simulated lateral load-displacement hysteretic curves of the repaired specimens agree well with the tested curves. Both the simulated initial lateral stiffness and the lateral strength closely match the test results. A close examination of Fig. 18 indicates some differences between the simulated and tested hysteretic curves. First, the simulated residual displacement (measured when the lateral load is zero) for both of the specimens is less than the corresponding test result. Second, no strength degradation is observed in the simulated hysteretic curve of specimen A14-R and the failure of this specimen could not be predicted. The reason for the differences between the simulated and test results may be attributed to two aspects: (a) the modification factor γ for the initial elastic modulus of the longitudinal bar is only a simple method to account for the existing damage, while the low initial elastic modulus of the longitudinal bar leads

to a small residual displacement; and (b) the buckling damage of the longitudinal bar is not considered in the proposed model, which results in a high lateral strength at later stage of testing.
