The Bonding of Prostheses to Bone by Cement

Sir John Charnley MD

Abstract This Classic Article is a reprint of the original work by Sir John Charnley, The Bonding of Prostheses to Bone by Cement. An accompanying biographical sketch of Sir John Charnley, MD is available at DOI [10.1007/s11999-010-1547-6](https://doi.org/10.1007/s11999-010-1547-6). The Classic Article is reproduced and adapted with permission and copyright © of the British Editorial Society of Bone and Joint Surgery from Charnley J. The bonding of prostheses to bone by cement. *J Bone Joint Surg [Br]*. 1964;46-B:518–529.

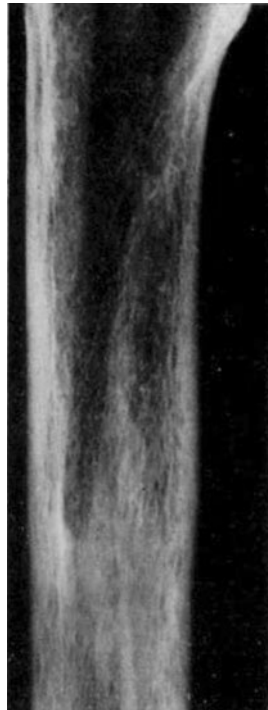
Fig. 1 Radiograph showing no demarcation between cement and cancellous bone. This prosthesis was tight after three and a quarter years.

low-friction acetabular prosthesis. Function had been excellent for the first three years but then pain had returned and weight bearing had become defective as a result of wearing out of the Teflon socket. The cement here did not contain a radio-opaque tracer and the radiograph of the specimen (Fig. 1), with detail unobscured by surrounding soft parts, showed no bone reaction to demarcate the limits

of the cement. Radiological evidence of demarcation between the cement and the cancellous bone was absent in all six specimens. It was only when the cut specimen was examined (Fig. 2) that the limits of the cement could be seen.

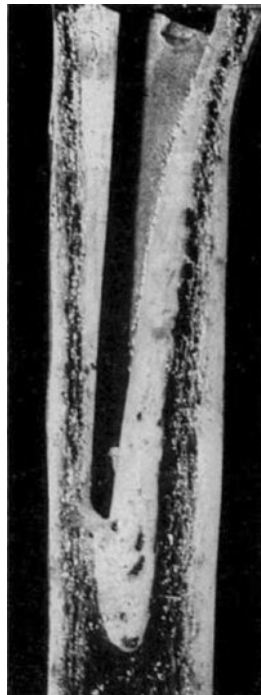
Fig. 2 The limits of the cement.

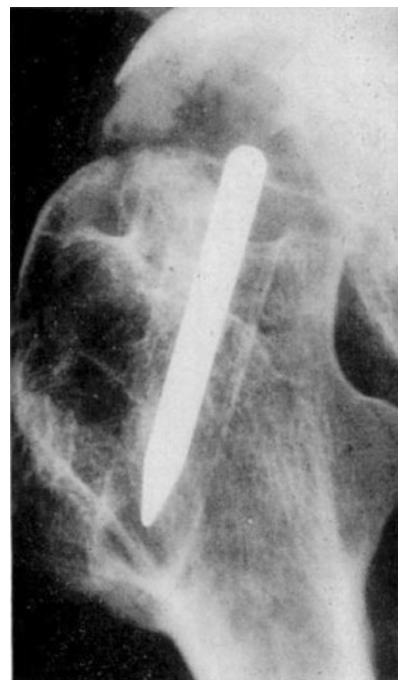
Fig. 3 Condensation in cancellous bone demarcating radiotranslucent plastic and bone. This condensation usually indicates motion between prosthesis and bone.

In five of the six specimens a fine white line of fibrous tissue between the surface of the cement and the cancellous bone could be seen. Without a lens this fibrous layer was hardly visible in the distal half of the specimen and was more obvious in the proximal part, where the cement lay in soft cancellous bone. The thickness of the fibrous layer was estimated at about 1 millimetre in the proximal part and about 0.25 millimetre or even less in the distal part. It is interesting that radiographically there was no suggestion of this line of fibrous tissue being demarcated by condensation in adjacent cancellous bone. In this respect the appearances are quite different from the radiographic appearances some time after insertion of an acrylic Judet prosthesis, when there is always a faint line of condensation in the layer of cancellous bone in contact with it (Fig. 3).

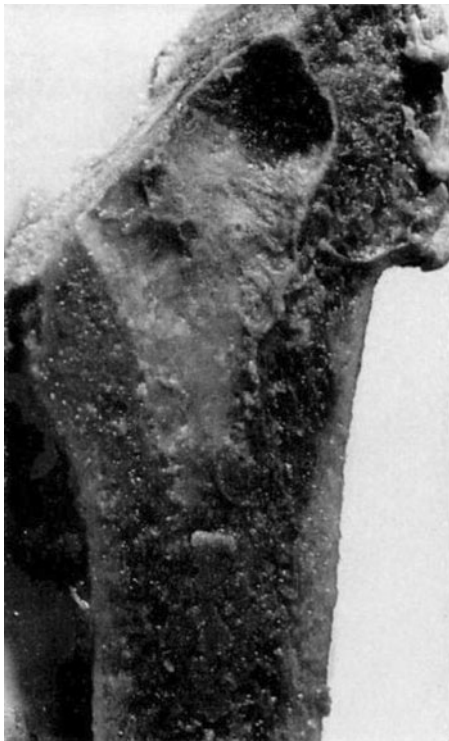
Fig. 4 Relatively smooth bed lined with fibrous tissue after extraction of cement. This bone had been curetted at time of insertion.

In one specimen the cement in the proximal part could be peeled away from the fibrous layer leaving a relatively smooth surface (Fig. 4) and the cement removed at this level had a nodular appearance (Fig. 5). The roughness of the surface of the cement is always an exact replica of the surface of the cancellous bone at the time of operation; and when cancellous bone has been curetted the surface of the cement is smoother. When this technique was being developed curettage was always used, but curettage is now

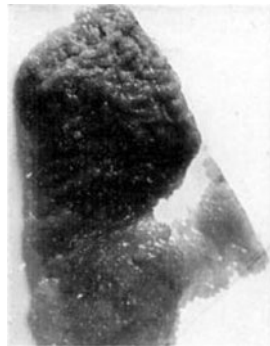
Fig. 5 Showing the relatively smooth surface of cement.

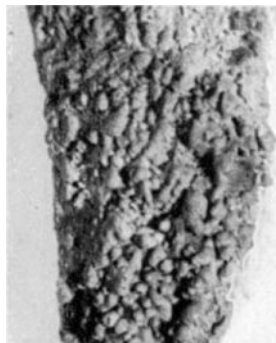
Fig. 6 Showing the rough surface from a specimen where curettage was not used.

avoided in order to present the roughest possible surface to the cement (Fig. 6).

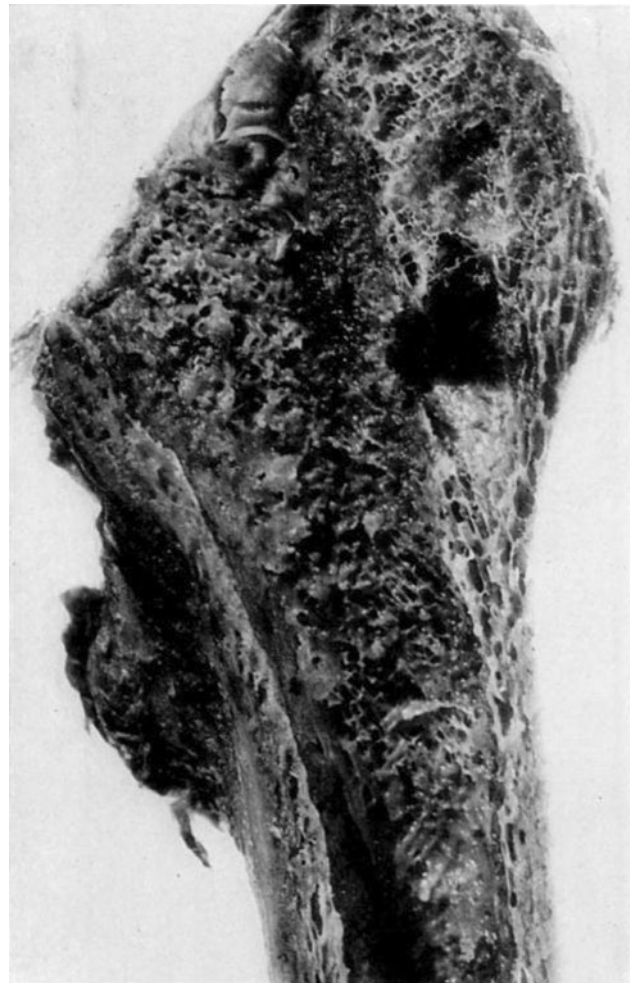
Fig. 7 The femur after dissolving away cement with chloroform. The prosthesis had been *in situ* one and a half years. Note the change of the inner layers of the cortex to cancellous structure without loosening of cement.

cementing an Austin Moore prosthesis, no naked-eye evidence of a fibrous intersection could be seen and this was demonstrated very effectively by dissolving away the cement with chloroform. This revealed the surface of the cancellous bone in contact with the cement unobscured by a thick layer of fibrous tissue (Fig. 7). The histology in this case revealed a fine layer of fibrous tissue about $5\ \mu$ thick. This patient lived a normal active life, considering her age, for twelve of the eighteen months she lived after the operation.

These specimens reveal an interesting point in relation to osteoporosis of the cortical bone of the femoral shaft. As shown in Fig. 7 the inner layers of the cortex of the femoral shaft can revert to cancellous bone. The radiographic appearance of enlargement of the medullary canal suggests that the prosthesis may be loosening but direct examination shows that this appearance does not necessarily mean loosening as all the prostheses were held tight.

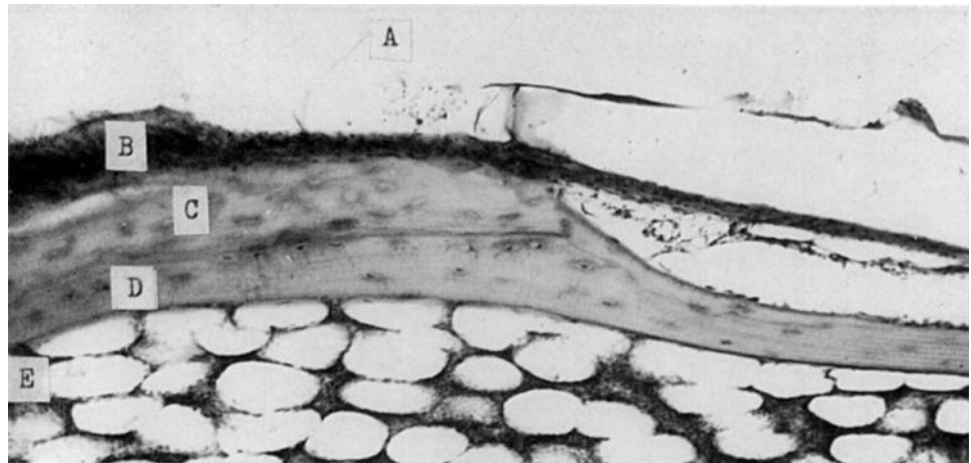
Fig. 8 Section of cancellous bone in specimen illustrated in Fig. 7. A indicates site of cement. B is layer of fibrous tissue. C is dead cancellous bone. D is new lamellar bone deposited on dead bone and closing the trabecular space. E shows fatty marrow with normal appearance.

Histology of the cement-bone bond in all six cases showed a uniform appearance. In no case was there sclerosis of cancellous bone. Cancellous bone spaces, which must have been broken into at operation, had repaired themselves and sealed off the open end of the trabecular space with a thin layer of lamellar bone. In a few cases there were superficial lamellae of bone with the spaces empty of osteocytes, but on the side away from the cement there was always a thin layer of new lamellar bone. A striking feature was the normal appearance of the cellular contents of the marrow spaces in the layer of spongiosa in contact with the cement (Fig. 8). There was no fibrosis which might have been expected from the presence of a foreign body giving rise to mechanical or chemical irritation.

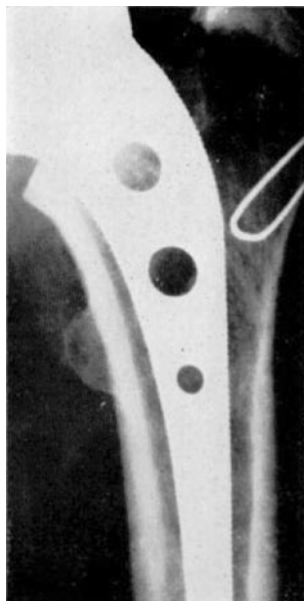
Fig. 9 Absorption of bone at the upper end of the femur. The prosthesis does not settle lower down in the shaft because weight is taken by the cement. Appearances immediately after operation.

An almost constant feature was the absorption of bone in the stump of the femoral neck next to the collar of the prosthesis, a process which is complete one and a half years after operation. Radiographically the collar of the prosthesis projected above the level of the bone sometimes by as much as one and a half inches (Figs. 9 to 11). This appearance results from the fact that, if the stump of the calcar femorale absorbs, the cement will prevent the prosthesis from sliding into the medullary canal. The two cases with loosening of the prosthesis have been excluded as the absorption was concealed by the downward shift of

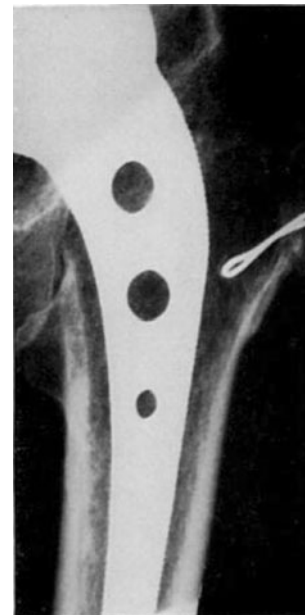
Fig. 10 Absorption of bone at the upper end of the femur. The prosthesis does not settle lower down in the shaft because weight is taken by the cement. One and a half years later.

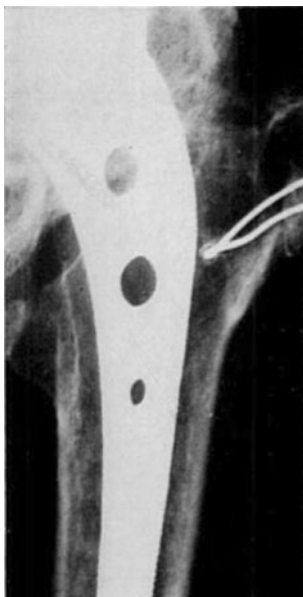
Fig. 11 Absorption of bone at the upper end of the femur. The prosthesis does not settle lower down in the shaft because weight is taken by the cement. Two and a half years after operation and immediately before attempting extraction of the prosthesis. Note that enlargement of the medullary canal as a result of osteoporosis did not indicate looseness of fixation of the cement.

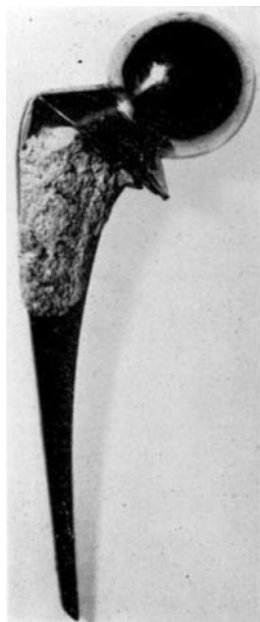
Fig. 14 Showing how extraction was possible only by fracturing the cement to leave behind the cement distal to the fenestrations in the shaft of the prosthesis.

Some idea of the strength of the cement fixation may be gained from a description of the difficulties encountered in extracting these prostheses. When the prosthesis had a solid stem of the Thompson type, it was easy to knock out the prosthesis leaving the cement behind since adhesion between the cement and surface of the metal does not occur. When the prosthesis was of the Moore type, with a fenestrated stem, extraction was not possible without gross mutilation of the bone and even fracture of the shaft of the femur. By using a punch or an engineer’s cold chisel lodged under the collar of the Moore prosthesis, it was sometimes possible to knock it out by repeated hammer blows using great violence. It was evident that the most powerful grip of cement to bone lay in the distal part of the shaft and not in the trochanteric region, because the prostheses came out as a result of the cement fracturing at the level of the distal fenestration. The proximal cement came out with the prosthesis but the distal cement was left behind. Some idea of the violence needed to extract these prostheses can be gained from the damage to the stainless steel (Figs. 14 and 15). The strength of the fixation of the

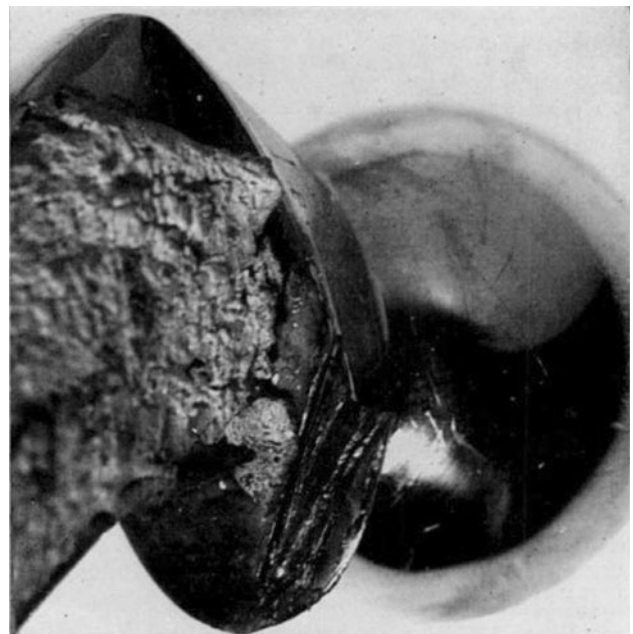
Fig. 15 An Austin Moore prosthesis inserted with cement showing the damage to the metal caused by the violence needed to extract it after one and a half years.

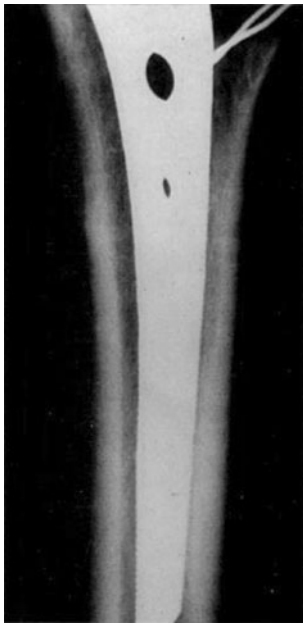
Fig. 16 Same case as Figs. 9, 10 and 11. A prosthesis which defied extraction after two and a half years in situ. The stem of the prosthesis had a serrated surface.

cement to bone in the distal half of the prosthesis was demonstrated in one instance where the prosthesis had been specially made with serrations on the surface of the stem for the express purpose of holding the cement. It was decided to extract the prosthesis and convert the hip into a

pseudarthrosis because of mechanical failure of a Teflon socket. The prosthesis, however, defied extraction, and the head had to be cut off, leaving the stem in situ. In this patient the cement-bone junction had been exposed to the load of active weight bearing for two and a half years (Figs. 16 to 18).

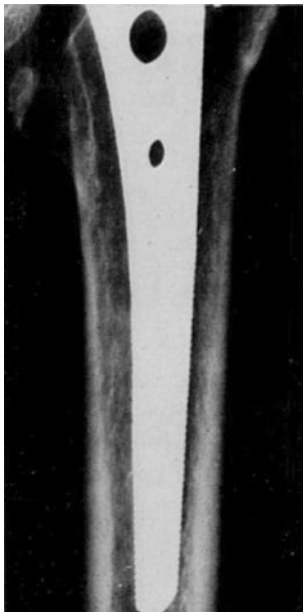
Fig. 17 Same case as Figs. 9, 10 and 11. A prosthesis which defied extraction after two and a half years in situ. Note that enlargement of the medullary canal did not indicate loosening of the attachment of the cement.

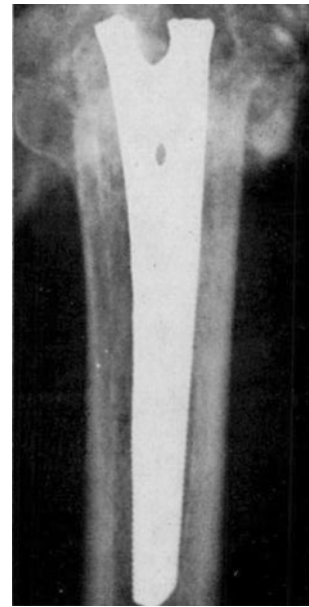
Fig. 18 Same case as Figs. 9, 10 and 11. A prosthesis which defied extraction after two and a half years in situ. After failure to extract the head has been removed. (This indicates that cement is more rigidly anchored in the distal part of the femur than in the proximal part (unlike Figs. 14 and 15, where the distal stem of prosthesis is smooth).)
