Adverse Local Tissue Reaction Associated With a Modular Hip Hemiarthroplasty

Michael R. Whitehouse PhD, MSc, FRCS (Tr & Orth),
Makoto Endo MD, PhD, Bassam A. Masri MD, FRCS(C)

Received: 25 February 2013 / Accepted: 19 June 2013 / Published online: 29 June 2013
© The Association of Bone and Joint Surgeons® 2013

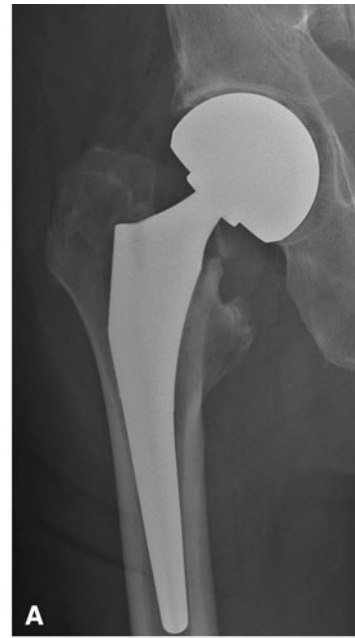
Fig. 1A–B One-day postoperative (A) AP and (B) lateral view radiographs show the uncemented modular implant.

confirmed the limb length discrepancy and Brooker Grade III heterotopic ossification [1], and further showed the cementless stem to be well-fixed. Initial postoperative radiographs showed the stem was in 1.5° valgus alignment and 9° anterior to posterior alignment (Fig. 1). Alignment was unchanged on followup radiographs and there was no detectable subsidence. Initial management included conservative measures, including analgesia and physiotherapy, as the patient felt his symptoms were not severe enough to justify revision surgery.

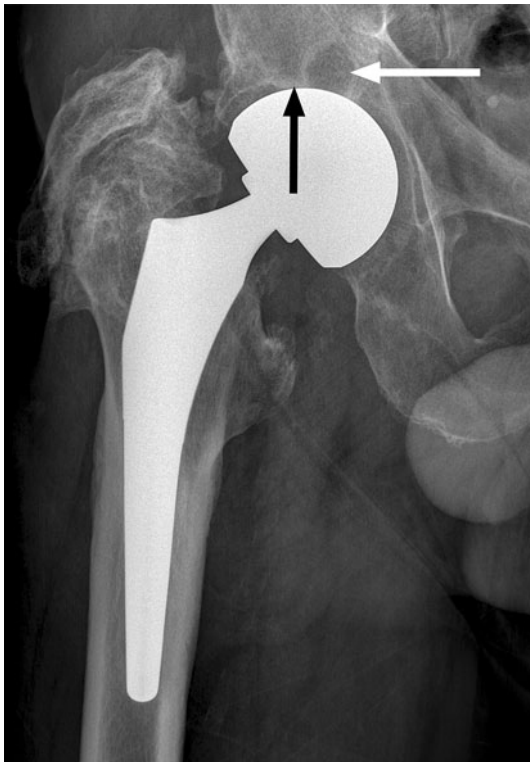
Fig. 2 Acetabular erosion (black arrow), cyst formation in the sourceil (white arrow), and heterotopic ossification were seen 53 months after surgery.

decision was made to perform revision surgery 53 months after the index operation. Radiographs obtained before revision surgery showed a substantial cavitory focal acetabular erosive lesion (maximum dimension, 1.5×1.3 cm). The femoral head rested on subchondral bone; there was complete chondrolysis but no evidence of acetabular erosion beyond the subchondral bone with the exception of the cavitory lesion in the sourceil region (Fig. 2).
