Creep degradation mechanism by water-rock interaction in the red-layer soft rock

H.F. Deng^{1,2,3} · M.L. Zhou^{2,3} · J.L. Li^{2,3} · X.S. Sun^{2,3} · Y.L. Huang¹

Received: 25 September 2015 / Accepted: 25 July 2016 / Published online: 18 August 2016
© Saudi Society for Geosciences 2016

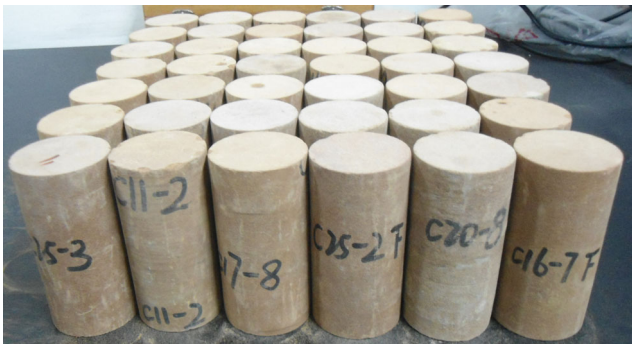
Fig. 1 Typical rock samples

A typical bank slope comprised of red-layer soft rock in Three Gorges reservoir area was selected, and samples were taken from the hydro-fluctuation belt. The test specimens were prepared based on the specification requirements ($\Phi 50\text{mm} \times 100\text{mm}$) as shown in Fig. 1. Besides, samples with obvious defects were rejected. *P*-wave velocity and rebound value were scrutinized to eliminate samples with extreme outliers (Deng et al. 2011).

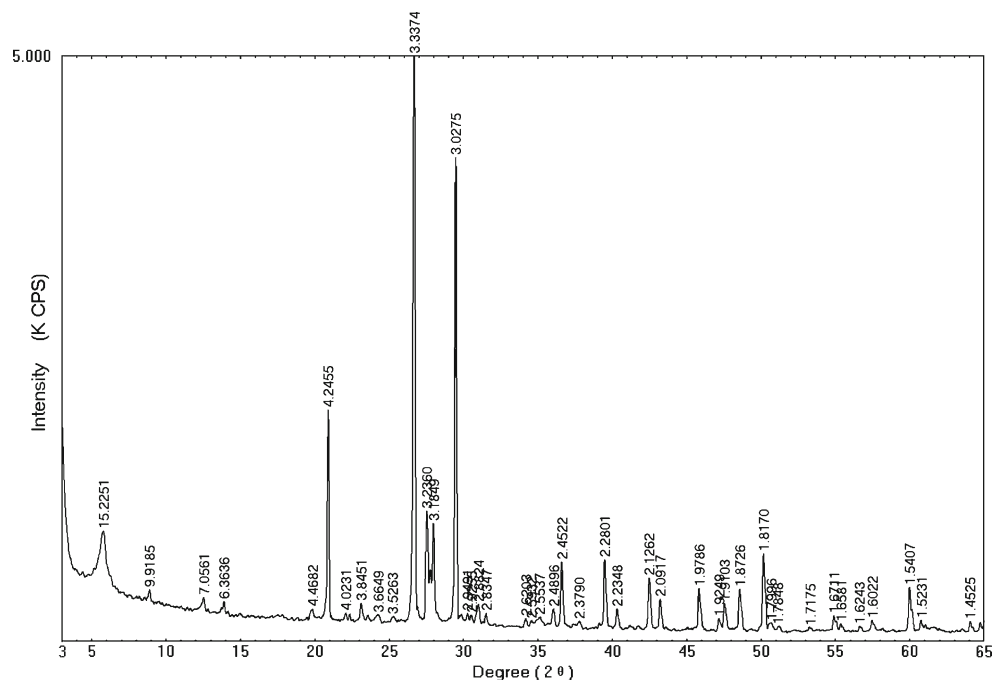
Fig. 2 X-ray diffraction spectrum of rock samples

X-ray diffraction was employed to identify mineral contents of the specimens; the XRD spectrum is shown in Fig. 2. The identification test showed that the rock class was argillaceous siltstone, and the mineral contents (mass fraction) were as follows: smectite 15 %, chlorite 5 %, illite 5 %, quartz 33 %, feldspar 15 %, calcite 25 %, and dolomite 2 %.

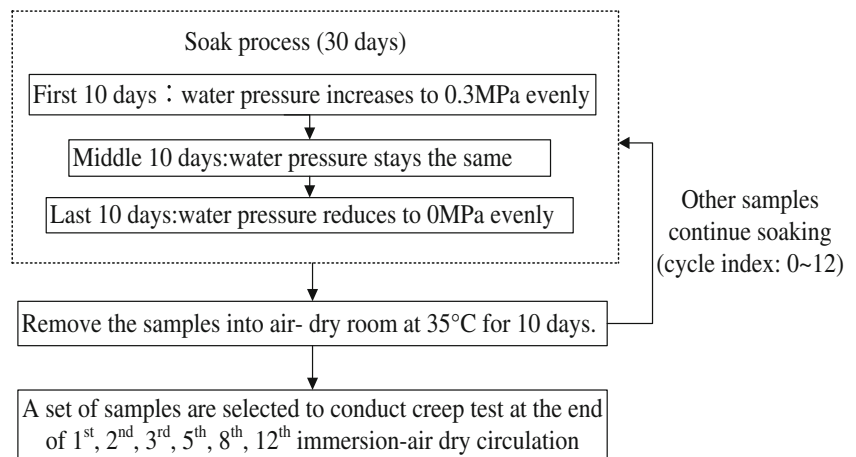
Fig. 3 Flow chart of immersion-air-dry circulation

The aim of this paper was to simulate reservoir fluctuation and immersion-air-dry circulation (i.e., real condition of bank slope). The experiment procedure is clearly shown in Fig. 3, rock samples were placed inside a rock dissolution apparatus, and every immersion stages took 30 days; during the first 10 days, the rise in the reservoir water level was simulated by evenly increasing the water pressure to 0.3 MPa. Since the studied reservoir water level has been fluctuating from 145 to 175 m, a 0.3 MPa pressure was chosen as a proxy of water pressure. The relative stability period of the reservoir water

was simulated during the next 10 days. Finally, the pressure was reduced uniformly to 0 MPa during the last 10 days to simulate the drop in the reservoir water level. Consequently, soaked samples were air-dried at 35 °C room temperature (since, the temperature of the studied area during the impoundment season was around 35 °C) for 10 days to replicate the natural air-dry process of the bank slope following the reduction in the water level. A set of samples were chosen from the air-dried ones to conduct creep test at the end of the first, second, third, fifth, eighth, 12th immersion-air-dry circulation, and the other samples were replaced to the rock dissolution apparatus to keep the immersion-air-dry circulation. A total of 12 cycles were executed during the experiment.

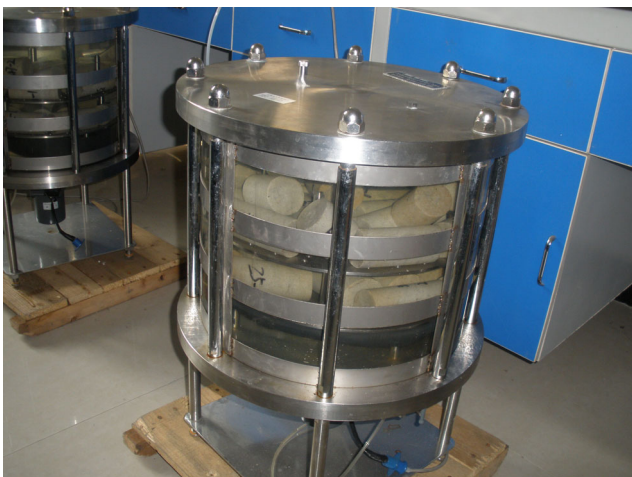
**Fig. 4** YRK-1 rock dissolution apparatus

The dissolution apparatus is shown in Fig. 4. It was used to soak rocks during water-rock interaction test. The fluctuations of water pressure can be well simulated by the process of soaking.

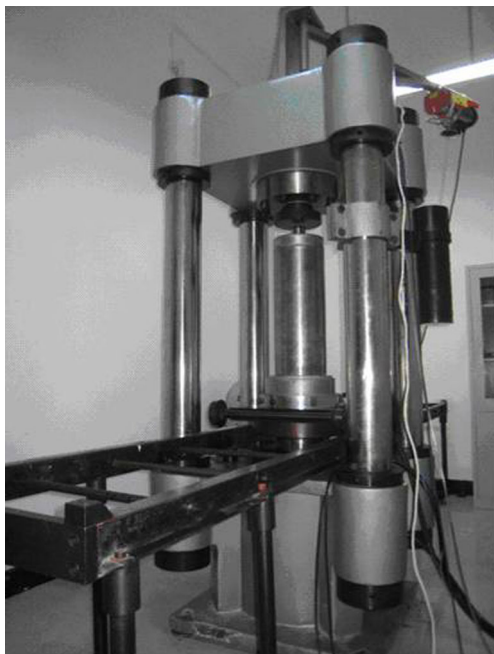
**Fig. 5** RLW-2000 rock creep testing machine

The creep tests were conducted using RLW-2000 rock creep test machine, as shown in Fig. 5. The sample is sealed with heat shrinkable tube, and the axial and lateral strains are collected by displacement sensors, as shown in Fig. 6. The testing temperature was set to 20 ± 2 °C.

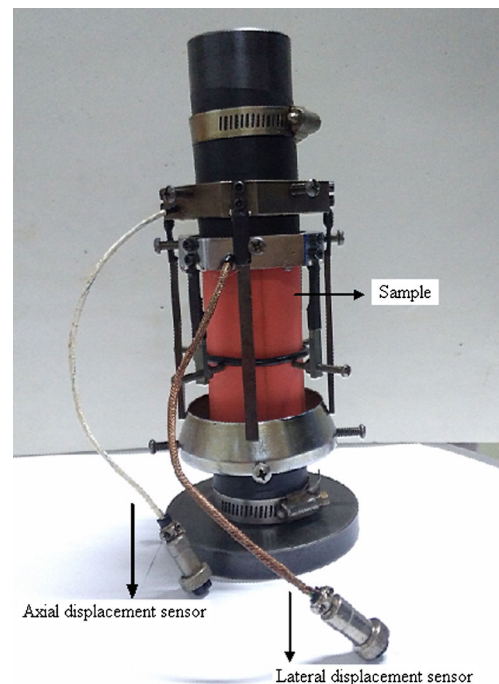
**Fig. 6** The sample ready for test

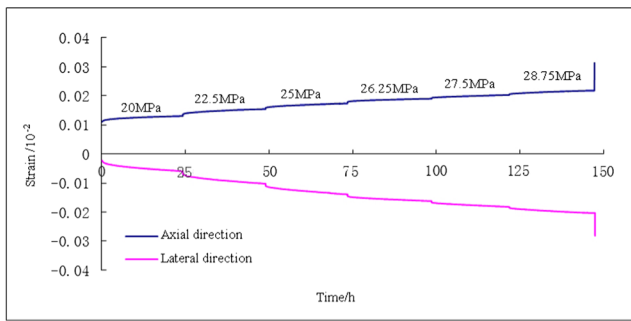
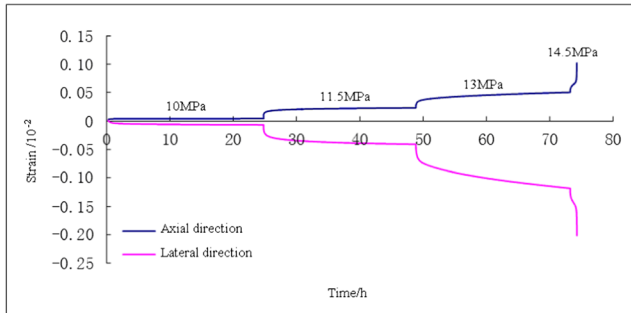
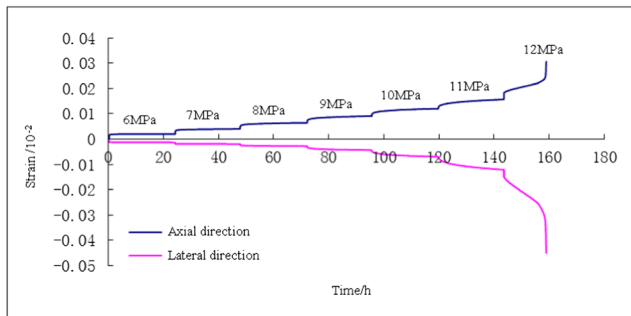
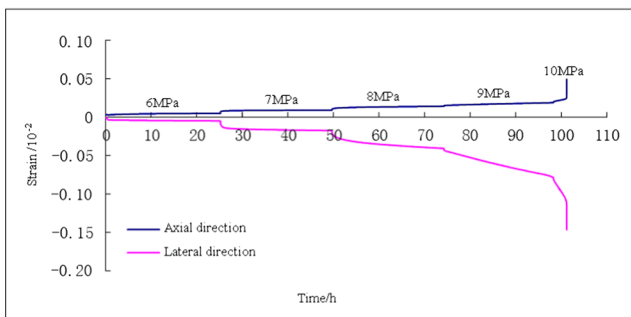
(a) C16-1 creep curves at confining pressure 5MPa (0 cycle)

(b) C20-5 creep curves at 5MPa confining pressure (2 cycles)

(c) C14-9 creep curves at 5MPa confining pressure (5 cycles)

(d) C17-9 creep curves at 5MPa confining pressure (12 cycles)

Fig. 7 Axial and lateral creep curves for the red-layer soft rock under different water-rock interaction cycles. **a** C16-1 creep curves at confining pressure 5 MPa (0 cycle). **c** C20-5 creep curves at 5 MPa confining pressure (2 cycles). **e** C14-9 creep curves at 5 MPa confining pressure (5 cycles). **g** C17-9 creep curves at 5 MPa confining pressure (12 cycles)

Figure 7 shows the axial and lateral strain of initially saturated rock specimens under different water-rock interaction cycles. The curves for various stress levels were obtained by using superposition principle. The applied pressures were displayed on the curve. Similarly, the degradation in fracture strength of red-layer soft rock under water-rock interaction cycles is shown Fig. 8.

After careful investigation of Fig. 7 and Fig. 8, the following conclusions were made:

- (1) Red-layer soft rock showed considerable creep deformation in all stress levels. Axial and lateral deformation incorporated instantaneous and creep deformations. Each step of creep deformation included primary stage and secondary stage under low axial stress level. The smaller deviatoric stress had the smaller primary creep deformation and time as well. The duration and slope of primary stage curve increased, while the deviatoric stress increased. The creep deformation curve had tertiary stage at the failure stress level. The duration of this stage was short. However, samples were quickly broken due to large deformation.

- (2) The comparative study of creep curves for rock samples under different water-rock interaction cycles revealed that the strength of the samples decreased gradually, while the water-rock interaction cycles increased. The failure strength of soft rock decreased by 37, 55, and 62 % from its initial strength, during the first, the third, and the eighth water-rock interaction cycles, respectively. Relatively, the degradation rate of soft rock strength was fast during the first three cycles and then gradually became stable.

- (3) Instantaneous and creep deformations rose gradually, when water-rock interaction cycles increased (by keeping constant axial stress increment). The rheological properties of the samples were considerable and conformed to the creep deformation characteristics of actual bank slope affected by the water-rock interaction.

- (4) When the water-rock interaction increased, the lateral creep deformation was higher than the axial creep deformation under same axial stress. Effect of lateral dilation was more pronounced, while the applied axial stress moved towards the failure stress level.

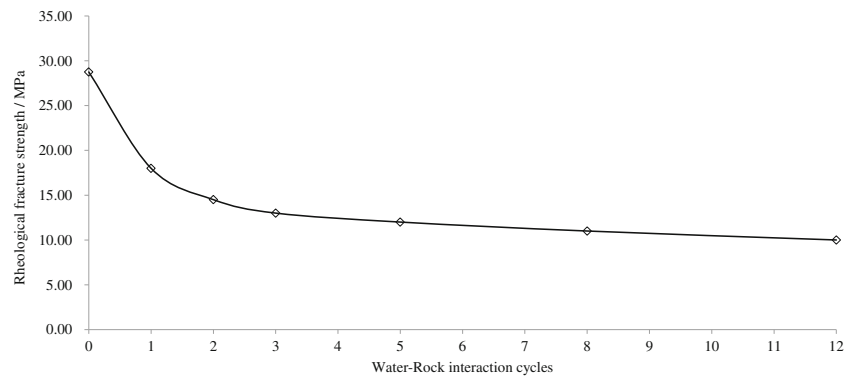
Fig. 8 Fracture strength degradation curve for the red-layer soft rock under different water-rock interaction cycles

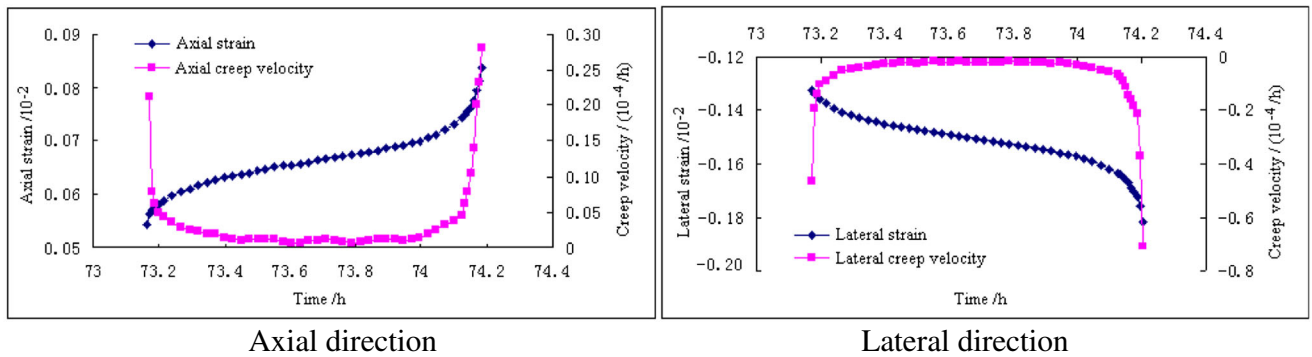
Fig. 9 Axial and lateral creep velocity curves of rock samples under different water-rock interaction cycles at the failure stress level. **a** C16-1 the relationship between strain, creep velocity, and time at the failure stress level (0 cycle). **c** C20-5 the relationship between strain, creep velocity, and time at the failure stress level (2 cycles). **g** C14-9 the relationship between strain, creep velocity, and time at the failure stress level (5 cycles). **e** C17-9 the relationship between strain, creep velocity, and time at the failure stress level (12 cycles)

(a) C16-1 the relationship between strain, creep velocity and time at the failure stress level (0 cycle)

(b) C20-5 the relationship between strain, creep velocity and time at the failure stress level (2 cycles)

(c) C14-9 the relationship between strain, creep velocity and time at the failure stress level (5 cycles)

(d) C17-9 the relationship between strain, creep velocity and time at the failure stress level (12 cycles)

Figure 9 shows the tertiary stage of axial and lateral creep velocity at the failure stress level for the red-layer soft rock specimens under different water-rock interaction cycles.

The following important points can be noticed from Fig. 9:

- (1) Observations of rock samples under different water-rock interaction cycles at the failure stress level were basically the same. All of the creep curves exhibited three typical stages—primary (damped), secondary (steady-state), and tertiary (nonlinear accelerated) stages. The deformation at each stage was significant. Generally, both primary and tertiary stages took short period of time. In contrast, secondary stage spent long period of time.

- (2) During the early stage of water-rock interaction, the average creep velocity at the secondary stage was relatively low. While, the average creep velocity at the tertiary stage was high and the samples were broken suddenly. As water-rock interaction cycles increased, the average creep velocity at the secondary stage increased gradually. Nonetheless, the creep velocity at the tertiary stage decreased smoothly. The percentage of time taken by the tertiary stage increased steadily. However, the fragility of the rock has reduced slowly.

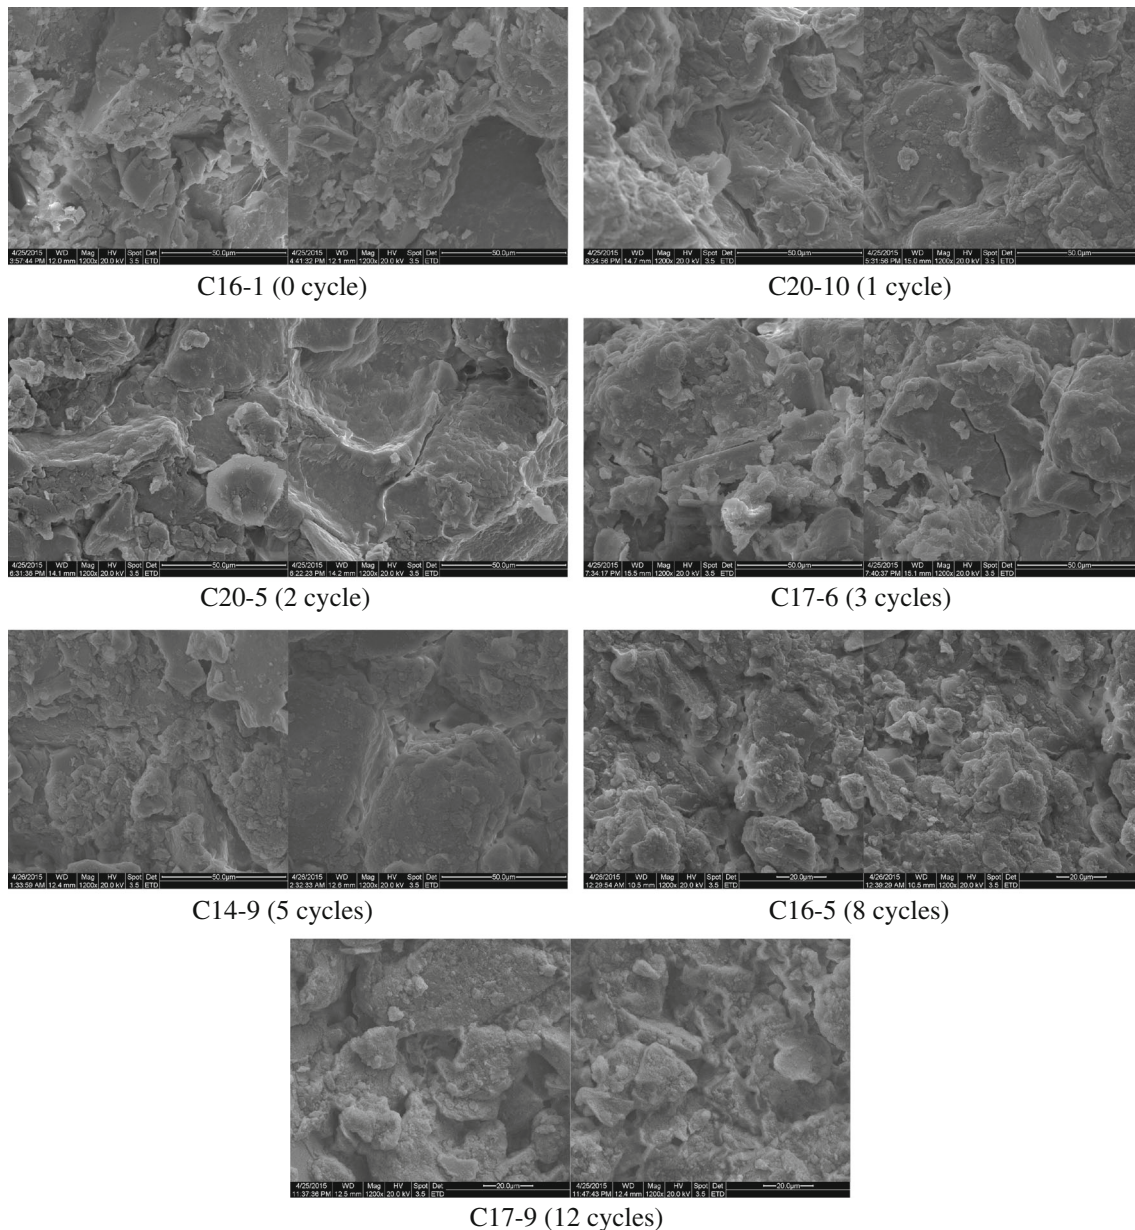
Fig. 11 Microstructure changes on the specimens during the process of water-rock interaction (1200 \times)

Scanning electron microscopy (SEM) analysis was carried out on the samples under different water-rock interaction cycles. Results are shown in Fig. 11.

- (1) In the beginning, saturated samples had angular mineral particles, comprised of irregular polygon. Additionally, the particles made good contact with each other and the contact surface was flat and smooth, characterized by clear boundaries and tiny cracks on it.

- (2) After the first water-rock interaction cycle, boundaries of particles became fuzzy, tiny pores and cracks developed, and partial protuberance on the surface of the particles gradually converted into round shape during the water-rock interaction.

- (3) The surface of mineral particles was no longer flat following the second water-rock interaction cycle. In the mean time, edges and corners at the convex position were gradually converted into sleek and small corrosion pits developed by water-rock interactions emerged on the surface of mineral particles. Moreover, micro cracks and pores developed gradually.

- (4) Following the third water-rock interaction cycle, the contact between mineral particles has changed from surface-surface to edge-angular. Similarly, micropores have emerged and clear cracks noticed on some large particles. In the mean time, small particles rose significantly and the structure became porous and loose in time.

- (5) To come to the fifth water-rock interaction cycle, loose particles slightly fragmented into small particles and congregated around the large particles. Pores and cracks between the mineral particles became clearer, and the boundaries seemed sleeker. Meanwhile, small particles got smaller and smoother and the structure turned out into a more loose and porous state.

- (6) More globular particles adhered to the surface of mineral particles. Likewise, large particles disintegrated into small particles. Pores and cracks between particles have been filled during the eighth water-rock interaction cycle.

- (7) Considering the last water-rock interaction cycle, the structure has changed its state from dense to loose and porous state. The contacts between the particles were predominantly edge-edge and edge-corner connections.

Generally, micro cracks and pores of rock samples were developed gradually, during the process of water-rock interactions. Boundaries of large particles appeared to be sleeker and more remarkable. Pores and cracks between the mineral particles became clearer. In the mean time, small particles got smaller and smoother and the structure turned out in to a more loose and porous state.

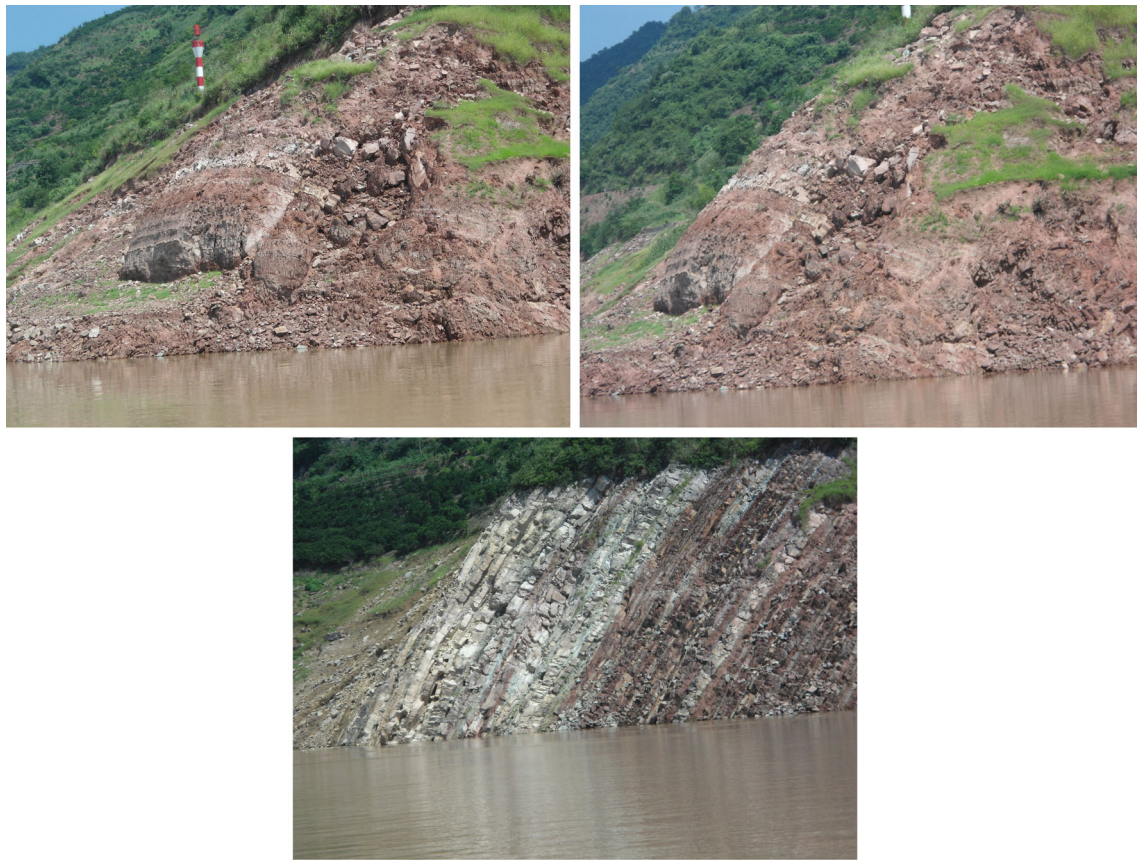
Fig. 12 Typical failures of red-layer soft rock in the vicinity of hydro-fluctuation belt in Three Gorges reservoir area (July 2013)

The built up damages on the bank slopes, due to successive fluctuations in the reservoir water level, will not be noticed at a time. But after repeated actions, the damage may build up and it will result to slope instability. Statistics showed that many bank slope instability did not occur during the initial time of water storage but after several rise and fall cycles of reservoir water. This can be proven from the real failure phenomena of the rock bank slope. Figure 12 shows a typical failure of rocks in the vicinity of hydro-fluctuation belt bank slopes.

The impoundment of the reservoir has started since 2008 and stored water up to 172.8 m. Figure 12 shows that few floras have grown in the vicinity of the hydro-fluctuation belt (145~175 m). The cracks and fractures have developed with large openings. Stratified disintegration and fragmentation have occurred on the rock mass. This destruction revealed that the red-layer soft rock has been significantly affected by repeatedly fluctuating reservoir water.
