Volume estimation and evaluation of rotational landslides using multi-temporal aerial photographs in Çağlayan dam reservoir area, Turkey

Tümay Kadakci Koca¹ · M. Yalcin Koca¹

Received: 1 August 2018 / Accepted: 25 January 2019 / Published online: 16 February 2019
© Saudi Society for Geosciences 2019

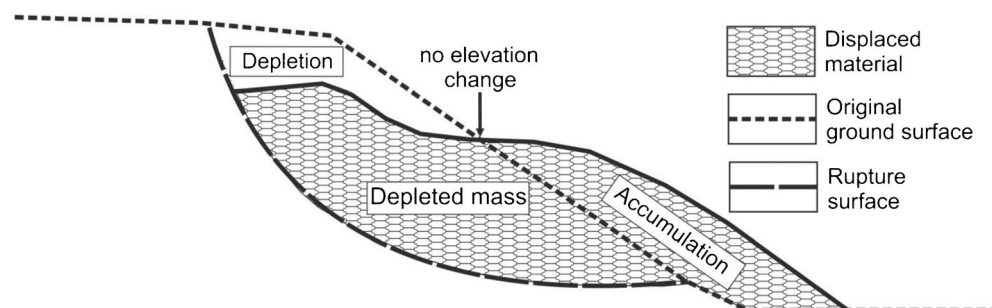
Fig. 1 The illustration of the parts of a landslide body (modified after De Bari et al. 2011)

2009; Larsen et al. 2010; Fuller et al. 2016; Amirahdi et al. 2016). They found that there is a strong relationship between the area (A) and the volume (V) of displaced material independent from local physiographical setting (Eq. 1). The term displaced material has been defined by IAEG Commission on Landslides (1990) as the material displaced from its original position on the slope by movement in the landslide and it is referred to the sum of depleted mass and the accumulation (Fig. 1).

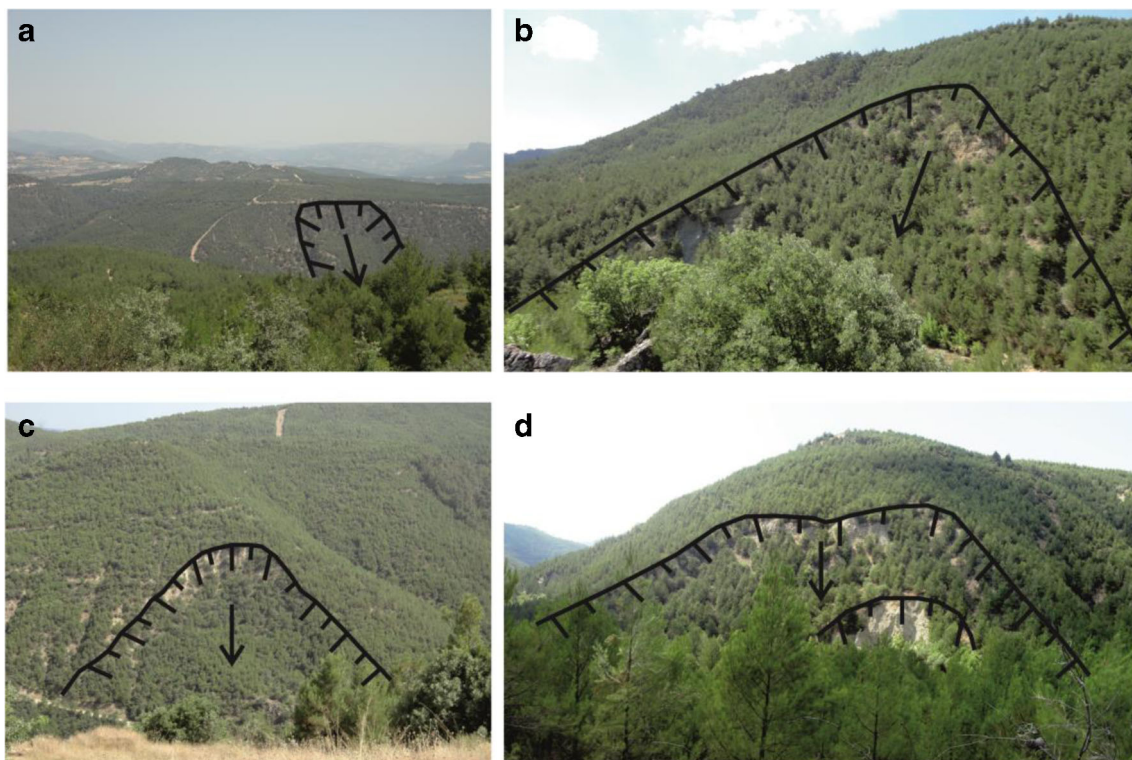
Fig. 4 Landslides observed in the Çağlayan dam site. **a** Landslide-1. **b** Landslide-2. **c** Landslide-3. **d** Landslide-4

There are four landslides in the dam reservoir area (Fig. 4). Three of them are on the northern bank (landslide-1, 2, and 4) and the other one (landslide-3) is on the southern bank of the reservoir area.

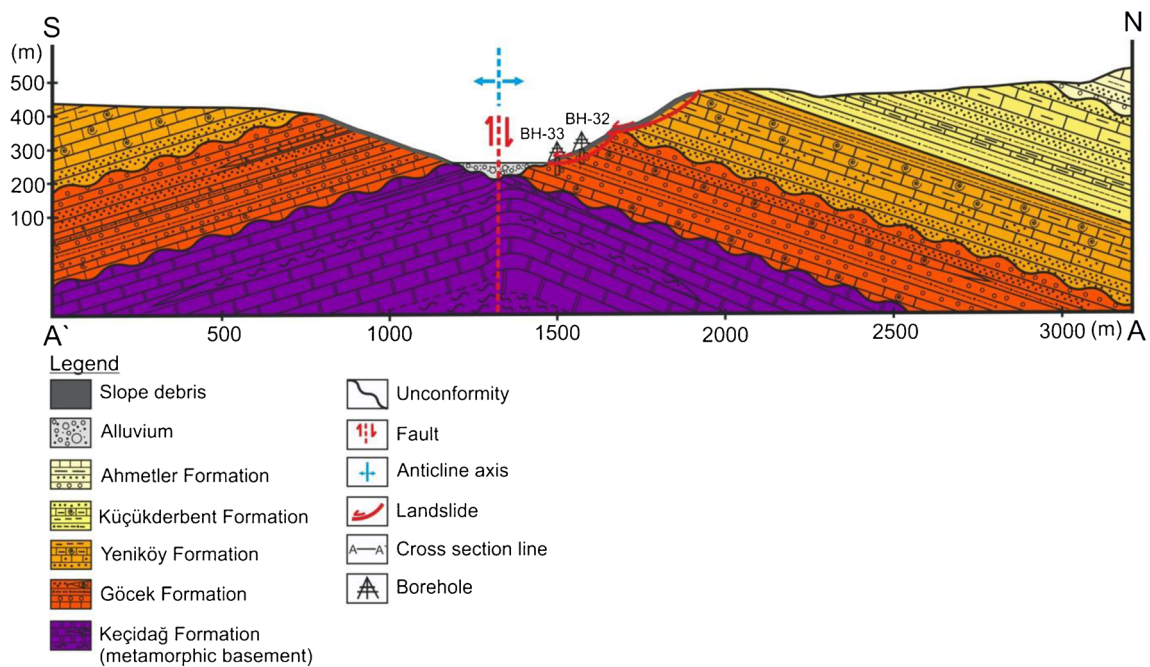
Fig. 5 Geological cross section of A-A' constructed through the Landslide-1

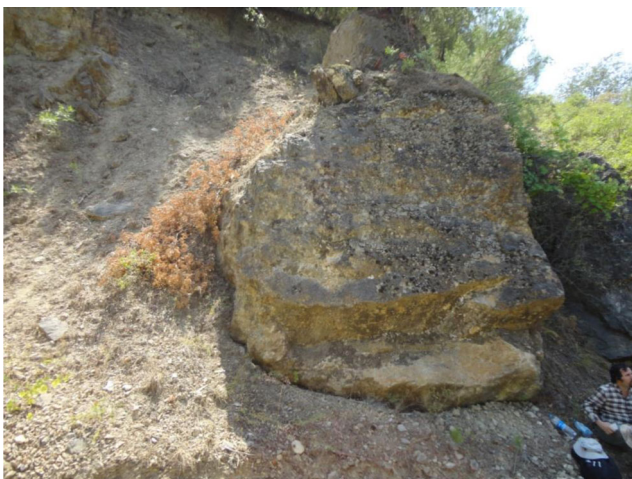
Fig. 6 Rock blocks removed by the mass movements

about geological units and their thicknesses. Two out of nine boreholes are located in the streambed (BH-18, 36); three boreholes are on the northern bank of the reservoir area (BH-21, 32, 33) and the others on the southern bank (BH-23, 26, 28, and 31) (Fig. 3). The depths of the boreholes are ranging between 15 and 50 m. The maximum thickness of the highly fractured and partially disintegrated (RQD = 0–50%) sedimentary rocks is 23 m with a mean of 9 m. The rock units are mantled by unconsolidated, coarse-grained slope debris with a thickness of 1.3 to 15 m in southern bank and 2 to 6 m in northern bank. In the streambed, the first 6 m below the ground level is composed of alluvium with a maximum grain size of 20–30 cm. The materials transported and deposited by the landslide range from gravel to several meter-sized blocks of limestone at the toe of Landslide-3 (Fig. 6).

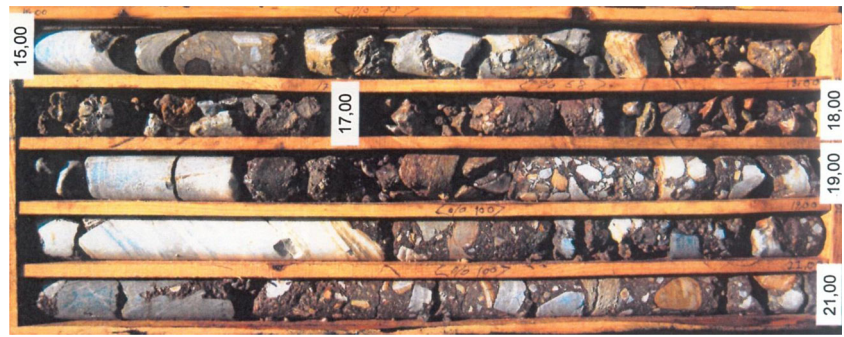
Fig. 7 The core box of BH-32 between the depth 15 and 21 m showing the breccia zone

BH-32 and 33 are located in the lower part (accumulation zone) of Landslide-1. Breccia zone was intersected between the depths 9 and 16 m below the ground surface in BH-33 and between 15 and 23 m in BH-32 (Fig. 7).

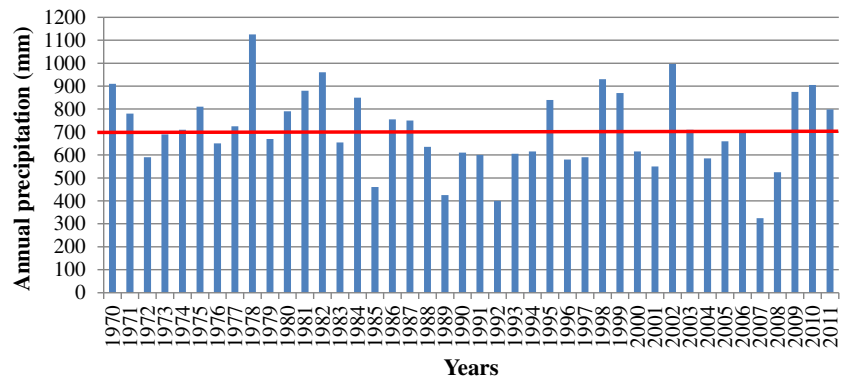
Fig. 9 Mean annual precipitation records for the years between 1970 and 2011 (the red line refers to the mean annual precipitation of all years)

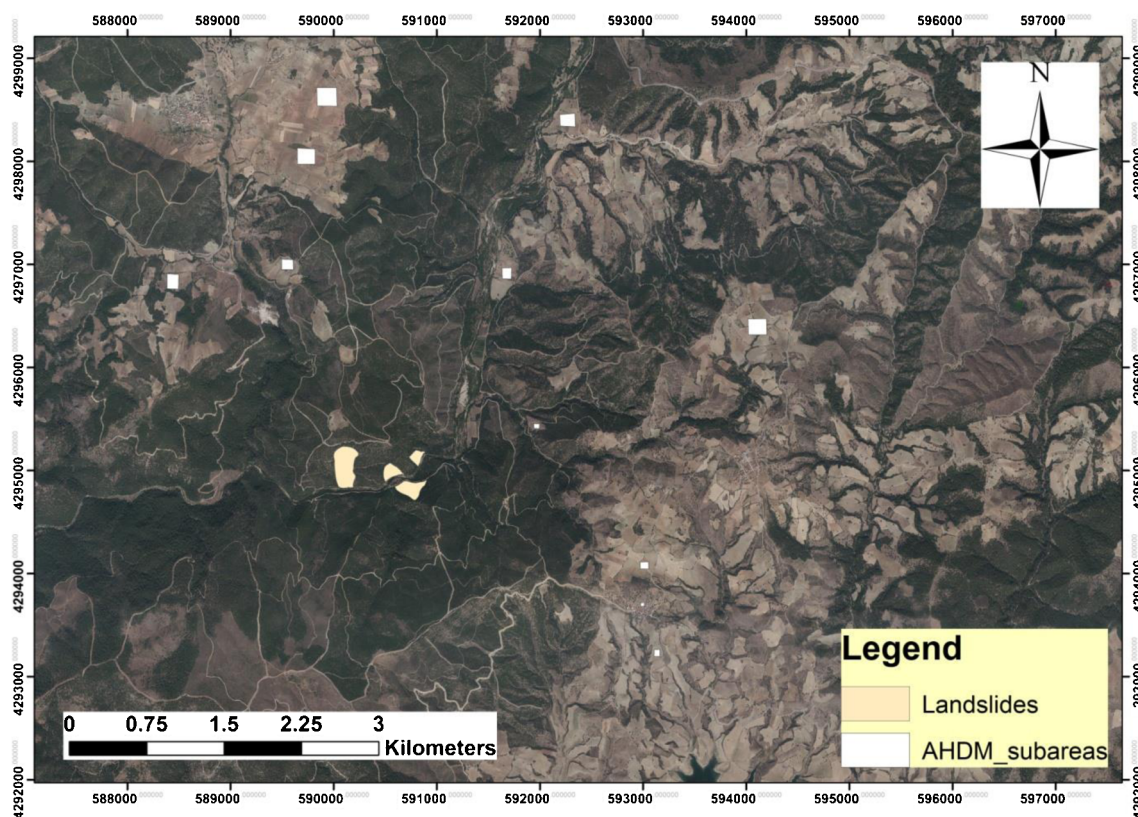
Fig. 11 The sub-areas in the region to determine the average height error between images

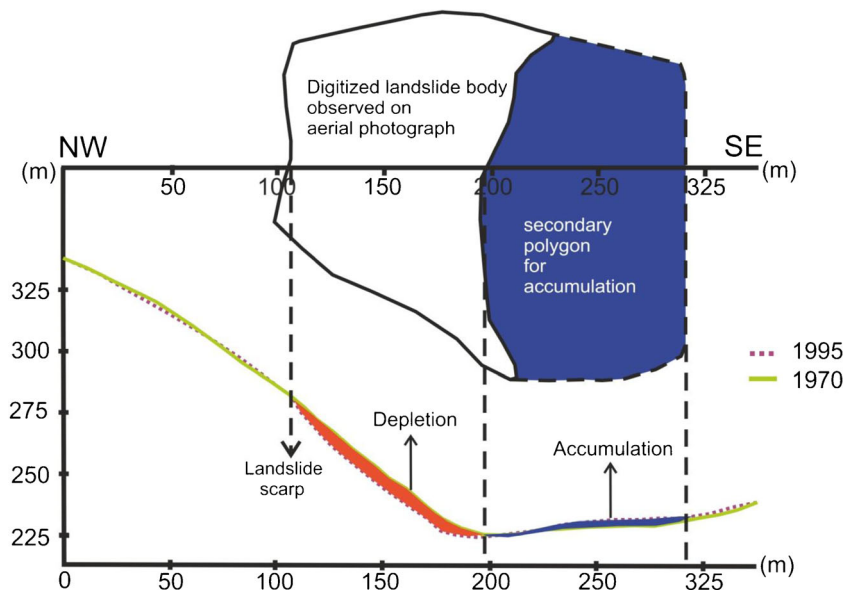
Fig. 13 Illustration of drawing secondary polygon for accumulation on the plan view of Landslide-4 with respect to the overlapped cross-section profiles of 1970 and 1995

Prior to volume calculations, cross-sections were extracted from DEMs of each year. The overlapped cross-section profiles of 1953 and 1970 as well as 1995 and 1970 indicated that the accumulation zone of Landslide-4 is not involved within the digitized polygon (Figs. 13 and 14). Accordingly, no accumulated material volume can be calculated for Landslide-4. Topographical comparison between 1953 and 1970 also revealed that there is a scarp 63 m behind the main scarp which was not observed on the aerial photograph (Fig. 14). The overlapped cross-section profiles of 1995 and 1970 highlighted that the reactivations are the repeated development of the same type of movement which occur in different scarps in the main landslide body. In other words, reactivations are independent movements of portions of the initial displaced mass.

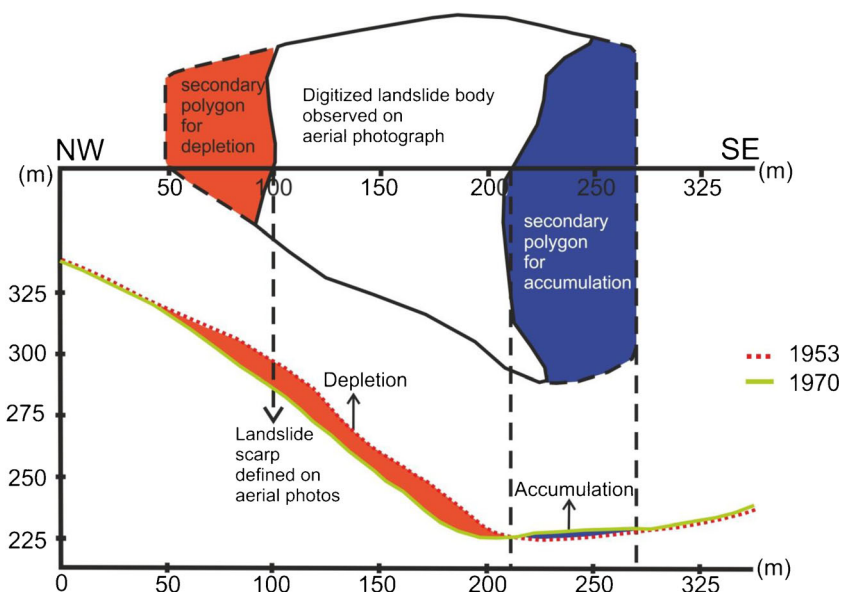
Fig. 14 Illustration of drawing secondary polygon for accumulation on the plan view of Landslide-4 with respect to the overlapped cross-section profiles of 1953 and 1970

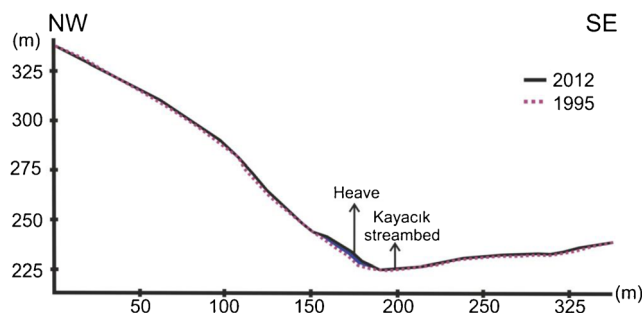
**Fig. 16** The cross-sections of Landslide-4 showing the differences in topography between 2012 and 1995

The topographical changes between 1995 and 2012 for Landslide-4 indicated that the heaving in the toe may refer to the possibility of a future landslide event (Fig. 16).

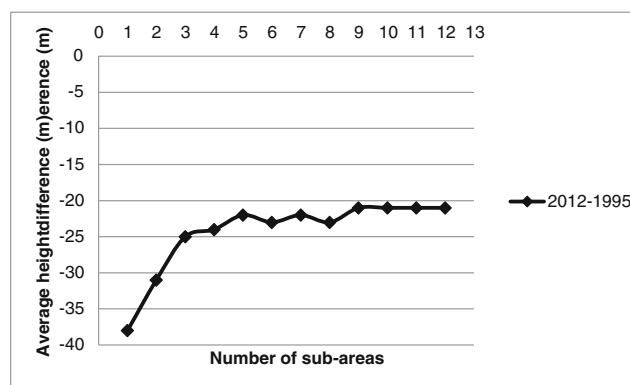
**Fig. 17** The change in average height difference between two successive DEMs with respect to the number of sub-areas

Various numbers of sub-areas with varying sizes from different locations were used in determining average height error between two DEMs. Figure 17 shows that 11 sub-areas can produce average height errors independent from their size and location for the DEMs used in this study. The average errors from 11 sub-areas for the periods 1970–1953, 1995–1970,

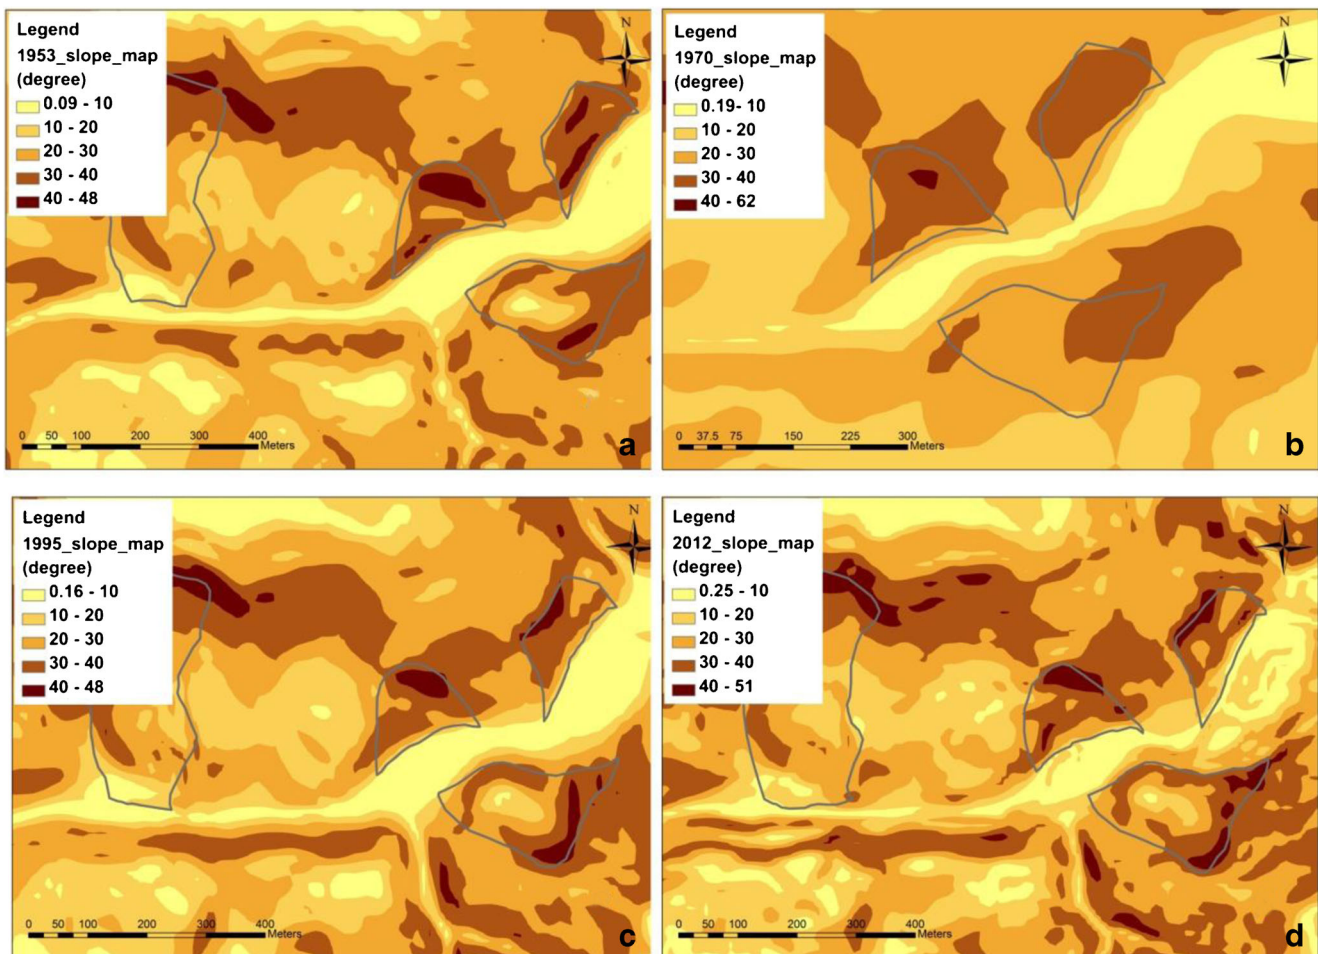
Fig. 19 The slope maps of each year. **a** 2012. **b** 1995. **c**1970. **d** 1953

Slope gradient was also examined as a predisposing factor of landslides. Slope maps highlighted the landslide scarps and partly the release surfaces (Fig. 19). The steep main scarps and lateral edges of landslides are well correlated with the slope angle of 40°–50°. On the other hand, a geologic differentiation can be made between the landslides based on the critical slope angle. The mean critical overall slope angle determined from cross-sections for Landslide-1, 2, and 4 which are formed of unconsolidated conglomerate and sandstone was found to be 33°. Besides, Landslide-3 is mainly composed of highly fractured clayey limestone which allows rapid infiltration of water during intense rainfalls. Therefore, it fails even though the slope angle is lower than 33°.
