Assessment of the rock slope stability of Fushun West Open-pit Mine

Abstract

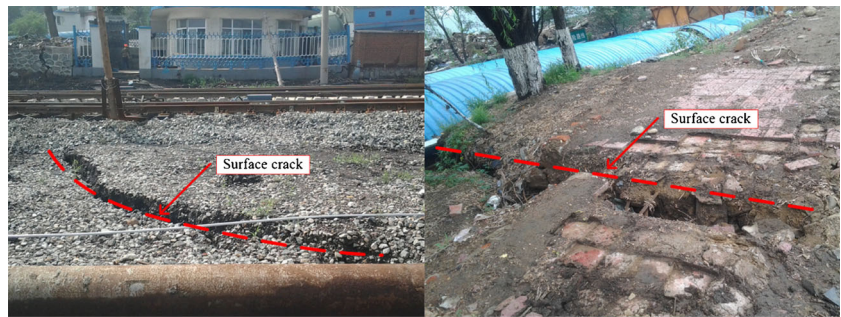
Fig. 2 The damage observed in situ

(a) the surface crack

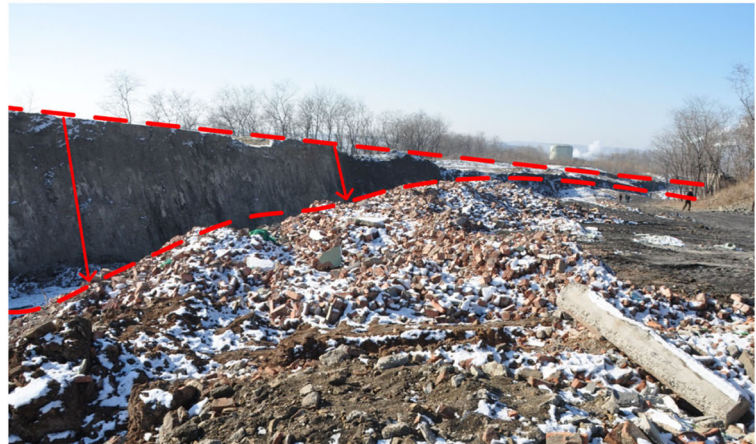
(b) the tensile crack in the top of the slope

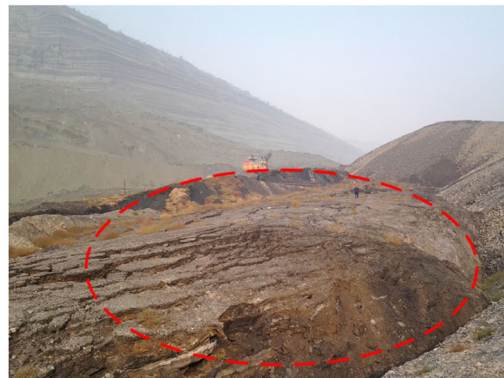
(c) the heave in the bottom of the slope

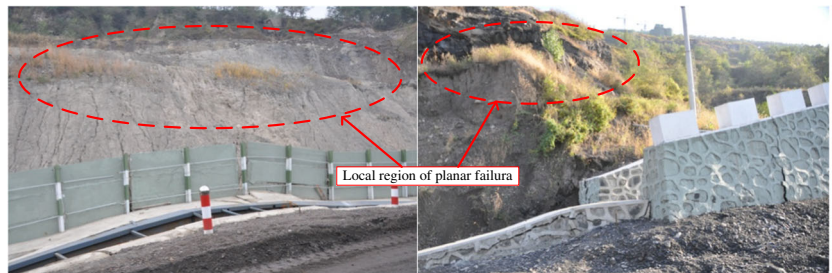
(d) some local region of planar failure

the planar failure of the south slope and the SMR results are consistent with the field observations.

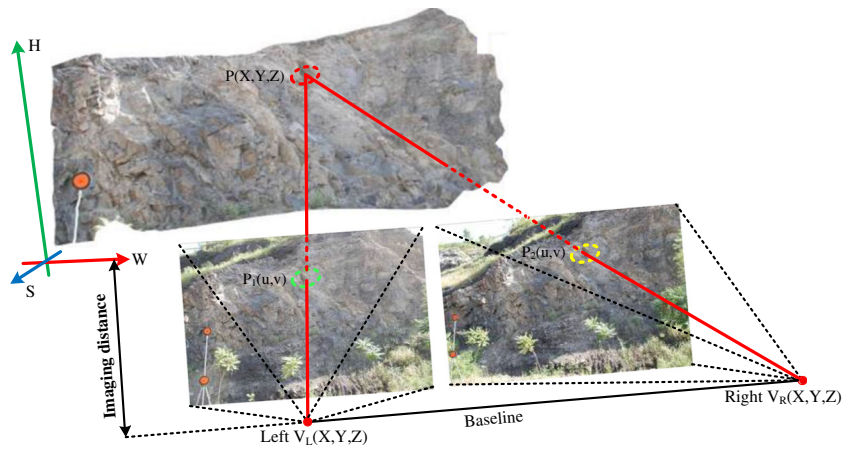
Fig. 4 The parameter of the discontinuities obtained by ShapeMetrix3D system

(a) the principle of the ShapeMetrix3D system

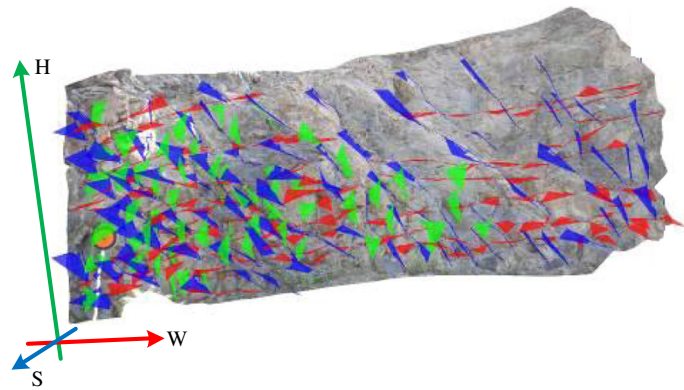
(b) the result of the identification of the joint

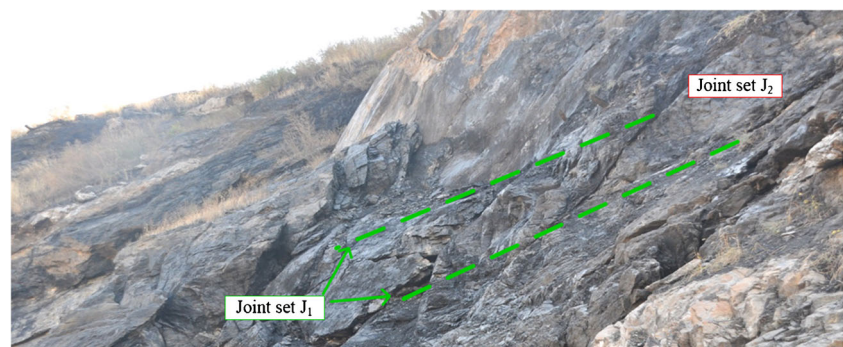
Fig. 6 The dominant joint set observed in situ

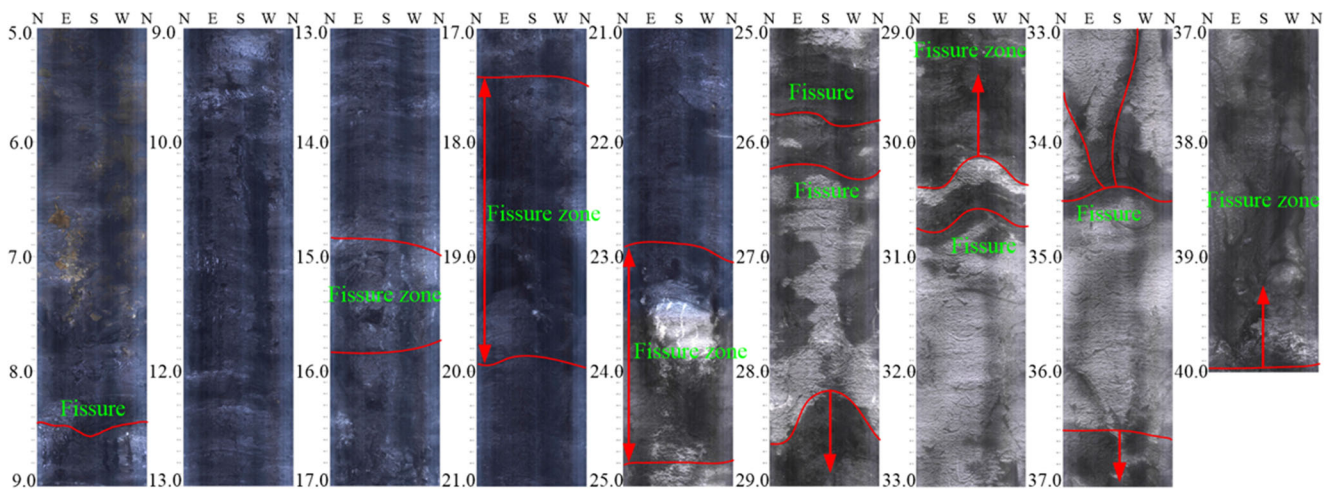
Fig. 7 The testing result of the borehole TV technique

cores were obtained during the excavation and deformation of the slope. The result of the test map can be used to evaluate the damage and the quality of the rock mass as shown in Fig. 7.

Figure 7 shows the borehole testing result near the section I-I at the top of the south slope. The depth of the hole is 40.0 m. Due to the surface of the slope is covered by the quaternary soil, so the borehole 0~5 m is protected by the steel pipe in order to reduce the risk of the collapse of the borehole. Therefore, Fig. 7 only shows the image from 5.0 to 40.0 m. The 14.7~31.0 m is mixed with the coal seam and the fissure zones. The cracks and breakdown areas can be observed at 8.4 m, 14.8~15.8 m, 17.4~19.9 m, 22.9~24.8 m, 25.7 m, 26.2 m, 28.6~30.4 m, 26.2 m, 28.6~30.4 m, and 30.8 m. The region between 33.0 and 34.5 m has some large fissures. From 34.5 to 35.3 m some opening fissures can be found in this region.

While in the region 36.5~40.0 m the broken zones can be clearly identified. From the monitoring result of the borehole TV technique, the fissure zones, and broken areas can be clearly identified in the slope. The coal seam and the carbonaceous mudstone mixed can also be observed in the slope. However, the fissure zone and the broken zone are small and the broken zone is not totally ruptured. At the same time, there is no obvious water leakage in the borehole. The interior rock mass quality of the south slope can be visualized through the borehole TV technique. The rock mass of the slope is partially stable in general. This is almost in accordance with the estimation of the RMR results.

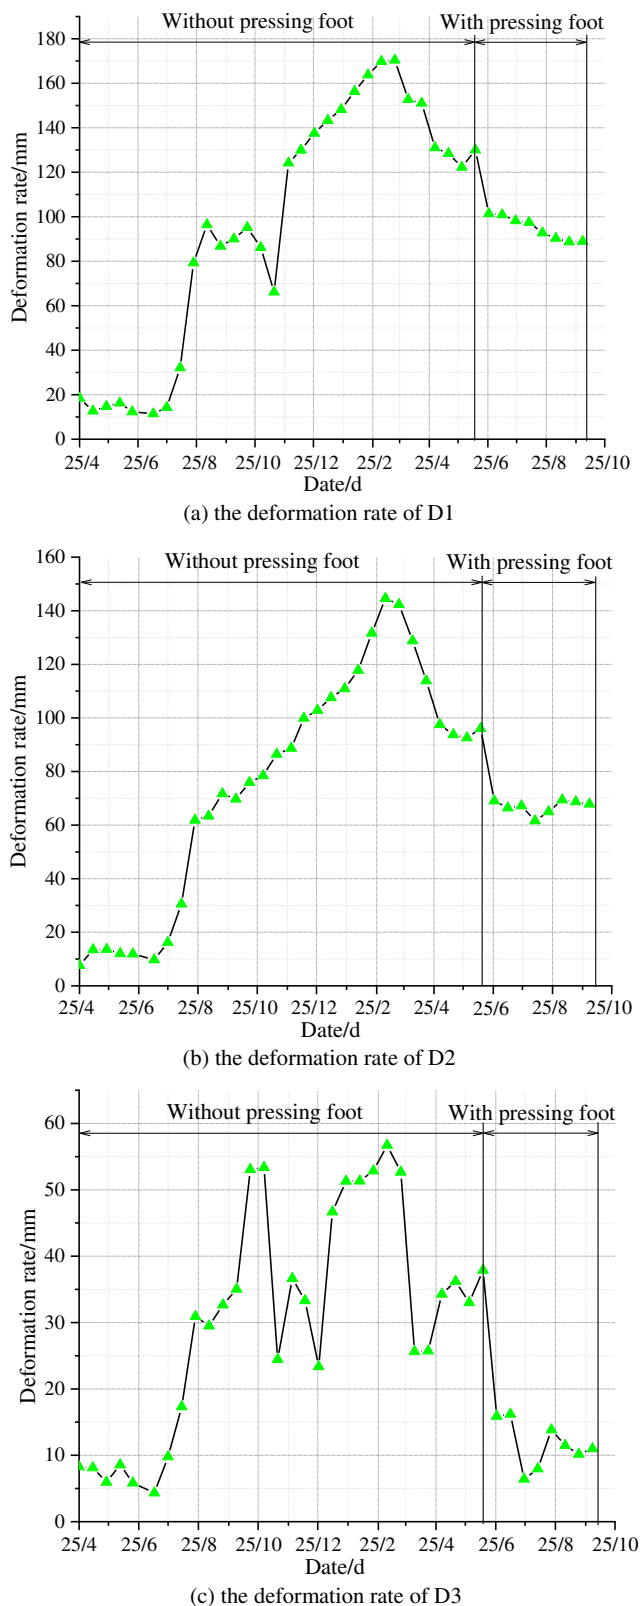
Fig. 9 The deformation rate monitored in-situ

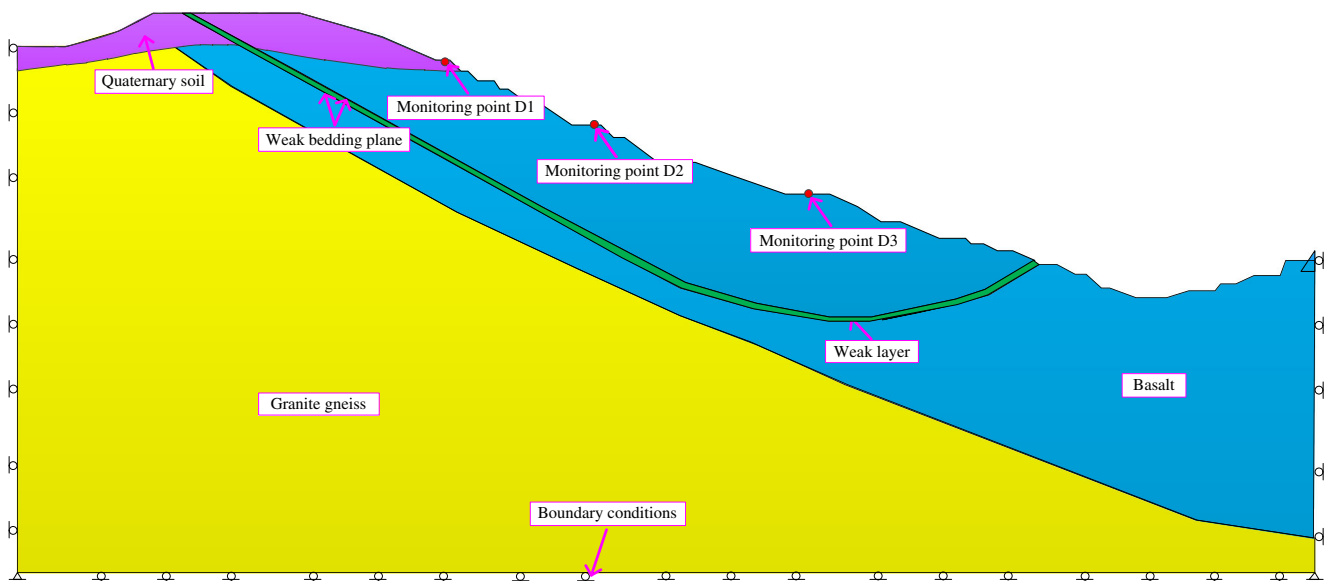
Fig. 10 The geology condition of section I-I

In order to further acquire the deformation characteristics of the slope, the monitoring point D1, D2, and D3 (Fig. 10) were selected to analyze the damage process of the slope. The monitoring data curve of monitoring point D1, D2, and D3 from April 25, 2013 to October 2, 2014 is presented in Fig. 9. It is shown that in Fig. 9(a) the deformation rate gradually increased from 2013, especially from August 2013 due to the rainy season. After that, there was a brief decrease, and then the deformation rate began to increase rapidly again. This was mainly because the slope was already in the state of limit equilibrium. But after the implementation of the pressing foot project, the slope deformation rate has decreased significantly. The curve of monitoring point D2 shows a similar law with D1, but the deformation rate is not decreased in November 2013 and the value is relatively small than monitoring point D1 (Fig. 9(b)). The law of monitoring point D3 is roughly the same with monitoring point D1 and the value of the deformation rate is the lowest of three monitoring points (Fig. 9(c)). It is also shown that without the pressing foot of the south slope, the deformation rate is relative large. The maximum displacement of D1, D2, and D3 was 170 mm, 144 mm, and 56 mm separately for each day. While in the case after the pressing foot of the slope, the maximum deformation of D1, D2, and D3 was reduced to 101 mm, 69 mm, and 16 mm per day separately. The tendency of deformation rate decreases obviously. The deformation rate monitored on-site indicates that the pressing foot of the south slope obviously controlled the deformation of the slope along the weak bedding planes.

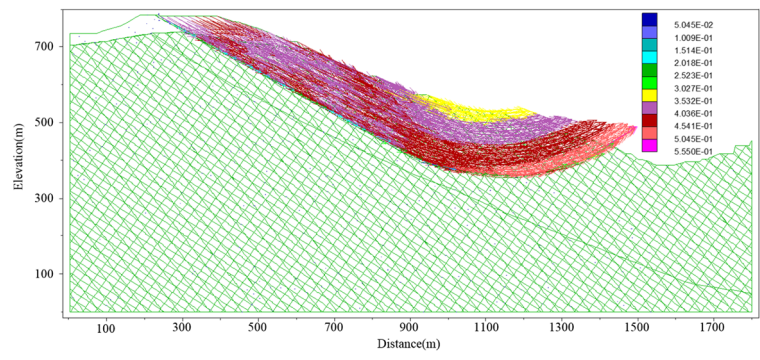
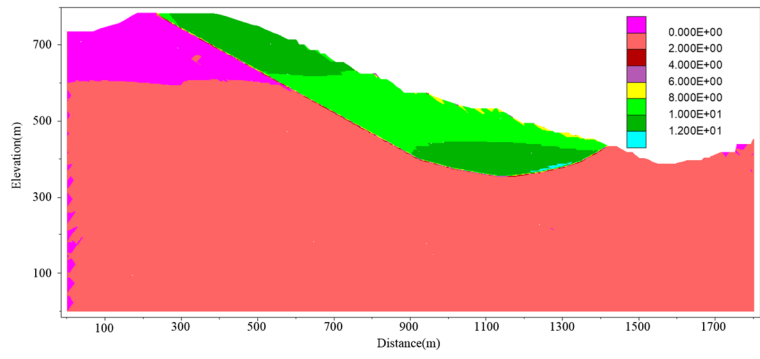
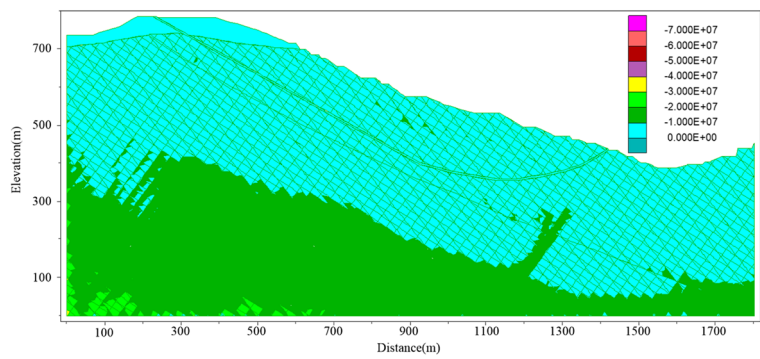
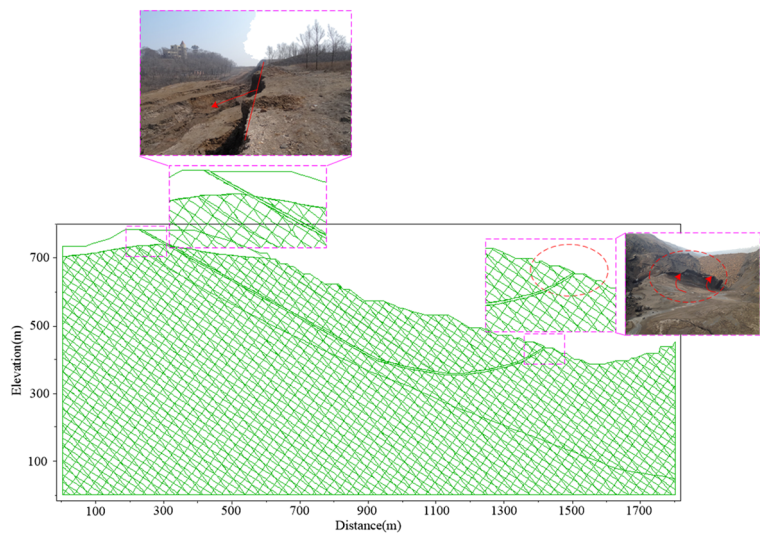
Fig. 11 The result of the numerical simulation

(a) the velocity vectors

(b) the X displacement contours

(c) the major principle stress contours

(d) the deformation of the block

The results of the typical section of the south slope are presented in Fig. 11. The vector of the velocity clearly indicates the landslide of the slope mainly occurred along the weak bedding plane. It indicates that the block near the bedding plane changing fast and the block near the slope surface are slow down. Figure 11(b) also shows the failure mode of the slope when the FOS is 1.09 approximately to 1.0. The FOS of the slope indicates that the slope is in limit equilibrium state. The displacement in X direction is obvious in the toe of the slope and the top of the slope. The X-displacement in the deep of the slope along the weak bedding plane means that the landslide is mainly slip along the bedding plane. Figure 11(c) shows the major stress contour of the slope, the stress distribution is relatively uniform, only a small part of the stress concentrated near some joint sets and weak layer. The result in Fig. 11(d) also illustrates that the planar failure is the primary failure mode of the south slope. The displacement near the slope surface is relative small indicates that the joint sets are the secondary factor for the triggering of landslide in the south slope. However, it should note that the combination of joint sets in the frontal surfaces may form some isolated blocks and detach from the slope.

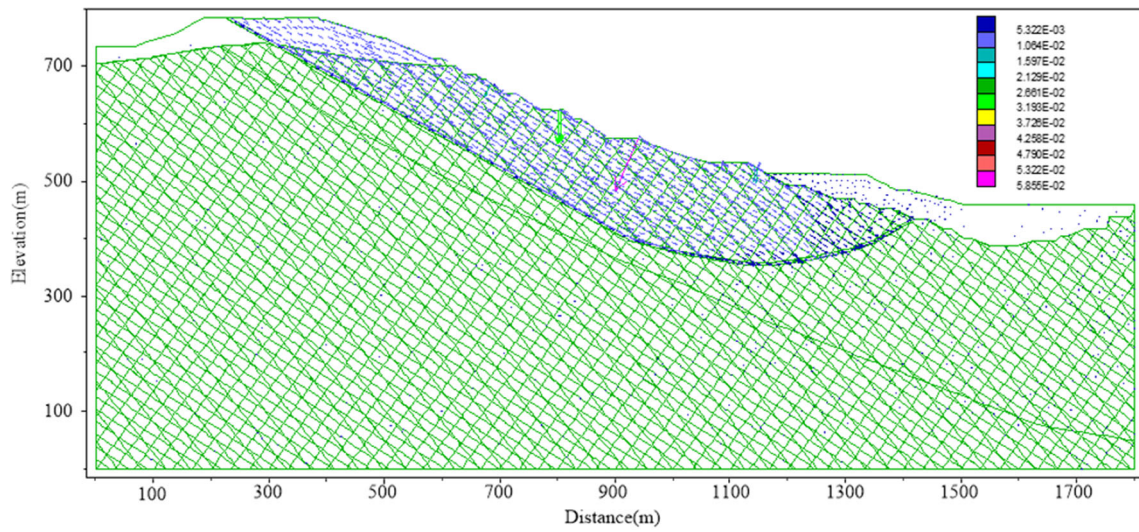
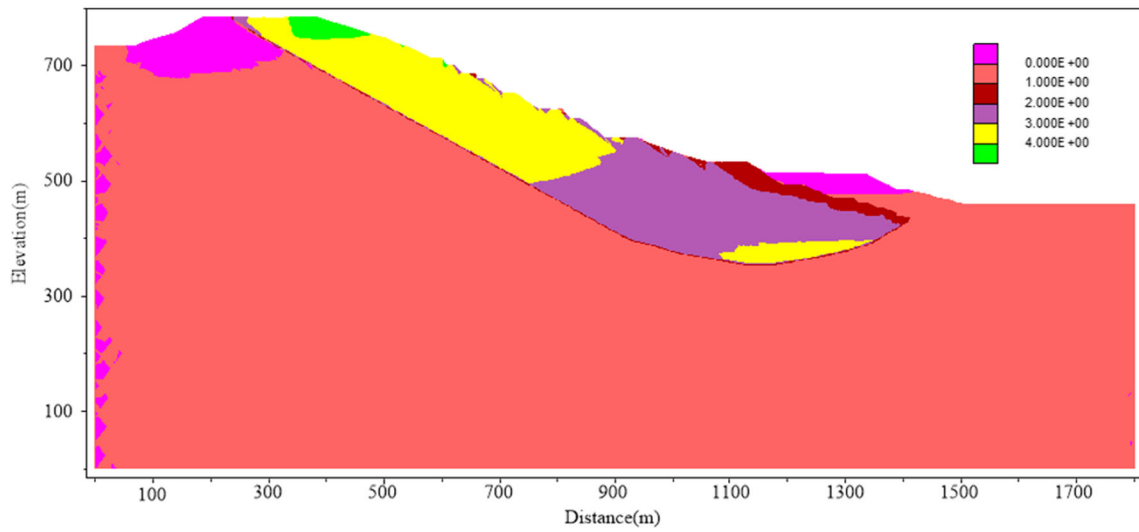
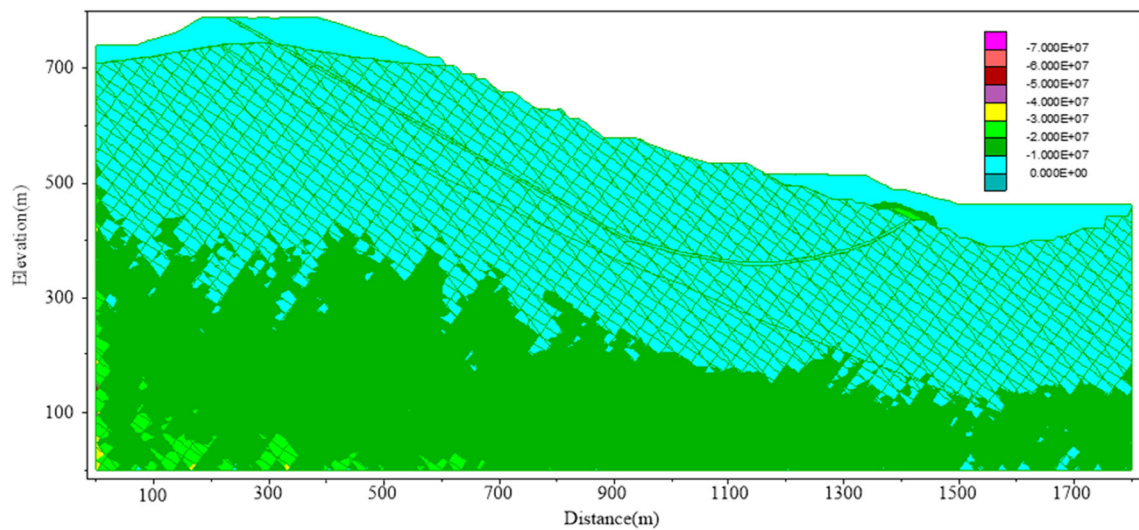
Fig. 12. The numerical result after the pressing foot of the slope

(a) the velocity vectors

(b) the X displacement contours

(c) the major principle stress contours

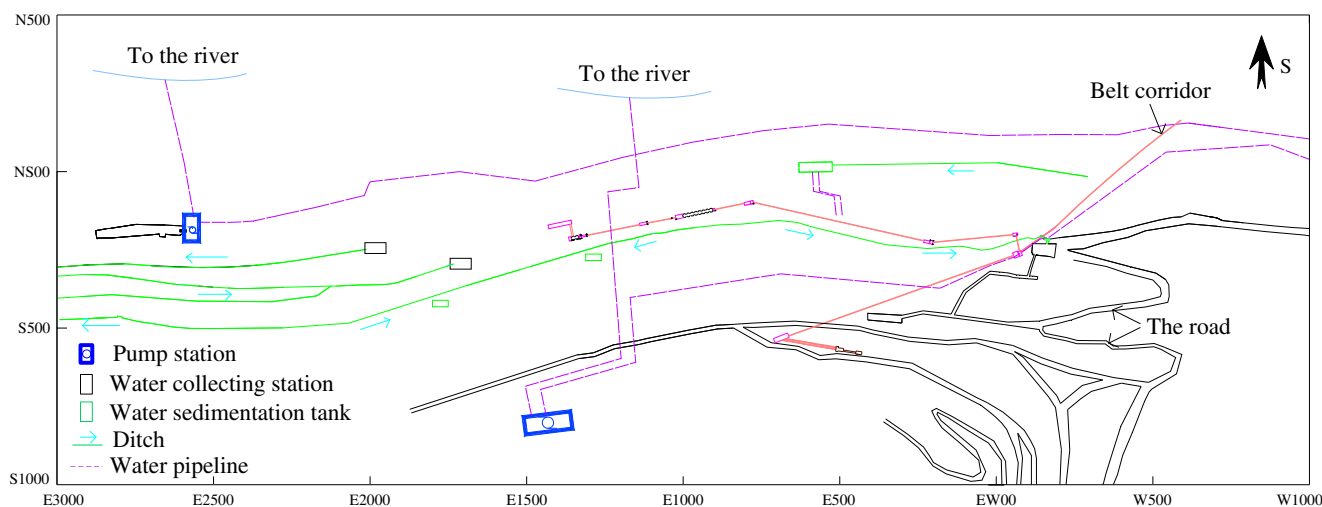
Fig. 13 The designed drainage system of the south slope of the open-pit

distribution map, the water leakage points and strips were delineated and the corresponding drainage system was established. The drainage ditch was employed in the place corresponding to the water leakage points and strips. Finally, the water is discharged through the pump station. The plan view of the designed drainage system is presented in Fig. 13. The construction of drainage system can further effectively control the occurrence of slope hazards.

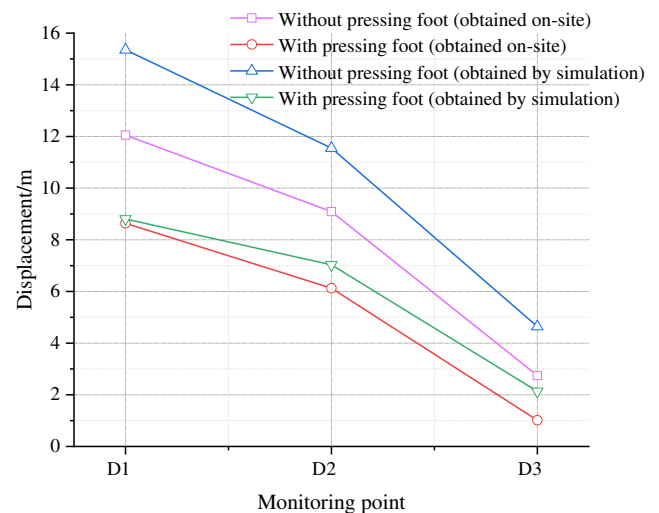
Fig. 14 The displacement curve without and with pressing foot of the south slope

The validation of the numerical calculation for the study of slope deformation mechanism can be verified by the monitoring data from the study area. In order to illustrate the reliability of the calculation results in this paper, three different monitoring points are selected from section I-I accordingly. Furthermore, the accumulated displacements of 3 months before and after the pressing foot project (July 1, 2014) were counted. Thereafter, both the numerical monitoring data and the corresponding in situ monitoring data were presented in Fig. 14. It indicates that the displacement decreased with the pressing foot project and the displacement of the slope

gradually decreases from top to bottom. The tendency of on-site monitoring data is consistent with the simulation results. The damage zone delineated by the simulation can also observe in situ (Fig. 11(d)). The simulation can reproduce the failure process of the south slope and forecast the possibly deformation trend. The numerical results also reveal the same failure mode with the empirical method. Both the empirical method and numerical method reveal that the weak bedding plane is the main factor leading to the instability of the slope.
