Visual inspection of fire-damaged concrete based on terrestrial laser scanner data

Abstract Visual condition survey and inspection is typically the initial method employed in the assessment of concrete damaged by fire, and it is among the most significant non-destructive testing methods. In spite of visual inspection being simple in principle, it is capable of providing cardinal information about the condition of the fire-damaged structure and act as a basis upon which subsequent and detailed assessment methods can be founded. When concrete is exposed to various elevated temperatures, it undergoes change in its physical characteristics among others, and indicators such as change in surface texture, cracks, spalling and colour change become evident. These indicators of fire-damaged concrete can be assessed using visual inspection methods and further assessed with more advanced methods in a case where detailed investigations are needed. In this study, visual inspection of terrestrial laser scanner data of fire-damaged concrete was investigated by modelling and analysing laser intensity. An analysis of the generated intensity images from laser intensity data has proved useful and val

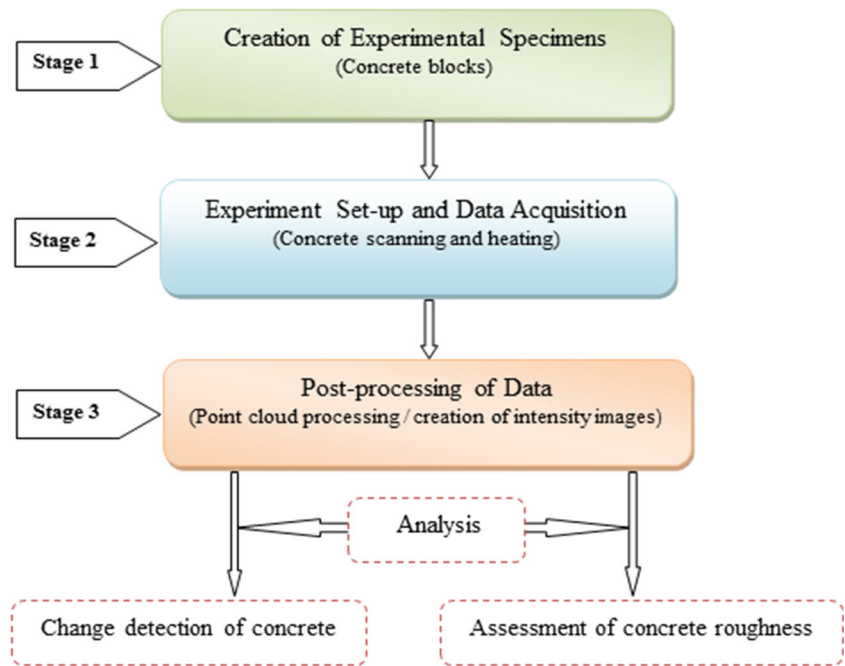
Fig. 1 Workflow of methodology

The overall workflow of the methodology which was employed in this study is illustrated in Fig. 1 below:

With reference to Fig. 1 above, the three main stages that composed the methodology are explained as follows:

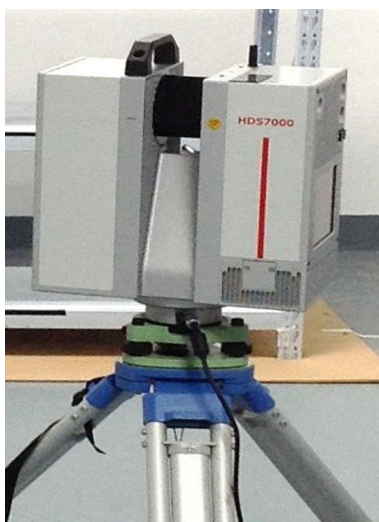
Fig. 2 HDS7000 laser scanner

The experiments were carried out in a controlled laboratory. The factors that have an influence on the laser returned intensity under such conditions are the scanning geometry and the instrumental effects. Since the experiments were carried out in a controlled environment and at short range, atmospheric losses were neglected. Scanning of the concrete specimens was carried out using Leica's HDS7000 laser scanner (Fig. 2) and shown in Table 2 are the technical specifications of the scanner.

Scanner	Leica HDS7000
Ranging method	Phase
Wavelength	1500 nm
Field of view (Ver/Hor)	320° × 360°
Laser class	1
Range	0.3–187 m
Linearity error	≤1 mm
Samples/s	1,016,000
Beam diameter	~3.5 mm at 0.1 m
Beam divergence	<0.3 mrad
Temp range	0–45 °C
Colour	External
Weight	9.8 kg

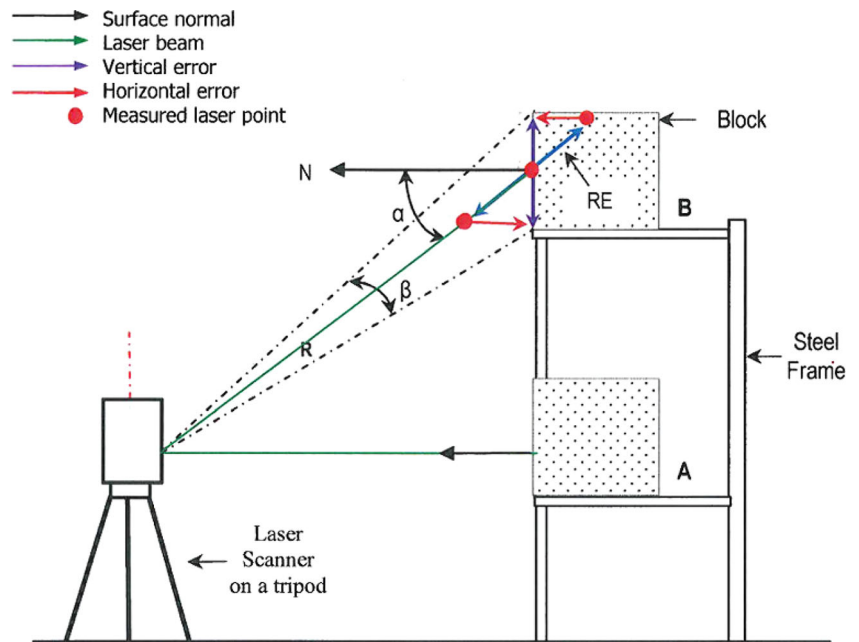
Fig. 3 Scanning the block at normal incidence and the range error at non-normal incidence. Modified from Bitenc et al. (2010).

The concrete blocks were placed on a steel frame at roughly the same height as the scanner to ensure normal incidence of the laser (shelf A in Fig. 3) and the scanning distance was 3 m. The whole essence of optimising the measurement setup was based on the fact that in theory, an increase in scanning incidence angle and distance leads to a decrease of the backscattered laser intensity (Kaasalainen et al. 2011). Higher angles of incidence of for instance greater than 20° lead to poor geometry of intersection and have an effect on the precision of range determination. Furthermore, Bitenc et al. (2010) state that the random range error indicated in the scanner technical specifications only holds when scanning is carried out at normal incidence to the object that is scanned. Therefore, the range error (RE) as a result of

scanning at non-normal incidence and the effect that this has on the laser point positioning error for both the vertical and horizontal is illustrated in Fig. 3 in the case of scanning the block on shelf B.

Bitenc et al. (2010) used a pulse laser scanner and calculated the range error as shown in Eq. (1) below:

$$RE = \frac{R \cdot \beta \cdot \tan \alpha}{2}, \quad (1)$$

where RE is the range error, R is the range, β is the divergence of the laser beam and α is the angle of incidence. In this study, the scanning distance only had an error of a few millimetres because an effort was made to scan as close as possible perpendicular to the concrete specimens.

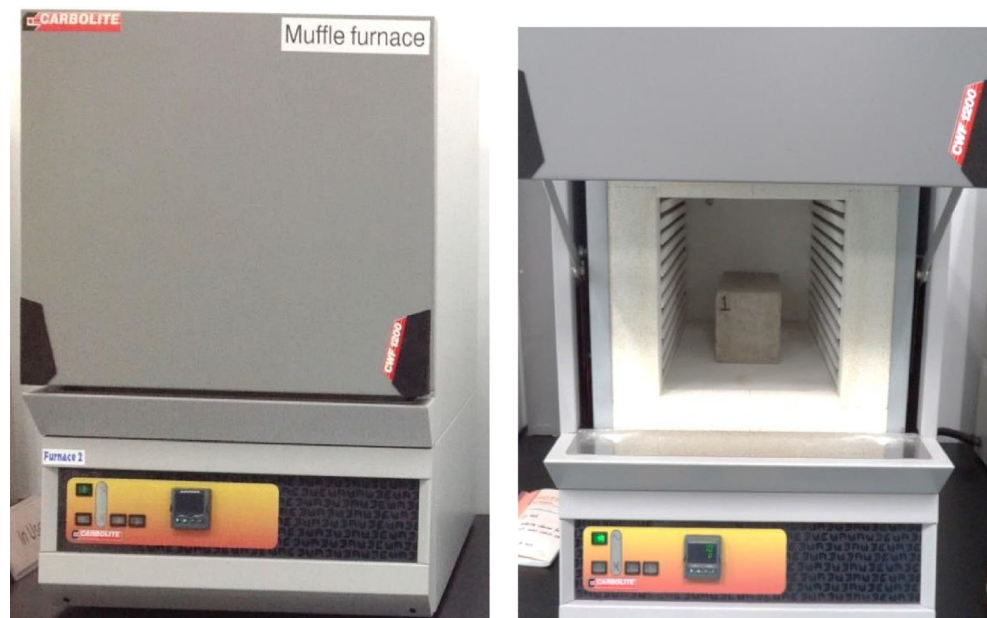
Fig. 4 Carbolite CWF 12/23 electric furnace, shown is the exterior and the chamber

After the unheated concrete specimens were scanned with the laser scanner, they had to undergo heating, and a Carbolite CWF 12/23 electric furnace (Fig. 4) was used for this purpose. Prior to heating the concrete specimens, the furnace was tested, whereby its recorded temperature was also verified by measurements that were taken using a

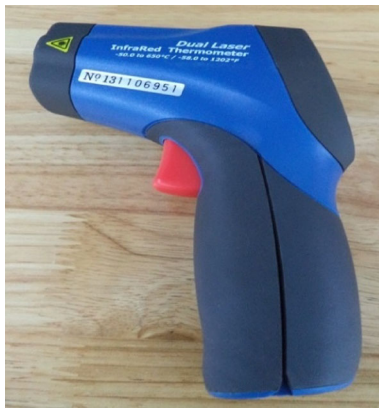
Fig. 5 Infrared thermometer

dual laser infrared thermometer (Fig. 5). For easy identification, the concrete specimens were labelled as Block C, Block 1, Block 2, Block 3 and Block 4. The specimens, Blocks 1 to 4, were then heated according to the specifications shown in Table 3. The peak temperatures were maintained for 1 h to simulate fire exposure time, and after that, the furnace was switched off with the specimen inside and left to cool down to room temperature in order to avoid

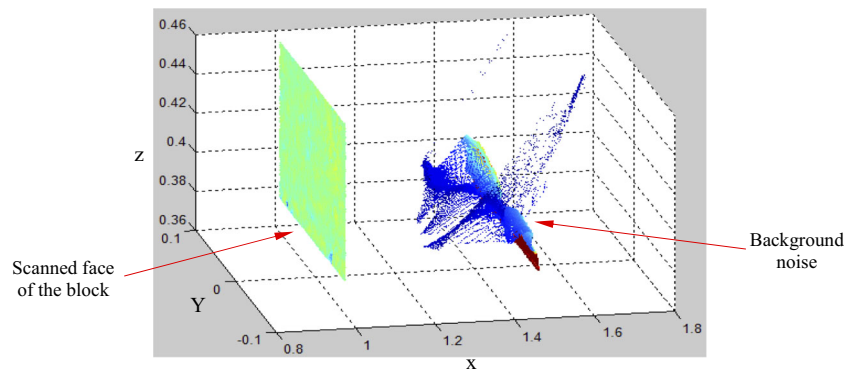
Fig. 6 Clipping the scanned face of the block

The alignment strategy implemented for the scans was a vital prerequisite for the subsequent stages in data processing. The preceding steps were helpful in devising a proper way of clipping the scanned face of each block from the point cloud, and Fig. 6 illustrates part of this process.

Shown in Fig. 6 above is a point cloud consisting of the scanned face of the block and noise in the background after the initial step of data filtering. Since the scanned face of the block was the area of interest, a reasonable section of data points around this area was selected whilst leaving out the points on the edges of the block so as to avoid the problem of mixed pixels. The noise at the background of the scanned face of the block was eliminated via limiting the point cloud based on the scanning distance function, the Y and Z dimensions of the block. The error of the scanning distance at 3 m was found to be ± 2 mm. These data processing steps and others were implemented in tailor-made Matlab functions. The sample data points that covered the selected area on the scanned face of each block were more than 15,000, and it is the intensity of these points that was used to create 2D intensity images. Sample data points for each block were also

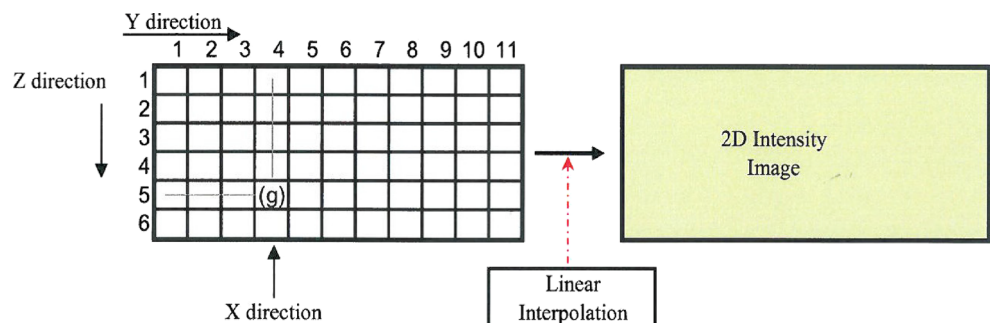
Fig. 7 An illustration for generating 2D intensity images

Intensity images were generated using intensity data for the control, unheated and the heated concrete blocks. The procedure employed was implemented in a Matlab script, and it involved creating a grid covering the Y and Z directions on the scanned face of each block and where the X direction was treated as the direction from which the image should be viewed. A grid size (g) of 0.001 m was chosen so as to produce images of good quality, and the linear interpolation technique was applied using the intensity value at each location so as to create a surface rather image covering the entire face of each concrete block. The procedure for generating 2D intensity images is illustrated in Fig. 7. Other interpolation techniques such as spline, cubic and nearest neighbour were also explored, but there were no significant differences in the images that were created using these techniques.

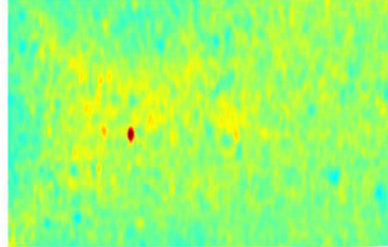
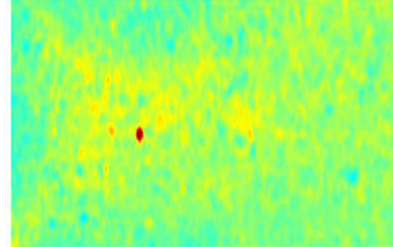
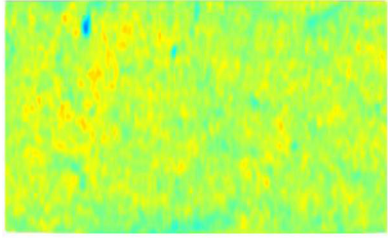
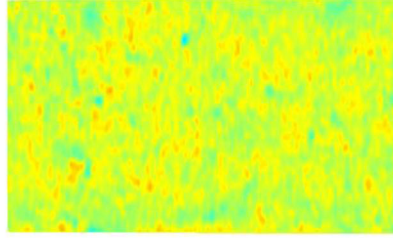
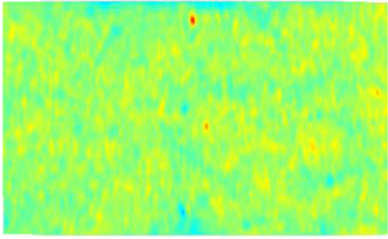
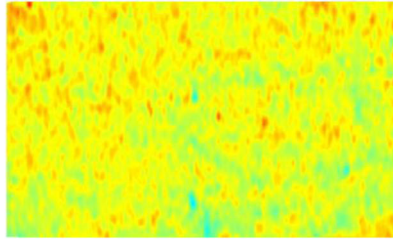
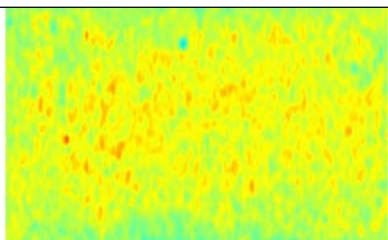
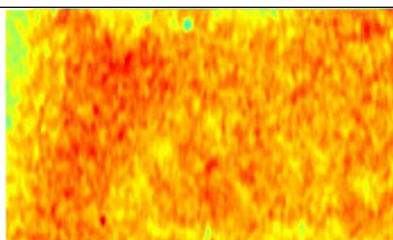
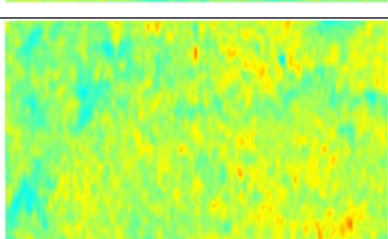
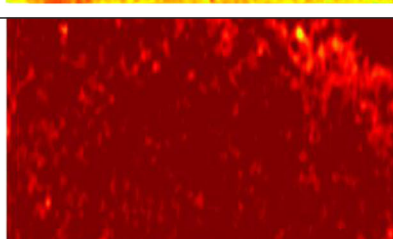
Table 4 Intensity images of control, unheated and heated concrete blocks

Visual inspection is normally the initial step in the assessment of fire-damaged concrete. Table 4 shows a comparison of unheated and heated concrete intensity images. The status of Block C (the control block) remained the same, since it was unheated and acted as

a reference. However, the blocks that were heated to various temperatures show remarkable differences, and it can be seen that the intensity values increase after heating which is useful in roughly assessing the change in state of heated concrete. Furthermore, visual

inspection of concrete intensity images is informative, it well complements existing visual inspection methods of fire-damaged concrete and it has the potential to act as a basis upon which to employ detailed laboratory investigations.

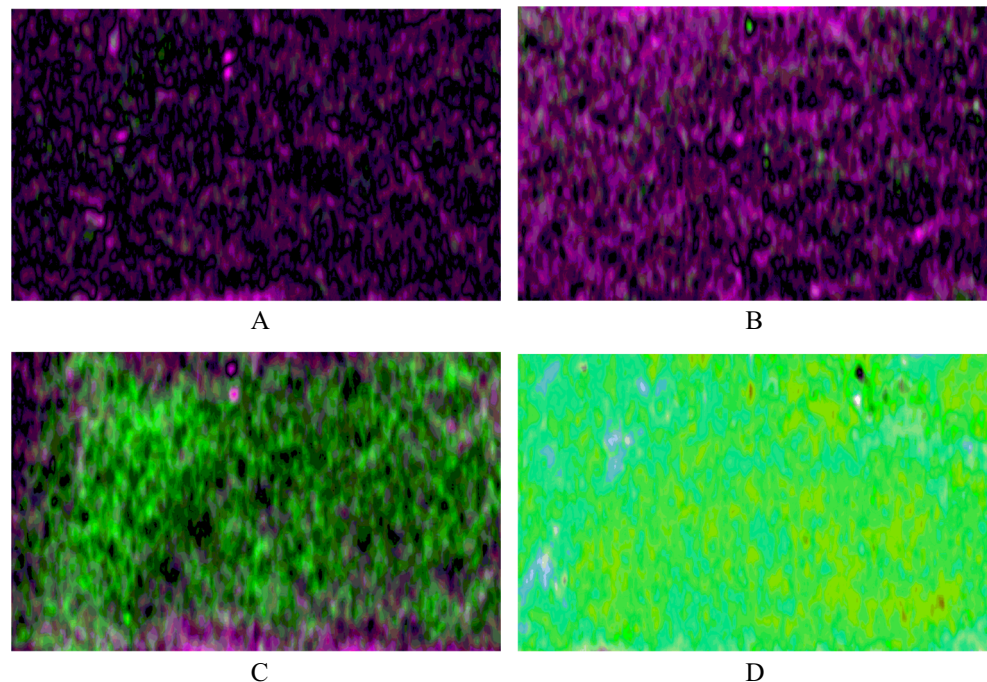
Fig. 10 Change images lettered a to d are for Blocks 1 to 4, respectively, and show the change due to heating

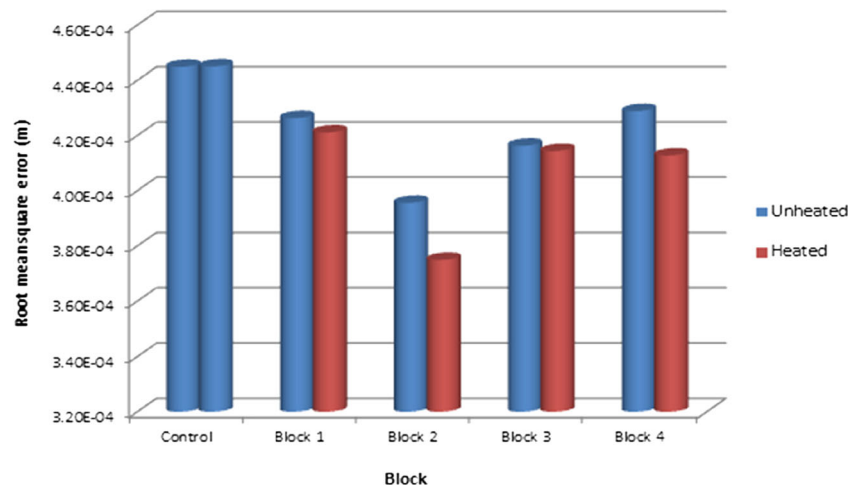
Fig. 11 Surface roughness of unheated and heated concrete blocks

It is obvious that concrete undergoes some physical modifications when subjected to heating, and one such change is surface roughness. As a way of assessing surface roughness of concrete blocks before and after heating, the root mean square errors of the faces of the concrete blocks to the fitted plane were computed. The control block was also included in the assessment of surface roughness. Figure 11 below shows the results where change in surface roughness can be seen, although it is worth stating that the root mean square errors are relatively small, and this is attributed to the fact the concrete used in this study was fairly smooth and with minor rugosity.

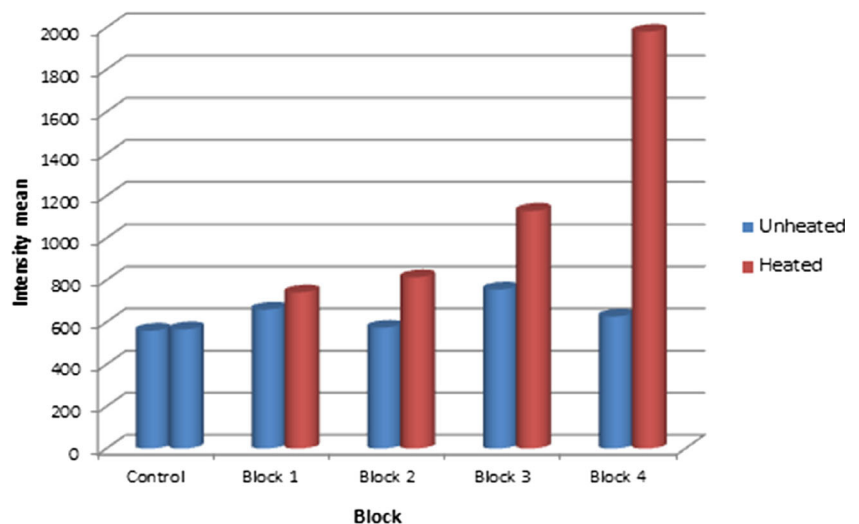
Fig. 12 Comparison of unheated and heated concrete blocks based on the intensity mean

The computed mean intensity and mean standard deviation for the heated and unheated concrete blocks which are presented in Table 6 were used to perform the comparative analysis so as to assess the effect of thermal treatment on the returned intensity for the blocks and further relate this to the exposure temperature that each block was heated to.

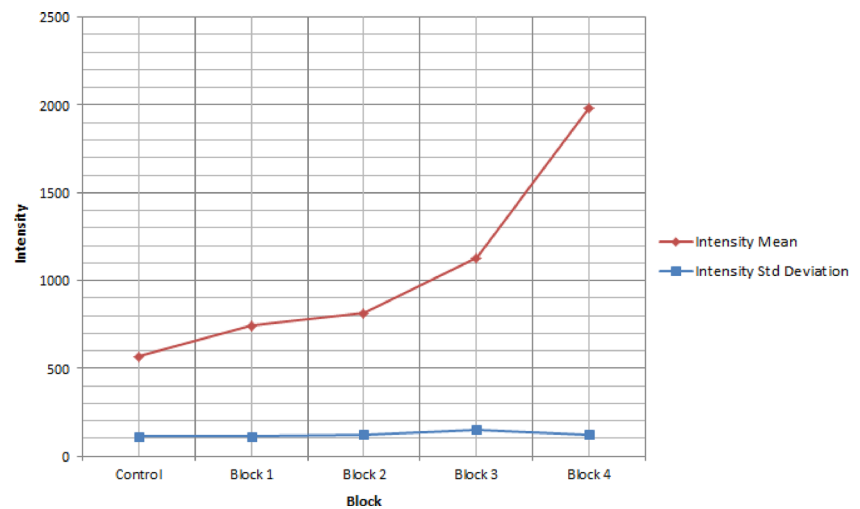
Fig. 13 Comparison of the intensity mean and intensity standard deviation for the control and heated concrete blocks

A relation between the intensity mean and the intensity standard deviation is shown in Fig. 13 for the heated concrete blocks and the control block. It can be observed that the intensity mean compared to the intensity standard deviation is able to better show an increase in intensity in relation to the various temperatures that the blocks were heated to. However, the intensity standard deviation does show a minimal increase in intensity up to Block 3 and then it starts to decrease.
