Microstructure and Mechanical Characteristics of Dissimilar TIG Welded 9% Cr Heat-Resistant Steels Joints

Abstract

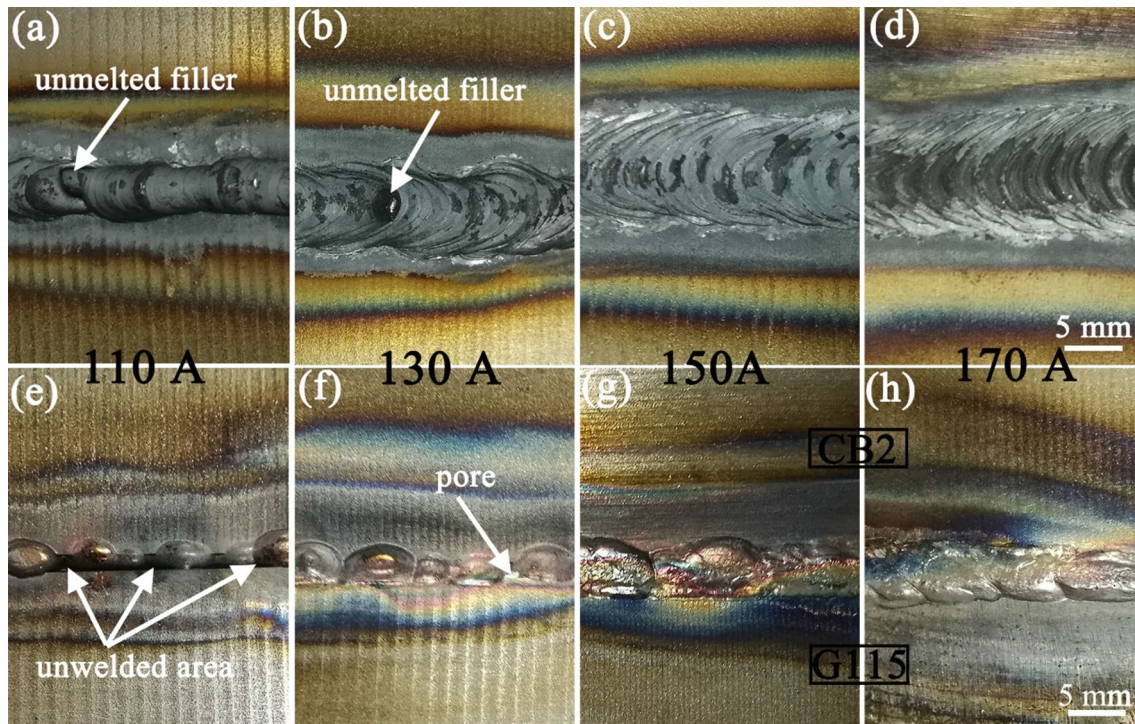
Fig. 2 Macro-morphology of welded joints: **a–d** were top surfaces at 110, 130, 150 and 170 A, respectively, **e–h** were their root surfaces, respectively

Figure 2 illustrates the effect of welding current on macro-morphology of TIG-welded joints. Figure 2a–d depict the appearance of the top surface of joints, and their welding current was 110, 130, 150 and 170 A,

respectively. Figure 2e–h correspond to the root surface of their joints, respectively. Owing to fixed welding speed, the heat input at 110 and 130 A was insufficient to melt all filler wire, leading to un-melted filler left in WM, as shown in Fig. 2a and b, meanwhile the higher and narrower WM was observed at lower current. In Fig. 2e and f, pores were found on the root surface and the welded area was very small at 110 A, indicating that full penetration was not realized at 110 and 130 A. The main reason was that the spreading of liquid welded metal was partially limited by un-melted filler. When current increased to 150 and 170 A, more heat input promoted the formation of WM and the WM was

continuous on the top and root surfaces, achieving full penetration throughout the weld length, as exhibited in Fig. 2c, d, g, f.

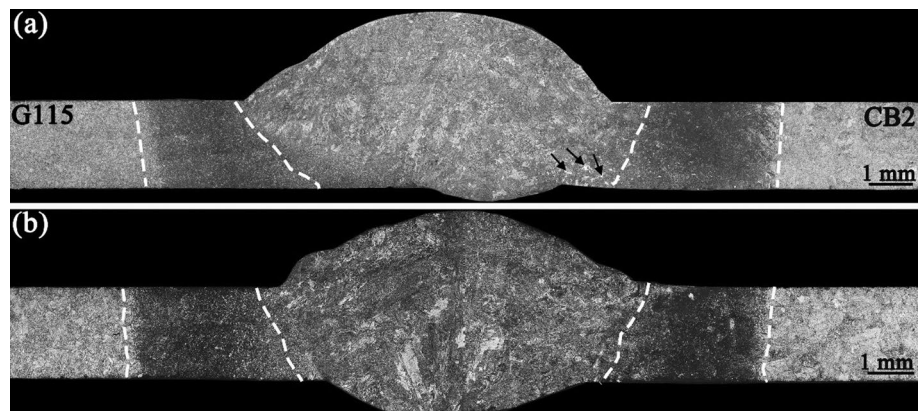
Fig. 3 Cross-sectional macrostructure images of welded joints: **a** 130 A, **b** 150 A

Figure 3a and b are cross-sectional macrostructure images with welding current of 130 and 150 A, respectively. There were soft ferrite patches in WM near CB2, as arrows marked in Fig. 3a. Figure 4a and b are magnified OM images of ferrite marked in Fig. 3a, which was consistent with this literature [12]. It could be obviously noticed that the martensite of WM seems to be coarser at 150 A, which was attributed to heat input. In Fig. 3b, the profile of WM on top and root sides was more symmetrical than that of Fig. 3a, and

the WM of Fig. 3a on the top side was higher. The width of HAZ was approximately 3 mm in both sides of G115 and CB2, and large HAZ was associated with high heat input and thin plates.

The effect of welding current on tensile strength at room temperature is depicted in Fig. 14. The joint at 110 A had the lowest tensile strength due to very small welded zone, as proved by Fig. 3a and e. With increasing current from 110 to 150 A, the tensile strength gradually increased. The tensile stress at 130 A was lower than that of 150 A because lower heat input made filler incompletely melt and some unwelded pores existed on the root surface of WM, partly deteriorating mechanical properties of joints. Sound joints were obtained with larger current of 150 A, as shown in Figs. 3c and g and its tensile strength was 673 MPa. As welding current exceeded 150 A, the tensile strength basically kept stable

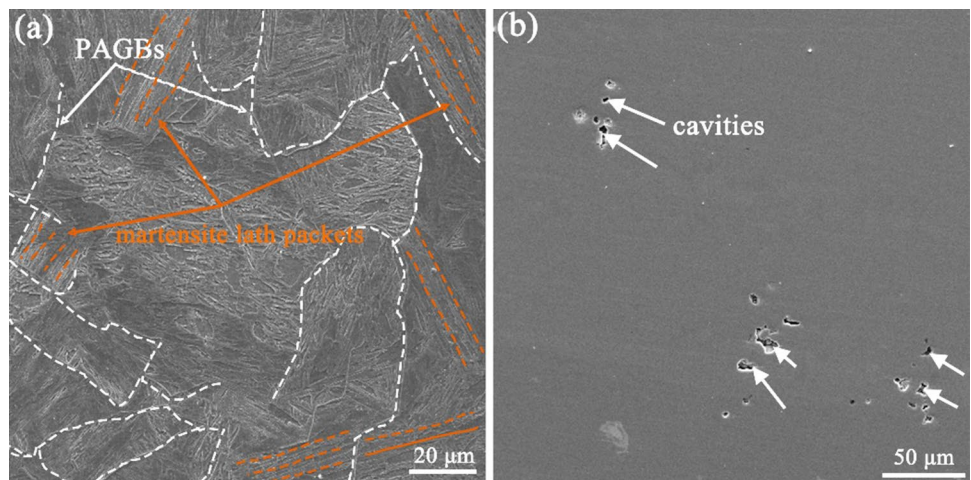
Fig. 5 SEM images of WM at 130 A

Figures 5 and 6 show the microstructure of WM with different welding current of 130 and 150 A, respectively. In both WM, quenched lath martensite was noticed inside the prior austenite grains (PAGs) (marked by white dotted line) and a large number of laths formed lath packets (presented by orange dotted line). There were some cavities in WM formed during the solidification process of weld pool, as shown in Fig. 5b, which might influence the mechanical properties of joints. Figure 6b is the magnified SEM image of WM, and the width of lath martensite varied from 0.5 μm to 1.5 μm . The EBSD of Fig. 6c illustrates the lath characteristic of martensite and the orientation of martensite in packets was basically consistent. Figure 7 gives TEM result of WM, Fig. 7a and b illustrate that the microstructure of WM was lath martensite, and some dislocations distributed on the

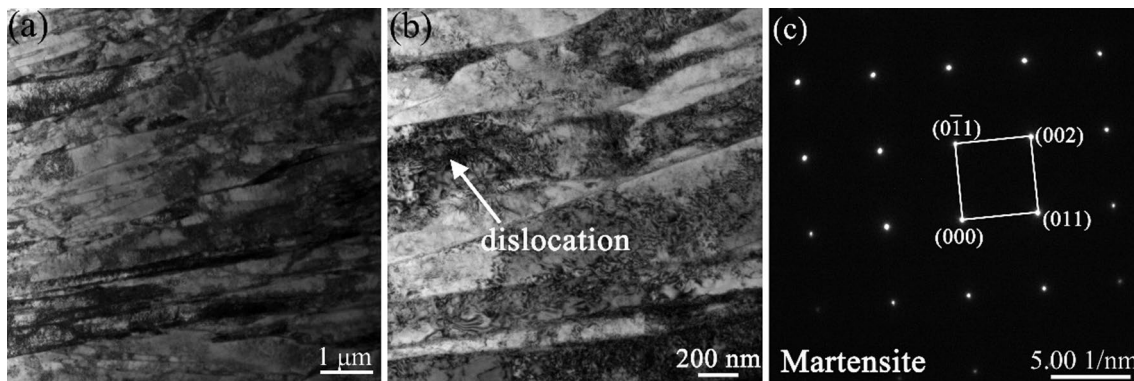
Fig. 7 TEM analysis of WM: **a** and **b** morphologies of martensite, **c** diffraction pattern of matrix

laths at 150 A. No precipitate was found in WM owing to high cooling rate. The martensite was body-centered cubic structure, which was confirmed by Fig. 7c.

The microstructure of CGHAZ and FGHAZ was untempered martensite in PAGs [6]. Average grain size of CGHAZ was 50 μm , estimated from Fig. 7b. During TIG welding, the temperature of CGHAZ could far exceed A_{c3} , promoting prior austenite grain growth, as illustrated by Pandey et al. [23]. The temperature of FGHAZ was just above A_{c3} , and the dwelling time was short due to faster cooling rate. Finer grains (average grain size of 10 μm) are observed in Fig. 8c. Figure 8d presents the microstructure of ICHAZ, which was composed of untempered and tempered martensite [24]. The temperature of ICHAZ was between A_{c1} and A_{c3} ,

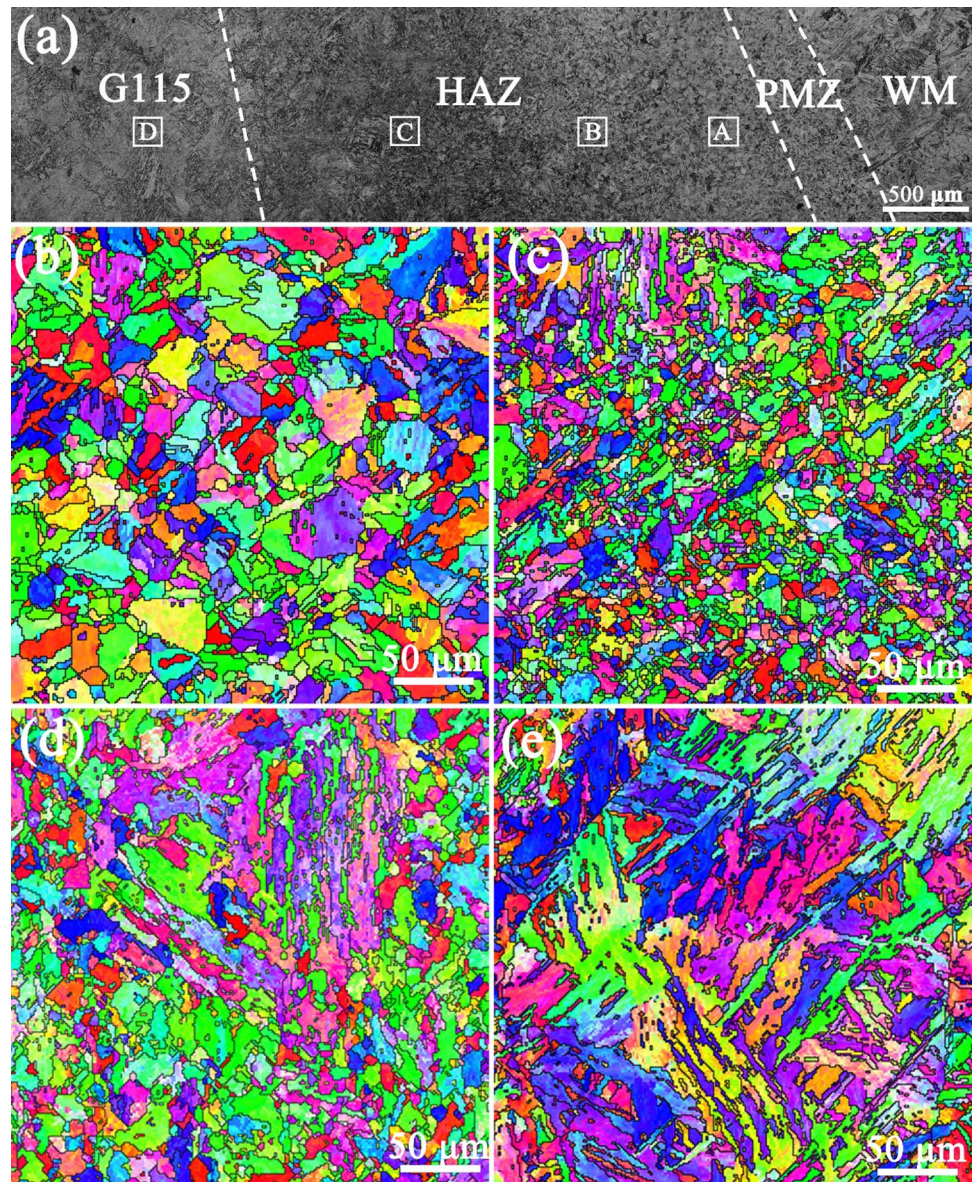
Fig. 8 **a** OM of joint transition zone at G115 side, EBSD images of **a**) CGHAZ, **b**) FGHAZ, **c**) ICHAZ and **d**) BM

Figure 8a shows the OM of joint transition zone at G115 side at 150 A, and it consists of WM, partially melting zone (PMZ), HAZ and base metal (BM). During TIG welding process, the peak temperature of welding thermal cycle decreased from WM to BM, thus the HAZ was divided into three sub-zones: coarse grain heat affected zone (CGHAZ), fine grain heat affected zone (FGHAZ) and inter critical heat affected zone (ICHAZ). Figure 8b–e show the EBSD of CGHAZ, FGHAZ, ICHAZ and BM, respectively, corresponding to region A, B, C and D in Fig. 8a.

and partial tempered martensite transformed into austenite, subsequently forming quenched martensite by air cooling process. Fig. 8(e) presents that the microstructure of BM was tempered martensite blocks. Figure 9 gives the TEM result of G115 steel, and Fig. 9a and b prove that tempered martensite inside PAGs was main structure of G115 steel and some dislocations and dislocation tangles distributed on laths. From Fig. 9c, some precipitates with width of 200 nm exist along prior austenite grain boundaries (PAGBs). Figure 9d presents the chemical composition of precipitates marked in Fig. 9c, and their composition seems to be similar, namely W-enriched $M_{23}C_6$ (M: Fe or Cr) phase.

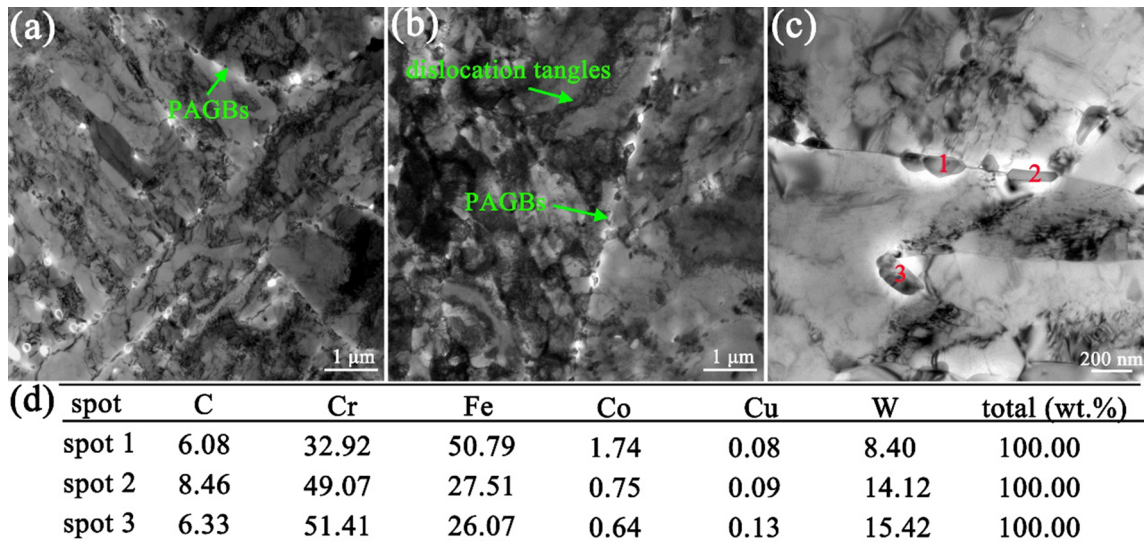
Fig. 9 TEM results of G115 steel: **a** and **b** microstructural morphology of martensite and PAGBs, **c** and **d** the distribution and chemical composition of precipitates

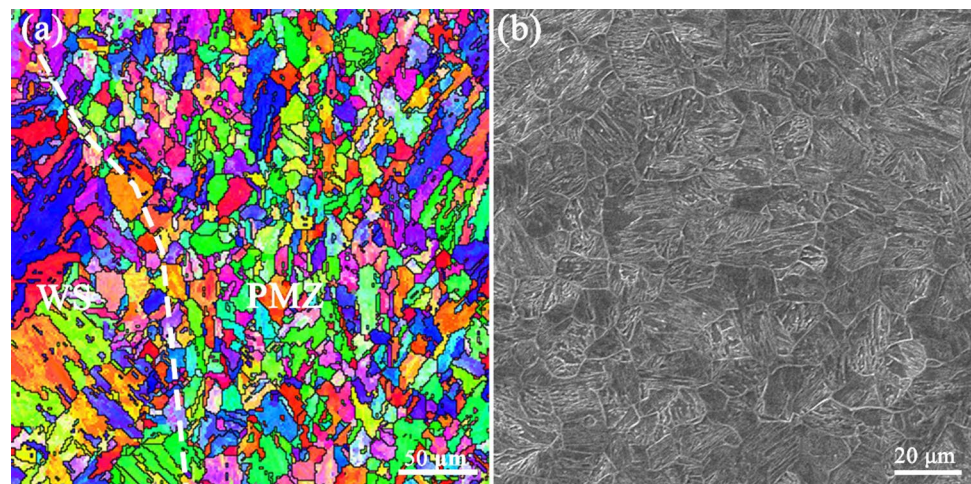
Fig. 10 **a** EBSD image of WM and PMZ, **b** SEM of PMZ

Figure 10a is EBSD image of WM and PMZ, revealing that PMZ lied along WM boundary in welded joint at 150 A. Combined with Fig. 10b of SEM image, PMZ was composed of equiaxed PAGs with average diameter of 15 μm and its microstructure was quenched martensite. During welding, the temperature of WM exceeded the liquidus temperature of the alloy, the temperature of HAZ was higher than a critical value A_{c1} but lower than the solidus temperature of the alloy, and PMZ was a region in which the experienced temperature was between solidus and liquidus of the BM. Therefore, the PMZ consisted of

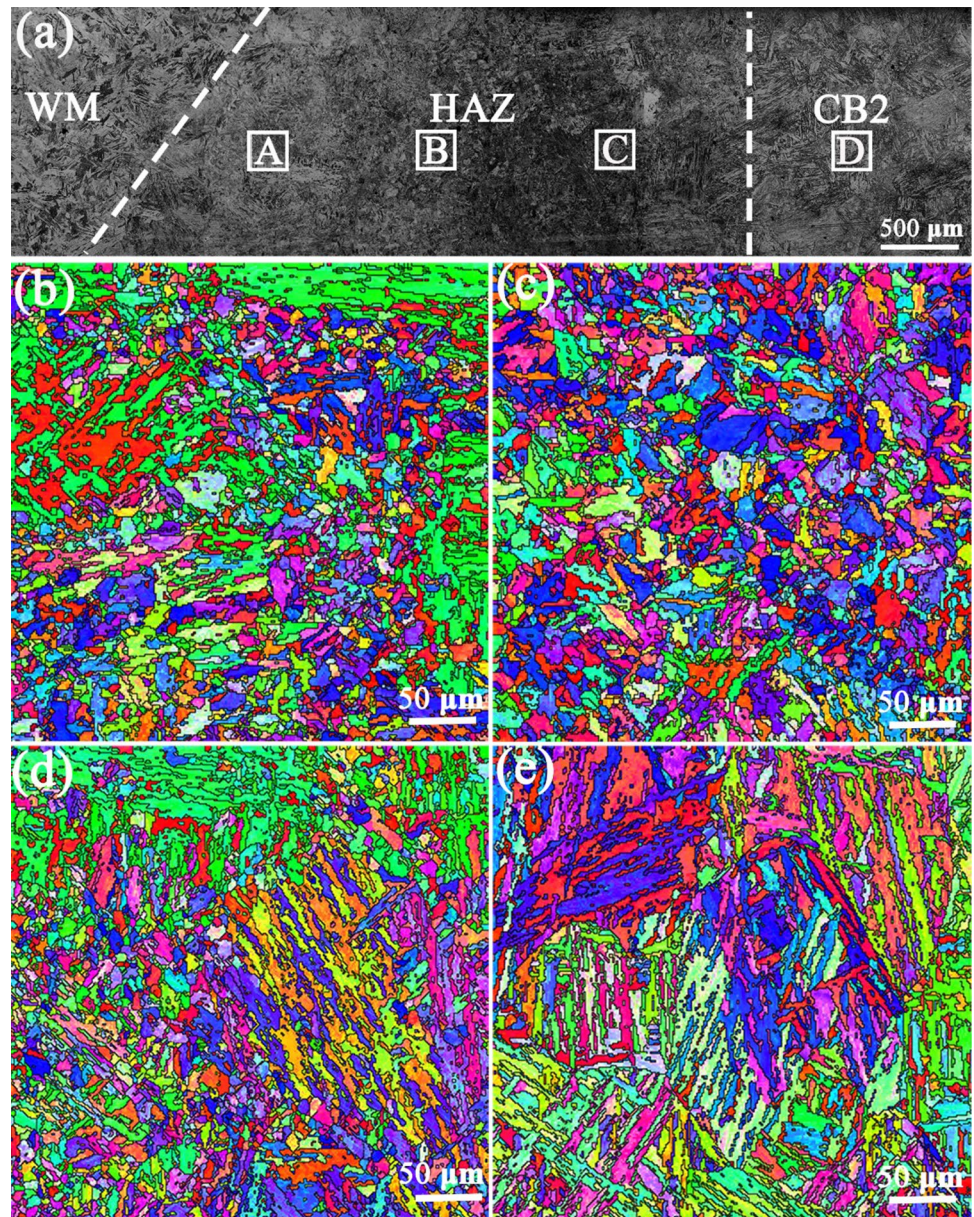
Fig. 11 **a** OM of joint transition zone at CB2 side, EBSD images of **b** CGHAZ, **c** FGHAZ, **d** ICHAZ and **e** CB2 steel

Figure 11a reveals that the transition joint at CB2 side consisted of WM, HAZ with three sub-regions and BM at 150 A. Figure 11b–e correspond to region A, B, C and D of Fig. 11a, respectively. According to Fig. 11b, CGHAZ was composed of coarse martensite blocks, while FGHAZ was comprised of untempered martensite within equiaxed PAGs. Compared with HAZ of G115 steel, the grain size of CGHAZ and FGHAZ at CB2 steel seems to be larger. The microstructure of ICHAZ at CB2 side was untempered and tempered martensite, which was similar to ICHAZ at G115 side. Coarse tempered-martensite blocks are presented in Fig. 11e. Figure 12 is TEM images of CB2 steel, and Fig. 12a and b illustrate that the microstructure of CB2 steel was martensite-dominated structure. Some precipitates distributed along martensite-lath border and inside laths. Figure 12c is diffraction pattern of precipitate marked in Fig. 12b, demonstrating that the precipitate was $M_{23}C_6$ (M: Fe or Cr) particle with face-centered cubic structure.

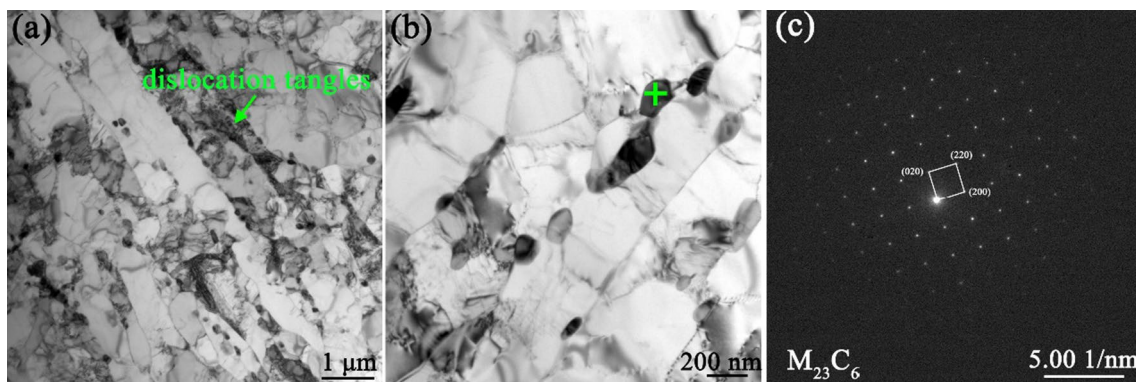
Fig. 12 TEM images of CB2 steel: **a** martensite morphology, **b** precipitate distribution, **c** diffraction pattern of precipitate marked in (b)

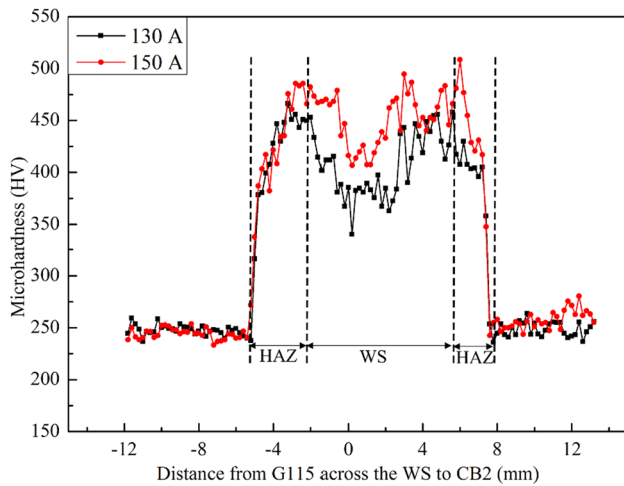
Fig. 13 Microhardness profiles of joints with 130 and 150 A

Figure 13 gives microhardness profiles along the transverse direction of a half thickness of base metals from G115 across WM to CB2 steel, and hardness point was measured at an interval of 0.25 mm. Average hardness of G115 and CB2 steel was about 249 HV and 254 HV, respectively. The specific value of 396 HV and 449 HV corresponded to the average hardness of WM at 130 and 150 A, respectively. Compared with BMs, higher hardness was occurred in WM, which could be attributed to quenched martensite with high carbon content in WM.

For the HAZ, the variation of hardness was basically identical at G115 and CB2 side, as shown in Fig. 13. The highest hardness was occurred in CGHAZ closed to WM, and with increased distance from WM, the microhardness of HAZ gradually decreased. Liu et al. [13] reported that the peak temperature become higher, resulting in decreasing carbide particles and the increasing carbon content of martensite. The peak temperature of CGHAZ was higher than that of FGHAZ, and more precipitates dissolved into the matrix, which resulted in higher hardness occurred in CGHAZ [25, 26]. The microhardness of ICHAZ was lower than other HAZ because the microstructure of this region was mixture of tempered and quenched martensite.

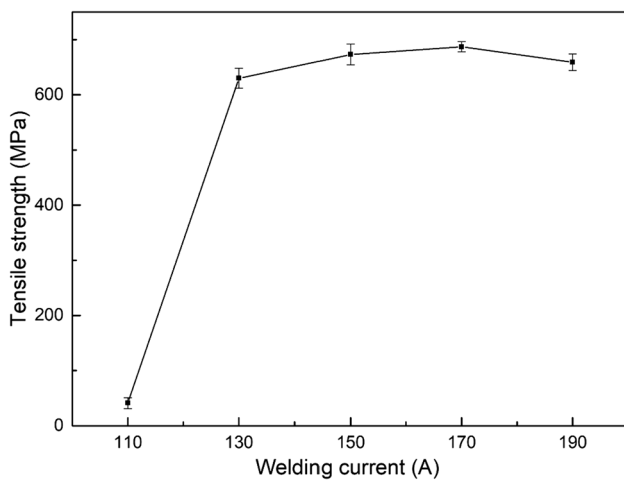
Fig. 14 Tensile strength with different welding current at room temperature

and had no obvious change. It could be explained that the failure of these tensile samples occurred in the base metals, not influenced by WM and HAZ.

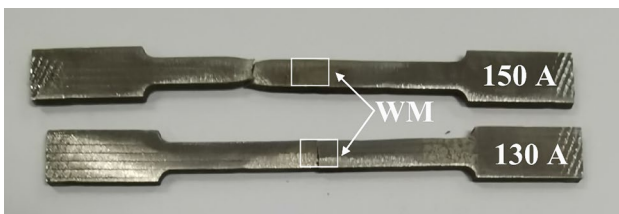
Fig. 15 Macro photo of specimens after the tensile test at 130 A and 150 A

Figure 15 is macroscopic photo of specimens after the tensile test at 130 A and 150 A, respectively. Figure 16a and b present the longitudinal cross-sectional images of fracture at 130 and 150 A, respectively. Figure 17a and b are their SEM images of the fracture morphology, respectively. As shown in Figs. 15 and 16a, the tensile specimen at 130 A failed in WM and there was no tensile deformation at the fracture site. Therefore, brittle fracture was fracture mode of welded joint at 130 A, which was also proved by quasi-cleavage areas in Fig. 17a. As current increased to 150 A, obvious plastic deformation and necking were observed at the fracture location because failure appeared in G115 steel, as shown in Figs. 15 and 16b. Fractograph of Fig. 17b presents a large number of fine dimples on

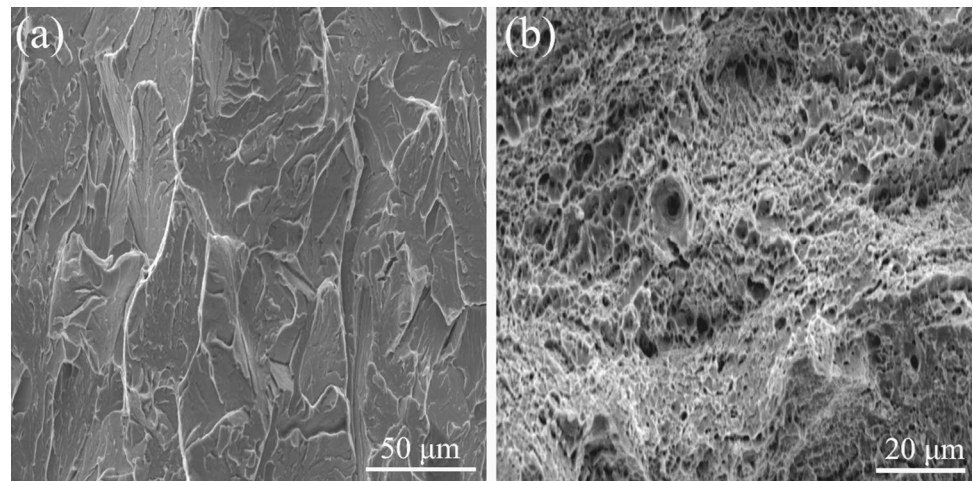
Fig. 17 SEM images of the fracture surface at room temperature: **a** 130 A, **b** 150 A

the fracture surface, which indicates that ductile fracture was the fail mode of welded joints at 150 A.

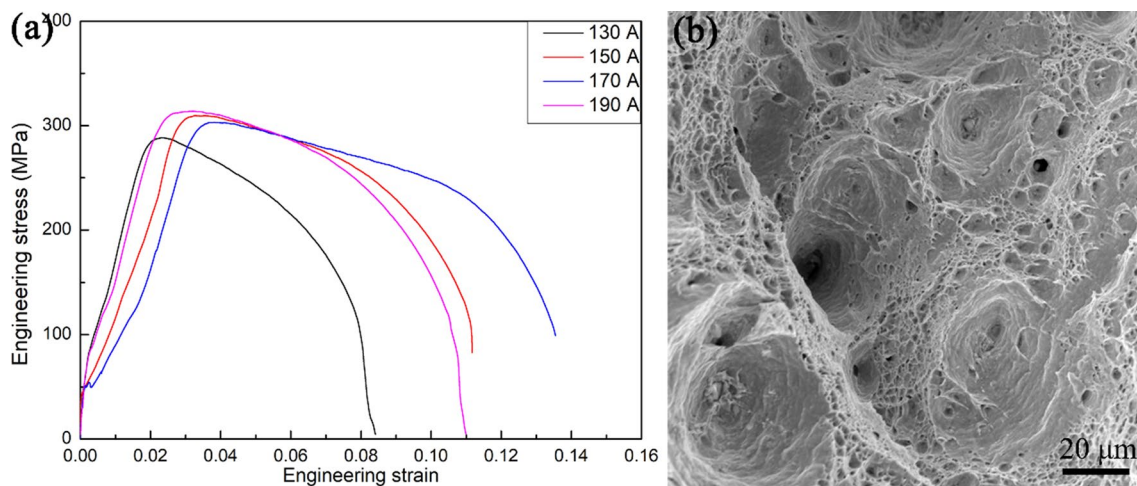
Fig. 18 (a) Engineering stress–strain curves at 650 °C with various welding current, (b) fracture morphology at 150A

The 9% Cr heat-resistant steels were widely applied in high-temperature conditions, so it was essential to explore the mechanical characteristics of welded joints at an operating temperature of 650 °C. Figure 18a is the engineering stress–strain curves at 650 °C with various welding current. According to Fig. 18a, lower tensile strength and elongation of joint were observed at 130 A, while elevated-temperature strength at 150, 170 and 190 A was almost same and higher than that of 130 A. Based on energy conservation and emission reduction, 150 A was suggested as the optimal welding current in this work and its tensile stress at 650 °C was 309 MPa. The tensile stress at 650 °C was slightly less than half of tensile strength at room temperature. Wang et al. [27] reported that at 650 °C, fast diffusion could assist dislocation in bypassing nano-sized precipitates by means of climbing. With the decreasing interaction between precipitates and matrix, precipitate strengthening gradually weakened and the tensile strength subsequently decreased. Xiao et al. [28] also reported that this phenomenon might be related to subgrain coarsening and decreasing dislocation density. Figure 18b exhibits SEM picture of fracture morphology at 150 A. Dense inhomogeneous dimples were noticed in Fig. 18b. These deep dimples were formed by microcavities coalescence, but there were fine dimples existed between deep dimples, which could ascribe to precipitates located in these regions [29].
