Defect Detection in the Winding Layer of CNG Composite-Wound Cylinders

Abstract

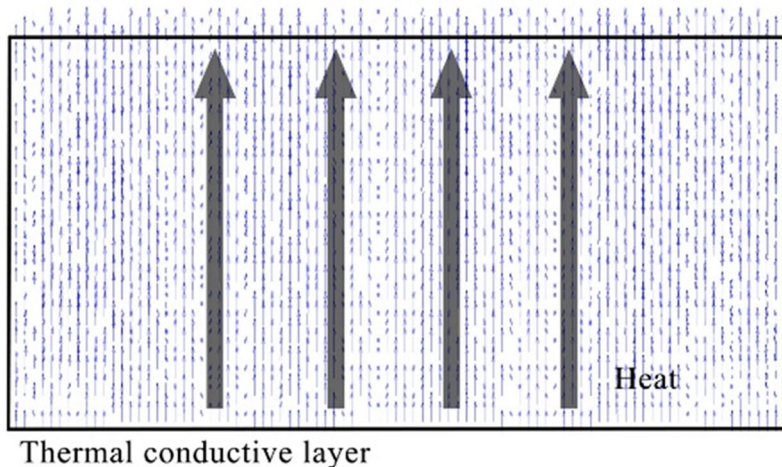
Fig. 1 Distribution of heat flow lines without defects

There is a thermal effect during the gas filling process: as the temperature inside the gas cylinder continuously increases, a temperature difference is formed between the inside and the outside of the cylinder, and thus, heat is transferred to the external environment through the winding layer and the steel layer. Heat is transferred mainly through three mechanisms: heat conduction, heat convection, and heat radiation. Thermal convection occurs

between the gas and the steel liner, heat conduction occurs between the steel liner and the winding layer, and heat convection and heat radiation occur between the winding layer and the external environment. This study only considered the heat conduction process; the heat radiation and heat convection processes were ignored to simplify the model. The overall structure of the gas cylinder

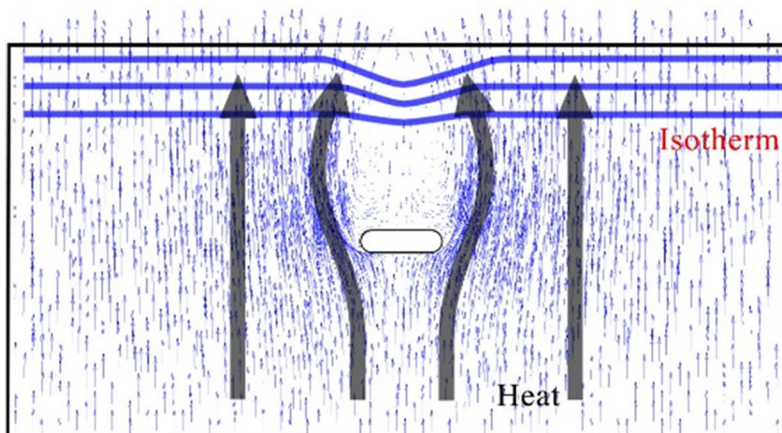
Fig. 2 Distribution of heat flow lines in the presence of defects

is symmetrical. For a qualified gas cylinder, there are no protrusions or depressions on the inner or outer surfaces. Therefore, the temperature distribution on the outer wall of the cylinder is uniform during the filling process, and the direction of heat flow is perpendicular to the surface of the wall, as shown in Fig. 1. When there is a defect in the winding layer of the cylinder, the heat flow tends to propagate forward around the defect because the thermal conductivity of the air is lower than that of the winding layer (Table 1 [43]). The isotherms are perpendicular to the heat flow lines. Figure 2 shows that the isotherm has a significant depression; that is, the temperature distribution of the cylinder surface is uneven, indicating that the defect is equivalent to a source of thermal resistance that hinders heat transfer. The temperature differences can be captured

by an infrared thermal imager as hot spots, which can be used to identify and measure the defects in the cylinder winding layers.

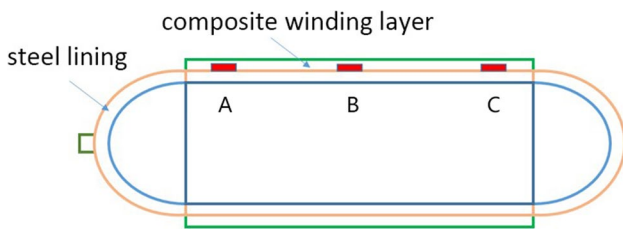
Fig. 3 CNG composite-wound cylinder model with a defective winding layer

Three defects, A, B, and C, were added to the three-dimensional model of the gas cylinder. Defect B was located at the centerline of the cylinder, and defects A and C were symmetrically arranged at distances of 150 mm from the centerline of the cylinder. According to GB 24,162–2009 “Periodic inspection and evaluation of hoop wrapped fiber reinforced composite gas cylinders with metal liners of compressed natural gas for automotive vehicles,” the damage in the winding layers can be classified into three types (Table 4). A defect with a depth of less than 0.25 mm is defined as primary damage, which refers to minor damage that occurs during normal use. Cylinders with primary damage can continue to be used. A defect at a depth greater than 0.25 mm but less than 1.25 mm is defined as secondary damage, which refers to damage that is more serious than primary damage but can be repaired. A defect at a depth greater than 1.25 mm is defined as tertiary damage, which refers to serious damage that occurs during use. Cylinders with tertiary damage can no longer be used. Based on this classification of winding layer damage, the depths of defects A, B, and C were set to 0.25, 0.75, and 1.25 mm, respectively. The CNG composite-wound cylinder model with a defective winding layer constructed in this study is shown in Fig. 3.

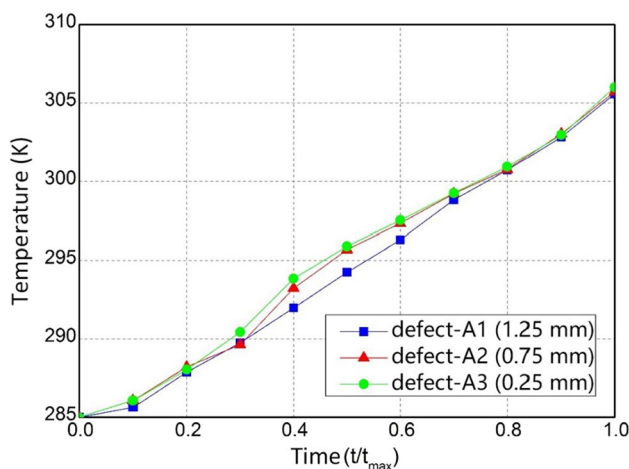
Fig. 5 Temperature curves at different defect depths

To study the influence of the winding layer defect depth on the temperature and to explore the method for quantitatively evaluating the defect depth, we set the winding layer defect depth as a variable. The depths at defect A in the cylinder winding layer were set to A1 = 1.25 mm, A2 = 0.75 mm, and A3 = 0.25 mm. Three simulations were carried out to obtain the temperature curves of A at different defect depths (Fig. 5). At the beginning and end of the filling process, the temperature curves almost overlapped, and the temperature differences between the three curves were almost zero. However, in the middle stage of the filling process, the temperature curves at different defect depths significantly differed. Therefore, a method for the quantitative detection of cylinder defects was established by quantifying the differences between cylinders with different winding layer defect depths during the middle stage of the filling process.

After the further processing of the simulation data, the gradient changes of the temperature curves under different defect depth conditions were obtained. The differences between the temperature curves obtained at different defect depths were amplified by normalization. Then, a parameter R closely related to the defect location and defect depth was proposed. The value of R reflects the deviation of the temperature at the defect from the temperature in the normal region.

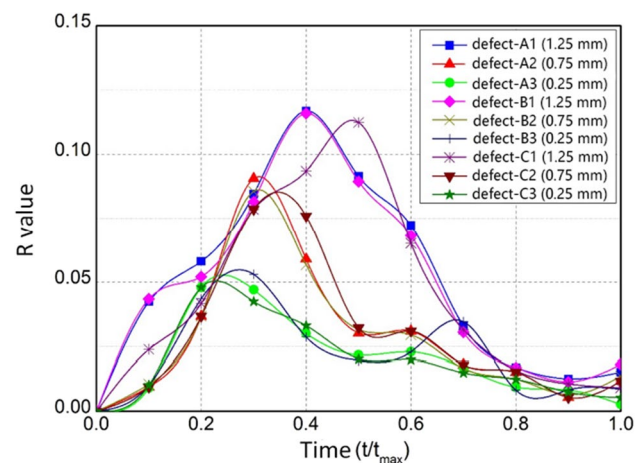
Fig. 6 R values for each defect at different depths

The simulation process was repeated on defects B and C using the same three defect depths as those for point A. The R values as a function of time at A, B, and C with different defect depths are shown in Fig. 6. In general, the R value gradually increased during the initial stage of filling. After reaching the maximum, the R value then gradually decreased until the end of filling. This effect occurs because a defect can be considered to be a source of thermal resistance in the heat transfer process, which can effectively hinder heat transfer. At the beginning of the filling process, the temperature inside the cylinder is low, and the difference between the temperatures of the inside and outside is limited. At this time, the hindrance in the heat transfer is not significant. As the temperature difference increases, the thermal resistance phenomenon becomes more pronounced, and the R value gradually increases. After a certain period of time, the difference between the temperatures of the outside and inside of the cylinder gradually decreases, so the R value gradually decreases.

Figure 6 shows that when the defect location is known, the defect depth and the maximum R value are correlated. The deeper the defect is, the larger the maximum R value is. The relationships between the defect depths at A, B, and C and the corresponding maximum R value were established and are shown in Fig. 7. According to the criteria described in Sect. 2.1, the white region indicates that the defect is unacceptable and that the cylinder needs to be discarded. The blue and orange regions indicate that the defect is acceptable but needs to be repaired. The gray area indicates that the defect is acceptable, i.e., the cylinder meets the working condition requirements and can be used without repair.

The maximum R values of defect B at depths of 0.25 mm, 0.75 mm, and 1.25 mm can be determined from Fig. 6. According to Eq. (1) (T_s is the environmental temperature of $25\text{ }^\circ\text{C}$), the maximum R value of defect B was 0 at a 0 mm depth and 0.2 when the depth approached 5 mm. The above data points and boundary points are listed in Table 5. Similarly, the data points and boundary points at defect C are listed in Table 6.

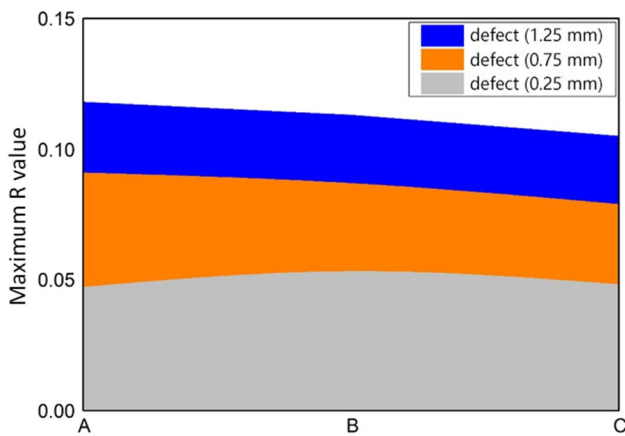
Fig. 7 Maximum R value of each defect

When the defect location is known, a function can be fitted between the maximum R value and the defect depth by using the correlation between these values and the boundary conditions. In engineering practice, a location with an abnormal temperature and the maximum R value can be obtained by infrared thermal imaging technology. The depth of the defect in the winding layer can therefore be determined using the fitted relationship function.

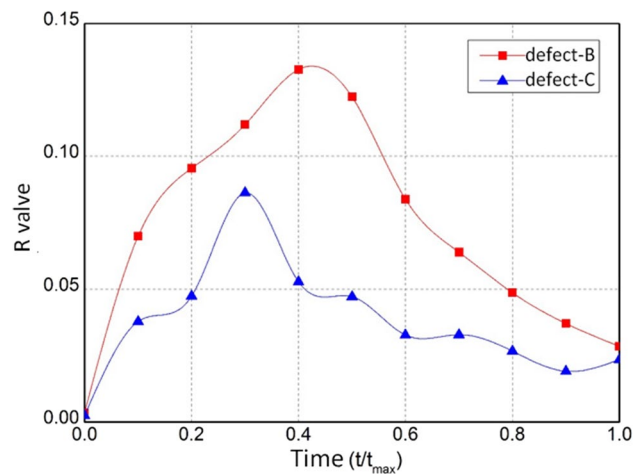
Fig. 8 R values at B and C as a function of time

In this section, a composite-wound gas cylinder with defects in the winding layer was customized. A groove was cut at point B to form a rectangular defect with a size of $10\text{ mm} \times 10\text{ mm} \times 1\text{ mm}$ in the winding layer, and another groove was cut at point C to form a rectangular defect with a size of $10\text{ mm} \times 10\text{ mm} \times 2\text{ mm}$. The gas filling experiment was performed on this cylinder. The R values at defect B and defect C as a function of time were captured using infrared thermal imaging technology (Fig. 8). The maximum R value was 0.138 at defect B and 0.0863 at defect C. The two data points are marked in Fig. 9.

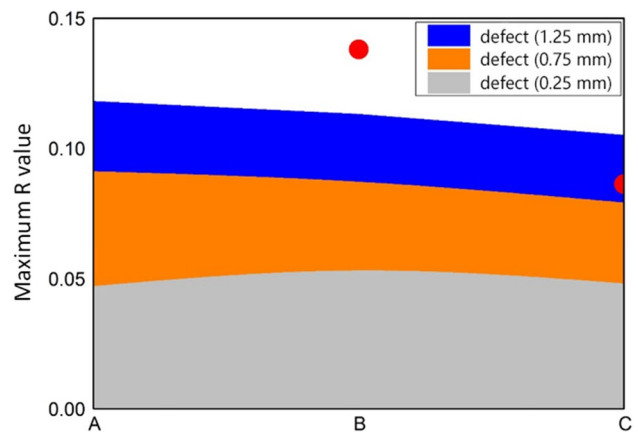
Fig. 9 Maximum R values at defects B and C

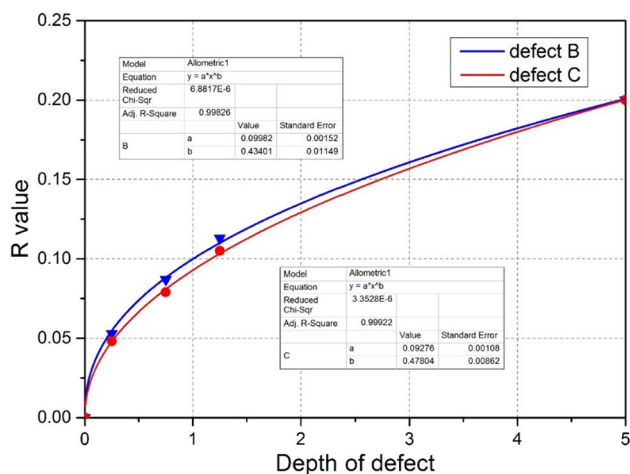
Fig. 10 Defect depth-maximum R fitted curve

The data in Tables 5 and 6 were fitted well by a power function to obtain the maximum R value-defect depth curves at defect B and defect C (Fig. 10). When the maximum R value of defect B was 0.138, the depth of defect B determined by the fitted curve was 2.11 mm, while the actual depth was 2 mm. Similarly, when the maximum R value of

defect C was 0.0863, the depth of defect C determined by the fitted curve was 0.86 mm, while the actual depth was 1 mm. The method established in this paper can evaluate and classify defects at the level of the basic detection requirements. Thus, this method be used to quantitatively detect defects in a cylinder winding layer.
