NEWS AND NOTES

Rajamala Landslide: Continuation of a Never-ending Landslide Series – Sajin Kumar, K.S., University of Kerala. *E: (sajinks@keralauniversity.ac.in)* and Thomas Oommen, Michigan Technological University, USA. (*E:toommen@mtu.edu*)

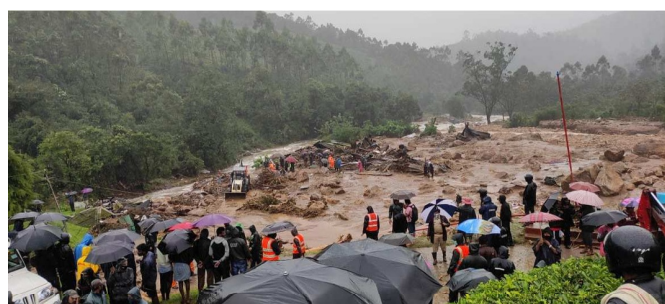
Fig.1. View of the demolished *layams* and progress of search operations for corpses (Photo courtesy: Dhanushkodi, Chinnar)

A massive landslide occurred at Nayamakkad(Pettimudy) tea estate (77.01°E longitude and 10.17°N latitude), near Rajamala in Idukki district, Kerala, on the wee hours of 7 August 2020 (Fig. 1). This landslide killed 70 people, apart from demolishing four hutments (called ‘layams’- quarters for tea garden workers) and uprooting several trees and poles. This landslide travelled swiftly for about 1.3 km and finally debouched into Kanniyar river after destroying the hutments. The landslide swollen in size as it proceeded downhill. In Kerala, landslide occurrences are common during the rainy season, but it is the third consecutive year the state is experiencing catastrophic landslides owing to anomalous rain. Usually, the cumulative rainfall for the season is in tandem with the average, but what the last three years witnessed was sporadic high-intensity rainfall, clustered in a

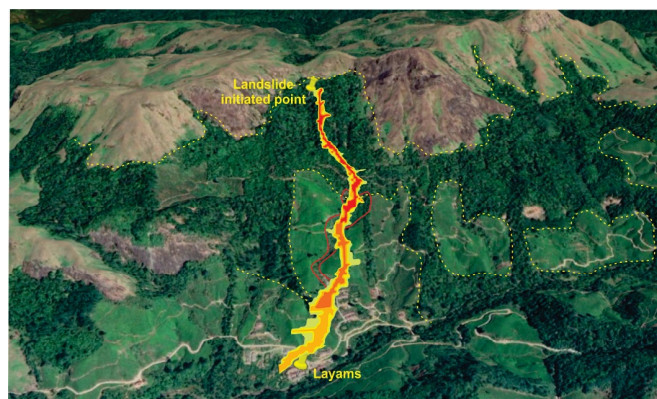
Fig.2. Pre-event Google Earth image showing the location of landslides. Landslide runout was modeled using Laharz and draped over Google Earth image. Yellow dotted line indicates boundary between different land use category and red line indicates the suspected landslide.

From the analysis of the pre-event images of Google Earth, it is observed that the landslide is confined to a barren flat-topped hill composed of Precambrian crystalline rock (Fig. 2). The water pooled across the flat-topped hill was surcharged to the nearest gully, which was a geomorphic hollow or zero-order basin. It is in this geomorphic hollow the landslide occurred. The landslide initiation point is the boundary between two land use categories: barren rocky outcrop and forest plantation.

The morphological interpretation of the terrain using the same set of Google Earth images also revealed a scoop-out portion, suspected to be a paleo-landslide, confining to the same geomorphic hollow but in the downstream side (Fig. 2).
