# A Case Study of the 12 July 2021 Bhagsunath (McLeod Ganj) Flash Flood in Dharamshala, Himachal Pradesh: A Warning Against Constricting Natural Drainage

Vikram Gupta, Biksah Kumar Ram, Sandeep Kumar and Kalachand Sain\*

Wadia Institute of Himalayan Geology, 33 GMS Road, Dehradun - 248 001, India

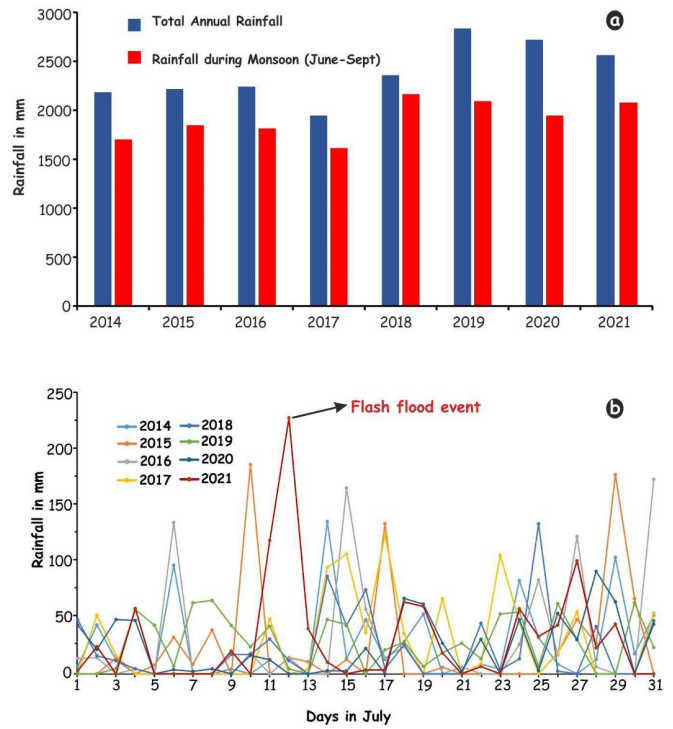
**Fig.2.** (a) Annual rainfall of the Dharamshala township of the years 2014 – 2021 indicating ~ 80% rainfall during monsoon in the month of June – September. (b) Line diagram of the precipitation for the month of July for years between 2014 and 2021

Indian Meteorological Department daily rainfall data of Dharamshala town for the period between 2014 and 2021 has been analyzed. It shows that the area receives an average of ~ 2,350 mm rainfall per year, and ~80% of this rainfall occurs during the rainy season between June – Sept (Fig.2a). Figure 2b depicts the daily rain plot for the month of July for years 2014-2021. It has been noticed that the area received 120 mm rainfall on 11<sup>th</sup> July and 230 mm on 12<sup>th</sup> July 2021.

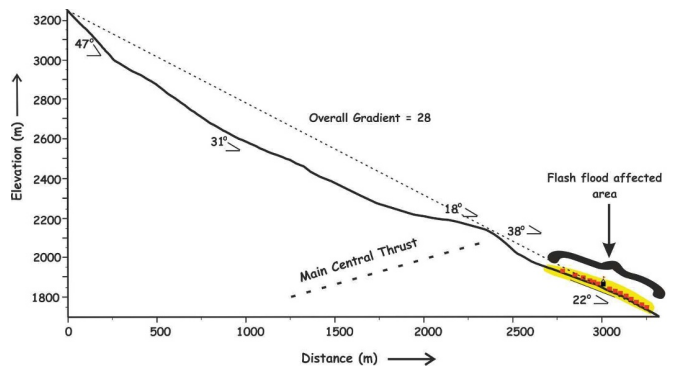
**Fig.3.** Longitudinal profile of the Bhagsu nala indicating general concavity in the overall gradient. The slope break is marked by a knick point where the Main Central Thrust cut across the channel. Please note the flash flood affected area at the outlet of Bhagsu nala catchment.

The longitudinal profile of the Bhagsu nala indicate that the overall gradient of the nala is  $28^\circ$  in the entire study area (Fig.3). It ranges between  $50^\circ$  in the upper part and gradually decreases towards downstream. There is a major knick point in the profile at an elevation of  $\sim 2100$  m, marked by convexity in the profile (Fig.3). It is represented by major thrust 'Main Central Thrust' in the area. At this point, the gradient of the nala abruptly changes from  $18^\circ$  to  $38^\circ$ . Further downstream towards the lower end of the Bhagsu nala, the gradient is  $\sim 22^\circ$ .

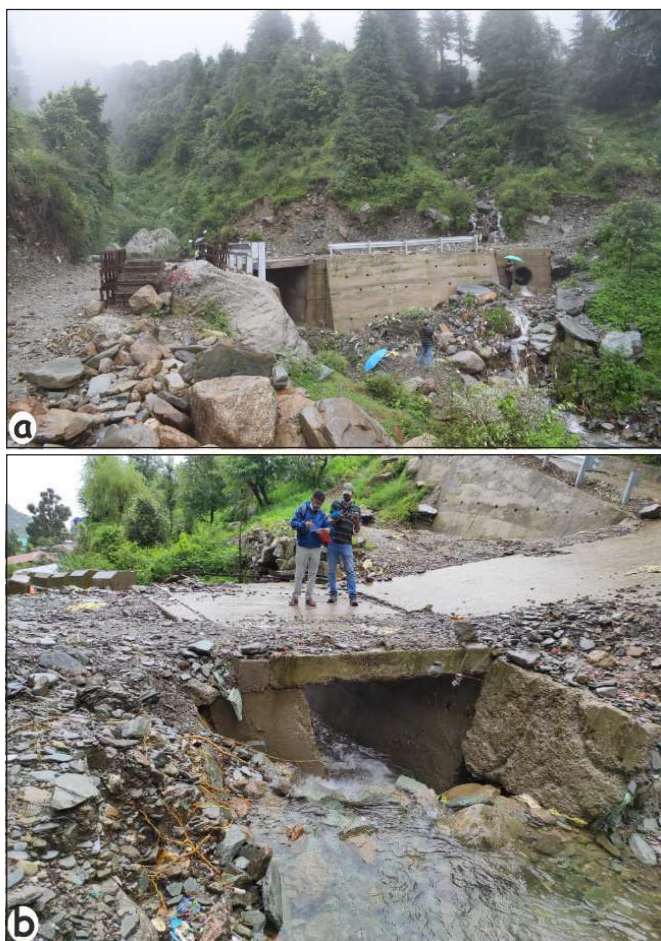
**Fig. 4.** (a) View of the Bhagsu nala looking upstream (b) View of the culvert reducing the carrying capacity of the Bhagsu nala

Field survey was carried out at the end of July. It has been noticed that two second order streams of about 7-8 m wide join at an elevation of  $\sim 2500$  m to form the Bhagsu nala, which is about 10-20 feet wide in the upper reaches (Fig. 4a). Towards the lower reach of the catchment, there is a connecting road by the side of the Bhagsu nala and new road of  $\sim 10$  feet wide has been cut up at an elevation of  $\sim 2000$  m above msl to join the habitation on the upper slope. This new road cut crosses the Bhagsu nala at an elevation of  $\sim 1900$  m and 1920 m. Thus, two culverts 12 feet x 10 feet and 6 feet x 5 feet were constructed on the nala (Fig.4b). This has greatly reduced the carrying

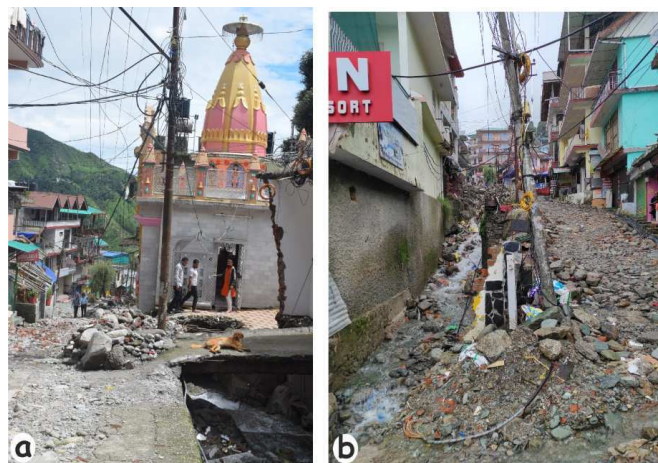
**Fig.5** (a) A temple constructed right on top of the Bhagsu nala and (b) view of the constricted drainage towards the lower reach of the Bhagsu nala.

capacity and affected the normal flow during the high discharge. Further downstream, the width of the nala has been constricted and restricted with an average width between 6-8 feet. At places, it is observed to be just 2-3 feet. This has greatly reduced the carrying capacity of the nala. In the lower reaches, the nala has been completely covered to be a part of the connecting road, and was utilized by the commercial establishment for their easy access. Even a temple was built right on the nala (Fig.5a). There were about 90 commercial and residential establishments on either side of the nala (Fig.5b).

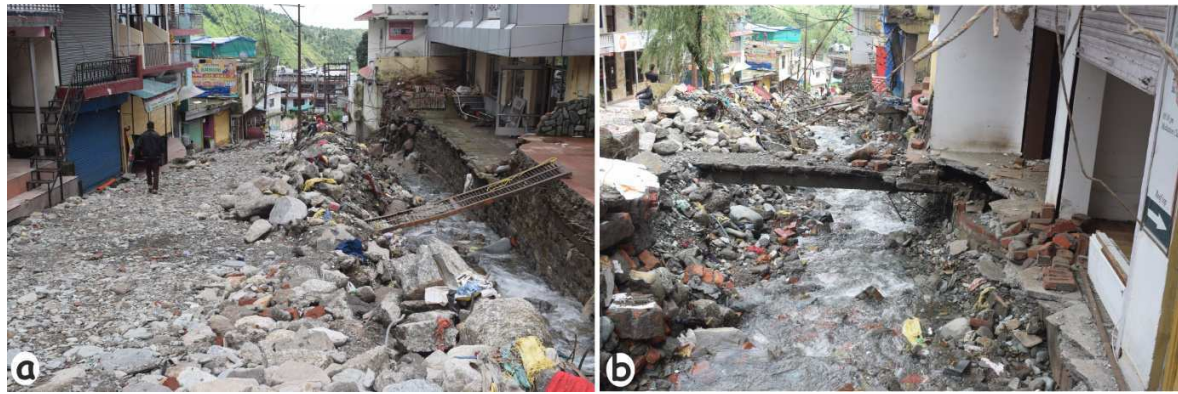
**Fig.6. (a)** Damage to connecting road and **(b)** damage to the residential and commercial establishments located by the side of the Bhagsu nala

On the fateful day of 12 July, the flash flood occurred in the morning between 8:30hrs and 9:00hrs, with the previous 12 hours cumulative rain of  $\sim 80$  mm. As per the local eyewitness, the discharge in the Bhagsu nala started rising in the morning and subsequently became higher than the carrying capacity of the culvert resulting into overflow of water onto the connecting road. This overflowing water has washed away the light vehicles parked on the road and swept into the nala that resulted into choking of the Bhagsu nala and aggravated the flash flood towards the lower slope. The gushing water has eroded the slopes on either side, risen to about 2-4 feet and entered into the commercial establishments, located on both side of the nala, causing their damage (Figs. 6a & b).
