# Characterization of Laser Remelted Plasma-Sprayed Mo Coating on AISI 1020 Steel

**Abstract** Plasma-sprayed molybdenum (Mo) coating was deposited on an AISI 1020 steel substrate. Laser remelting was used to eliminate the open pores and microcracks of the plasma-sprayed molybdenum coating. The quantitative investigation of porosity was carried out with the help of *Biovis* image analysis software. The microhardness was measured using a Vickers indenter. The influence of laser remelting on the wear volume loss of plasma-sprayed Mo was estimated by using a pin-on-disc wear test rig. The worn surface was characterized by scanning electron microscopy. The experimental results demonstrate that the porosity of the coating was decreased and microhardness was improved by laser remelting. The laser remelted plasma-sprayed Mo coating exhibits better wear resistance compared to the untreated plasma-sprayed Mo coating. It is concluded that laser remelting is a potential treatment for the plasma-sprayed coating. In this study, the laser remelted plasma-sprayed Mo coating exhibited of lowest porosity, higher hardness and better wear resistance.

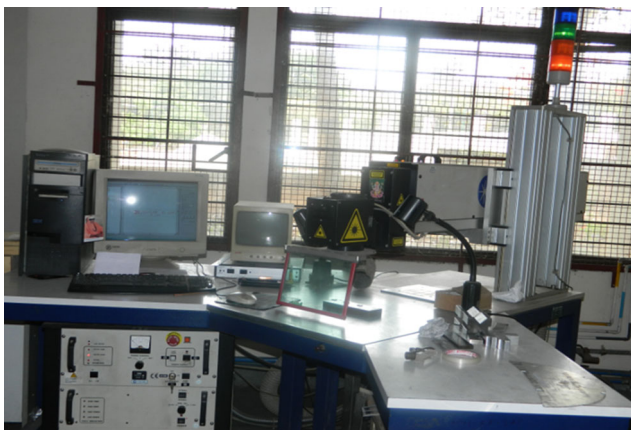
**Fig. 1** Laser setup

The laser remelting of plasma-sprayed Mo coatings was carried out using a 75 W, Nd: YAG Laser and the setup is shown in Fig. 1. The laser process parameters used for remelting are shown in Table 2. The sample surface was protected by argon gas during laser scanning.

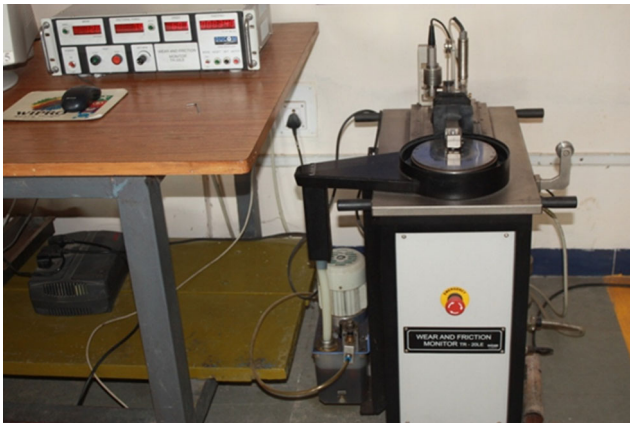
**Fig. 2** Dry sliding wear test rig

The wear performance of laser remelted samples and plasma-sprayed Mo coatings was tested using a pin-on-disc wear test rig (Ducom: model TR-20LE) shown in Fig. 2. The tests were conducted as per ASTM G99 standards. The normal load was applied on the pin by a dead weight through a pulley string arrangement. The system had a maximum load capacity of 100 N. The rotational speed of the disc was 0–2000 rpm. The disc is made of En-32 steel (0.14% C, 0.18% Si, 0.52% Mn, 0.015% S, 0.019% P, 0.13% Ni, 0.05% Cr, 0.06% Mo, balance Fe), having dimensions of 160 mm diameter and 8 mm thickness with a hardness value of HRC62. By using an electronic weighing machine, the initial weight of the specimen was measured. The wear tests are performed by sliding the coated pin against the disc, under dry conditions by varying the applied load, sliding

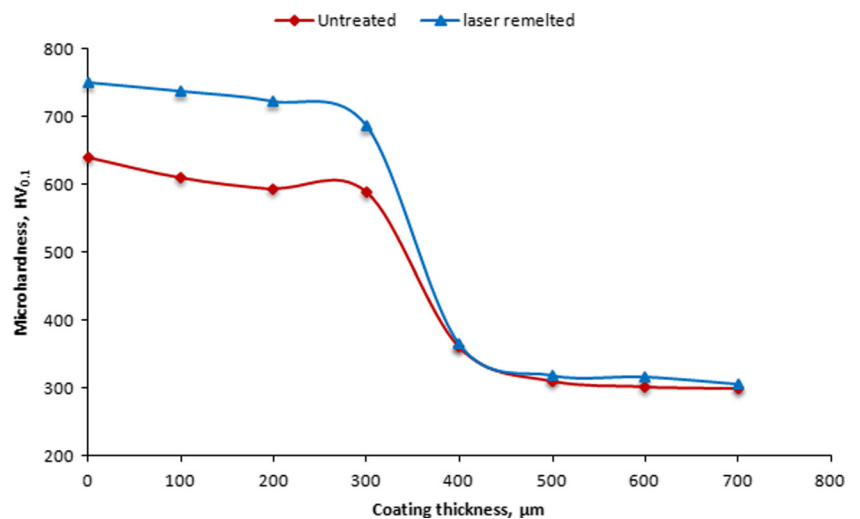
**Fig. 5** Variation of microhardness with distance from the surface

Figure 5 shows that the microhardness of the laser remelted coatings is higher compared to that of the plasma-sprayed coatings. After laser treatment, a graded distribution of hardness in the coating can be attributed to the formation of three regions such as the remelted zone, the heat affected zone and the substrate as can be seen in Fig. 4b. The enhancement of microhardness is mainly due to the melting layer becoming much denser; pores and other defects are substantially reduced or even eliminated after laser treatment. Similar results were observed by Liang et al. [12] and Yuanzheng et al. [13].

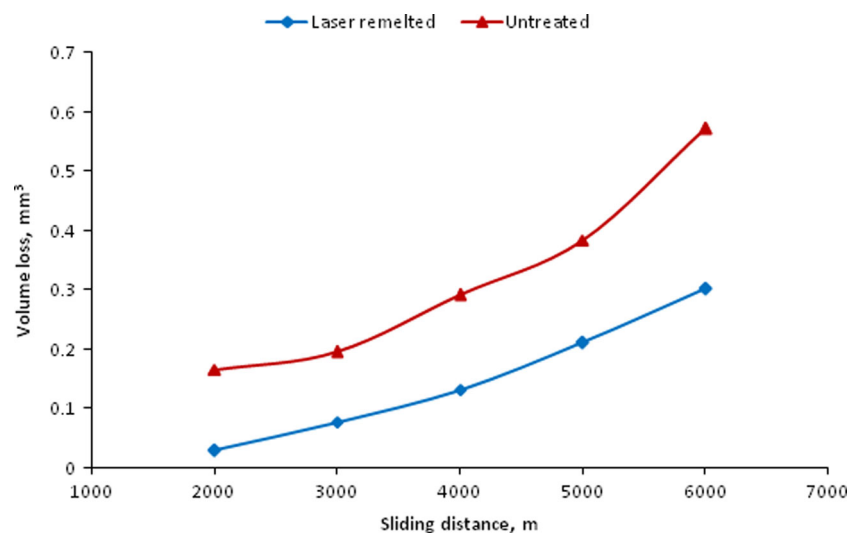
**Fig. 13** Effect of sliding speed on volume loss

It is observed from Fig. 13 that the volume loss of both the laser remelted plasma-sprayed coating and untreated

coating increases with increase in sliding distance. Kato, Das and Khedkar et al. [9–11] also observed a general linear trend of material loss of the sprayed coating increasing with increase in the sliding distance.

The innate defects associated with plasma-sprayed coatings such as high porosity and poor bond strength can be repaired by laser remelting. The laser remelting provides a dense and a pore-free microstructure. The results from Figs. 6, 13 and 15 demonstrate that the laser remelted Mo coating exhibits better tribological behaviour compared to the untreated Mo coatings. The improved tribological performance of laser alloyed coatings is essentially due to the presence of a metallurgical bond between the substrate as well as between splats and a significant decrease in

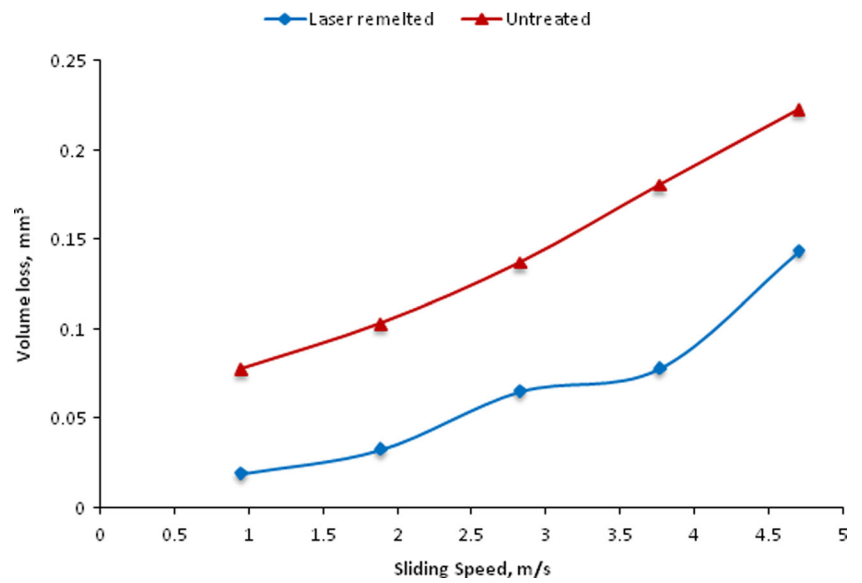
**Fig. 15** Variation of volume loss at different sliding speed

Figure 15 illustrates that the wear volume loss of the laser remelted plasma-sprayed Mo coating is very much lower than the untreated plasma-sprayed Mo coating. The defects connected with the plasma-sprayed coating could be eliminated or reduced by laser remelting. The laser remelting provides a dense and pore-free microstructure. The better

The volume loss of the laser remelted plasma-spray coating increases as the sliding speed increases as observed in Fig. 15. The plasma-sprayed coatings usually fail along the interface of the splats. Certainly, the temperature gradient built up between the substrate the coating as the sliding
