Landslides along the Jordanian Dead Sea coast triggered by the lake level lowering

Abstract The level of the Dead Sea lowers 1 m/year and this rate is in acceleration. The decline is causing one of the major environmental disasters of the twenty-first century. The freshwater resources management policy of Israel, Jordan, and Palestine controls the phenomenon. Since the 1960s, the level of this terminal lake dropped by 28 m and its surface shrunk by one-third. In the 1990s, international builders created major tourist resorts and industrial plants along the Jordanian shore while, during the same period, geological hazards triggered by the level lowering spread out. From the very beginning of the year 2000, sinkholes, subsidence, landslides, and river erosion damaged infrastructures more and more frequently: dikes, bridges, roads, houses, factories, pipes, crops, etc. Until present, scientific articles about this ongoing disaster concerned only sinkholes and subsidence phenomena. This paper focuses on the landslides issue along the Jordanian coast. Based on a set of ground observations collected since 1999, the dynamics of the triggering factors in relation to the evolution of the h

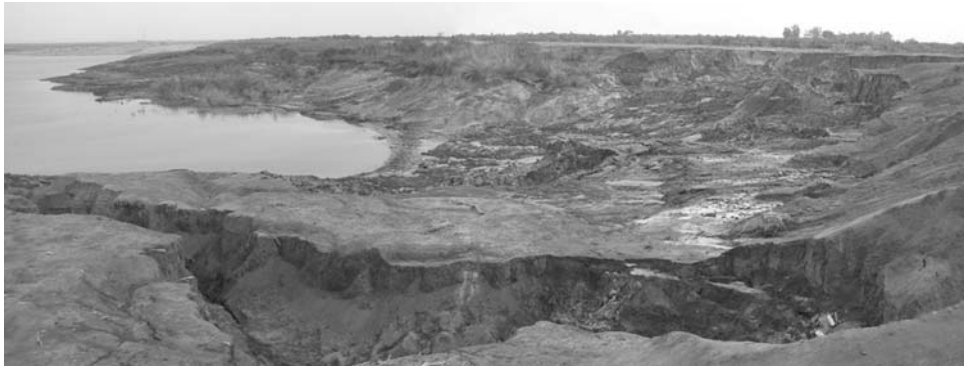
Fig. 3 Point of view toward the north. In the foreground, sapping and slipping landforms characterize headward gully erosion; the background presents a complex landslide combining slump and earthflow features (see Fig. 4). The affected area shows several amphitheatres, each one originated on a set of springs or in a place that concentrate

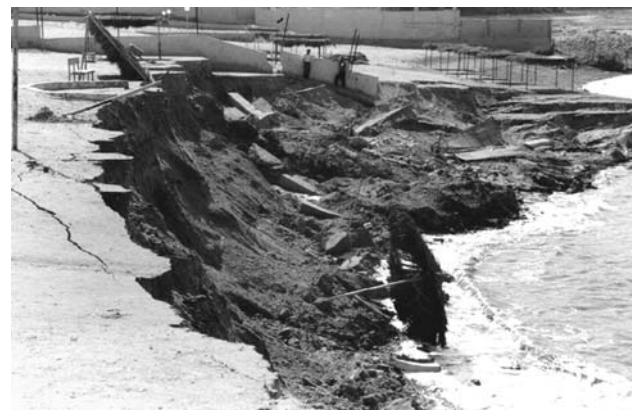
Fig. 5 September 6th, 1999, part of a touristic beach at the northern DS was destroyed by a sudden ground collapse. In 2004, a decametric sinkhole occurred close to the wall where people were looking at the scarp (*upper middle*). From 2006, the whole area was included into the perimeter of the private beach of a new five-star resort (Holiday Inn). The scarp was covered by a stone wall. In May 2007, the wall collapsed partially. In May 2008, three salty springs were found along the seepage surface (the beach). They attest that water is flowing below the hotel and its surroundings, continuing to dissolve salt remains

Landslide no. 2 is probably the first event of this kind along the DS coast, dating back to September 6th, 1999 (Fig. 5). It was a very rapid landslide (3 m/min to 5 m/s) (Turner and Schuster 1996). Since then, it is inactive (Fig. 6a). However, one has to mention that a decametric sinkhole appeared in 2004 over the main scarp. In May 2007, a wall built to hide this scarp partly collapsed, letting visible seepage of brine (Fig. 6b). In May 2008, three salty springs were observed in the zone of accumulation.

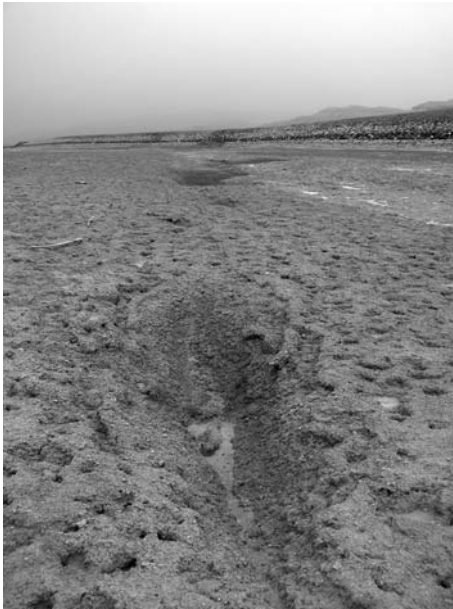
Fig. 11 Picture of the main scarp acquired in 2007. The crack was some 513 m long in May 2008. Underground water seeping into the sub-horizontal layers is responsible of this failure

In 2005, two dike failures 500 m apart belonging to landslide no. 4 were already apparent (Closson 2005). The shape of the main scarp became clearly visible only from 2007 (Fig. 11). In its present configuration, landslide no. 4 is of the confined type, i.e., the upper part undergoes relevant deformation whereas the toe is more or less stable.

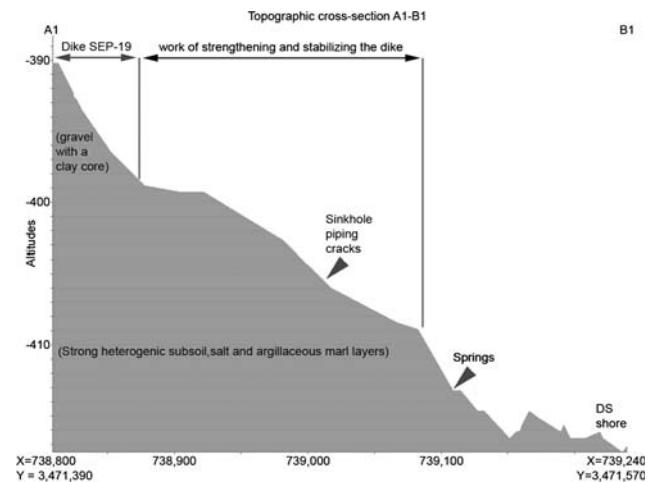
Fig. 13 Elevation along the profile A1–B1 (Fig. 12)

Figure 12 is an Ikonos image showing the position of the scarp in the environment of saltpan 19. Two topographic cross sections (Figs. 13, 14) realized with a handle GPS device are located. They underline the importance of the reinforced embankment. Indeed, subsidence dates back to the 1990s and engineers that built saltpan 19 encountered many problems of stability. The changes in the hydrogeological settings created geological hazards mostly in the northern and eastern parts of the Lisan. Since their first occurrence in 1992, their intensity increased drastically and forced engineers to strengthen the initial dike

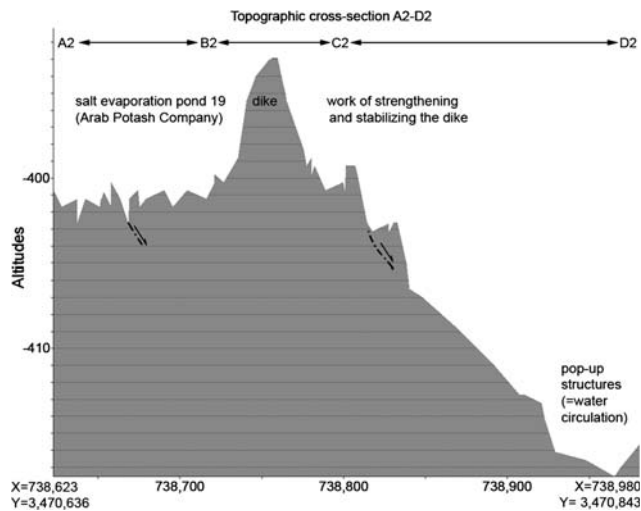
Fig. 14 Elevation along the profile A2–D2 (Fig. 12). Location of scarps and geomorphic features testifying the circulation of unsaturated water with respect to salt in the basement of saltpan 19
