# Assessment of weathering damage on the Petroglyphs of Cheonjeon-ri, Ulsan, Republic of Korea

Kurt Heinrichs · Bernd Fitzner

Received: 11 March 2010 / Accepted: 29 October 2010 / Published online: 16 November 2010  
© Springer-Verlag 2010

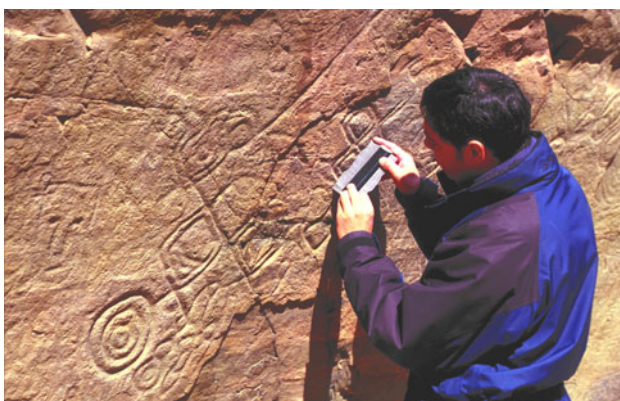
**Fig. 5** Profile measurements

In situ investigation of the Cheonjeon-ri Petroglyphs comprised profile measurements, monument mapping (mapping of weathering forms), rebound hardness measurements and ultrasonic measurements. The investigation areas are presented in Fig. 4. Profile measurements with a commercial profile comb were made at 30 petroglyphs of the Bronze Age for quantifying the morphological profile of the carvings (Fig. 5). The length of the measured sections amounted to 15 cm. The evaluation of results included graphic documentation of the profiles, determination of

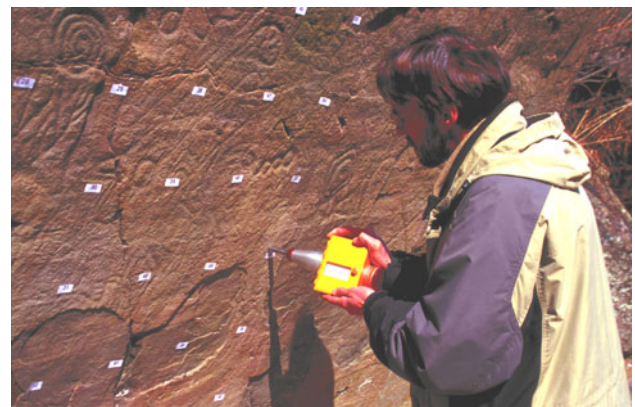
**Fig. 6** Rebound hardness measurements with Schmidt hammer

Rebound hardness measurements were carried out with a Schmidt hammer (type PROCEQ LR, impact energy: 0.735 N m) at two representative investigation areas, each about 2 m<sup>2</sup> in size and with a rectangular grid of 63 measuring points arranged on the stone surface (Fig. 6). The registered rebound hardness values were classified according to minimum, maximum, average and class distribution, comparing carved and non-carved areas as well as different states of weathering.

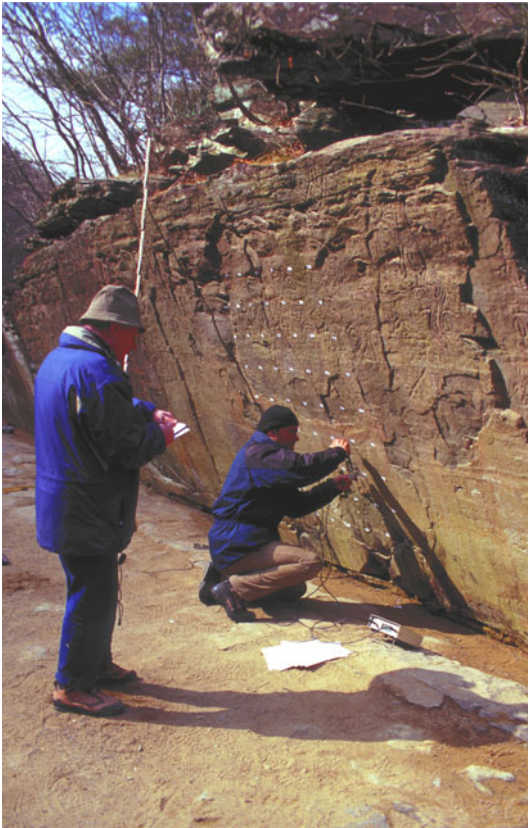
**Fig. 7** Ultrasonic measurements

Ultrasonic measurements were carried out with a STEINKAMP Ultrasonic Tester BPV (conic probes, 50 kHz) according to the refraction mode using the same grid of measuring points as for the rebound hardness measurements (Fig. 7). The horizontal and vertical distance between adjacent measuring points was 20 cm. Measurements were made along horizontal (*h*), vertical (*v*) and diagonal (two directions, *d1* and *d2*) measuring distances (Fig. 8). Evaluation of results included the

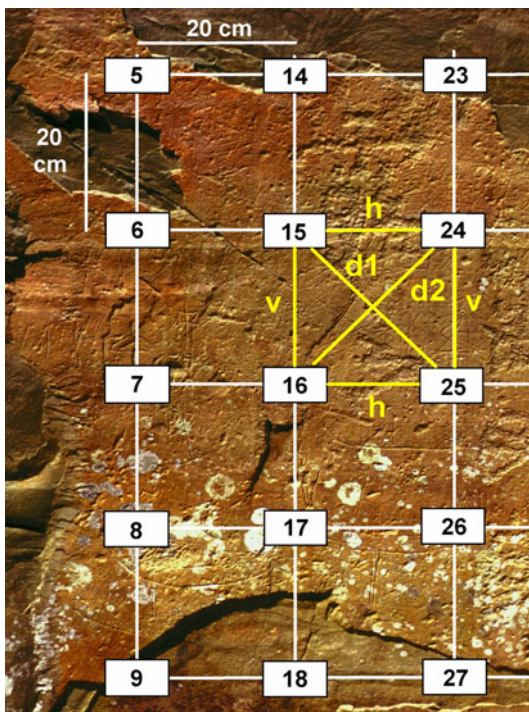
**Fig. 8** Grid of measuring points (section) at the investigation areas A and B for rebound hardness measurements and ultrasonic measurements (measurements: *h* horizontal; *v* vertical, *d1*, *d2* diagonal)

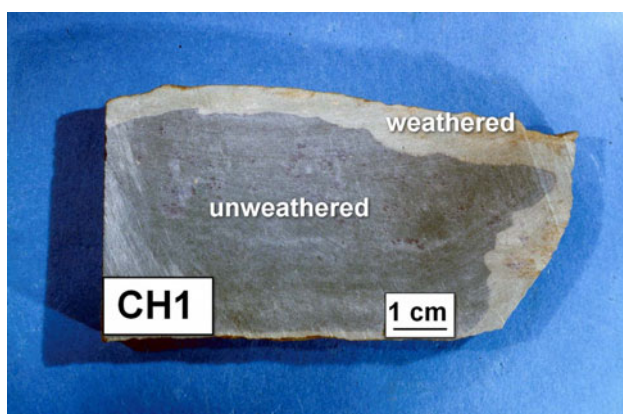
**Fig. 9** Sample Cheonjeon-ri 1: unweathered/weathered

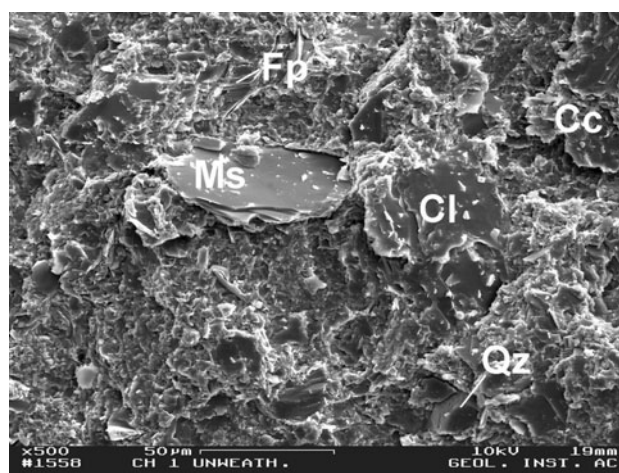
**Fig. 11** Sample Cheonjeon-ri 1: unweathered. SEM micrograph, image width: 0.23 mm. *Qz* quartz, *Fp* feldspar, *Ms* muscovite, *Cl* chlorite, *Cc* sparitic calcite

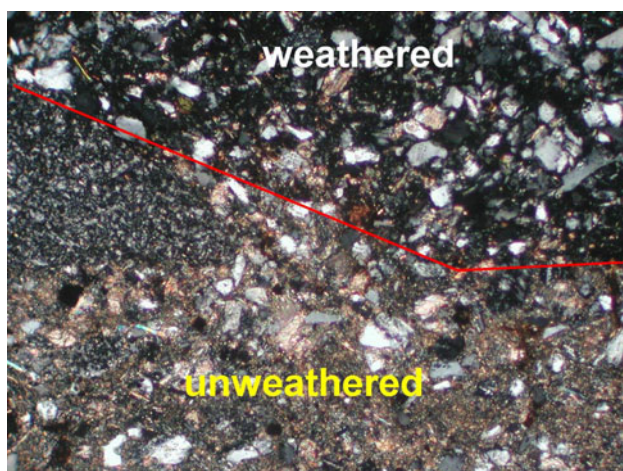
**Fig. 10** Sample Cheonjeon-ri 1: unweathered/weathered. Transmitted light microscopy, +Nic. Image width: 1.29 mm

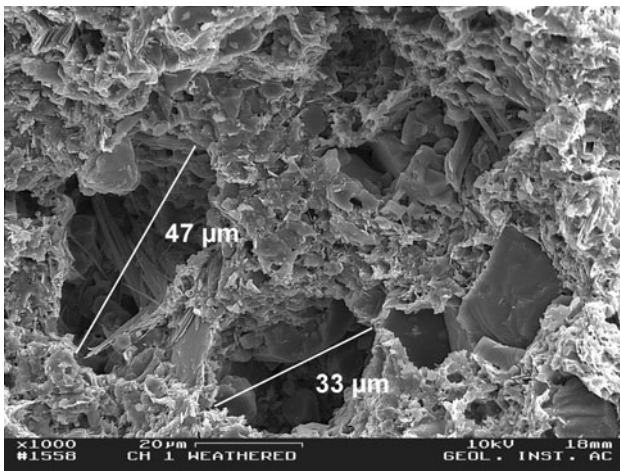
**Fig. 12** Sample Cheonjeon-ri 1: weathered. SEM micrograph, image width: 0.11 mm. Pores due to weathering

weathered part of sample Cheonjeon-ri 1, the weathered part shows a significantly higher total porosity, mainly resulting from increase of capillary pores due to the dissolution of the carbonate components, especially sparite (Figs. 11, 12). The pore surface in the weathered part of the sample is higher than in the unweathered part.

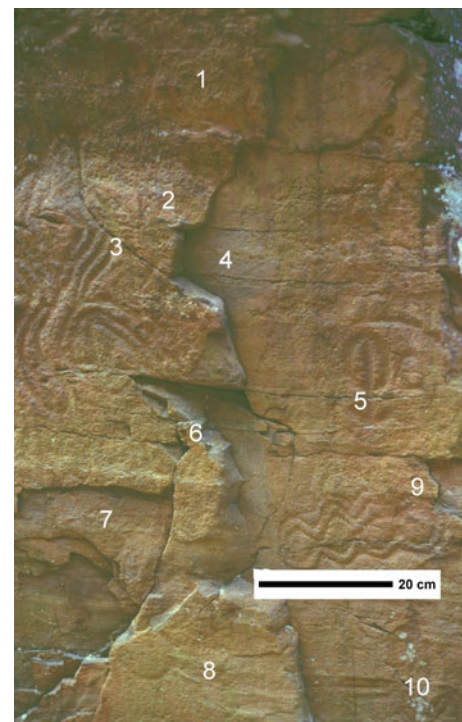
**Fig. 13** Weathering forms. 1 soiling, 2 crumbling–single scale, 3 fissure independent of stone structure, 4 break out, 5 fissure dependent on stone structure, 6 crumbling, 7 back weathering due to loss of scales, multiple scales, 8 crust, 9 single scale, 10 microbiological colonization

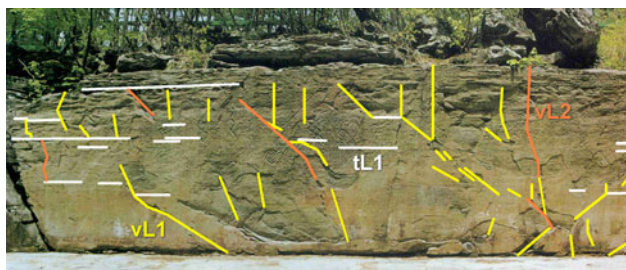
The map of “fissures” is presented in Fig. 16. Two intensities were distinguished according to opening width of the fissures. In all, 67 fissures were stated. “Fissures independent of stone structure”—distributed all over the investigation area—are prevalent. “Fissures dependent on

stone structure” mainly concern the upper part of the monument. Quantitative evaluation of the fissures has provided the following results:

- “Fissures independent of stone structure”, intensity 1 (opening width: narrow, mm-range): 37 fissures, total length of all fissures: 19 m; maximum length, individual fissure: 1.6 m; average length of fissures: 0.5 m.

**Fig. 16** Map of fissures. *tL1* fissures dependent on stone structure, intensity 1; *vL1* fissures independent of stone structure, intensity 1; *vL2* fissures independent of stone structure, intensity 2

- “Fissures independent of stone structure”, intensity 2 (opening width: wide, cm-range): 5 fissures, total length of all fissures: 5 m; maximum length, individual fissure: 2.0 m; average length of fissures: 1 m.
- “Fissures dependent on stone structure”, only intensity 1 (opening width: narrow, mm-range): 25 fissures, total

length of all fissures: 13 m; maximum length, individual fissure: 2.2 m; average length of fissures: 0.5 m; mainly in the upper part of the monument.

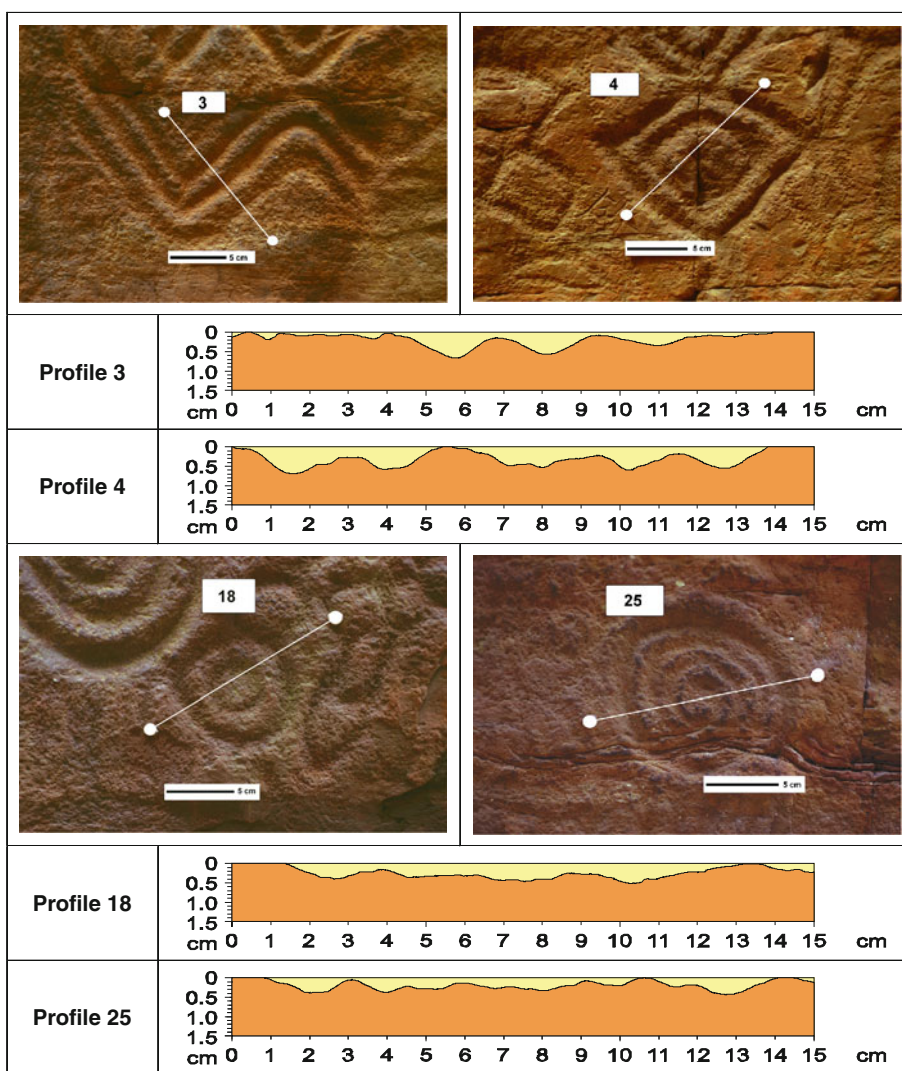
The profile measurements at 30 carvings of the Bronze Age statistically distributed all over the upper part of the monument have shown that the maximum depth of the carvings ranges between 2.9 and 9.8 mm (Figs. 17, 18). The maximum profile depth of 70% of the carvings is in the range between 4 and 7 mm. The average profile depth of the carvings was found to be mainly in the range between 1 and 4 mm.

**Fig. 17** Profile measurements at carvings of the Bronze Age: examples

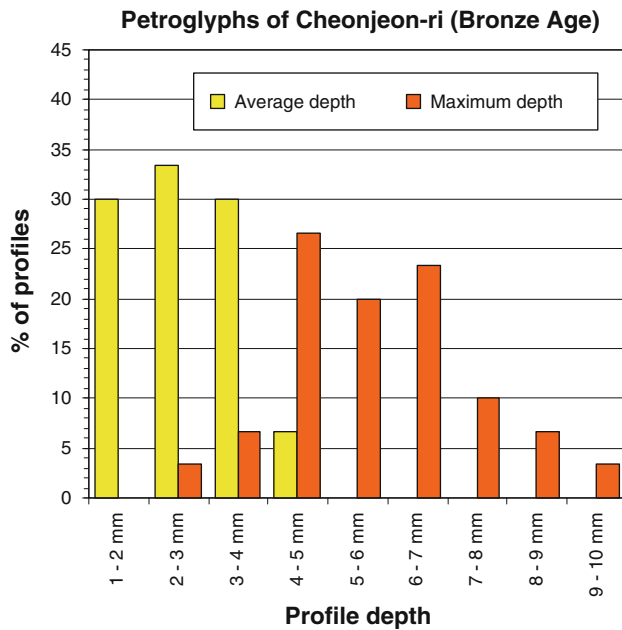
**Fig. 18** Profile measurements at carvings of the Bronze Age. Classification of average and maximum depths

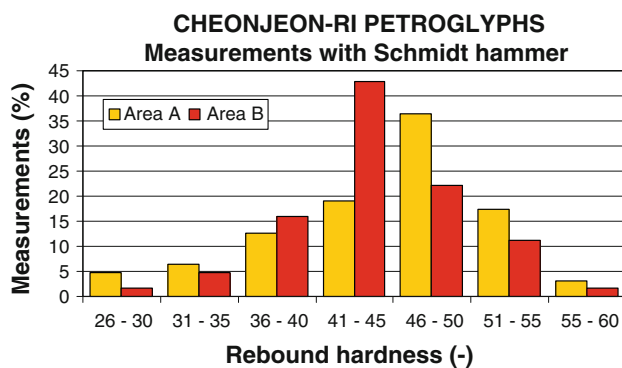
The distribution of the registered rebound hardness values is presented in Fig. 19. The rebound hardnesses range between 26 and 58 (investigation area A; average rebound hardness 45), respectively, between 30 and 60 (investigation area B; average rebound hardness 44).

**Fig. 19** Classification of rebound hardnesses (investigation areas A and B)

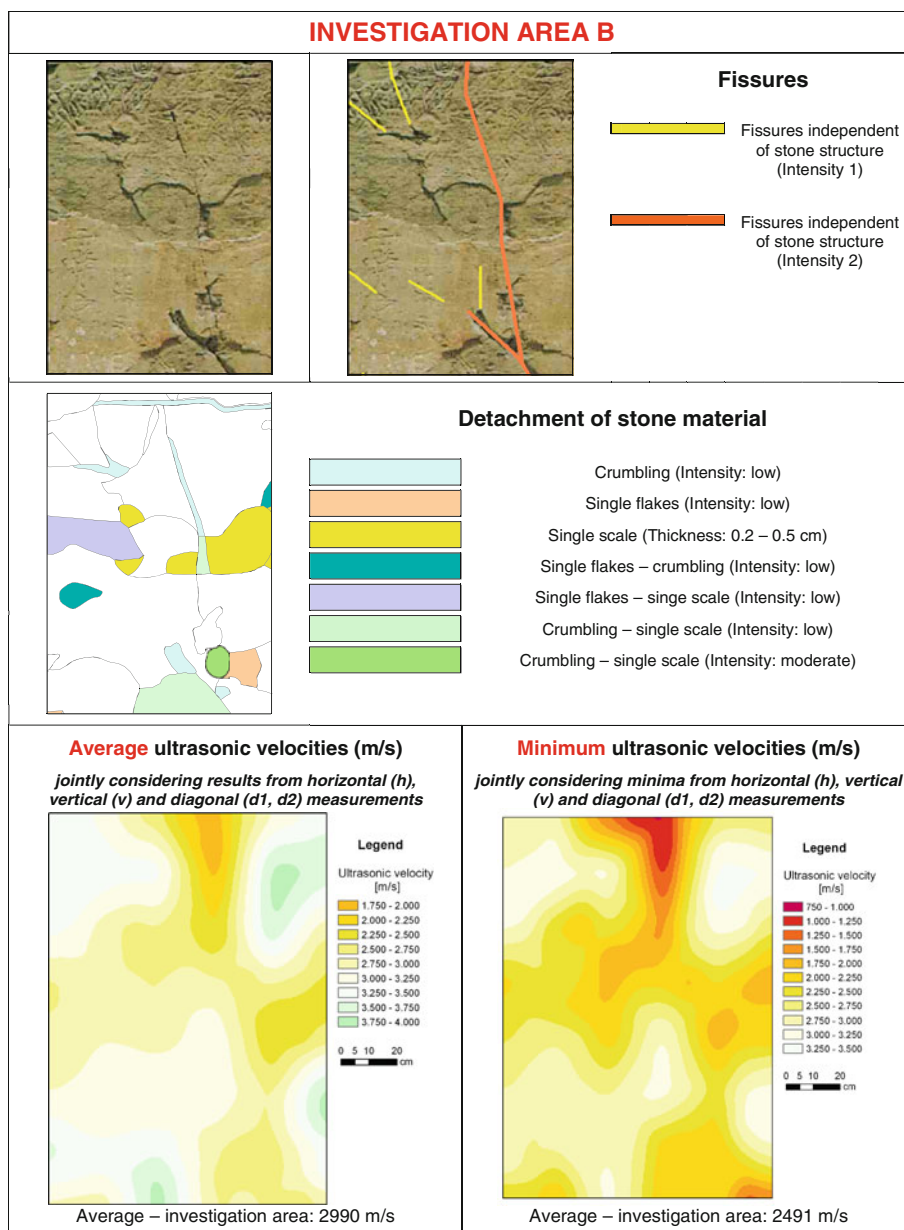
**Fig. 23** Investigation area B: maps of average and minimum ultrasonic velocities. In addition, corresponding maps of fissures and weathering forms relating to current detachment of stone material

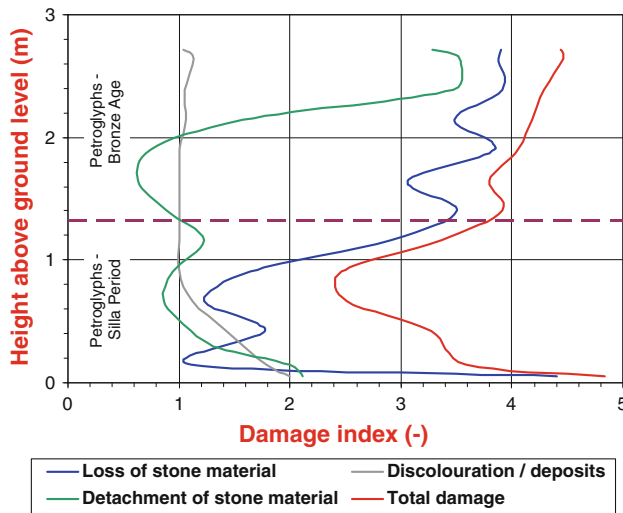
By trend, the vertical profiles of damage indices show higher damage indices for the upper part of the monument (with carvings of the Bronze Age) relating to loss of stone material, detachment of stone material and total damage, whereas higher damage indices are stated for the lower part of the monument (with carvings of the Silla Period) with respect to discolouration/deposits.

Fig. 29 Zonation of damage: vertical damage index profiles

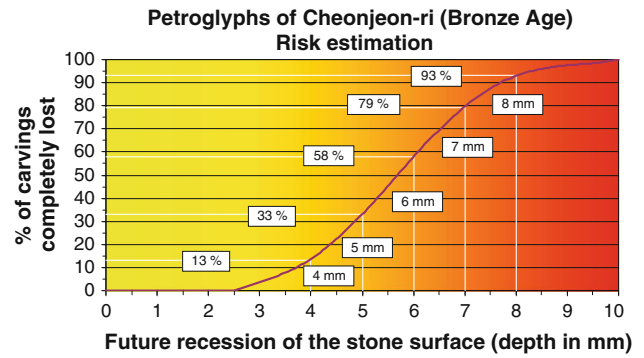
maximum and average profile depths and the deduction of quantitative risk prognosis “future recession of the stone surface—corresponding percentage of carvings that will be completely lost”.

Fig. 31 Risk prognosis derived from profile measurements at carvings of the Bronze Age

the results of the diagnostical studies—indicates the need of intervention for monument preservation. Decision of appropriate preservation strategies—including immediate safeguarding measures, measures for the reduction of causes of damage, measures for remedy of damage, preventive measures—will necessitate supplementary information from other disciplines such as rock mechanics, hydrology/hydrogeology, climatology, engineering sciences, microbiology, etc. At present, the continuous monitoring of the monument is highly recommended in order to recognize any further increase of weathering damage at the earliest possible stage and to eventually initiate immediate intervention.
