## An analysis of debris-flow events in the Sardinia Island (Thyrrhenian Sea, Italy)

**Abstract** On 6 December 2004, the Villagrande Strisaili area (middle-east Sardinia), was struck by debris flows; 330 mm of rainfall took place within 3 h with an hourly intensity of 120 mm, which is far more above than normal for the study area. In the urban center stony and driftwood deposits accounted for a total volume estimated as 10,000 m<sup>3</sup>. The event claimed huge amount of infrastructural loss and two human lives. According to the chronicle reports, the area experienced two debris-flow events in the last century. The present paper is the outcome of an intensive study of such debris-flow events including their physical processes and geomorphological effects through both field survey and laboratory analysis.

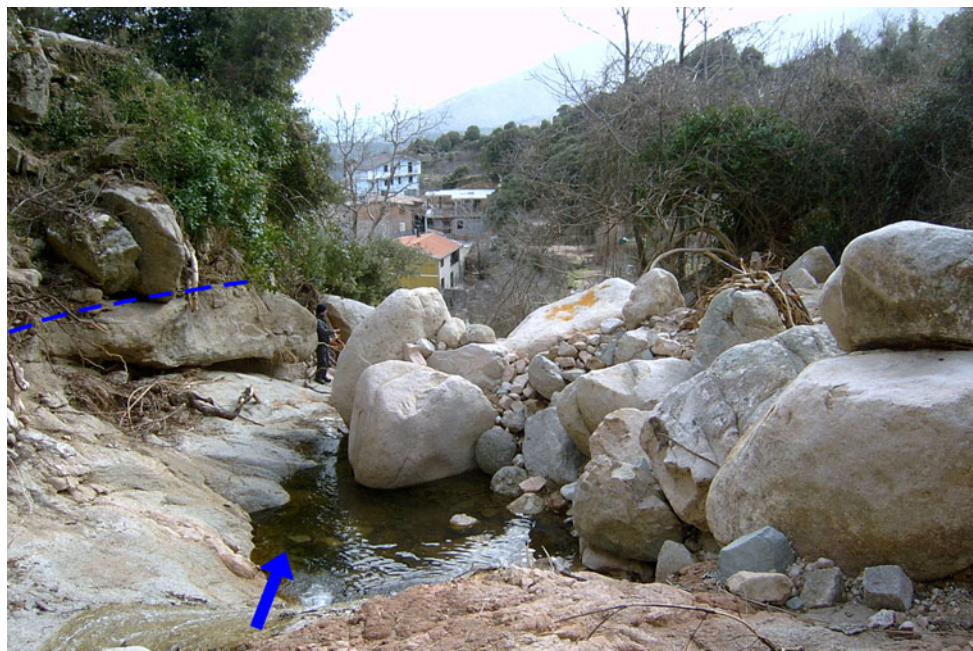
**Fig. 3** At the catchment head of the *Bau Argili* torrent, the dimension of the blocks set in motion by the 2004 flood also exceeded 2 m. Stream-bank erosion (*left* on the picture) has removed the uncohesive

sediment infilling the bedrock fractures, weakening the stability conditions of the blocks. Flow line (*arrow*) and maximum flow depth (*dashed line*) are indicated

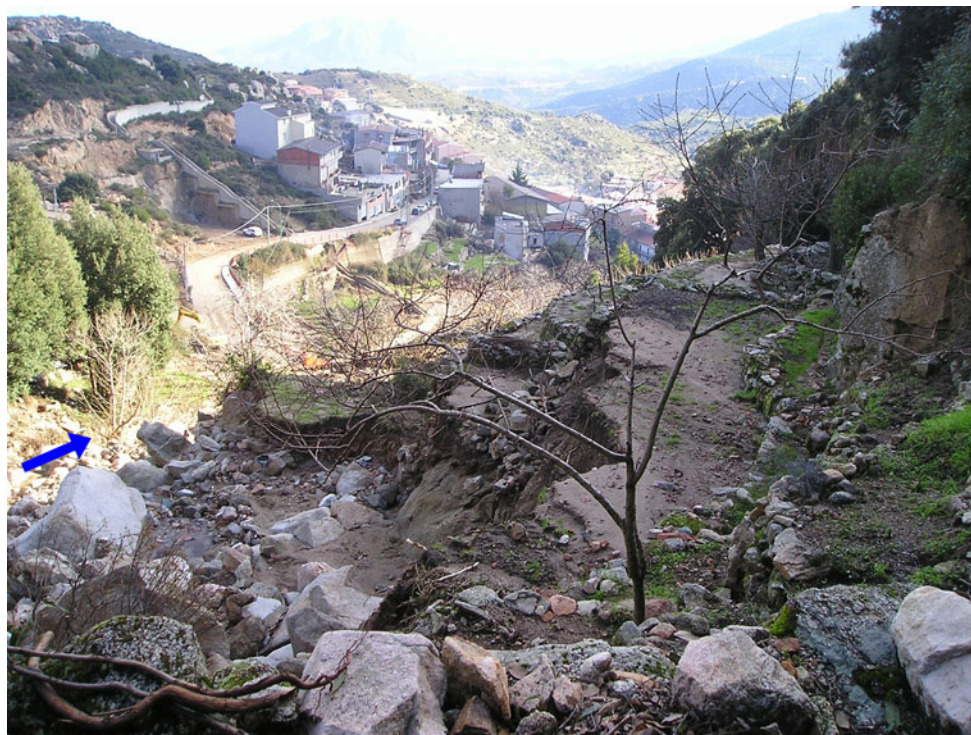
**Fig. 4** In the lower catchment sectors in vicinity of the housings, widely diffused, privately owned kitchen gardens, sustained by typical man-made stony walls, were partly invading the flood cross-section of the torrent. Several shallow slides just originated in such

leaving huge coarse debris in very unstable equilibrium. Forest tracks along the slopes have acted as preferential flow paths intercepting running water on the loose embankment materials resulting in deep gullies. In this case, the intensely fractured and weathered granitic bedrock have appeared to play a key role along the whole channel in the provision of materials. Processes that occurred along the *Figu Niedda* torrent are also similar with the previous one, but it differs from other water-courses due to greater steepness in channel profile and erosional processes operating in the channel bottom. In the catchment head, man-made terraces along the banks were partly removed and reworked and that has increased the sediment load in the downstream section (Fig. 4).

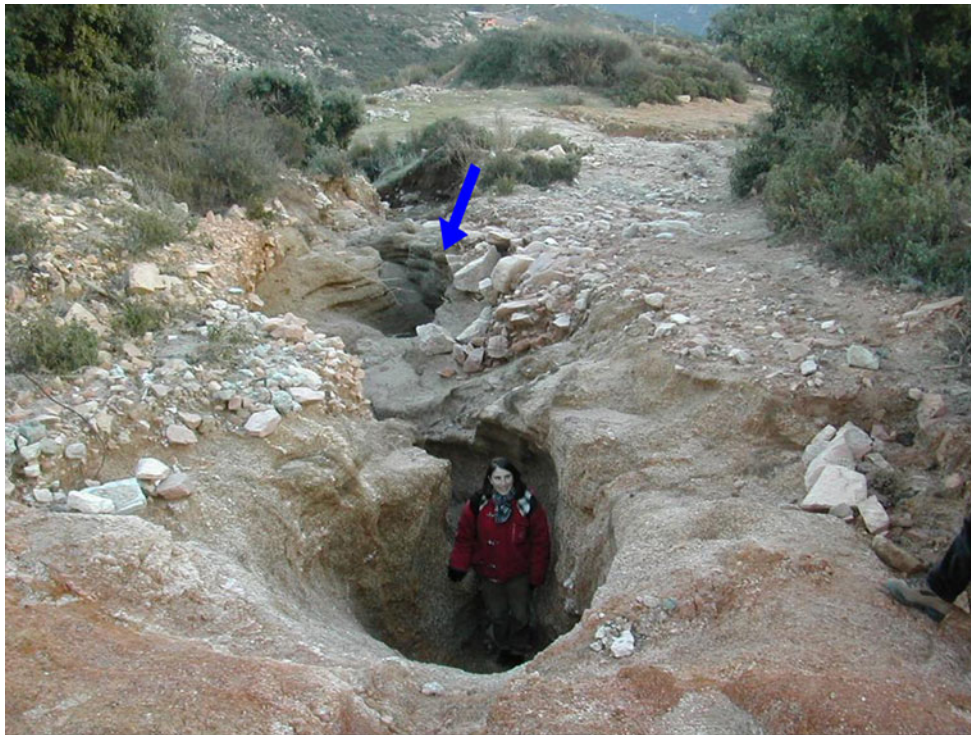
**Fig. 5** Gully erosion in a forestry track above the Villagrande village (*Serra e' Scova* catchment), produced by intense runoff. In the uppermost part of the village, erosion phenomena are particularly apparent along streams and forestry tracks. As a matter of fact, most

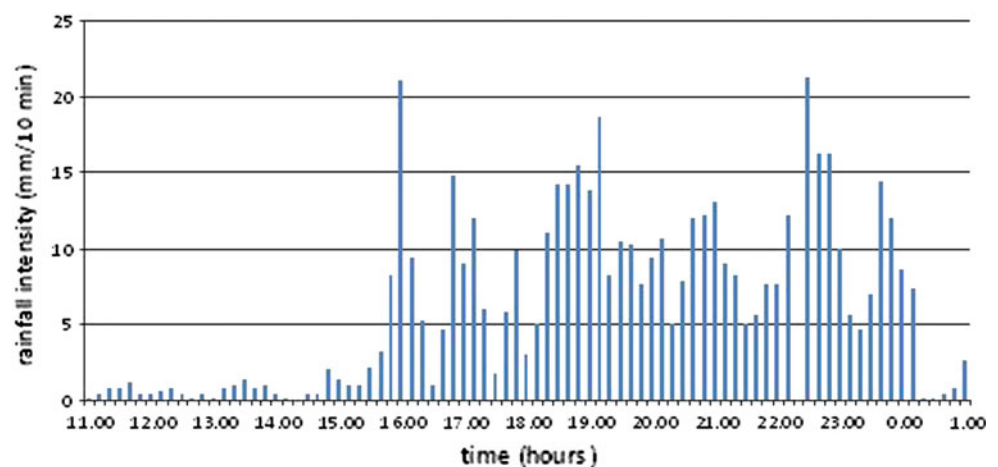
**Fig. 8** Rainfall intensity (mm/10 min) data at the Villanova Strisaili rain gauge (*Servizio Agrometeorologico Regionale*), ca. 4 km west-northward from Villagrande, recorded from 11:00 GMT of 6 December 2004 to 01:00 GMT of the following day

Rainfall recorded at Villanova Strisaili, only 4 km away from the Villagrande rain-gauge station (belonging to the *Servizio Agrometeorologico della Sardegna*) on 6 December 2004 show the amount of 552 mm in 24 h. The 10 min rainfall graph (Fig. 8) indicates 2 peaks of rainfall at 16:00–16:10 GMT (21 mm) and 22:30–22:40 GMT (21.2 mm).
