Evaluation of rock falls in an urban area: the case of Boğaziçi (Erzincan/Turkey)

Keywords Rockfall · Boğaziçi · Zonation map · Natural hazard · Hazard assessment

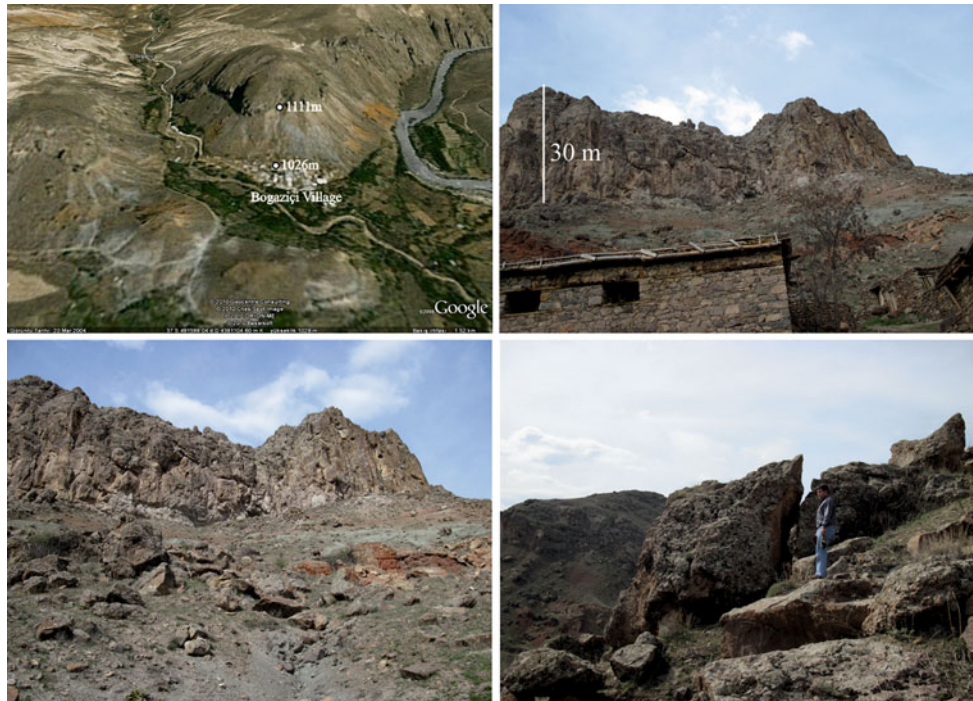
Fig. 3 Photos showing slopes and general view of the study area

below a very steep cliff that is the source of rock falls. The cliff has a slope of 90° in some places and a height of approximately 25–30 m; it is composed of highly fractured and cracked basaltic volcanic. It was observed that there were loosened blocks at some places on the 50–75° slopes facing toward the village (Fig. 3). These blocks sometimes present a danger for the village (Fig. 3).

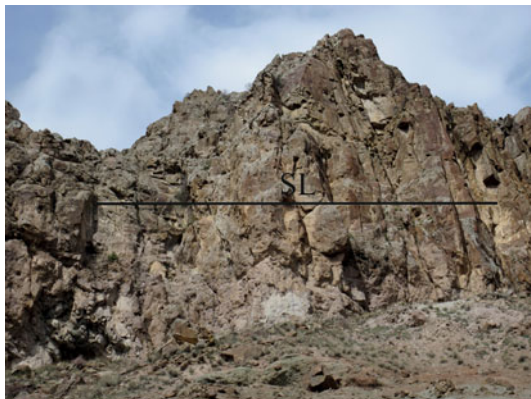
Fig. 4 Views from a scan line survey

Discontinuity properties of the rock masses in the study area that influence the risk of rockfalls were identified using the scan-line survey recommended by ISRM (2007). Line surveys with a total length of 62 m were performed in the study area and the characteristics of the discontinuities on the slopes were determined (Fig. 4). The DIPS software program was used to generate the stereonets from the scanline survey data collected. Based on these analyses, it was revealed that two major joint sets were identified in the cliffs. The orientations of these sets were found to be 79/210 and 84/156.

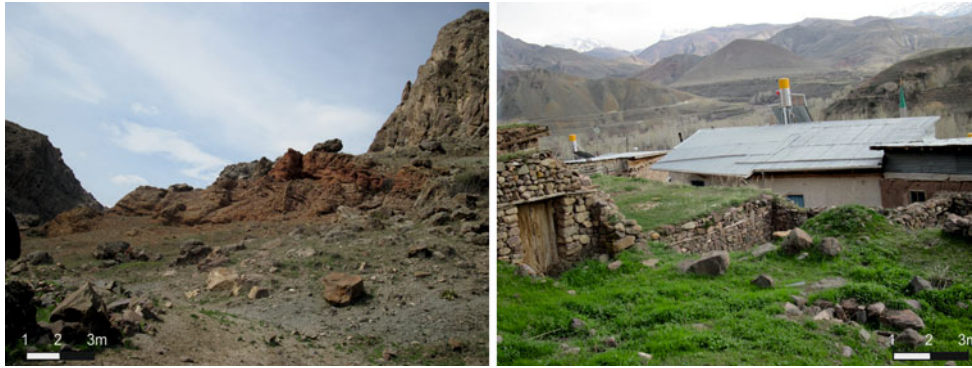
Fig. 6 Fallen rock blocs showed in the study area

discontinuity range was 1.32 m for 79/210 discontinuity; and 1.82 m for 84/156 discontinuity. The persistence of these discontinuities was greater than 20 m and were mostly terminated by another discontinuity. To determine block sizes of the discontinuities in the study area, volumetric joint count (Jv) was calculated, as specified in ISRM (2007), as shown in Table 1. Volumetric joint count (Jv) is a relative expression of block size and expresses the total number of discontinuities observed in a rock mass in unit volume. The discontinuities in the study area were defined as “large blocks” based on the volumetric joint count (ISRM 2007). In addition, block size measurements were conducted inside houses destroyed by previous rockfalls and for blocks suspended on the local slopes. It was found that average block size was 2–2.5 m³; however, there were blocks of up to 6 m³ (Fig. 6).

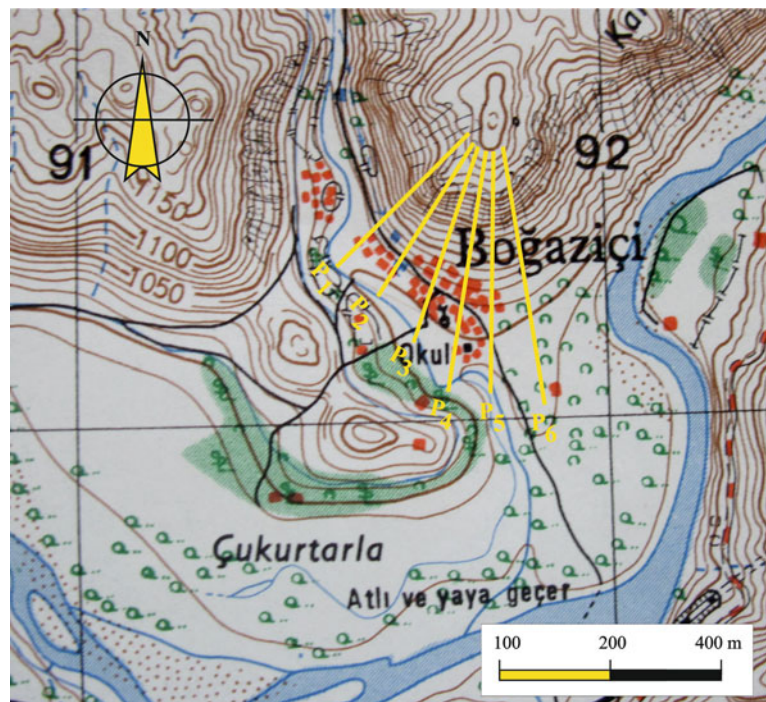
Fig. 7 Profiles used in the rockfall analysis

performed in six profiles (Fig. 7) using the RocFall V.4.0 software (Rocscience 2002). RocFall is a useful computer program based on the laws of motion and collision theory, which allows the path of rock blocks to be calculated. The kinetic energies, velocities, end points (fall out distances), and bounce heights at each point within a profile can also be calculated. RocFall can also assist in determining remedial measures: the material properties of each slope segment can be changed and the analysis re-run, comparing the results. The program produces three “envelopes”: the kinetic energy envelope, the velocity envelope, and the bounce height envelope. Boğaziçi village was settled without a scientific evaluation of local rockfall risk. While selecting the slope profiles used in the analyses, we paid attention that these profiles comprised the entire village settlement and were adequate to identify rockfall risk in the settlement. The field studies identified two different source regions for rock falls, consisting of the cliffs with a height

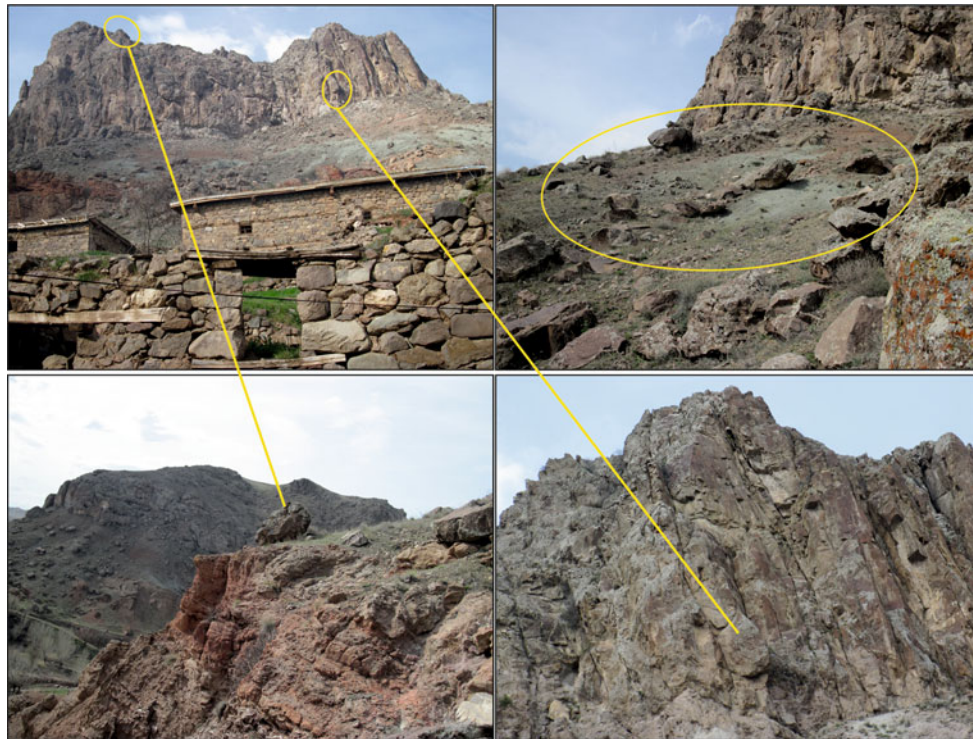
Fig. 8 Photos showing potential rockfall areas in the study area

of 35 m and slope of approximately 90°; and the deposits formed by previously displaced rock masses remaining on the slope (Fig. 8).

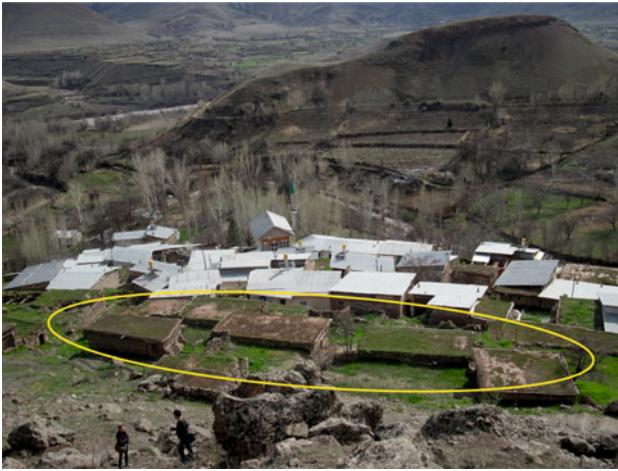
Fig. 11 Houses destroyed during the earlier rock fall

during previous rockfalls (Fig. 11), and may reach the inner sections of the settlement. Another important factor in rockfalls is the energy of the falling rock. Changes in the kinetic energy of the rocks were also calculated. It was found that the energy of the rocks reached 3 million J even at a horizontal distance of 350 m from the cliff. Furthermore, velocity (maximum 53 m/s) values were obtained in some locations. When considering the velocity of falling boulders, it is nearly impossible for people to shift away to
