# Landslide development at the shores of a dam reservoir (Włocławek, Poland), based on 40 years of research

**Abstract** This article presents results of our 40-year research on dynamics of a deep rotational landslide developed in clay deposits. The landslide is located in a lowland, within the shoreline of Włocławek Reservoir, with little water level variation, in Dobrzyń on the Vistula (northern Poland). It is an old landslide, which was active also before the construction of the reservoir. Our research was initiated in 1970, i.e. when the river Vistula was dammed there. Currently the landslide covers about 20,000 m<sup>2</sup> and has a volume of about 160,000 m<sup>3</sup>. During the 40 years, 3 periods of increased landslide activity were observed. The first, conspicuously, nearly 40 % increase in the rate of movements within the Central Landslide was initiated in the early 1970s and lasted till the early 1980s. It coincided with the initial filling of the reservoir and the first years of exploitation of Włocławek Reservoir. The increase in landslide dynamics was a direct effect of hydrological and morphological changes associated with the damming of the river. The next 2 pe

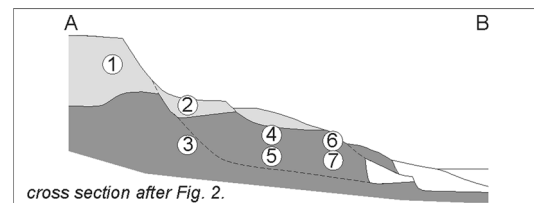
Location	Material name	Depth (m)	Undrained shear strength (MPa)	Plastic limit (%)	Liquid limit (%)	Moisture content (%)
1	Till	2-5	0.35-0.40	11.5	19.5	10.9
2	Till	2-4	0.40-0.60	-	-	-
3	Clay	7-10	0.19-0.25	20.5	61.3	22.0
4	Clay	3.7	0.04	-	-	-
5	Clay	5-7	0.18	-	-	-
6	Clay	1-3	0.05	18.1	38.9	21.3
7	Clay	2-3	0.10	20.8	68.7	22.8

Fig. 4 Selected geotechnical parameters of the soils

The landslide is 220 m long and 60–90 m wide. It covers an area of about 20,000 m<sup>2</sup> and has a volume of about 160,000 m<sup>3</sup> (Fig. 2). The main scarp reaches an altitude of 99 m a.s.l., while the toe is partly below the water level in the reservoir and the shoreline is at 57 m a.s.l. Thus the difference in altitude is 42 m. Mean slope angle is 13°, and it is a rotational landslide. The upper part of the landslide crown is located in Quaternary deposits (2 layers of glacial till, separated by sandy deposits) about 20 m thick, overlying Pliocene clays (Fig. 3). Selected geotechnical parameters of the soils are presented in Fig. 4, based on the data of Kuszyk et al. (2012).

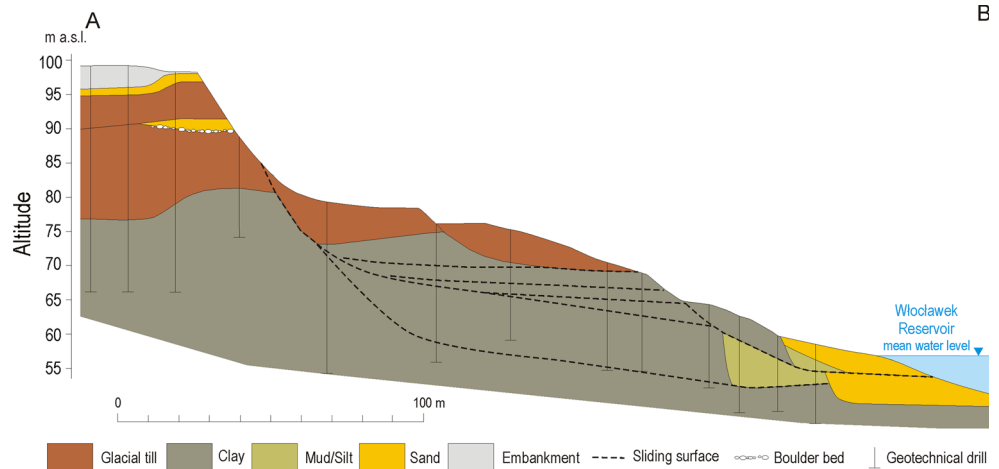
Fig. 3 Geological cross section of the Central Landslide

It is a deep rotational semi-circular landslide. This form develops as a result of retrogressive erosion (headward erosion). In the lower part of the landslide, in the surface layer (2–3 m thick), slow earthflow is observed. With the use of inclinometers in the late 1970s (Madej 1981), shear planes were identified at the depth of 7, 9, and 16 m. Because of the great dynamics of the landslide, inclinometric boreholes were destroyed and were not restored. Research conducted at the end of 2012 by Kuszyk et al. (2012) (e.g. geological drillings and cone penetrometer test) indicate that there are many shear planes (Fig. 3).

On the basis of geotechnical research conducted in the late 2012, the factor of safety  $F_s$  was estimated (by the Bishop method, Kuszyk et al. 2012). It reached 1.43 along the main cross section of the landslide (Figs. 2, 3) and  $\sim 1.2$  for the lower surface part of the landslide, where slow earthflow was observed.

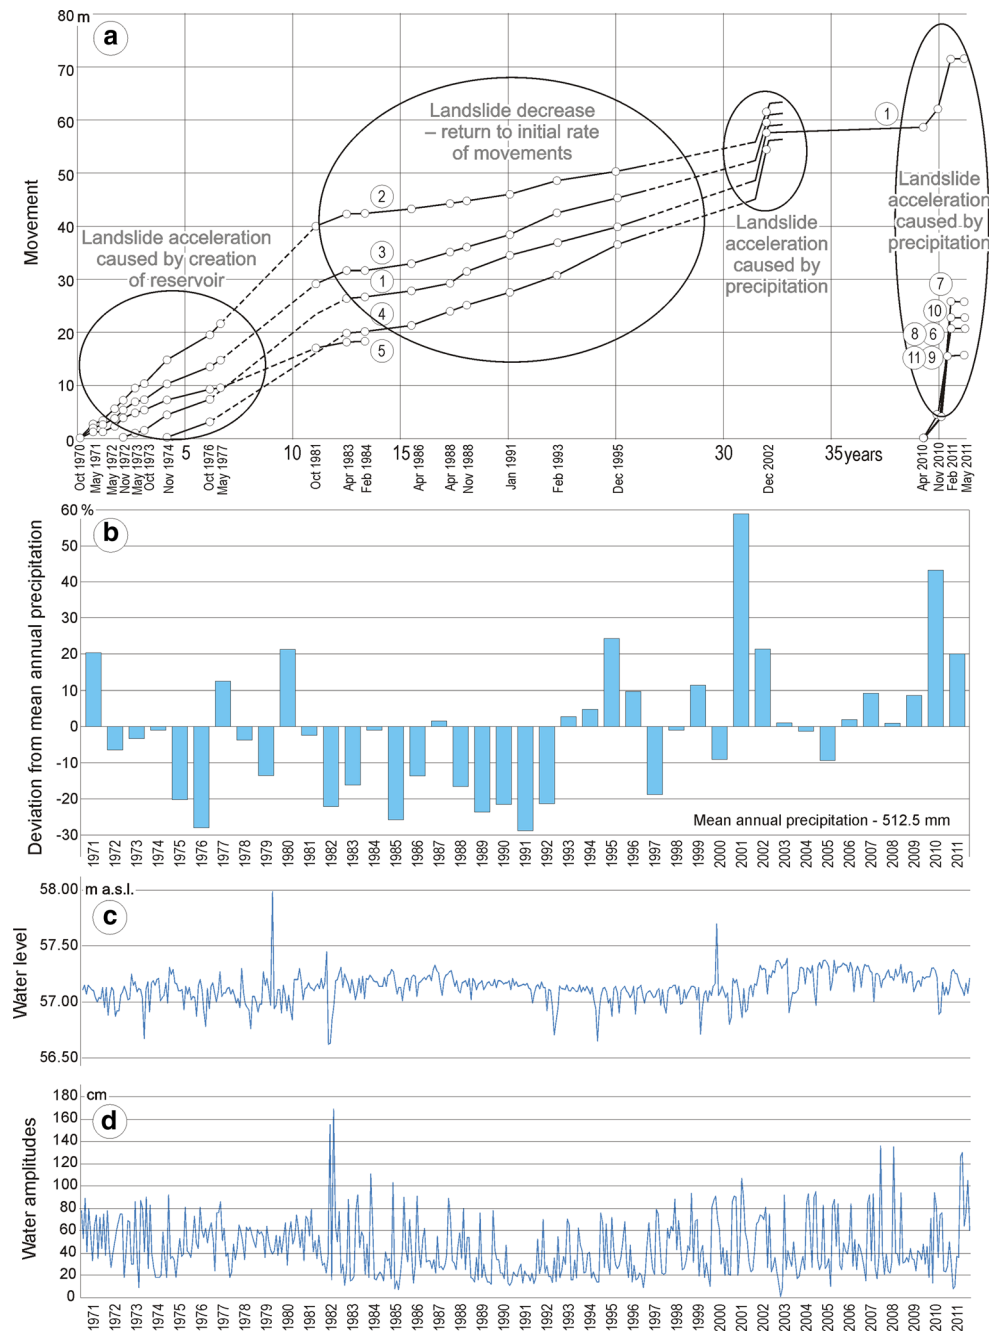
**Fig. 5** Dynamics of movements of the Central Landslide in relationship to precipitation and reservoir water level during the monitoring period, 1970–2011. **a** Colluvium surface movements recorded at control points (benchmarks). Numbering of benchmarks compatible with Fig. 2. **b** Deviation (%) from the long-term mean of annual precipitation. **c** Monthly reservoir water level fluctuations. **d** Monthly reservoir water amplitudes

As a result of changes associated with the construction of Włocławek Reservoir, the activity of pre-existent landslides increased and new landslides appeared along the whole right bank of the reservoir (Banach and Spanila 2000). The rate of movement of the Central Landslide in the first 4 years after creation of the reservoir (1971–1974) increased to 3.6 m/year, i.e. was 38 % higher than in 1959–1970 (Banach 1977). In the landslide cross section, the rate of colluvium movement clearly varied depending on the distance from the edge of the main scarp: 1.8 m in the upper part, 2.5 m in the middle part, and 3.6 m in the lower part of the landslide. Moreover, in that period, the rate of colluvium movement clearly varied also seasonally. Movements in the cold half-year (November–April) were 3–6-fold larger than movements in the warm half-year (May–October). A similar distribution of the rate of colluvium movement was observed till the early 1980s. On average in 1970–1984 it annually reached 1.4 m in the upper part, 2.4 m in the middle part, and 3.2 m in the lower part. The main scarp of the landslide as a result of headward erosion in that period receded 30 m (Fig. 5).

The clearly increased activity of the Central Landslide resulting from the creation of Włocławek Reservoir was maintained for 13 years, followed by a clear decrease in its dynamics. Between the mid-1980s and mid-2001, the movements reached only 1.0–1.7 m/year and were comparable with values recorded in the period before the reservoir was created. In 1983–2002, the upper edge of the landslide receded 12 m on average (Fig. 5).

However, from September 2001 till March 2002 (i.e. after nearly 20 years of dynamic balance of the Central Landslide), the rate of movements increased remarkably (Fig. 5). After that period, landslide activity returned to mean values.

movements from 20 January to 10 February 2011 (Fig. 5). These values are unusually high, never recorded during the earlier 40-year research on this form. On the landslide surface, numerous transverse ridges, scarps, cracks, and cavities were formed and quickly filled with water. The surface drainage network was completely destroyed. Its restoration was initiated as late as in 2014. Deformations affected the beach, paved footpath, and stone gabion protection of the bank, which was pushed into the reservoir by the pressing colluvial masses (Banach et al. 2013). Landslide morphology was remodelled completely. The cracks

The first, conspicuously nearly 40 % increase in the rate of movements within the Central Landslide was recorded in the early 1970s and lasted till 1983 (Fig. 5). Those years were distinguished by average or slightly lower rainfall. Only in 1970, 1977, and 1980, annual precipitation slightly exceeded mean values for 1970–2011 (Fig. 5). The period of landslide acceleration coincided with the initial filling of the reservoir and the first years of its exploitation, so it was a direct effect of damming of the river. The 8-m rise in water level, as compared to mean water level in the Vistula before its damming, caused a decrease in shear strength as a result of an increase in soil moisture content (reduced soil cohesion below the water level in the reservoir).

of observations. Annual precipitation in 2001 reached 826 mm, so it was 61 % higher than the mean for 1970–2010. This was due to heavy rainfall in spring and summer (April–September), when monthly precipitation was 68–227 % higher than the corresponding monthly means for 1970–2010. After a drier October and November 2001, the next few months were also extremely wet. Precipitation in February 2002 was 282 % higher than the corresponding monthly mean for 1970–2010 and was the highest in the study period (Fig. 5).

However, the major factor enabling the strong influence of precipitation and snow melt on the development of the Central Landslide was its location within the axis of a Miocene syncline. The syncline performs the function of a local discharge area, where groundwater from neighbouring areas is collected. Groundwater, particularly after long-term and intensive rainfall and snowmelt, gradually infiltrate the sliding surface. This process, coinciding with a high moisture content of displaced material and its reduced shear strength resulted in the acceleration of the Central Landslide, on an exceptionally large scale between 20 January and 10 February 2011 (Fig. 5).

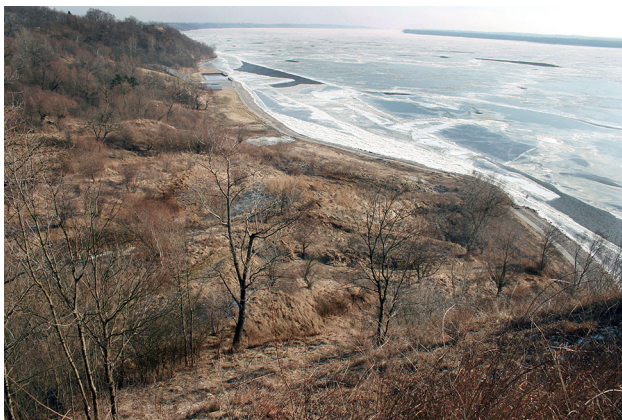
**Fig. 6** Lower part of the Central Landslide

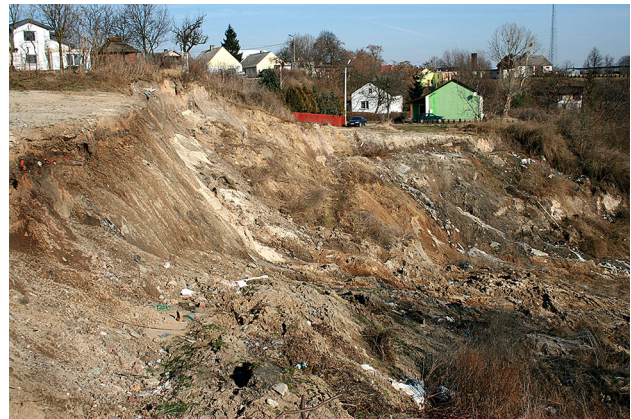
**Fig. 7** The main scarp of the Central Landslide after acceleration in 2010–2011

were deeper and broader, and many new depressions were formed and filled with water. Its toe entered the reservoir in a 60-m section of the shoreline, causing transformation of its bottom (Fig. 6). The main scarp between December 2010 and February 2011 receded 3–5 m (Fig. 7).

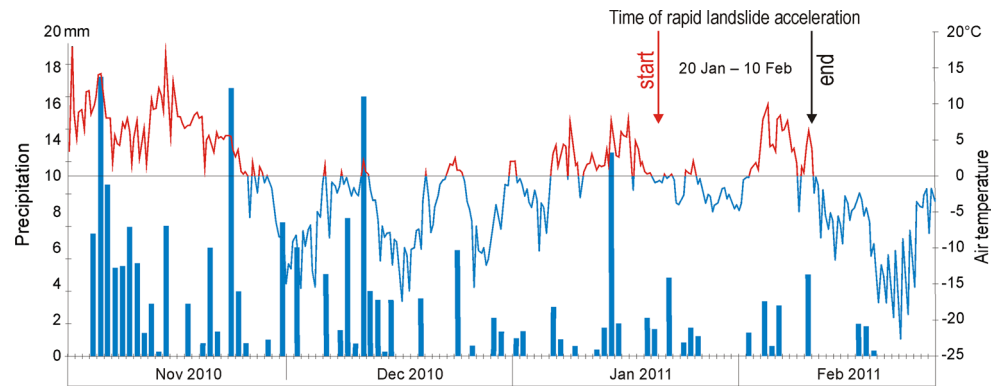
**Fig. 8** Temperature and precipitation before and during landslide acceleration in 2010–2011

The unfavourable effect of precipitation on stability of the Central Landslide was aggravated by low air temperature. Since 26 November, air temperature for most of the day was below 0 °C, water was retained in the soil and on the surface, as snow cover. Higher temperatures were recorded on 7–20 January (daily mean air temperature  $-1.2$ – $5.4$  °C) and 4–11 February ( $-3.2$ – $8.2$  °C). The sudden warm spell, resulting in the release of groundwater and melting of the accumulated snow cover, caused greater hydration of colluvium, an increase in its weight, and lowering of shear strength (Fig. 8).
