Terrestrial laser scanning monitoring and spatial analysis of ground disaster in Gaoyang coal mine in Shanxi, China: a technical note

Xugang Lian¹ · Haifeng Hu¹

Keywords Terrestrial laser scanning · Spatial analysis · Mine ground disaster monitoring

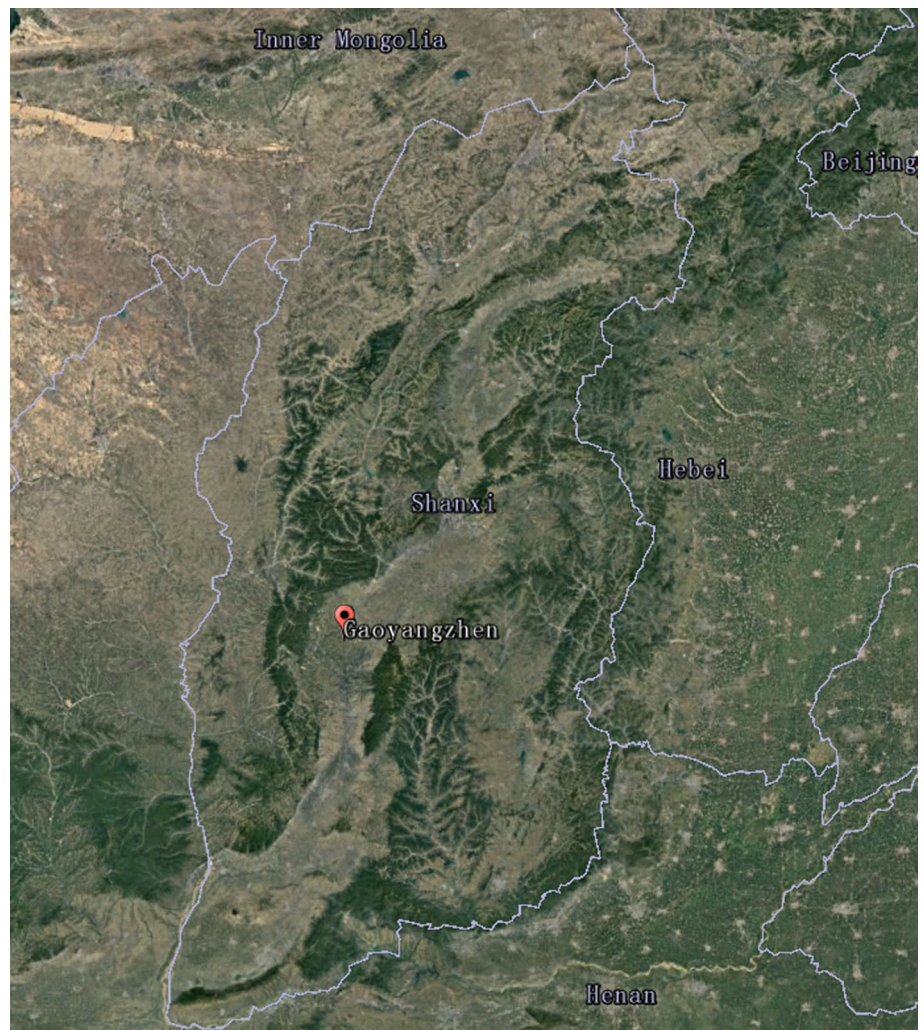
Fig. 1 Study area: Gaoyang coal mine in Shanxi Province, China

Figure 1 shows the study area located in Gaoyang coal mine, Lvliang City, Shanxi Province in China. The ground above the extracted coal panel is mountainous terrain, and the relative height difference is approximately 130 m. The width of the coal panel is 200 m, the average extracted depth is 330 m, the thickness of the coal seam is 8.7 m, and the loess layer thickness ranges from 66 to 123 m.

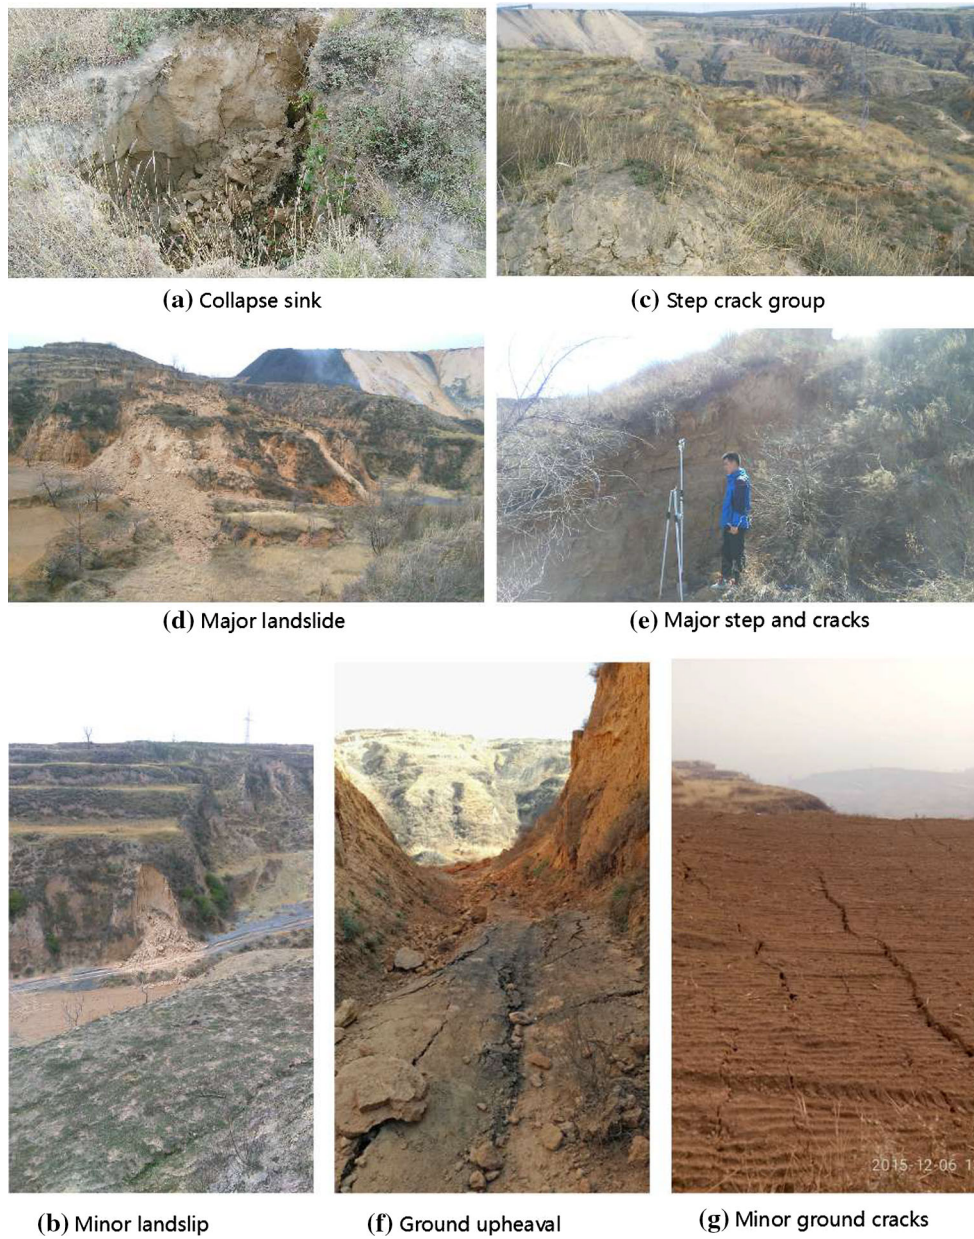
Fig. 3 Photographs of different ground disasters

During the extraction process, the ground disasters are formed, including collapse sinkholes, minor landslips, step crack groups, major landslides, major steps and cracks, ground upheaval, and minor ground cracks. The locations are shown in Fig. 2a–g, and the corresponding images are presented in Fig. 3.

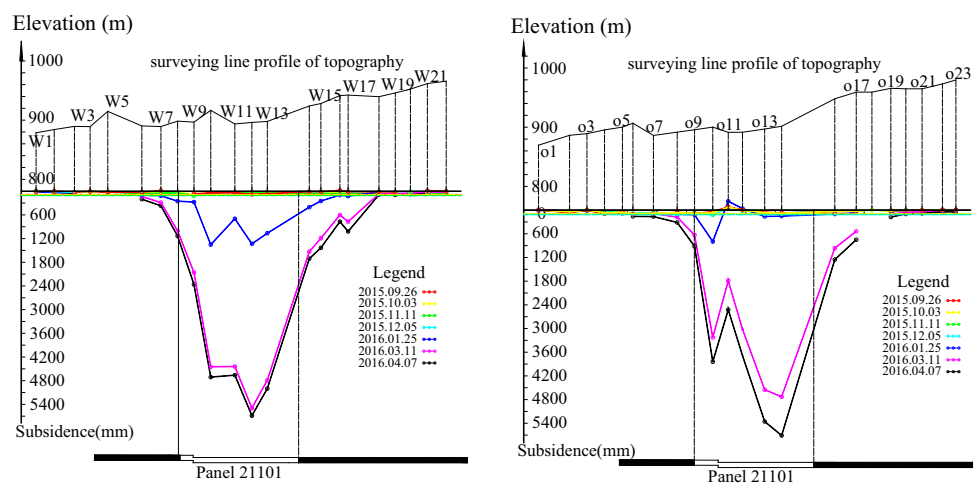
Fig. 8 Subsidence curves of W and O surveying lines during coal panel advancing

Two observation lines are located in the dip direction of the working face (Fig. 8). Before January 25, 2016, the subsidence of the two lines was small, and the advancing position was only under line W. On March 11, 2016, with the working face advancing and passing line O at approximately 70 m, the surface subsidence occurred significantly. As the working face continued to advance, the change of subsidence on the ground was small. In line W,

the subsidence between points W10 and W13 was larger at more than 4200 mm. The maximum subsidence point of 5686 mm was at W11, which was located at the center of the coal panel in the dip direction. The subsidence of point W17 was abnormal because of the gully between points W18 and W17, and point W17 was located at the slope, which was affected by the slope slipping. The horizontal distance between lines O and W was 50 m, and the subsidence of points between O10 and O14 was larger at more than 3000 mm. The maximum subsidence point O14, which was located in the center of the goaf, reached 5710 mm. In all observations of line O, the subsidence of point O11 is smaller because point O11 is located at the

bottom of the slope, and the horizontal movement is approximately 600 mm. Thus, a visible slip rupture at the field causes the point uplift at a certain degree.

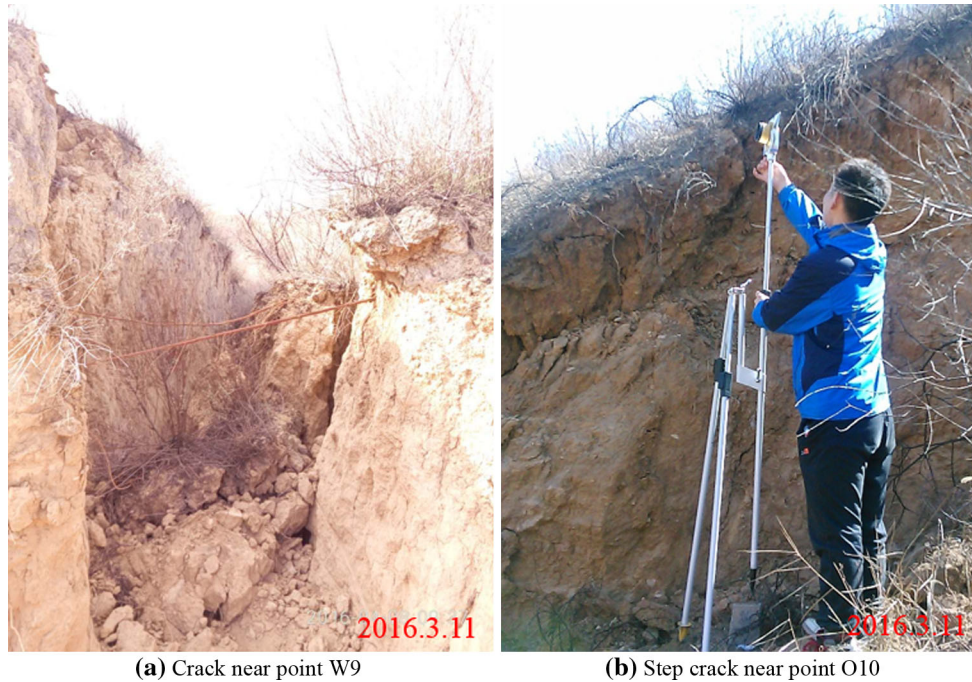
(a) Crack near point W9

(b) Step crack near point O10

Fig. 9 Surface step cracks caused by underground mining

As the working face advanced, the step cracks on the ground were also formed (Fig. 9). To monitor and determine the absolute movement and detailed characteristics of the step cracks, the total station and a laser scanner were utilized. The crack, as shown in Fig. 9a, is located near point W9 and on top of the slope, and the crack-step, as shown in Fig. 9b, is located near point O10 and at the bottom of the slope. According to Fig. 1, points W9 and O10 are on one line in advancing direction, and the main movement types are horizontal in advancing direction and

To record the geometric shape of the step crack in detail, the site shown in Fig. 9b was scanned, and the point-cloud data of the step crack were obtained. Furthermore, the 3D model of the step crack was obtained through point-cloud denoising, modeling, and sectioning.

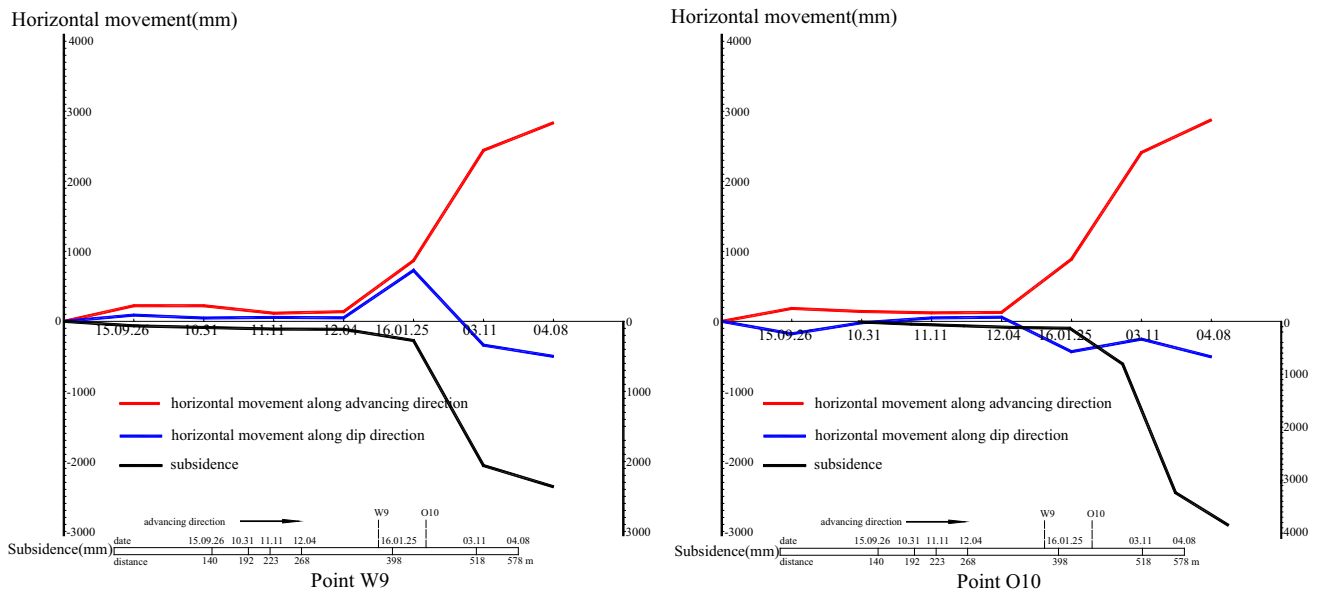
Fig. 10 Movement of points W9 and O10

subsidence (Fig. 10). The horizontal movement values of the two points along the advancing direction are similar because they are located on the same slope. The subsidence of point O10 is larger than that of point W9, and the difference is approximately 1500 mm.

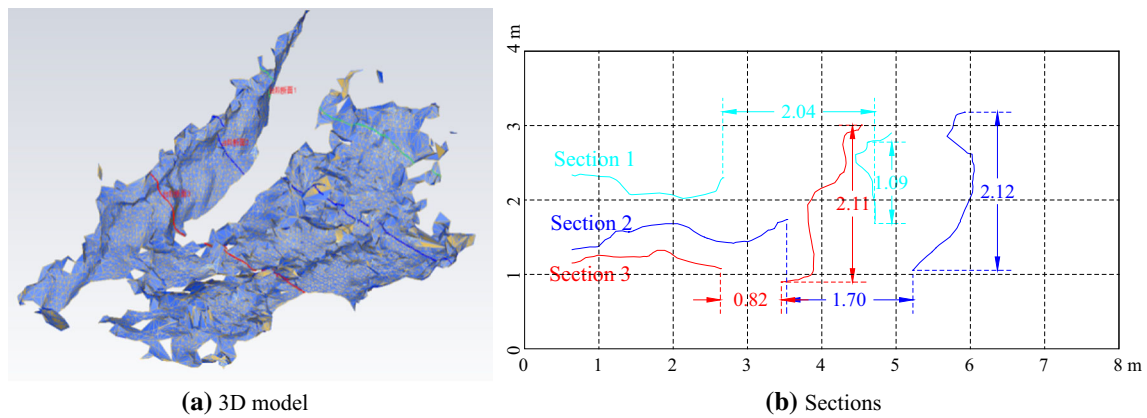
Fig. 11 3D model and sections of step crack

TLS is utilized to monitor the detailed characteristics of the step crack, which can accurately and fully collect the crack spatial information, and extract the sections in different locations to obtain the width of the crack and the height of the step. Three sections were extracted from Fig. 11a and b. On the basis of the section lines, the crack width is 2.04 m and the step height is 1.09 m in “Introduction” Section, the crack width is 1.70 m and the step

height is 2.12 m in “[TLS monitoring landslide caused by underground mining](#)” Section, and the crack width is 0.82 m and the step height is 2.11 m in “[Laser scanning on step crack caused by underground mine](#)” Section.

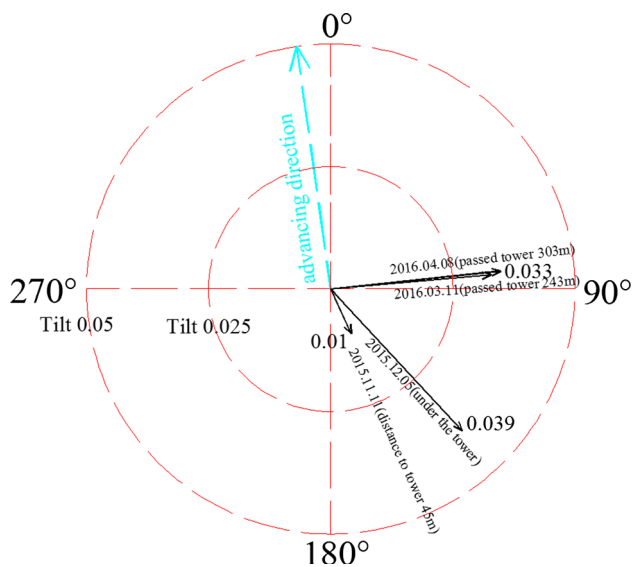
Fig. 13 Tilt change of tower body during mining

Based on a tilt calculation formula, the point cloud of four scanning times can obtain the following results: tilt on November 11, 2015 = 0.01, tilt on December 5, 2015 = 0.039, and tilt on March 11 and April 8, 2016 = 0.033. According to the “Operation Rules for Overhead Transmission Lines DL/T 741-2010,” the electric power industry standard published by the National Energy Board of China, the tower height is less than 50 m and the allowed tilt is 1%. Therefore, Fig. 13 shows the changes in tower tilt during mining, which illustrates the tilt of the tower, and is larger than 1% after December 5, 2015. Thus, the tower has been protected by the pulling steel cable. In Fig. 13, the tilt azimuth can be found, which is useful in locating the position of the pulling steel cable.
