# Integrating subsurface stratigraphic records with satellite images to investigate channel change and bar evolution: a case study of the Padma River, Bangladesh

Landsat data and stratigraphic records were employed to determine channel changes and bar evolution of a selected reach of the Padma River in Bangladesh. Analysis of multi-temporal images showed that the selected reach of the Padma River has undergone significant morphological changes since 1973. The mean width of the river has almost doubled, having increased from 5458 m in 1973 to 10,638 m in 2014. Bank erosion, totalling 281 km<sup>2</sup>, was more than double the accretion (123 km<sup>2</sup>), and the left bank experienced higher levels of erosion than the right bank. Analysis of the stratigraphy of the bar head, middle and tail sections revealed that erosion occurred in the head section, but that the middle section seemed to be stable, whereas accretion was estimated to be high in the tail section of the bar. Sedimentary facies analysis indicated that bar evolution is largely influenced by the variation of both water and sediment flows, as bar areas tend to accrete substantially following large floods. However, the

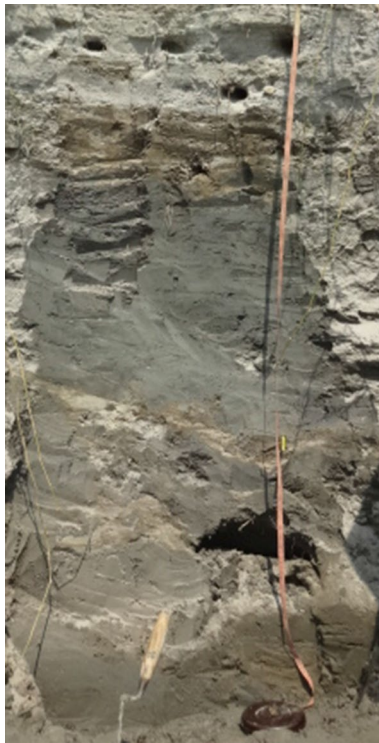
**Fig. 2** Exposed soil section

For stratigraphic analysis, sedimentary layers were exposed at the eastern side of the bar head and western side of the bar tail sections (Fig. 2). To expose a site fully, in the bar head and tail, soil was excavated with the help of a hammer, until any presence of water was detected. The head section was exposed to 2.92 m below the surface, while the tail section was exposed to 3.89 m. After exposing each section, the different layers of sediment were identified and their depths were measured. Subsequently, the lithostratigraphic units were carefully examined using the following criteria:

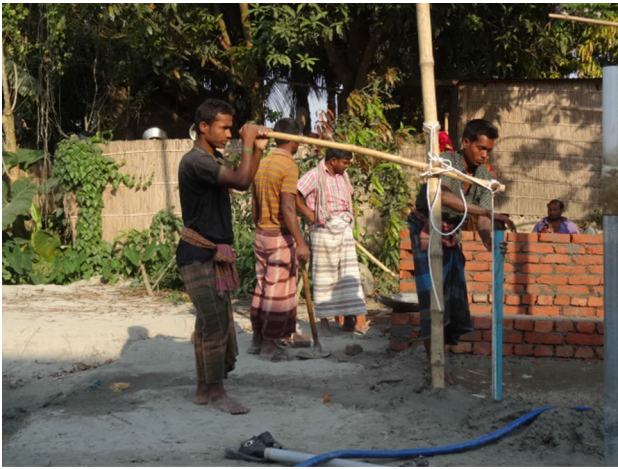
**Fig. 3** Sediment sample collection at the middle section of the bar by wash bottle method

Due to high population density and greater depth of section, an alternative strategy was used to examine the stratigraphy for the middle section of the bar. In this section, a wash bottle method was used as it allowed the collection of sediment from a greater soil depth (Fig. 3). Sediments were collected at approximately 1.5-m intervals until a hard rock layer was reached at 27.43 m depth from surface. Soil texture was then determined from sediments samples obtained from field, using the hydrometer method.

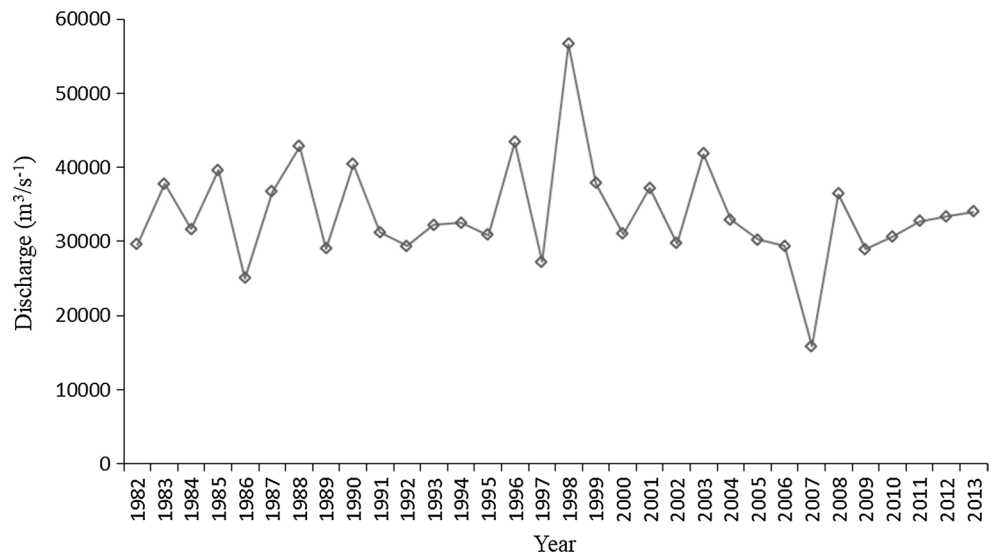
**Fig. 4** Variation in water flow at Baruria gauge station between 1982 and 2013

Daily discharge data, between 1982 and 2013, were obtained from the Bangladesh Water Development Board (BWDB). The records were specifically from the Baruria gauge station (Station ID: SW91.9L) (Fig. 1). Mean annual discharge was then calculated (Fig. 4). To determine any impact of flow variation on bar and channel characteristics, the Pearson correlation coefficient was used at the 95% significance level.

Spatial analysis of bar areas indicated that they increased from 90 to 199 km<sup>2</sup> between 1973 and 2014. At the same time, water discharge fluctuated significantly (27,931 m<sup>3</sup>/s<sup>-1</sup> in 1970 to 33,983 m<sup>3</sup>/s<sup>-1</sup> in 2013) as inferred from yearly water flow data from the BWDB (Bangladesh Water Development Board). From 1989 to 1995, the number of bars increased from 13 to 16, while the discharge was approximately 30,000 m<sup>3</sup>/s<sup>-1</sup> (Table 4) a somewhat stable discharge relative to flood discharge levels. The annual rate of bar erosion was highest (i.e. 15 km<sup>2</sup>/year) during the period of 1995–2000, despite the fact that when the river also experienced a high discharge of 56,623 m<sup>3</sup>/s<sup>-1</sup> in the 1998 flood. The rate of accretion was maximum (i.e. 15 km<sup>2</sup>/year) between 2000 and 2005, when the discharge rate was between 30,000 and 31,000 m<sup>3</sup>/s<sup>-1</sup> and there were no large flooding events.

From 1980 to 1989, the discharge fluctuated between 29,605 and 42,824 m<sup>3</sup>/s<sup>-1</sup>. During the same period, the total bar area decreased from 56.28 to 43.68 km<sup>2</sup> (Fig. 7). After the flood discharges of 42,824 m<sup>3</sup>/s<sup>-1</sup> in 1988, the bar area again expanded up to 76 km<sup>2</sup>. After this, area of the studied bar continued to increase to 154.47 km<sup>2</sup> in 2000. The discharge also increased during this time, reaching 56,623 m<sup>3</sup>/s<sup>-1</sup> during the 1998 flood. The analysis further showed that discharge decreased to 33,983 m<sup>3</sup>/s<sup>-1</sup> by 2013, as did the reduction in bar area (144 km<sup>2</sup> in 2013).

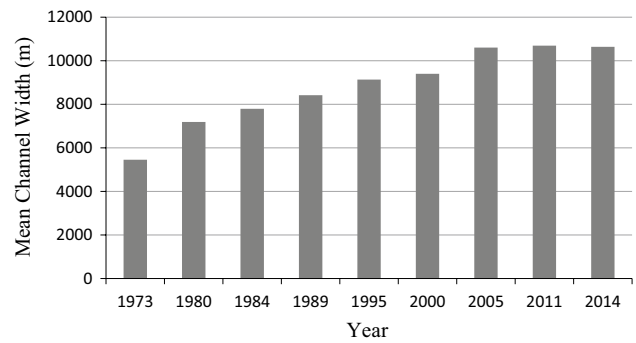
**Fig. 5** Variation in mean channel width along the study reach between 1973 and 2014

The analysis showed that, between 1973 and 2014, the width of the selected reach of the river has almost doubled, increasing from 5485 m in 1973 to 10,607 m in 2005. In detail, the channel width increment was gradual until 2005, but has been variable since then, including a decrease since 2011 (Fig. 5). The rate of increment was at a maximum between 1973 and 1980, while the second highest rate was observed between 2000 and 2005.

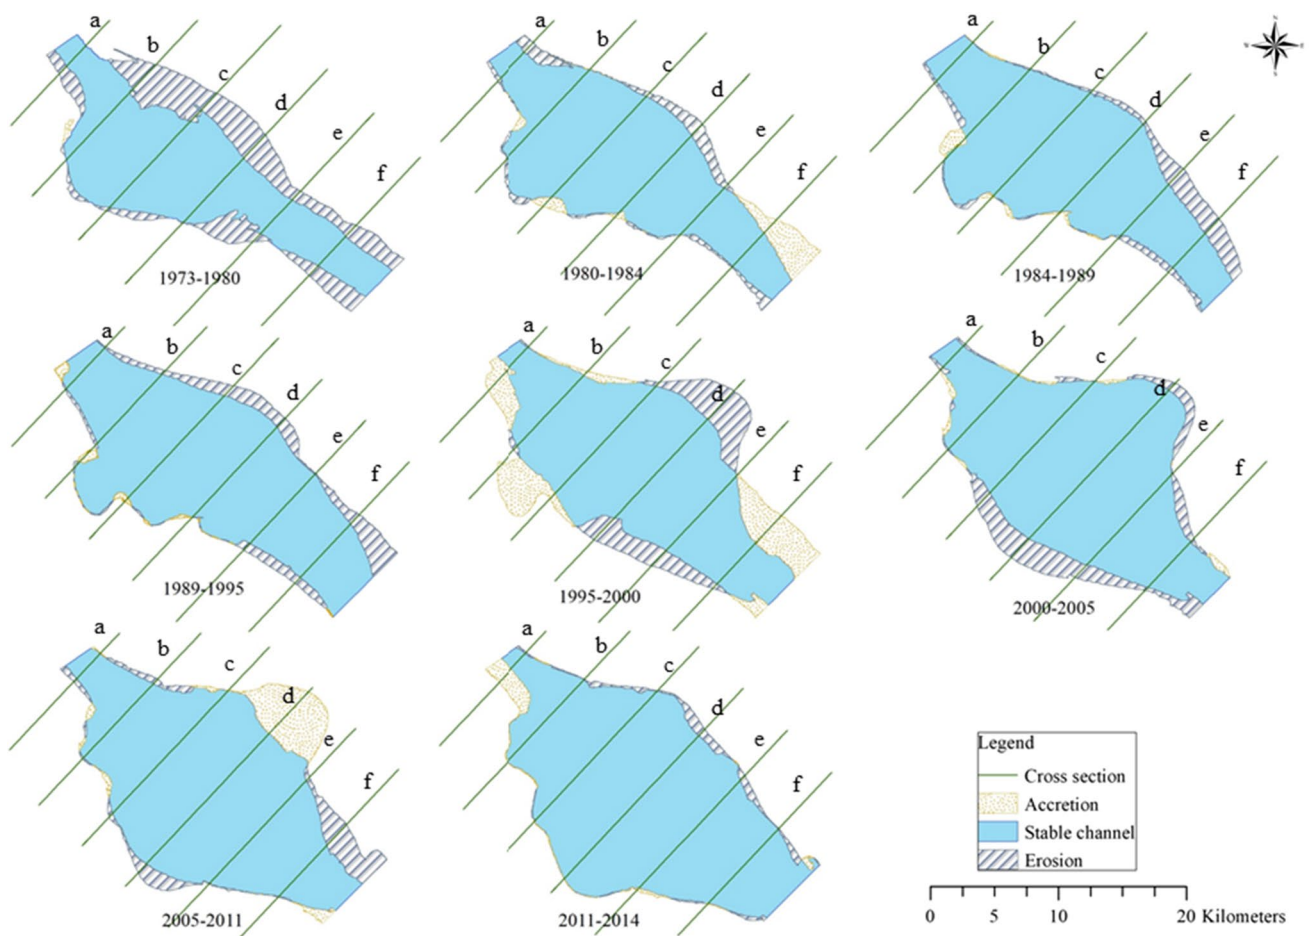
**Fig. 6** Spatial patterns of erosion and accretion in the study reach

Figure 6 shows erosion and accretion statistics of both banks from 1973 to 2014. The results indicate that, almost 281 km<sup>2</sup> of land was eroded between 1973 and 2014, while the amount of accretion was 123 km<sup>2</sup>, suggesting a net loss of bank materials to the channel. The analysis further indicated that rates of erosion and accretion varied between

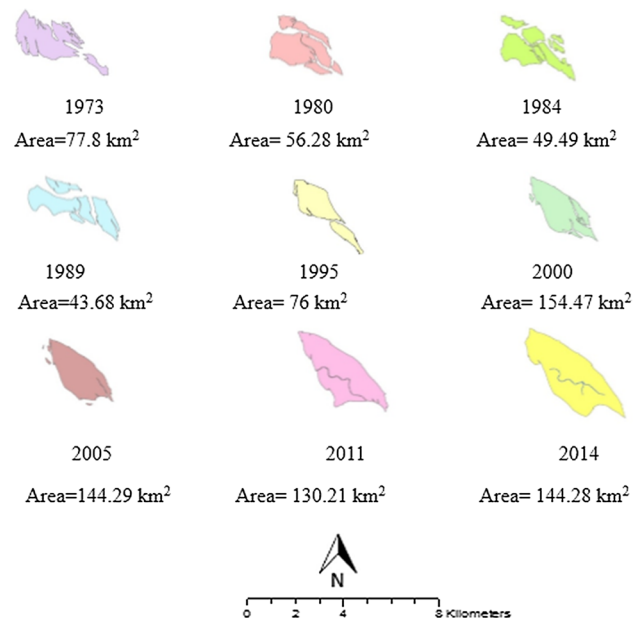
**Fig. 7** Bar evolution between 1973 and 2014

The bar chosen for stratigraphic analysis also shows areal expansion from almost 78 km<sup>2</sup> in 1973 to 144 km<sup>2</sup> in 2014 (Fig. 7). This is the largest bar in the study reach and has undergone frequent changes in size and shape, as inferred from the multi-date satellite images.

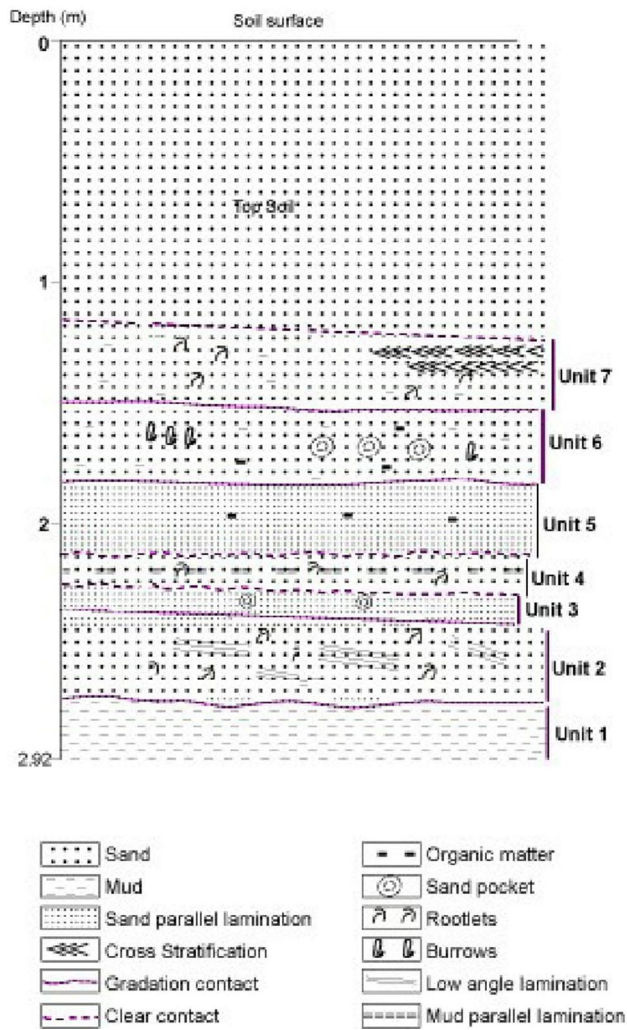
Fig. 8 Stratigraphy of the head section of the bar

The head section was divided into eight lithostratigraphic units (Fig. 8). As is evident from Fig. 8, the lowermost layer (i.e. unit one) is comprised of mud and is overlain by the thick sandy second unit. Notable features in the subsequent layers are: the presence of sand pockets in unit three (Fig. 9a), roots in unit four, sand parallel lamination in unit five (Fig. 9b) and roots and burrows in unit six. The next unit (i.e. unit seven) shows herring bone lamination (Fig. 9c) in a sandy layer, as well as some rootlets. The uppermost layer, i.e. the eighth unit, is a massive sandy layer.

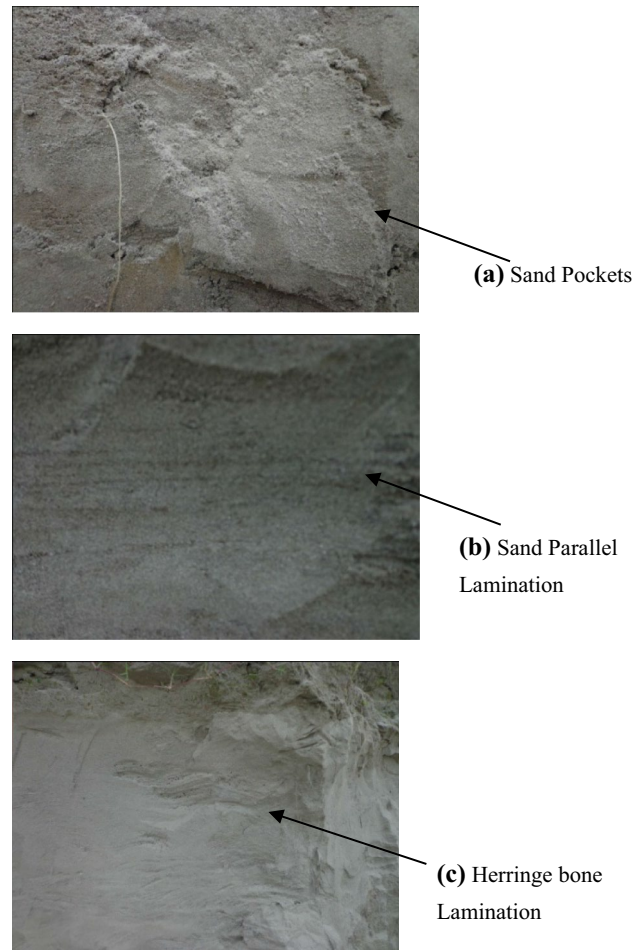
Fig. 9 a Sand pockets in unit 3; b sand parallel lamination in unit 5; and c herringbone lamination in unit 7

Bar stratigraphic records support the findings of satellite image analysis, especially by showing that bar evolution generally followed discharge fluctuation of the Padma River. For instance, the stratigraphic description of the bar head shows that the lowermost layer is a uniform mud layer overlain by sandy thick layer, which might have been created by sediment brought by high discharge during the 1988 flood though we have no sediment data to verify this. This supports the observation of Sinha et al. (2005), who noticed that mud-dominated units are recognized as flood deposits of major rivers. Sand pockets were observed in the next unit, which may have been created during fluctuations of inter-annual water flow between 1988 and 1990. In unit four, the presence of roots is likely to have resulted from stable flow conditions, which may correlate to the relatively stable discharge conditions between 1991 and 1995 (Fig. 4). The sand parallel lamination of unit five suggests that the flow regime was low energy during this period, while the presence of burrows and roots in unit six also supports stable depositional conditions during this time. Unit six was probably formed by sediment from the flood event of 1988. The rootlets in the seventh unit imply that it was exposed and vegetated for a few years. Between 2001 and 2004, water discharge fluctuated, which may be represented by the herring bone lamination of this unit.

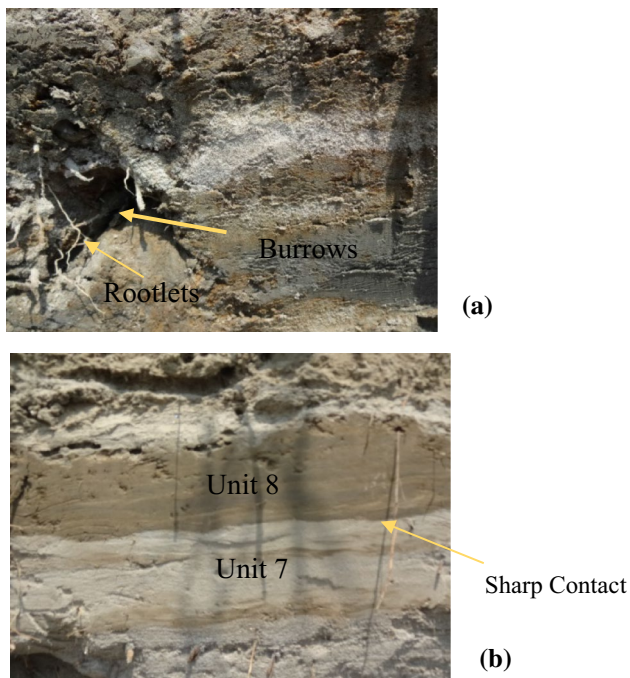
**Fig. 11** **a** Unit 5 showing rootlets and burrows; and **b** sharp contact between units 7 and 8

with low angle lamination in the lower part only. Unit five contains rootlets and burrows (Fig. 11a) and is overlain by a thick sandy layer (unit six) with clay laminations, along with depositional features like roots and burrows. Unit seven consists of sand and shows low angle mud parallel lamination. The eighth unit consists of clay and has a sharp contact with unit seven (Fig. 11b).

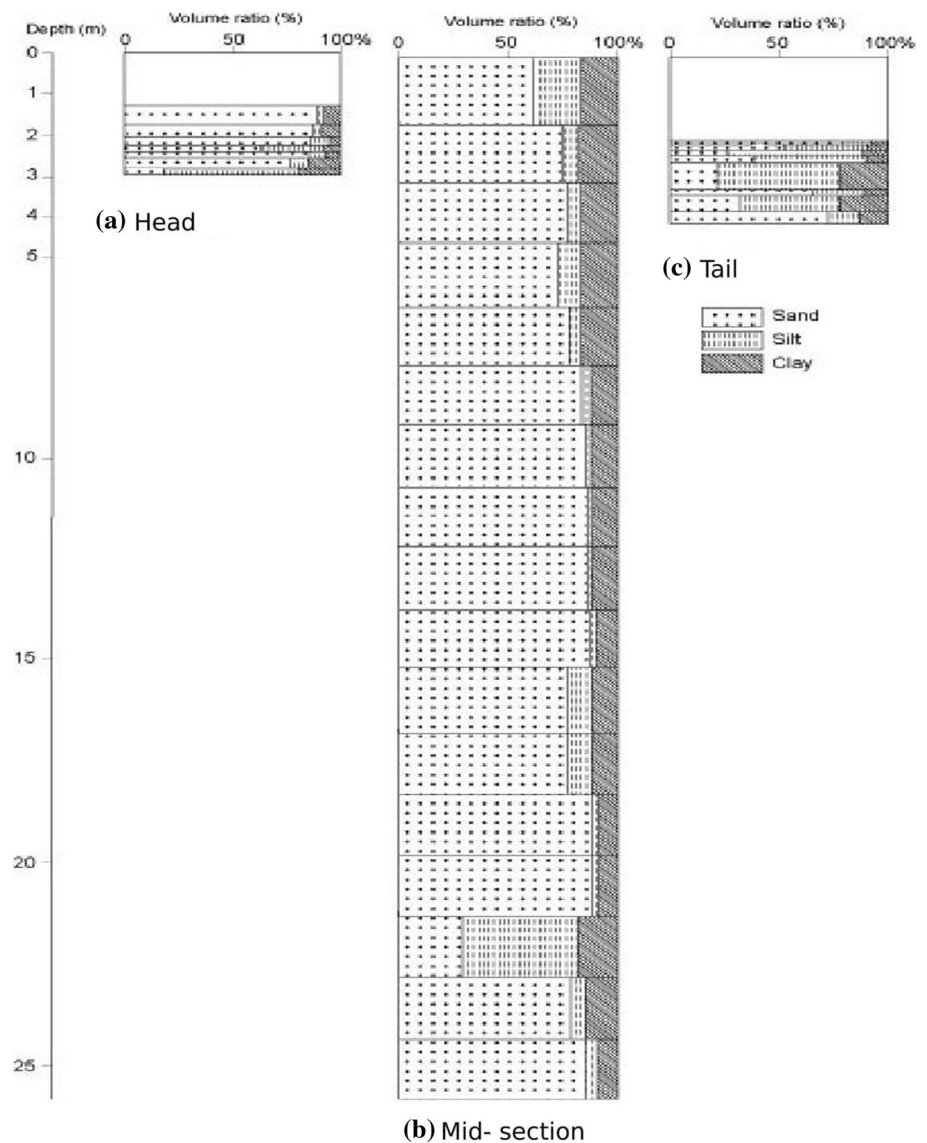
**Fig. 12** Textural variation in different sections of the bar **a** head; **b** middle and **c** tail

The textural variations within the head, tail and middle sections are illustrated in Fig. 12. The middle section contained much less variation in sedimentary texture than the tail and head sections (Fig. 12b). However, a dominance of sand is common to all the three sections (Fig. 12a–c).
