Analysis of the surface deformation characteristics and strata movement mechanism in the main shaft area of Chengchao Iron Mine

The surface deformation and strata movement caused by underground mining in a metal mine often exceeds the designed range, which can destroy main shafts and other key structures, causing huge economic losses and affecting production safety. Here, the main shaft area of Chengchao Iron Mine affected by tectonic stress is analyzed. Detailed monitoring data from the past 11 years were used to analyze the surface deformation characteristics and the strata movement mechanism. The results show that the surface deformation in the main shaft area shows S-shaped curve characteristics comprising a stable deformation stage, a rapid deformation stage and a stable deformation stage. The surface horizontal displacement vector in the main shaft area points to the western mining area, indicating that the surface deformation in the main shaft area is mainly affected by underground mining in the western area. From December 2007 to December 2009, the expansion of the movement line ($\epsilon = 2$ mm/m) was small; in December 2009, the expansion of the movement line increased

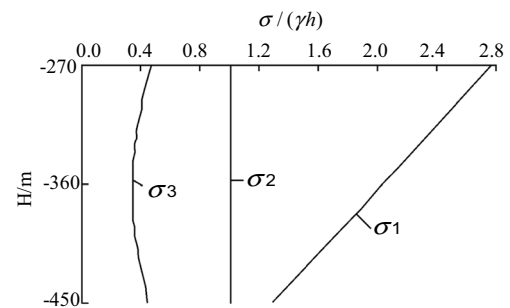
Fig. 1 Diagram of principal stress distribution in Chengchao iron mine

closest to the western mined-out area, is 1.04. The ratio of the cumulative horizontal displacement to the vertical displacement of DC24, which is slightly farther from the western mined-out area, is 1.81. In addition, the ratios at DS02 and DS01 are 2.17 and 1.82, respectively. Figure 8 shows that over time, the ratio of horizontal displacement to vertical displacement first increases and then decreases, reaching its maximum value in May 2012. The reason for this phenomenon is that the vertical deformation stabilized in 2010, whereas the period of horizontal displacement acceleration lasted until May 2012. This timing difference results from the large horizontal tectonic stress in the footwall of Chengchao Iron Mine (Fig. 1).

3. The above analyses indicate that the deformation and failure of the main shaft area were closely related to the sharp decreases of the movement and break angles that occurred from December 2009 to December 2012. As shown in Fig. 1, there is a large horizontal tectonic stress in Chengchao Iron Mine, and the NNW-striking joints are very developed in main shaft area. The main reasons causing the movement and break angles to become smaller than the

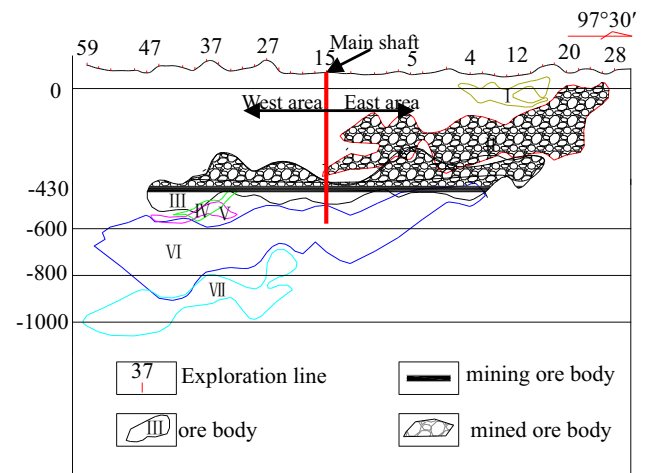
Fig. 2 Projection of main ore body

The main shaft of Chengchao Iron Mine is located in the #15 exploration line of the footwall (Fig. 2), which is the dividing line between the eastern and western areas of Chengchao Iron Mine. Operation of the main shaft began in 1989 with a total investment of ¥36.99 million (CNY) (currently equivalent to approximately ¥370 million or 56 million dollars). The depth of the main shaft is 635 m, the bottom elevation is –550 m, and the tower height is 71.2 m (Fig. 3). The transportation capacity of the main shaft is to upgrade 1.5 million tons of ore and 275,000 tons of waste rock each year. This project won second place in the Sixth Excellent Engineering Design competition of the Chinese Ministry of Metallurgy in 1992. After its completion, it became the most important main shaft in Chengchao Iron Mine. The main facilities of

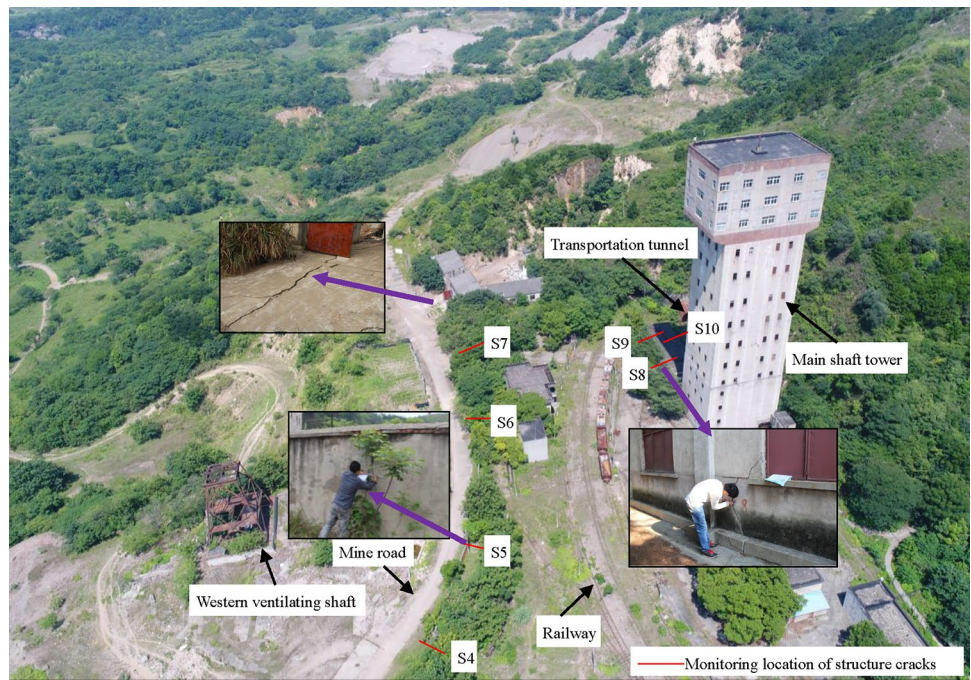
Fig. 3 Current situations in main shaft area of Chengchao iron mine took by UAV

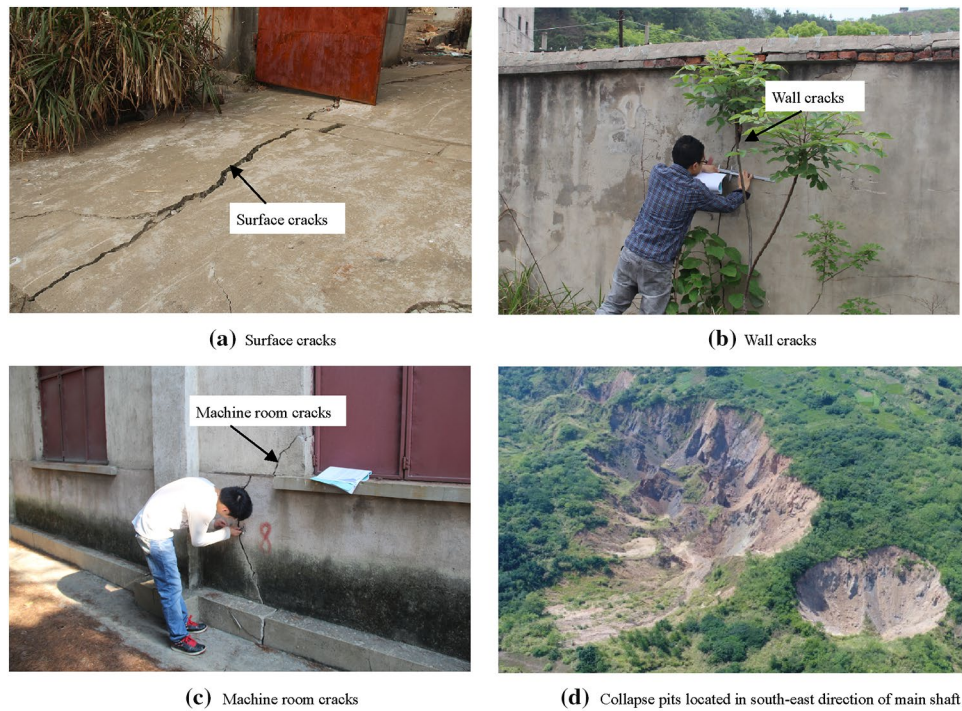
Due to the effects of underground mining, the ground of the main shaft area, the wall, and the machine room became cracked in 2012 (Fig. 5a–c), and the main shaft had to stop being used in 2015. The total service life of the main shaft was only 26 years; the loss of the main shaft before its designed time caused huge losses to Chengchao Iron Mine.

Fig. 5 Ground and structure damage in main shaft area

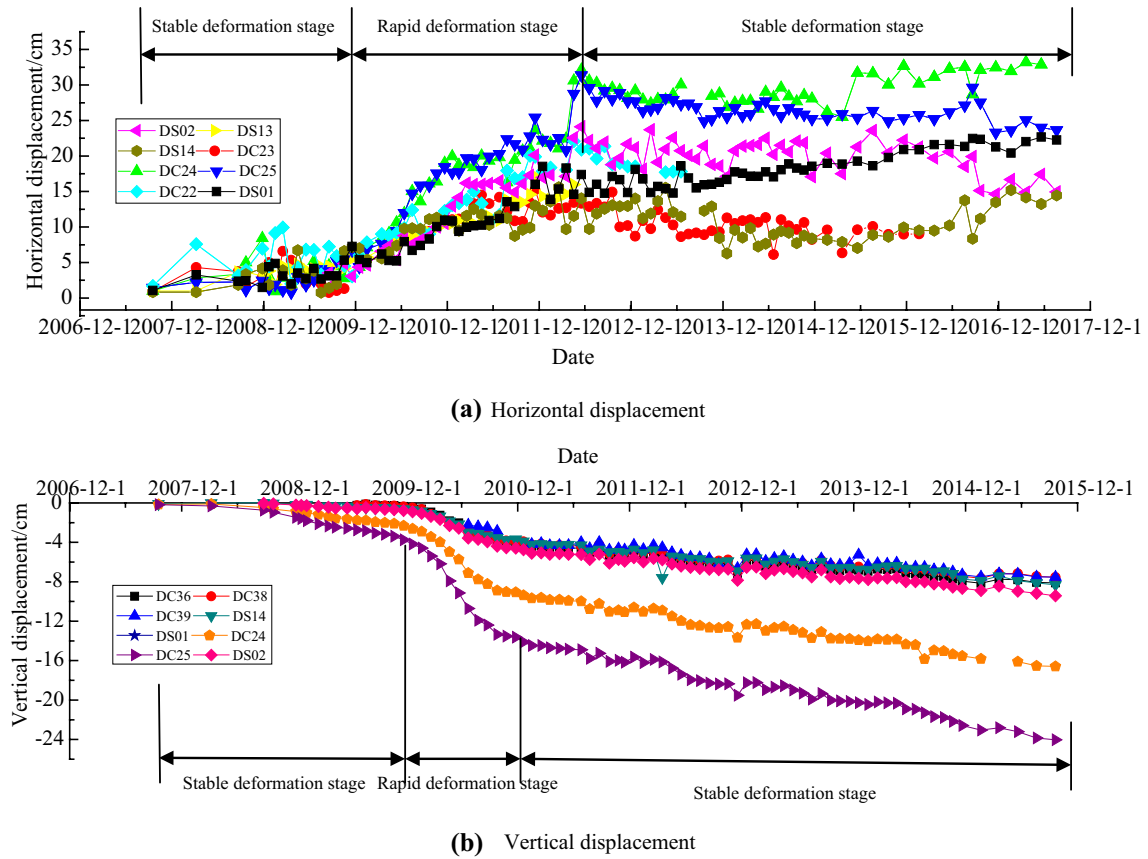
Fig. 6 Cumulative displacement curve over time of monitoring points in the main shaft area

The cumulative displacement curves of the monitoring points in the main shaft area over time (Fig. 6) are S-shaped curves. The curves first increase in a stable manner, then enter a rapid growth phase, and finally increase in a stable manner again. The rapid deformation stage of vertical displacement lasted from December 2009 to December 2010, and the rapid deformation stage of

displacement curves of the monitoring points from August 2007 to July 2017 and the vertical displacement curves from August 2007 to October 2015 in the main shaft area are plotted in Fig. 6. Based on the monitoring results of the cracks in the wall and the machine room, the curves of crack expansion over time are plotted in Fig. 7. The curve of the ratio of the horizontal displacement to the vertical displacement of typical monitoring points is plotted in Fig. 8.

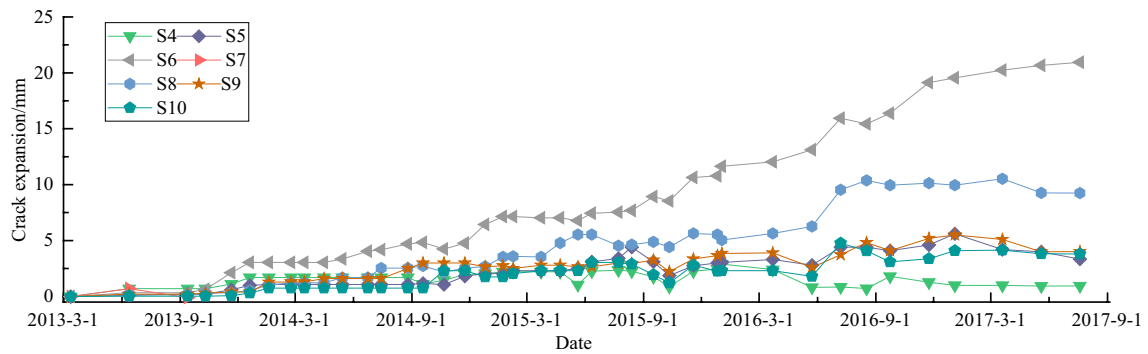
Fig. 7 Curves of the crack propagation of structures in the main shaft area over time

Figure 7 demonstrates that the expansion speed of cracks in key buildings is stable. The width of the fastest expanding crack, S6, expanded by 20.94 mm from March 2013 to July 2017, with an average expansion of 0.57 mm per month. The slowest expanding crack is S4, which had an accumulated expansion width of 0.94 mm and an average monthly expansion width of only 0.02 mm. Figure 6 shows that the surface deformation was stable from March 2013 to July 2017, corresponding to the stable expansion of cracks, indicating that there is consistency between surface deformation and the expansion of cracks in the main shaft area.

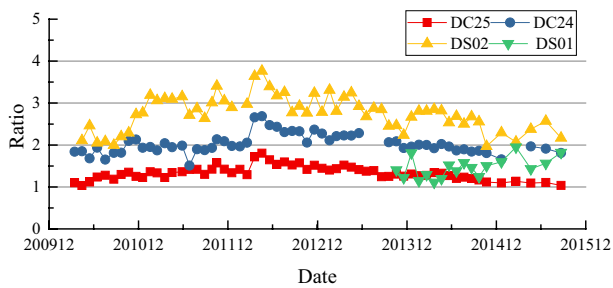
Fig. 8 Curves of ratio of cumulative horizontal-to-vertical displacement over time

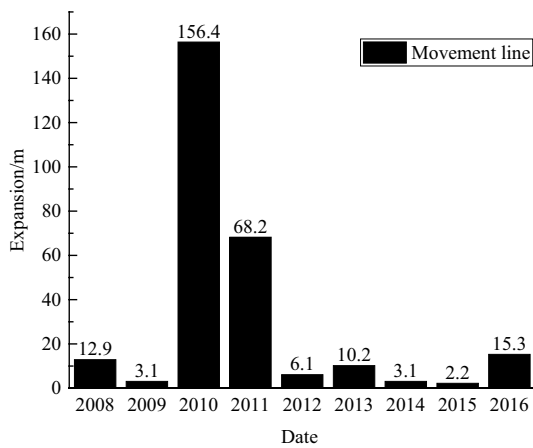
Fig. 12 Histogram of annual expansion of movement line on #I profile

The expansion of the movement line can be seen in Figs. 10 and 12. The movement line expanded slightly in the direction of the main shaft area from December 2007 to December 2009, with a cumulative expansion distance of only 16.0 m. Since 2009, the movement line of the western area expanded rapidly in the direction of the main shaft area. By December 2010, the movement line had reached the machine room of the main shaft but had not yet reached the tower of the main shaft. From December 2009 to December 2010, the expansion distance was 156.4 m, which is 9.8 times the total expansion distance from December 2007 to December 2009. By December 2011, almost the entire main shaft area had entered the movement area (i.e., the

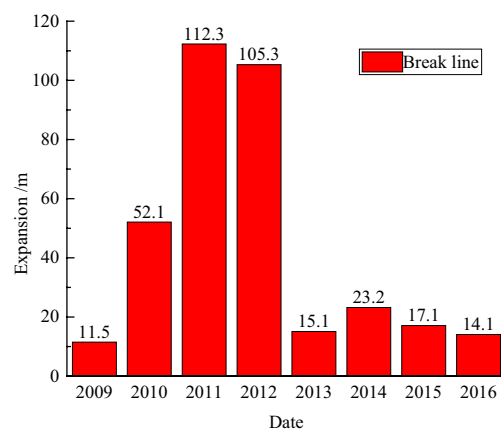
Fig. 13 Histogram of annual expansion of break line on #I profile

The expansion of the break line can be seen from Figs. 11 and 13. The break line from December 2008 to December 2009 expanded by only approximately 11.5 m. From December 2009 to December 2010, the expansion of the break line was approximately 52.1 m, which is 4.5 times the expansion distance from December 2008 to December 2009. From December 2010 to December 2011, the expansion of the break line was 112.3 m, which is 9.8 times the expansion distance from December 2008 to December 2009. From December 2011 to December 2012, the monthly expansion distance was 110.2 m, which is 9.6 times the total expansion distance from December 2008 to December 2009. After December 2011, the expansion of the break line returned to a stable level but continued expanding. By December 2015, the machine room entered the break area (the area within the break line). In December 2016, the shaft entered the break area. From December 2012 to July 2017, the expansion distance of the break line was 69.5 m, with an average expansion of 17.4 m per year.

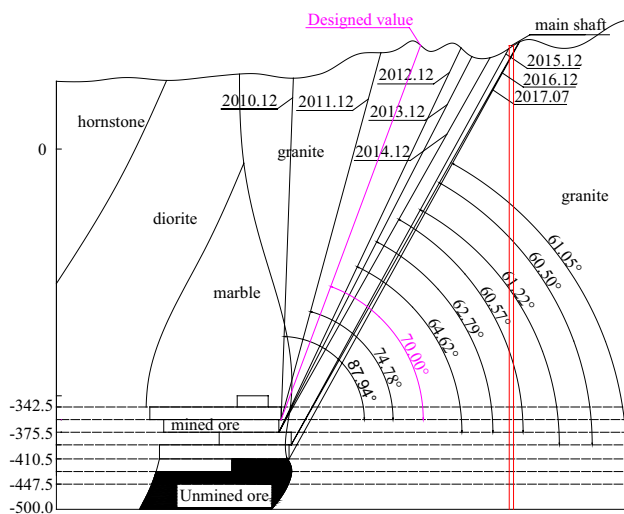
Fig. 15 Break angle of #I profile

2. From December 2010 to December 2011, the break angle changed from 87.94° to 74.76° , decreasing by 13.18° . From December 2011 to December 2012, the break angle changed from 74.76° to 64.62° , decreasing by 10.14° . After December 2012, the decrease rate of the break angle slowed. The designed value of the break angle of the footwall in the western mining area was 70° , which is based on the experience of the eastern mining area. In July 2017, the break angle of the footwall in the western area was 61.05° , which is 9.95° smaller than the designed value. As shown in Fig. 15, the main shaft is outside the designed range of the break angle. When the actual break angle becomes less than the designed value, buildings and facilities originally located outside the break area enter the break area, leading to the abandonment of the main shaft and other facilities.

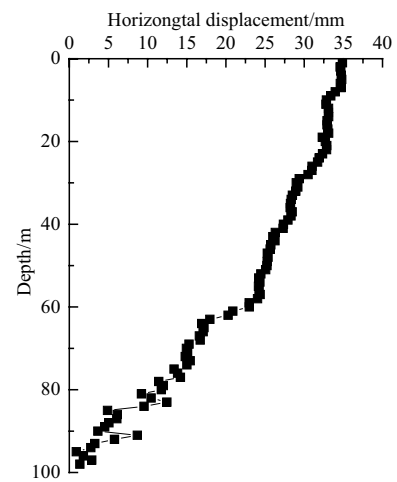
Fig. 16 Curves of the displacement with depth at the drill hole XF3

4. Figure 16 demonstrates that no obvious sliding failure was observed in the deep rock mass in the main shaft area, indicating that the failure mode of the deep rock mass in the main shaft area was not a type of shear slip.

4. The cumulative horizontal displacement of the deep rock mass from August 2011–July 2017, based on the results of deep rock monitoring, is plotted in Fig. 16.

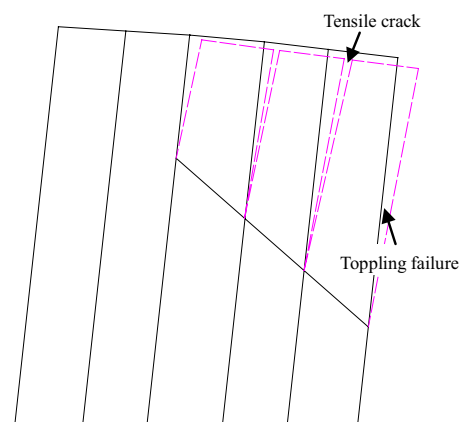
Fig. 17 Schematic diagram of toppling failure

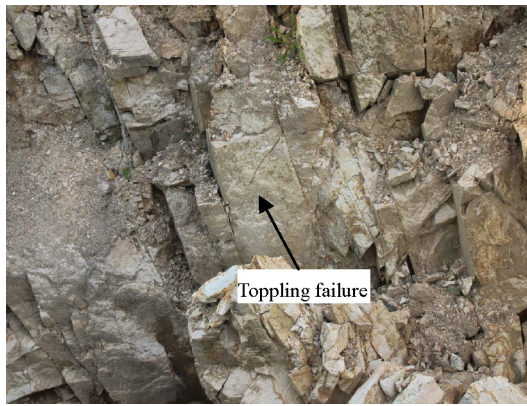
Fig. 18 Toppling failure in the footwall of west area

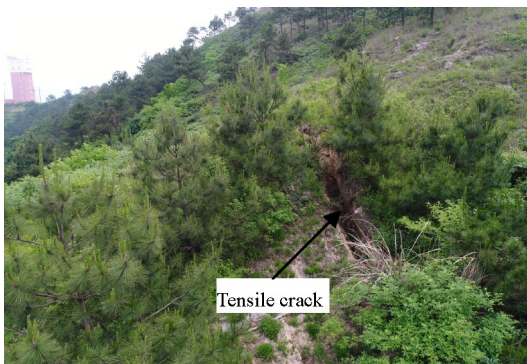
Fig. 19 Tensile crack around main shaft area

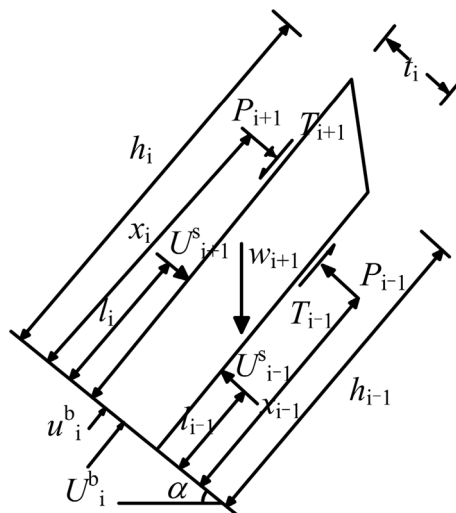
Fig. 20 Free-body diagram of cantilever beam limiting equilibrium model

Based on the free-body diagram of the cantilever beam limit equilibrium model (Fig. 20), Aydan and Kawamoto (1992) derived the following equation:

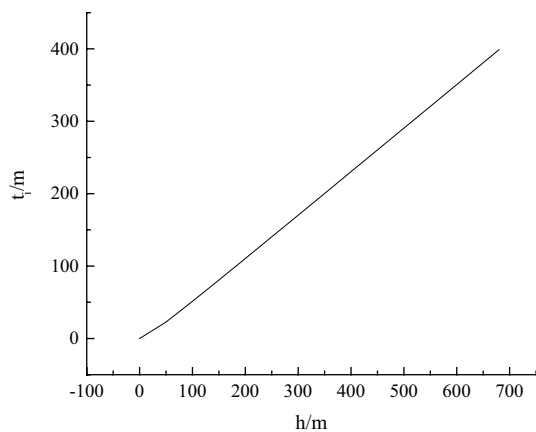
This equation can be solved using MATLAB, and the resulting curve is shown in Fig. 21. By December 2009, most of the ore at the level of -375.5 m in the western area of Chengchao Iron Mine had been mined. At the level of -393 m , only a few ore bodies had been mined in the southern part of the western area (as the mining progressed from south to north). With a mining depth of -375.5 m and an elevation of the ground surface in the main shaft area of 85 m , the calculated height of the cantilever beam is 460.5 m . Figure 21 shows that to prevent the cantilever beam from fracturing, the width of the cantilever should be 266 m , but the actual joint density is $3\text{--}10/\text{m}$. Hence, the toppling failure of the cantilever beam can be considered to have occurred within a distance of at least 266 m from the

Fig. 21 Relationship between h and t_i

When the underground mining depth reaches -600 m, the height of the cantilever beam will reach 685 m, and the width of the toppling failure of the cantilever beam will reach 402 m (Fig. 21).
